FIELD SURVEY AND NUMERICAL ANALYSIS OF 2011 TOHOKU EARTHQUAKE TSUNAMI IN THE NORTHERN PART OF MIYAGI, JAPAN

Tomohiro Yasuda¹, Taro Kakinuma², Takashi Tamada³ and Gozo Tsujimoto⁴

Keywords: Tsunami; post event survey; inundation height; bidirectional tsunamis

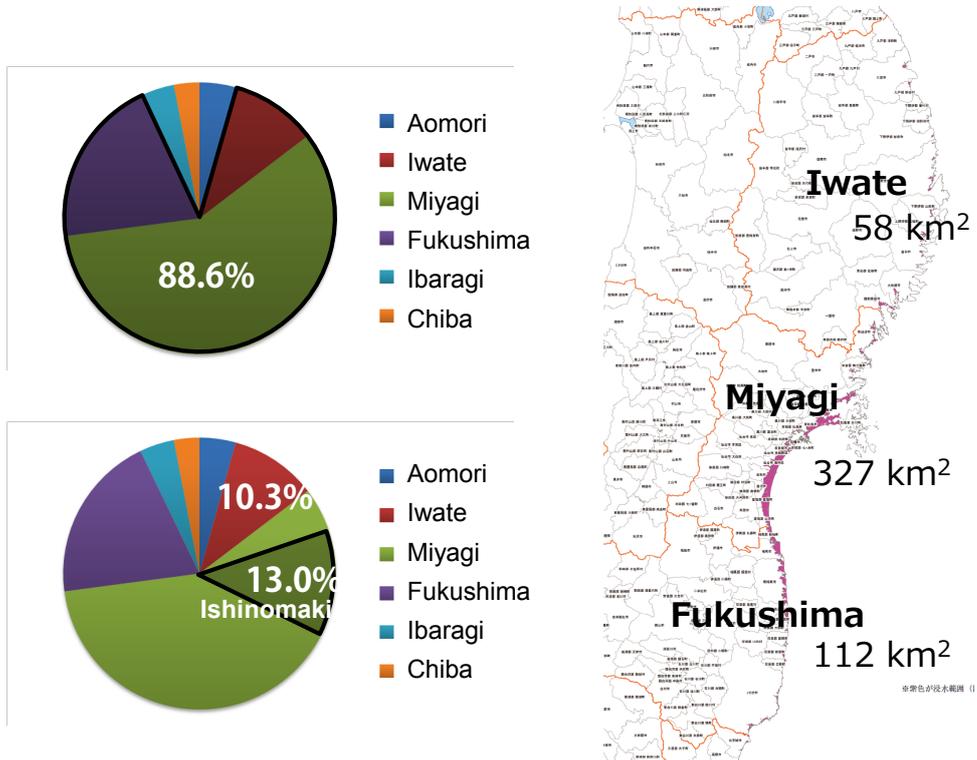
Figure 1. Inundation area caused by the 2011 Tohoku tsunami.

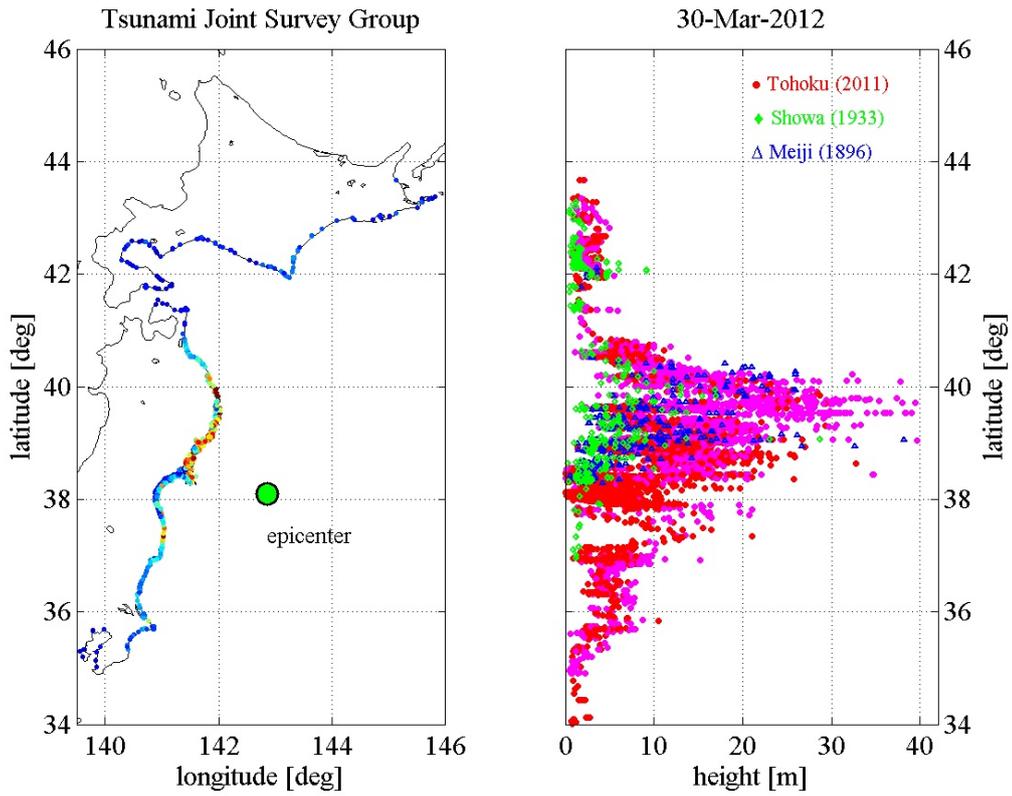
Figure 2. Measured tsunami inundation and runup heights of the 2011 Tohoku tsunami plotted versus latitude comparing with historical tsunami records (Mori et al., 2011).

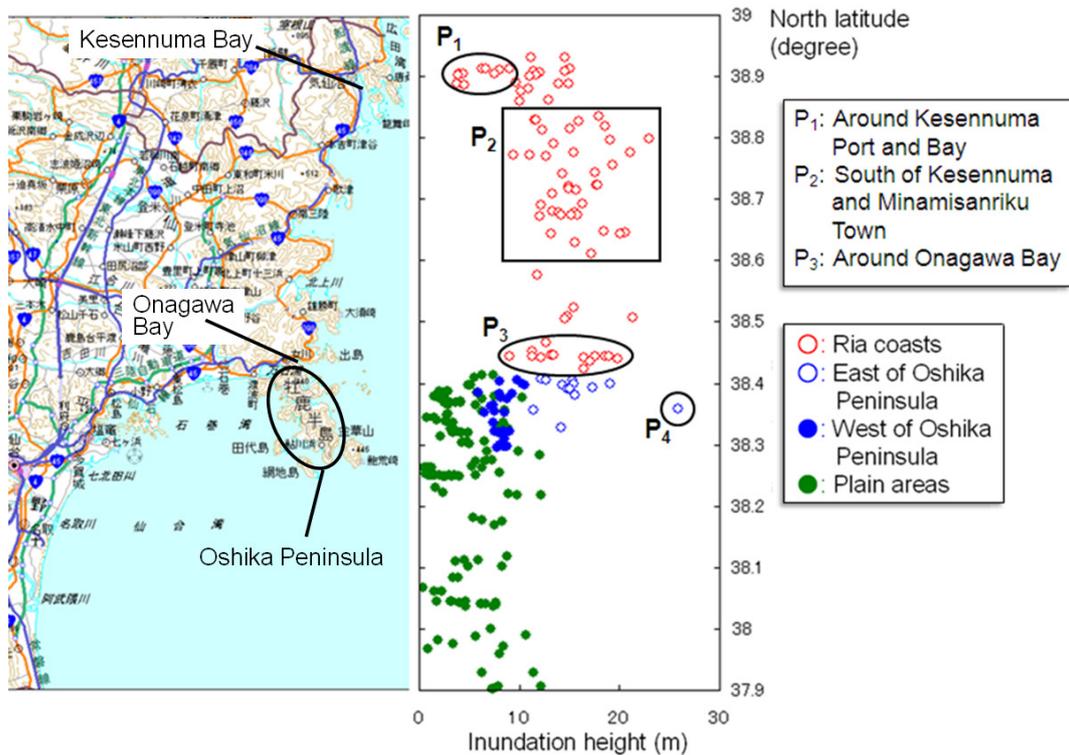
Figure 4. Distribution of inundation height in Miyagi Prefecture. The north latitude in the right-hand side graph corresponds to that in the left-hand side map. The data include a part of the trace survey results obtained by other teams of the JSG (Mori et al, 2012).

Around Kesennuma Port, although the low-ground area was damaged, the inundation height showed rather low level between 3 and 9 m, which are indicated by plots circled with Ellipse P1 in Fig. 4, because the port was behind the Karakuwa Peninsula as shown in Fig. 3. Photo 1 shows a fishing boat with a car, which ran into a house near a port wharf.

The inundation height was high through the coast around Onagawa Bay as shown by the plots circled with Ellipse P3 in Fig. 3, such that Onagawa Town was one of the most damaged places due to the tsunamis. The distribution of inundation height in the town is shown in Fig. 9. The Onagawa Town Hospital located at the center of Circle A shown in Fig. 9 was built on a hill at the level about 16 m above sea level, such that only the ground floor was inundated by the tsunamis, where the maximum inundation depth was 2.0 m.

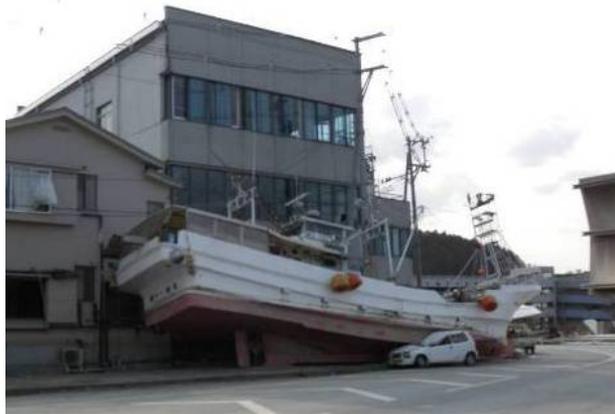
Photo 1. Fishing boat stranded on a road facing Kesennuma Port (The photo was taken on April 2, 2011.).

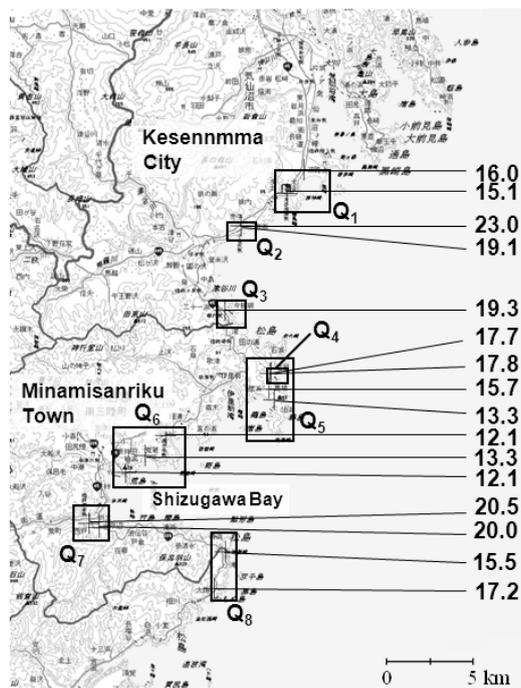
The distribution of inundation height in both the south of Kesennuma City and Minamisanriku Town is shown in Fig. 5. The inundation height was generally larger at bay heads due to concentration of the tsunami energy, as well as promontory tips through refraction of tsunami waves.

Figure 5. Distribution of inundation height measured by the authors in both the south of Kesennuma City and Minamisanriku Town (unit: m).

On house walls (N38°49'39.6", E141°34'42.1") in Hajikamimukaibara facing Oisehama Beach, indicated in the square area Q1 in Fig. 5, tsunami trace lines were marked clearly at the level 16.0 m above sea level. Photo 2 shows houses around there: the second floor of the right-hand side house was swept for a horizontal distance of approximately 50 m to come into collision with the left-hand side house, the foundation level of which was higher than that of the swept house by 2 or 3 m. The house is about 400 m away from the coastline as the crow flies, where the distance from a coastline is described as the direct distance between the place and the coast nearest to it in the present paper.

Inside the hall of Atago Shrine (N38°47'55.6", E141°32'12.1") in Akaushi in the area Q2 in Fig. 5, there were distinct trace lines at the level 23.0 m above sea level, where Atago Shrine was on a hill as shown in Photo 3, about 180 m away from the shoreline.

On walls and windows of a house (N38°45'18.3", E141°31'34.2") in Utou in the area Q3 in Fig. 5, clear trace lines were remained at the level 19.3 m above sea level and about 200 m away from the shoreline. Kurauchi Fishing Port was protected by breakwaters against wind waves but the breakwater height was too low to hinder the higher and longer tsunamis from propagating towards the land.

A sign board showing the inundation level was put on a private-house fence (N38°43'20.6", E141°33'22.3") by an inhabitant of the house on the east of Natari Elementary School, which located in the area Q4 in Fig. 5. The top edge of the plate was at the level 17.7 m above sea level and about 170 m away from the coast. After the attack of the 1933 Showa Sanriku Tsunami, he and his neighbors had moved out their low-ground residential areas to higher hills, where they must cut down tall cedars, such that his house was only flooded just above floor level without breakage.

There were trace lines remained clearly on walls of Shizuham Station on Kesennuma Line as shown in Photo 6, which is located in the area Q6 in Fig. 5. The trace lines of the station were at the level 12.1 m above sea level and about 260 m away from the shore. The tsunami height was over the level of railways, such that Kesennuma Line was heavily damaged: its railway concrete bridges were fallen possibly due to not only horizontal but also uplift force. Iron rails could not be cut easily, resulting in their bending or falling.

Clear trace lines were remained on windows of a house (N38°38'41.1", E141°26'12.1") located on the west side hill at Togura, in the area Q7 in Fig. 5, which level was 20.5 m above sea level and about 450 m away from the coast. According to an interview to a person who was carried by the tsunami flow for approximately 300 m off Togura, many persons had such experiences: another person who promptly rode on a roof of a floating house to take refuge was flown offshore until he was rescued by a fishing boat in the night of that day.

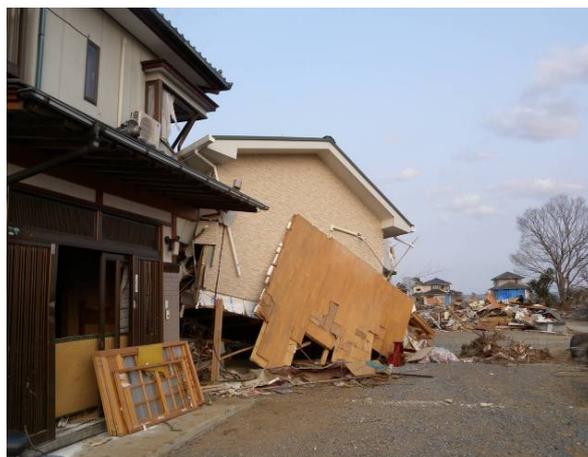
Photo 2. Damaged houses in Hajikamimukaibara, where the left-hand side house was collided with the second floor of the right-hand side house (The photo was taken on April 2, 2011.).

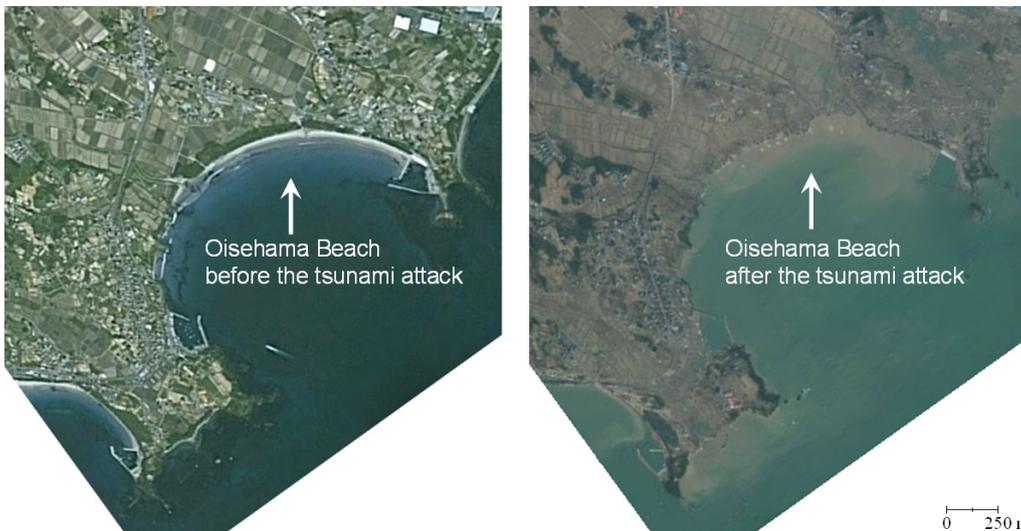
The sandy beaches of both Oisehama Beach and Ooyakaigan Coast seem to have lost sand zones about 50 m wide in the cross-shore direction by comparing before with after the tsunami event possibly due to subsidence of ground or erosion by tsunamis; the satellite photographs of Oisehama Beach before and after the tsunami attack are shown in Fig. 6.

Figure 6. Satellite photographs of Oisehama Beach before and after the tsunami attack (© 2010 Google, © 2011 Cnes/Spot Image, Image © 2011 TerraMetrics).

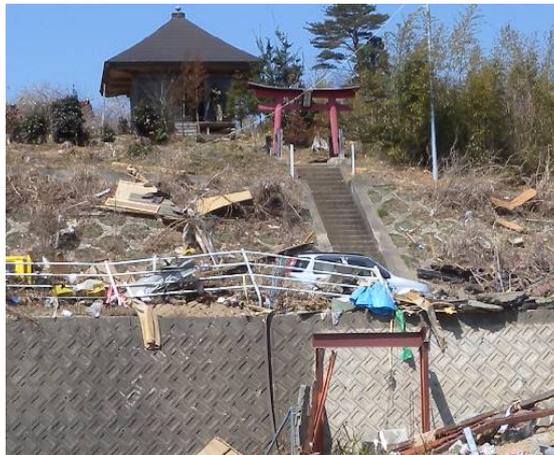
Photo 3. Atago Shrine (N38°47'55.6", E141°32'12.1") in Akaushi (The photo was taken on April 5, 2011).

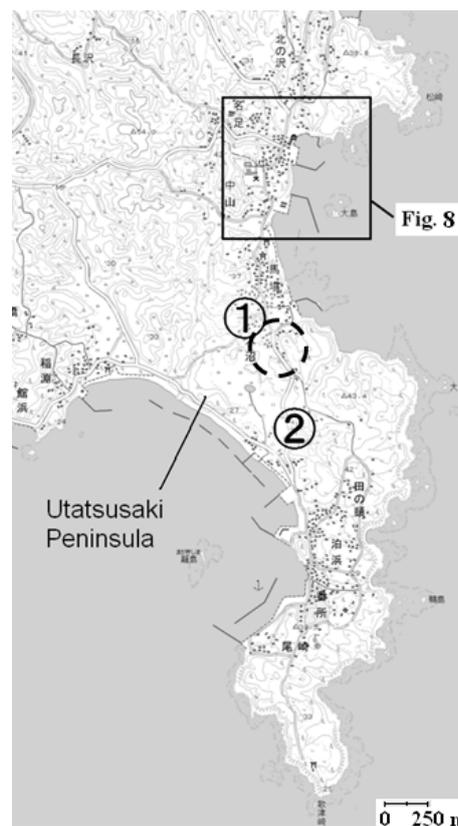
The area Q5 around Utatsusaki Peninsula in Fig. 5 is magnified in Fig. 7. The inundation height at Point ① (N38°42'52.4", E141°33'17.8") in Fig. 7 was just over the plum trees on a cliff slope according to the interview with survivors and a lot of remained debris at the level. It was 15.7 m above sea level, about 290 m away from the coastline. The affected family, whose house has been washed away, never imagined that the tsunamis would reach their house when they were staying out of doors at the level of the house foundation more than 10 m higher than the local mean sea level. They were listening to the tsunami warning through a community broadcast, which said that Japan Meteorological Agency forecasted the tsunami height to be 6 m. This episode warns the lack of current tsunami warning system which misleads the citizens. Although the predicted tsunami height was changed to 10 m before the tsunami runup, the family could not get the updated information because of the crash of the community broadcast system. After they watched approaching tsunami, they assumed it must be higher than expected, and they quickly evacuated to higher ground behind their house. From the elevated spot, they saw the flat water surface from below to offshore for about 20 minutes. Their house was lost in the tsunamis even though their ancestors had moved to the higher place after the 1896 Meiji Sanriku Tsunami. The family was friendly through our interview and looked energetic to blaze a new path to the future.

Figure 7. Utatsu Baba (①: N38°42'52.4", E141°33'17.8") and Utatsu Oiso (②: N38°42'31.8", E141°33'30.1").

The family also observed that in some distance the water surface rose roughly 4 m higher than the water surface below; the place is indicated by a dashed circle in Fig. 7. From this place, a panoramic photo, i.e., Photo 4 was taken to show both the east and west sides of Utatsusaki Peninsula. Several survivors told that bidirectional tsunamis came together from both the east and west coasts of the peninsula, which will be examined through numerical computation in a later section.

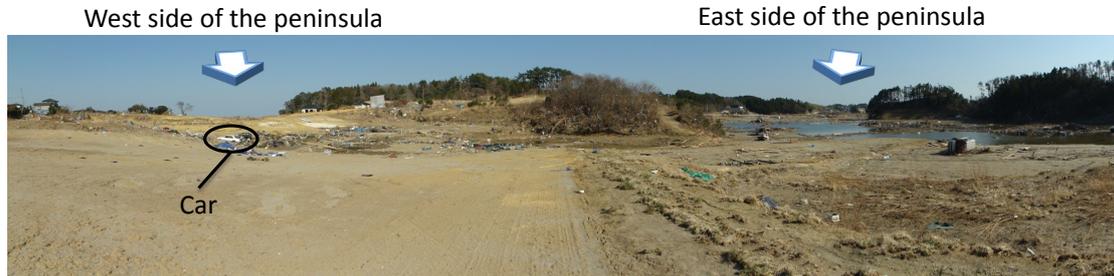
Photo 4. Panoramic view in Utatsusaki Peninsula (The photo was taken on April 5, 2011.).

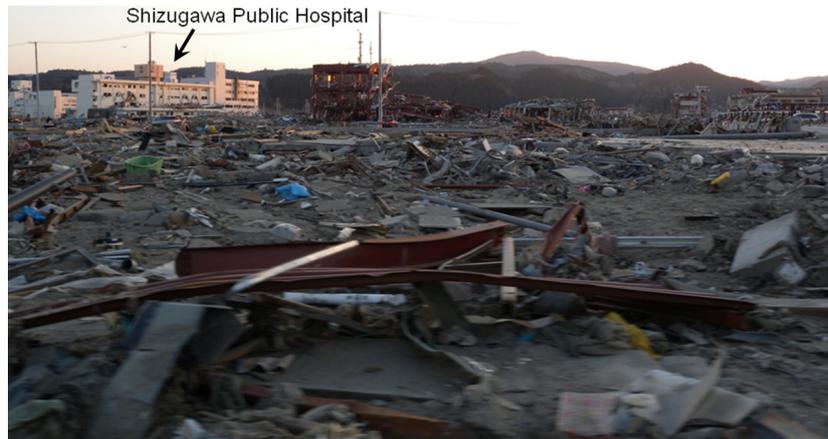
The flooded area in Shizugawa has been in ruins remaining only several reinforced concrete buildings including Shizugawa Public Hospital as shown in Photo 5, where steel frame buildings revealed their fragility. Especially along rivers, the tsunamis mercilessly reached inland far away from the sea: a lot of debris was left at the foot of a hill (N38°41'34.2", E141°25'45.3") along Route 398, which paralleled a river. The maximum runup level was roughly 18 m above sea level through a GPS receiver and about 2.5 km away from the coast.

Photo 5. View of Shizugawa on April 5, 2011.

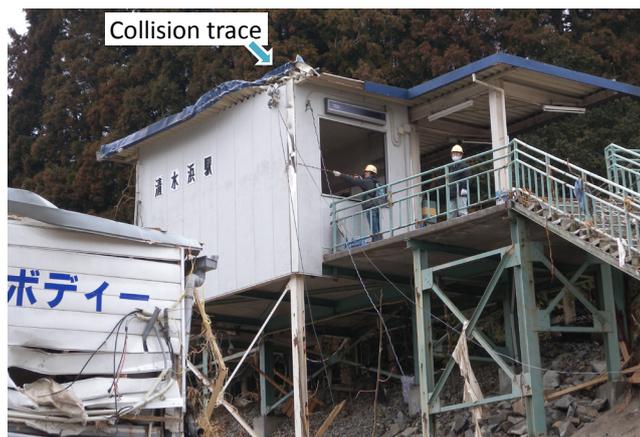
Photo 6. Tsunami traces on the building of Shizuhama Station (The photo was taken on April 3, 2011.).

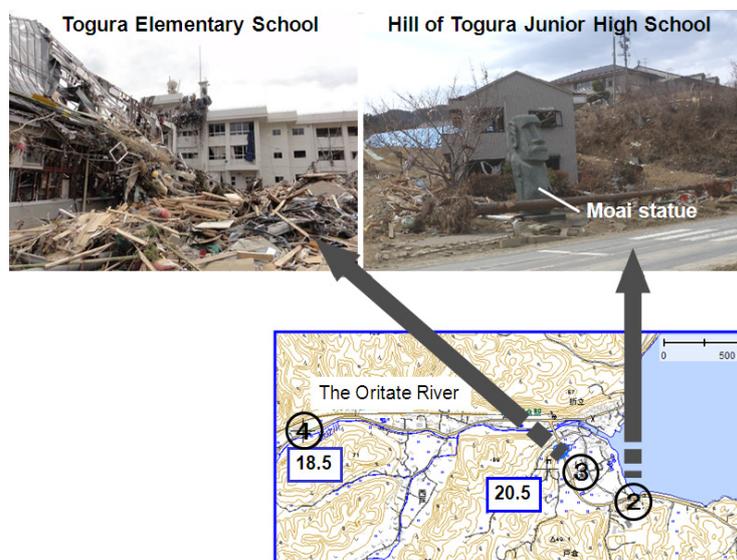
Fig. 8. Two public schools in Togura (The photos were taken on April 3, 2011. The unit of inundation height in the map is meter.).

It should be noted that parapets of coastal seawalls were left near the elementary school, which means that they were flown and delivered for about 100 m from the coastline. Along the Oritate River, the inundation height showed a large value even inland, i.e., 18.5 m above sea level at Point ④ in the map of Fig. 8 about 2 km away from the river mouth.

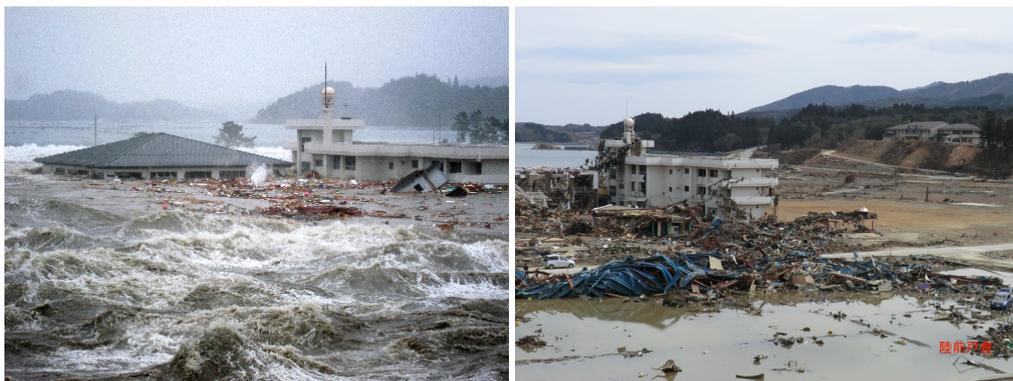
Trace lines were distinctly drawn on the ground-floor windows of Togura Junior High School (N38°38'33.9", 141°26'35.6"), where the inundation height was at the level 20.0 m and about 70 m away from the shoreline. Togura Junior High School was located on the south side hill of the town. The moai statues were built at the foot of the hill as the memory of the 1960 Chilean Earthquake Tsunami as shown in the right-hand side photo of Fig. 8. The maximum 'inundation depth' at the junior high school was only 1.7 m, while Togura Elementary School stood at the low-lying area in the middle of the town district as shown in the contour map of Fig. 8, which resulted in oyster shells left on the rooftop of the three-storied building of the elementary school due to the tsunamis as shown in Photo 7.

Photo 7. Situation of Togura Elementary School on March 11, 2011 and perspective of two public schools in Togura (Left photo was taken by a resident and right photo was taken by the authors on April 3, 2011.).

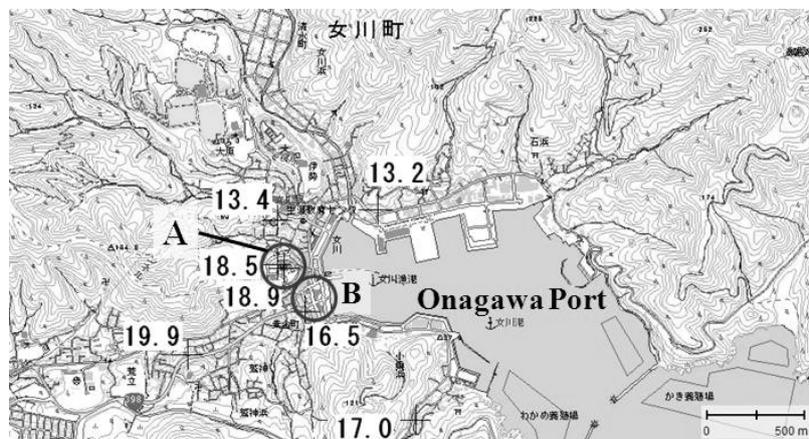
Fig. 9. Distribution of inundation height in Onagawa Town (The unit of inundation height is meter.).

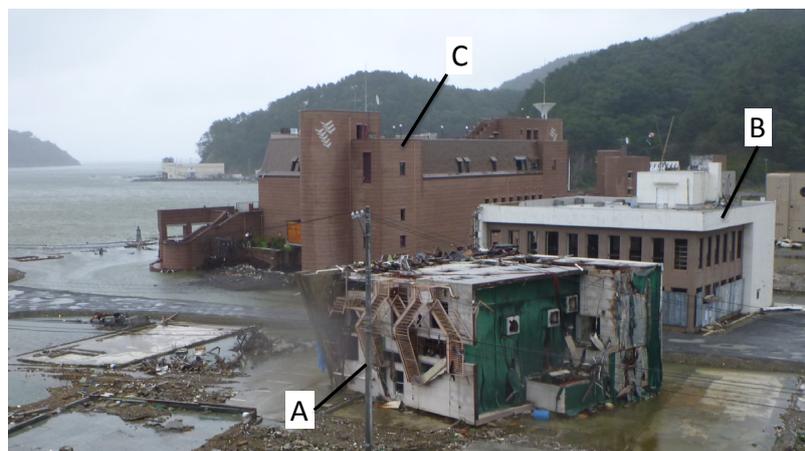
One of the significant features of damage in Onagawa Town was collapse of many reinforced concrete buildings, which are mentioned also in Suppasri et al. (2012) and Mikami et al. (2012). An example is shown in Photos 8 and 9: Building A was toppled and carried as shown in Photo 8 and the bottom of its foundation was revealed as shown in Photo 9 with foundation piles pulled out. The Buildings A, B, and C are in Circle B on the map of Fig. 9. The reason why Building B behind Building C, i.e., the north wing of Marinpal Onagawa, which was a facility for sightseeing and shopping, survived is not clear without information on conditions of structure, foundation, etc. but such a robust building as Building C is expected to play a role of a barrier to reduce tsunami force and current. It should be noted, however, that large velocity can be developed in a narrow space between strong structures as a big tsunami passes, resulting in, for example, local scouring between the north and south wings of Marinpal Onagawa as shown in Photo 10.

Photo 8. Example of damaged reinforced concrete buildings in Onagawa Town, where Building A is toppled down not behind Building C, i.e., the north wing of Marinpal Onagawa (The photo was taken on September 21, 2011.).

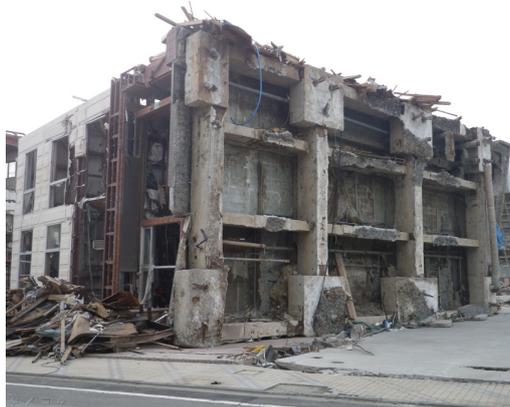
Photo 9. Foundation bottom of Building A in Photo 10 (The photo was taken on April 26, 2011.).

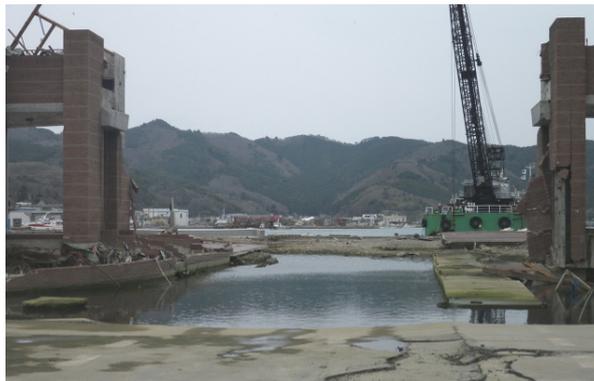
Photo 10. Local scouring between two wings of Maripal Onagawa (The photo was taken on April 26, 2011.).

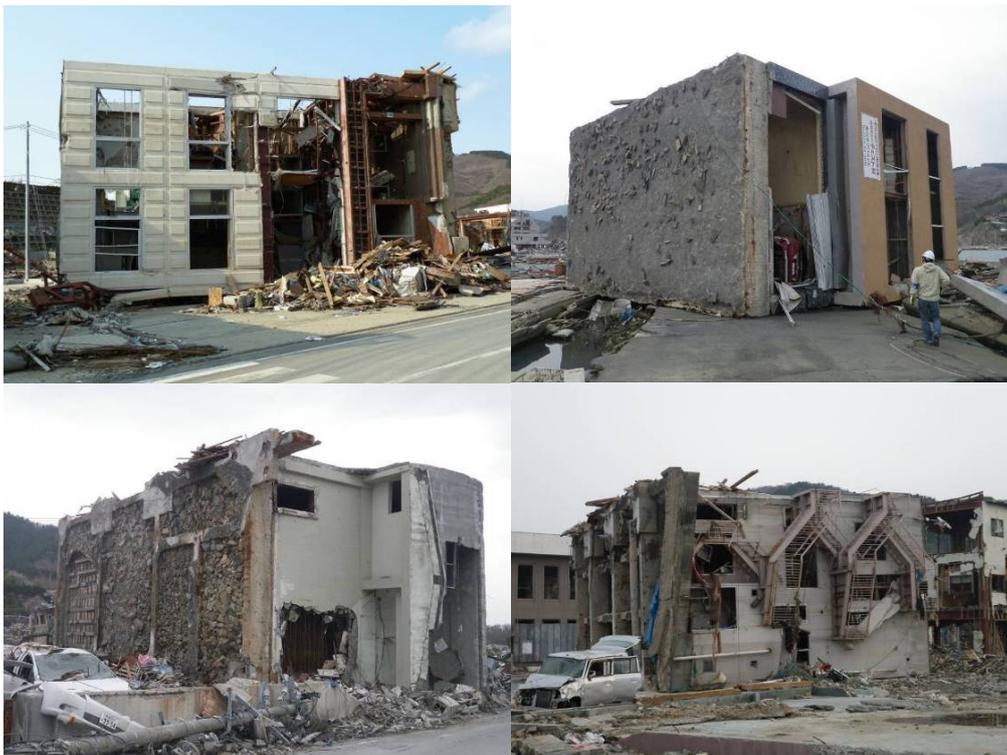
Photo 11. Examples of reinforced concrete buildings collapsed in Onagawa Town (The photos were taken on April 26, 2011.).

Other examples of reinforced concrete buildings collapsed in Onagawa Town are introduced in Photo 11. Reinforced concrete buildings are often used as shelters; in fact the south wing of Marinpall Onagawa was designated as an evacuation building against tsunamis but the huge tsunamis propagated over it. Future work is required to elucidate the mechanism of fall or collapse of structures due to seismic oscillations, soil liquefactions, forces of repeating water current, sand motions, and aging of the structures.

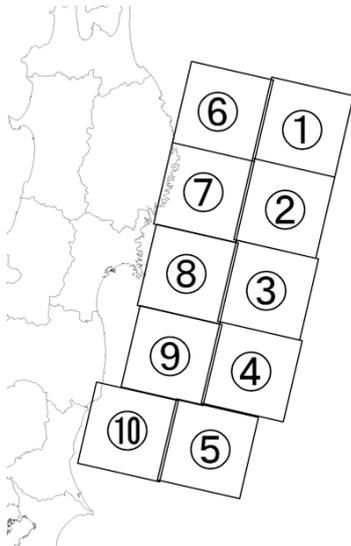
Several survivors observed tsunamis coming together from both the east and west coasts of Utatsusaki Peninsula as mentioned in the previous section. The bidirectional-tsunami propagation over the peninsula has been simulated through a numerical model based on nonlinear shallow water equations. Four computation domains of different mesh resolution, i.e., 1350 m, 450 m, 150 m, and 50 m, are nested in that order. The initial profile of water surface over dislocation is assumed to be the same as the permanent shift of seabed calculated through the method of Mansinha and Smylie (1971) using the fault model presented by Tohoku University (Imamura et al., 2011). The fault is divided into ten segments as shown in Fig. 10, where the length, width, strike, dip, and rake of all the segments are 100 km, 100 km, 193°, 14°, and 81°, respectively. The other parameters are shown in Table 2. The bottom friction is treated by choosing Manning's roughness between $0.025 \text{ m}^{-1/3}\text{s}$ and $0.04 \text{ m}^{-1/3}\text{s}$ considering the land use. The dry and wet model by Iwasaki and Mano (1979) is utilized to simulate tsunami runup. The time development is carried out using the leap-frog finite difference scheme with the staggered Arawaka C-grid (Arakawa and Lamb, 1977). The time interval Δt is equal to 0.5 s satisfying the Courant number condition.

Fig. 10. Segments of the fault model (Imamura et al., 2011).

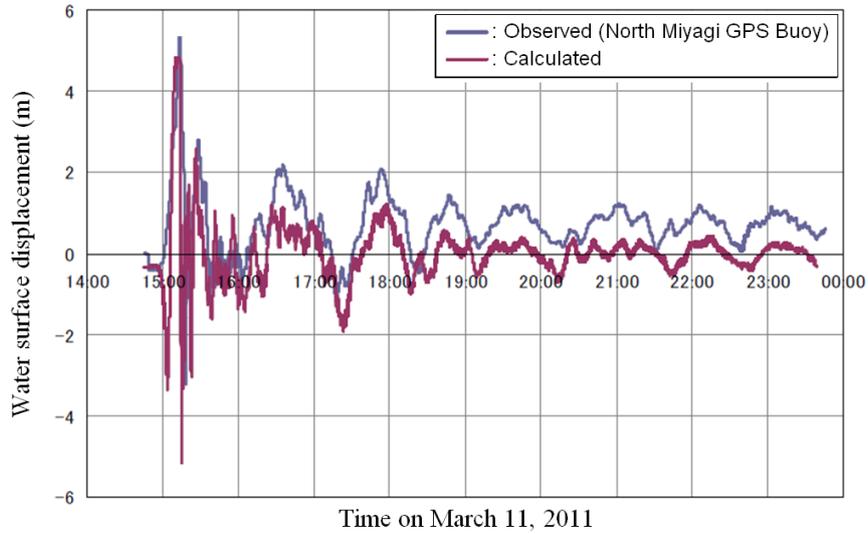
The calculation result of water surface displacement at the position of North Miyagi GPS Buoy is shown in Fig. 11 in comparison with the observed data through the GPS buoy (Kawai et al., 2011), where the buoy was located at the point (N38°51'28", E141°53'40") and the water depth was about 160 m. Calculation results of time variation in water level at Points 1-10 in Fig. 12 are shown in Fig. 13, according to which the maximum inundation depth is larger than 10 m at Points 1, 2, 3, 6, 8, 9, and 10. The first peak reaches the east coast of the peninsula and passes over Points 1-6, after that the inundation depth is 1.7 m at Point 7, where no tsunami has come yet from the west coast. About 7 minutes later than the first peak appears at Point 1, Points 8-10 on the west coast are attacked by the tsunami coming from the west or south, while the second peak appears at the east coast and travels towards the southwest. Then the first tsunami from the west coast and the second tsunami from the east coast come together around Point 3 or 4, which is consistent with the interviews, although the

Fig. 11. Numerical result of water surface displacement at the position of North Miyagi GPS Buoy in comparison with the observed data through the GPS buoy (Kawai et al., 2011).

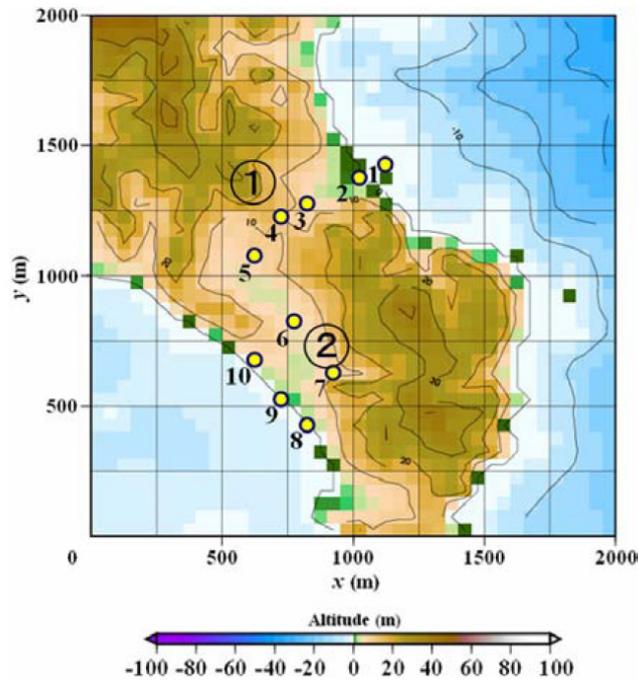
Fig. 12. Altitude in a part of Utatsusaki Peninsula. Points ① and ② are the same places as those in Fig. 7 in that order.

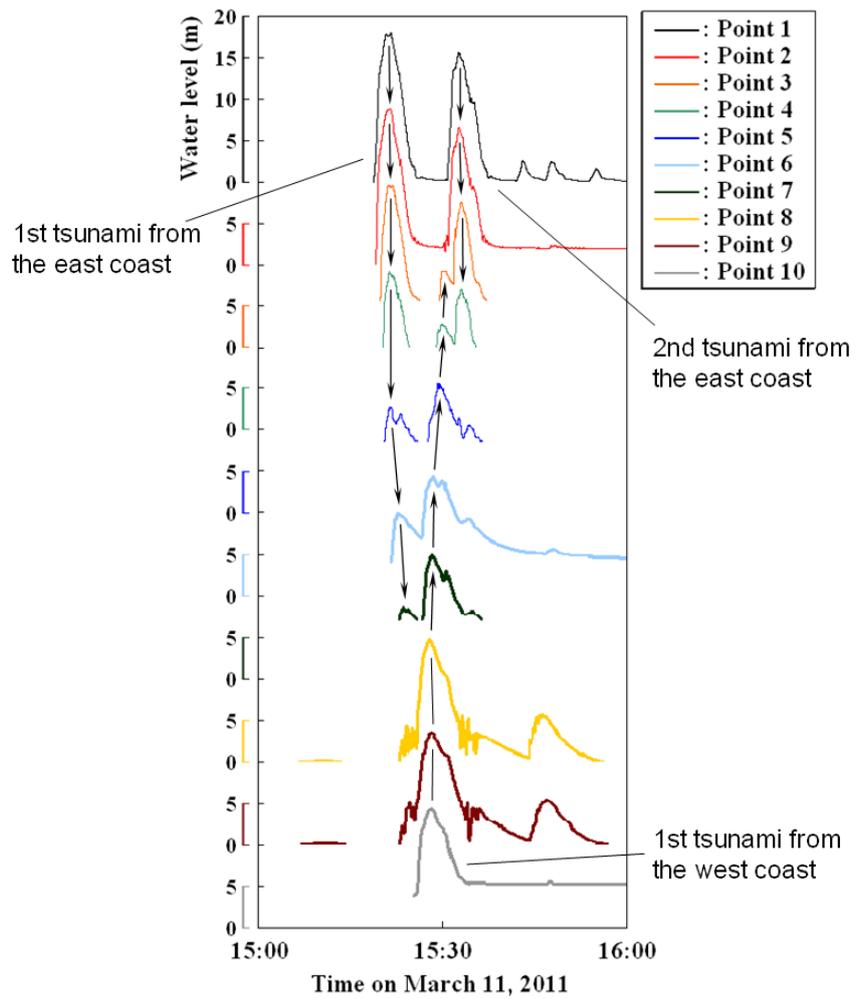
Fig. 13. Numerical result of time variation in water level at each point indicated in Fig. 12.

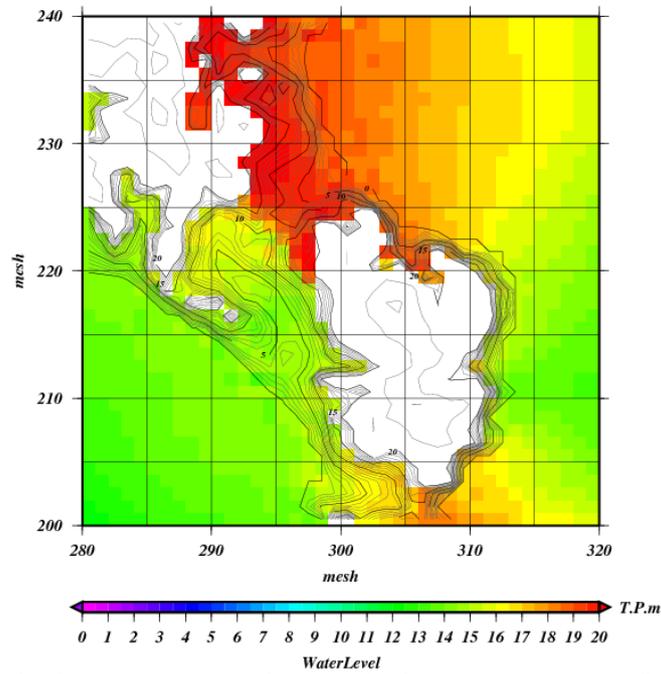
calculation results depend on the fault model. The distribution of the maximum calculated inundation height in the area of Fig. 12 during the tsunami event is shown in Fig. 14, where the maximum inundation height is between 15 and 20 m in the area and higher on the east than on the west of the watershed of peninsula, which agrees with the field survey results referring to the interviews to survivors.

Fig. 14. Numerical result of the maximum inundation height in the area shown in Fig. 12.
