SINGLE-LAYER BREAKWATER ARMOURING: FEEDBACK ON THE ACCROPODE™ TECHNOLOGY FROM SITE EXPERIENCE

Keywords: rubble-mound breakwater; single-layer armouring; ACCROPODE™ units; biodiversity

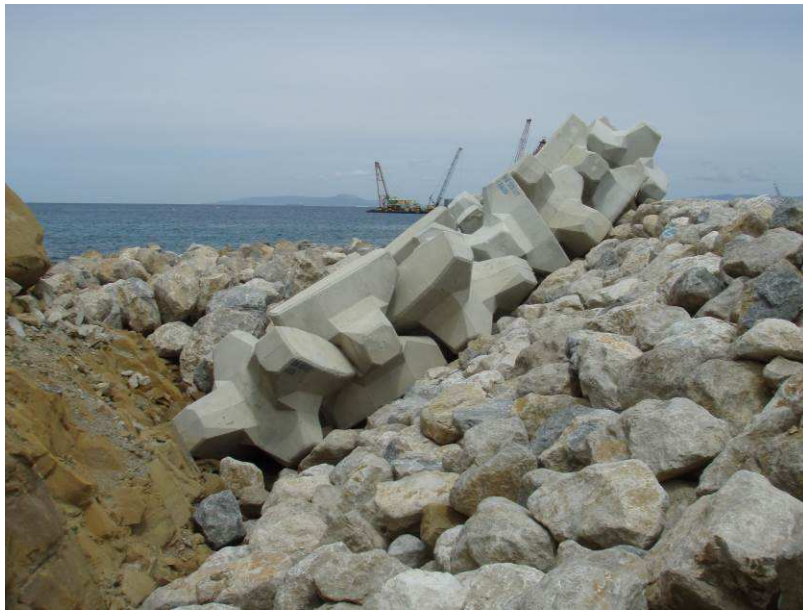
Figure 1. Construction of single layer armouring made of ACCROPODE™ units.

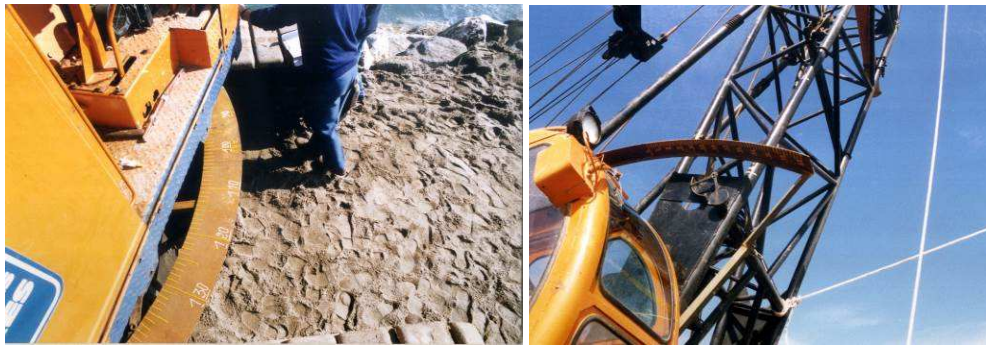
Until the middle of the 90's positioning systems were also much less accurate than those used nowadays. One of these systems consisted in welding a compass on the crane and a sort of plumb line on the boom in order to know the distance and the direction (see Figure 2). Polar coordinates for locating the units were then used while taking into account the accurate location of the center of the crane.

Figure 2. Compass frame welded on the crane (left) and frame for the vertical angle of the boom (right).

These systems are no longer in use today and digital systems with satellites have replaced the former mechanical systems. Most of the contractors use georeferenced coordinates. They allow for obtaining the coordinates instantly thanks to DGPS and RTK systems. As a result, the accuracy of the coordinates together with the new practices for the underwater placing have broadly improved both the quality and the productivity of the armour units placing.

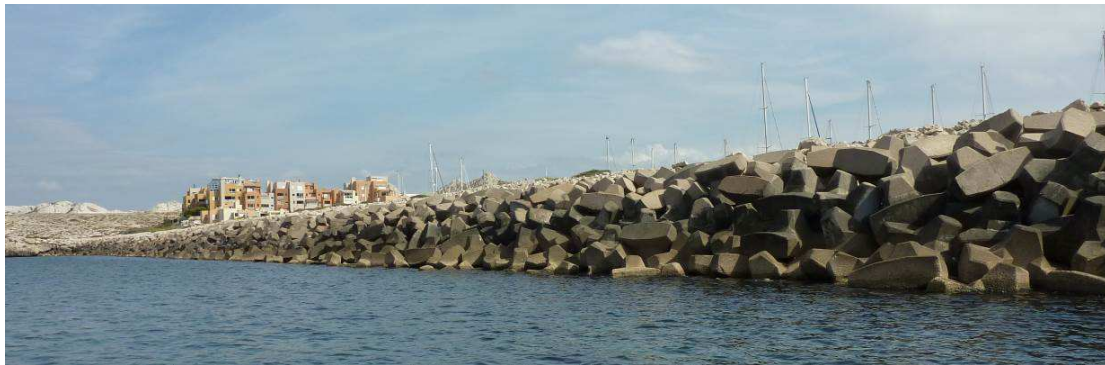
and dry/wet alternating cycle is continuous. The armour layers are in a correct alignment. There is no evidence of misalignment of the armouring, see example in Figure 4.

The units are contained within a single layer envelope and very few units are slightly out of profile. (A unit is considered to be out of profile when it is more than 1/3 of its size out of the mean alignment).

The armour layers do not present any major loss of packing density where gap could have been seen. The units are still fairly interlocked with each other (exceptions have been seen, but most of the units are interlocked). The basic “diamond shape” pattern is generally observed (leading to one unit interlocked between two units of the row below), but not systematically. Through the year and thanks to this diamond shape arrangement, the units have not formed “columns” of units along the slope. The diamond shape acts as a spring allowing for the units to re-arrange themselves without creating arcs or bulbing profiles. Randomness of units placing is generally present, but it is not always the case in all areas of the breakwaters. Some areas present lots of similar unit orientations, but this does not seem to strongly affect the stability of the area. The units remain well interlocked even in this case and after several decades on these positions. Through the years and under wave action, the armour units tend to flatten their orientation (axis of the noses becoming vertical). This is also due to the initial placing carried out in the early eighties when the units were placed more systematically with the axis of the noses slightly vertical.

Figure 4. Le Frioul breakwater, in the South of France, built in 1984.

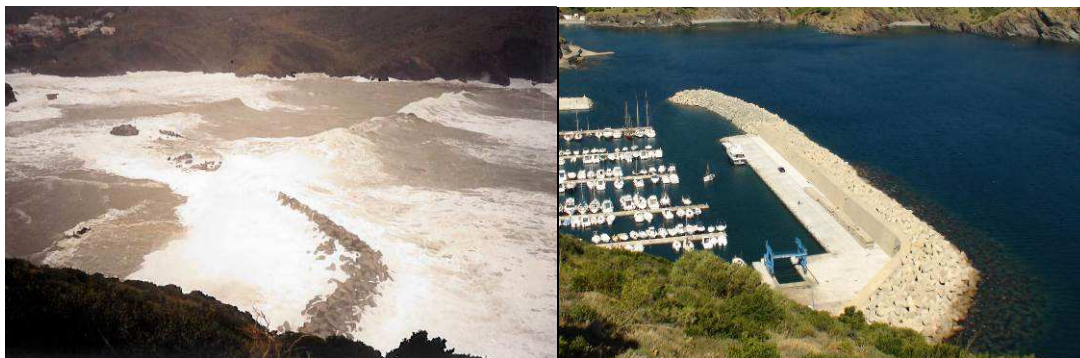
Very few units were found to be extracted out from these armour layers. Some have nevertheless been seen. It was not possible to identify where the extracted units were coming from in the armour layer as no obvious scars were visible. It was not possible either to determine if these armour units were extracted after the completion of the construction or during the construction itself by misplacing the units. Very few units are found to be broken. The condition of the structure’s toe reinforcement with rocks was observed to be efficient and prevents the units from moving away. The first row of ACCROPODE™ units is generally well locked in the trench or by the rock toe reinforcement. The placing of the armour units was correctly carried out by taking into consideration the importance of the interlocking above and below water. For example, the port of Port Bou completed in 1998, was built with the help of divers and it is clearly visible when inspected the structure that the interlocking of the units was a priority. This structure was significantly impacted by storms (see Figure 5, left) during its construction and since its completion. However the structure is still in good condition (Figure 5, right).

Figure 5. Storm during the construction of the Port Bou site (left) and Port Bou after completion (right).

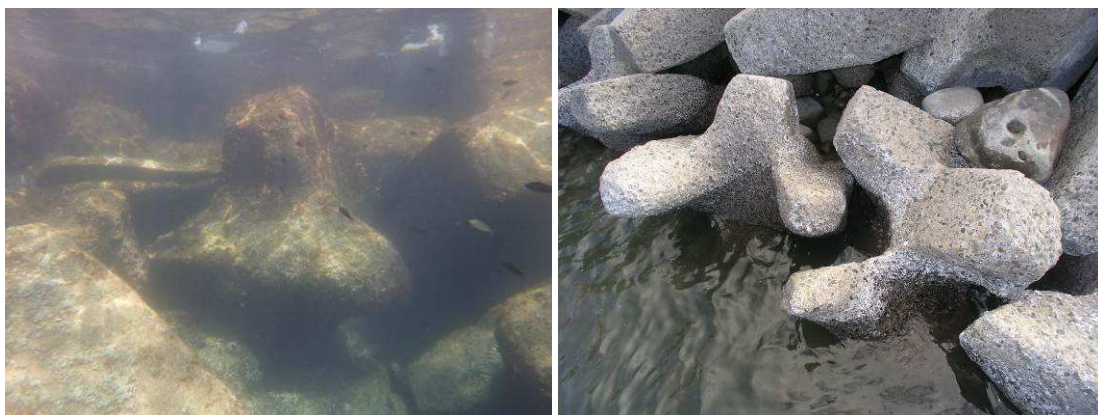
Most of the concrete alterations are believed to be the results of significant and repetitive movements. Most of the reported damage is believed to be caused by mechanical action rather than chemical action induced by the sea water. The armour units can be rounded and sharp edges have mostly vanished. Such action can be caused by the sand and small rocks moving continuously around the units. It was the case for the former Grand Rivière port built in the 80's (see Figure 7, right).

Such alteration can also be the result of low of packing density. When the interlocking is not sufficient, the units may be subjected to move. If these units are rocking continuously, they become worn out and scratch on the other neighboring units. As a result, the units loose small pieces of concrete and tend to be rounder (Figure 7, left).

Figure 7. Unit not interlocked, rounded shape (left). Units worn out by mechanical action of the sand and small rocks projected by the waves (right).

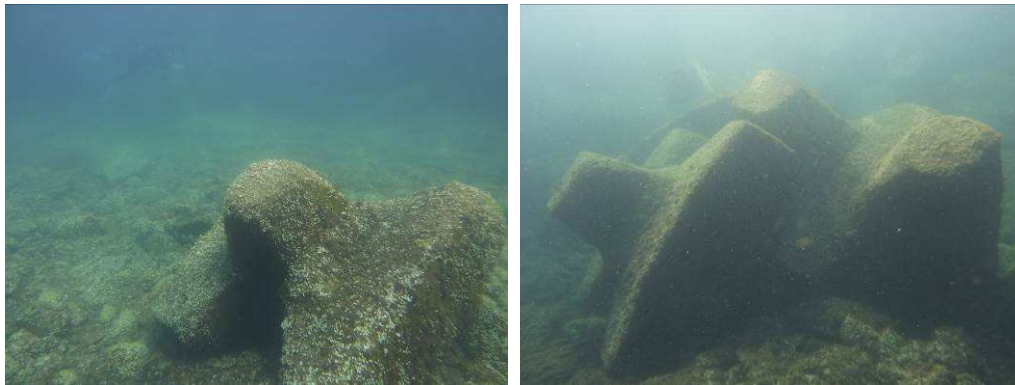
On several breakwaters, extracted units have been observed. Their number is variable from one to several units and sometimes they have been observed in groups. The extraction of one unit does not systematically imply major loss of density and damage. It was observed that the gap left by one unit is sometimes self-healed, and sometimes not. Such evolution depends on the interlocking and the possibility of the units above the gap to re arrange themselves and fill the gap. Surprisingly the units located around the gap do not systematically show evidences of movement. They seem not to having moved at all and the gap is still there. The underlayer is sometimes clearly exposed, but no sign of underlayer rock extraction have been seen on the inspected structures.

In some cases, several units have been found extracted. It has been observed several single units extracted along the breakwater but also groups of extracted units. (Figure 9, right). The armour layer where these units have been extracted are generally significantly damaged as the low packing density also leads to some units' breakage as explained above.

Figure 9. Single extracted unit laying on the seabed (left), group of extracted units (right).

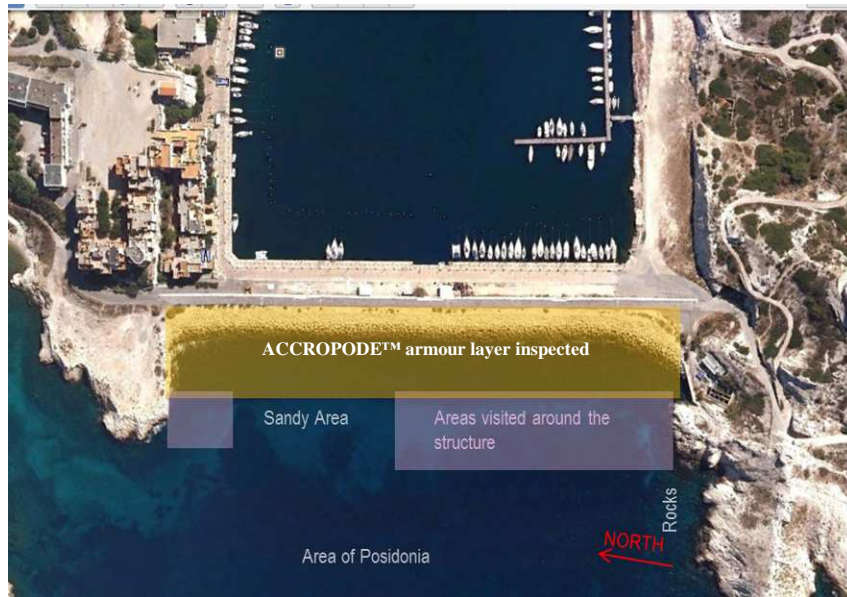
The inspections have been conducted either by transects or by static station for observing the fauna and flora. Depending on the size of the structure, similarly to the observations carried out for the structure stability, parts of the armouring could be observed only. The observations were always starting from the natural environment around the structure. An inventory of the species present around the structure was carried out. Then the bedding layer was inspected (when present), followed by observations on the toe reinforcement and the armour layer underwater. For the deeper water structures the total height of the armouring was split in several zones, since there are significant differences in marine growth depending on the depth. For the shallower structures the differences in terms of colonization of the armour layer along the slope were limited, hence only one or two areas were considered. Photos and videos were recorded in order to identify a posteriori the observed species. As an example, Figure 12 below shows the areas that were inspected on the Le Frioul breakwater (France).

Figure 12. Inspected areas on the Le Frioul breakwater.

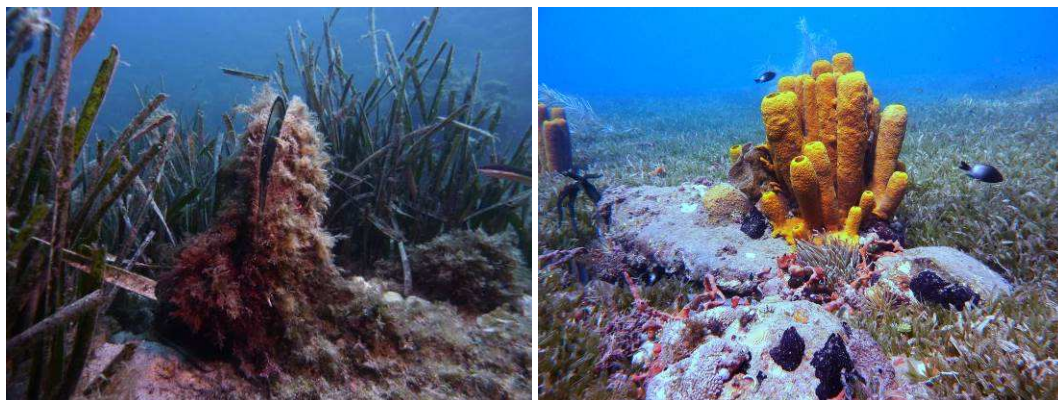
The inspected structures were built on various substrates. Some of the structures are located in sandy areas where the local biomass is limited, whereas some are located near coral reefs where biodiversity is very important. Several breakwaters are close to sea grass areas such as the protected posidonia in the Mediterranean sea or other types of sea grass (e.g. *Thalassia Testudinum*, Figure 13, right) in the Caribbean waters. Protected and rare species have been reported next to some of the structures. For example, in Le Frioul islands next to Marseille, *Posidonias Oceanica* and giant naclres (e.g. *Pinna Nobilis*, Figure 13, left) have been observed right at the bottom of the breakwater. Some breakwaters are built next to coral reefs, such as in the south of Dominican Republic or in Mayotte Island. The seabed is covered with small corals and cnidairae such as sponges. In both cases, there is a real discontinuity in terms of marine life colonization between the natural and the artificial environment created by the breakwater. As a first observation, the breakwater acts either as an attractive shelter for marine species or on the opposite remains totally artificial and poorly colonized. The differences in marine life between the natural and the artificial environment are more obvious on the sandy areas, where the number of species and taxons varies a lot. This is far less the case when the structures are placed on a coral reef. The figures here below are two illustrations of environment found during the inspections.

Figure 13. *Pinna Nobilis* protected species close to the Frioul brekwatater (left), surroundings of the Bellefontaine terminal (right).

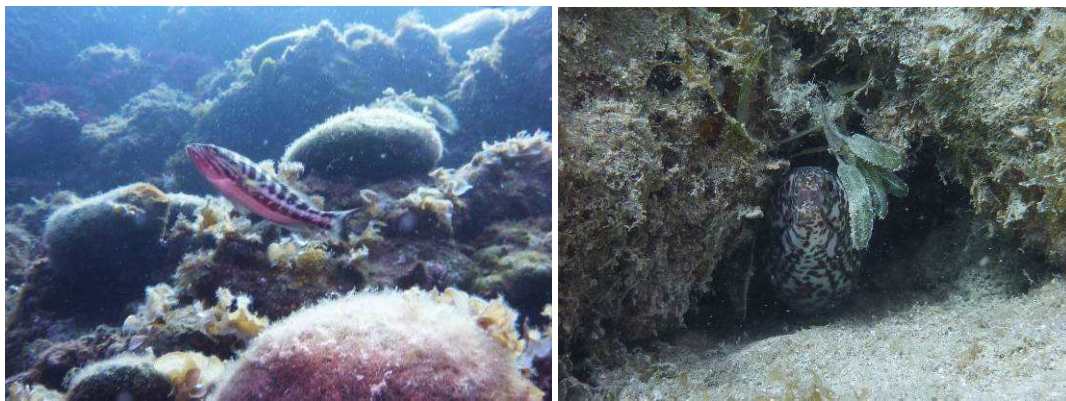
Bedding layers seem to offer more shelters than any other part of the structure for numerous species. Lot of juvenile organisms, (mainly represented by fish and crustaceans) are present in this part of the structure. Small predators also hide in the bedding layers holes such as morays and groupers (Fig 14) For an example, the breakwater of le Frioul is an interesting case since toe berm at the bottom of the structure made of smaller stones is highly colonized by marine organisms. Complex ecosystems have settled and developed on these small rocks. Complete trophic chains are present on the Frioul breakwater, from the pioneers organism producers and different levels of predators. Small species of groupers come to feed on the marine organisms present on the rocks. They can find both shelter and food.

Figure 14. Grouper on the basement in Le Frioul, South of France (left), moray (*Gymnothorax Moringa*) in Saint Martin in the French Caribbean (right).

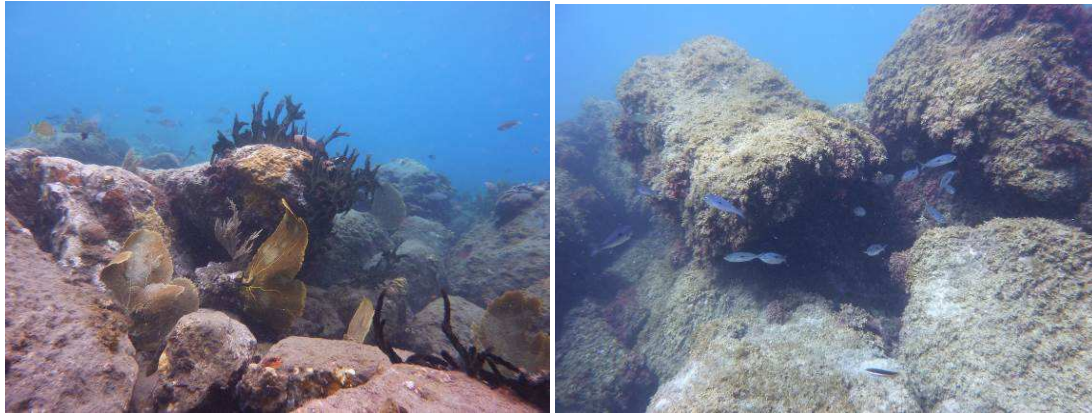
The inspected toe berms in the Mediterranean Sea are mostly covered by algae and chlorophyts (Figure 15, right). Small benthic organisms feed on these sea weeds as well as fish. The structures in the Caribbean waters are mostly colonized by fans, sponges, corals (Figure 15, left).

Figure 15. Toe reinforcement in Case Pilote (Martinique) (left) and toe berm reinforcement rocks in Pointe Rouge covered of algae (south of France)(right).

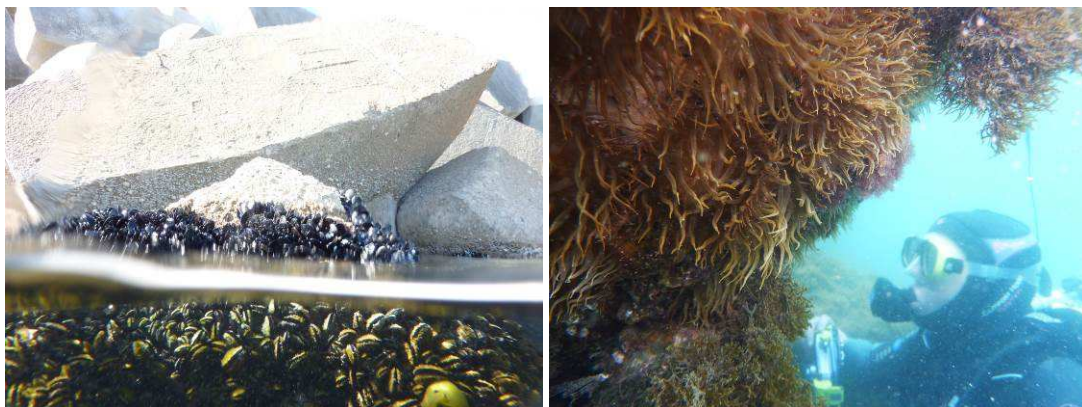
In the colder waters, all of the visited armour units have a thick layer of chlorophits on their exposed faces to the sunlight. The others faces in the shade, are mostly colonized by cnidariae such as sponges, small corals, anemones see fig 16 on the right side. Starfish, octopus, nudibranches, gastropods use the lower faces of the units during the day and leave for finding food at night. On several inspected armour layers, mussels have grown next to the water level see Fig 16 left side. The units act as favorable support for the larvae to settle, but they mostly are small individuals. Fishers and mussels grower frequently come to collect small mussels.

Figure 16. Mussels on the armour unit (left) and Shaded face of an armour unit colonized by anemone in the South of France (right)

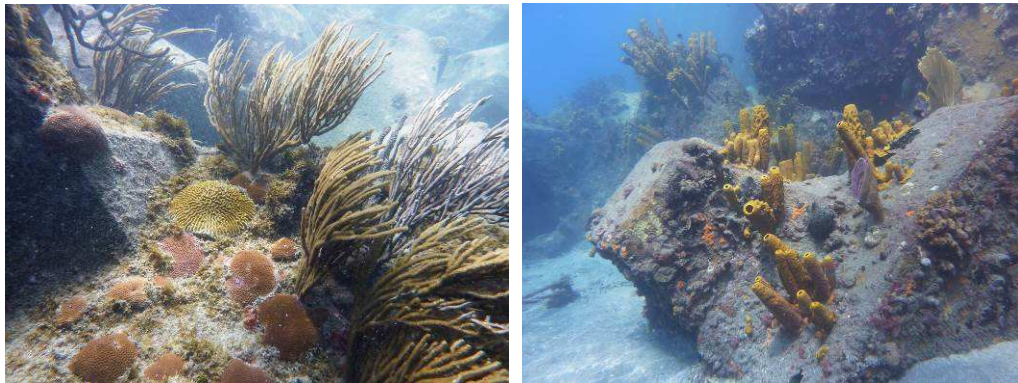
good support to grow. Coral colonies have been observed on all of the inspected structures located in warm waters. Soft and hard corals have been observed as well as spongiaridae developing directly on the concrete units. The spongiaridae are differently represented on a given structure, in function of their exposure to the waves. Massive corals can develop in the most exposed areas of the breakwater apart from the run up/down zone. The extension of the area colonized by corals depends on the continuous agitation of the waters. Most of the structures do not present any or very few species of corals between 0 and -2m. However when the normal agitation is low, coral can grow next to the water surface and develop much better than other places on the armour layer by looking for sunlight close to the sea level. It is the case for example in the structure or Le Marigot in Saint Martin where large *Acropora Palmata* coral colonies (Figure 19, right) have been observed. Some of these colonies grown on the armour units themselves are larger than 2,5m in diameter at a depth of 1.5m below the surface. In these two areas (Bellefontaine and Le Marigot), the daily agitation is very limited. This allows corals and sponges to grow as it was observed at Bellefontaine Terminal, see Figures 17 and 18.

Figure 17. Soft and hard coral colonies at St Martin, 2m in depth (left) and colonization on the first row of units (5m depth) at Bellefontaine terminal.

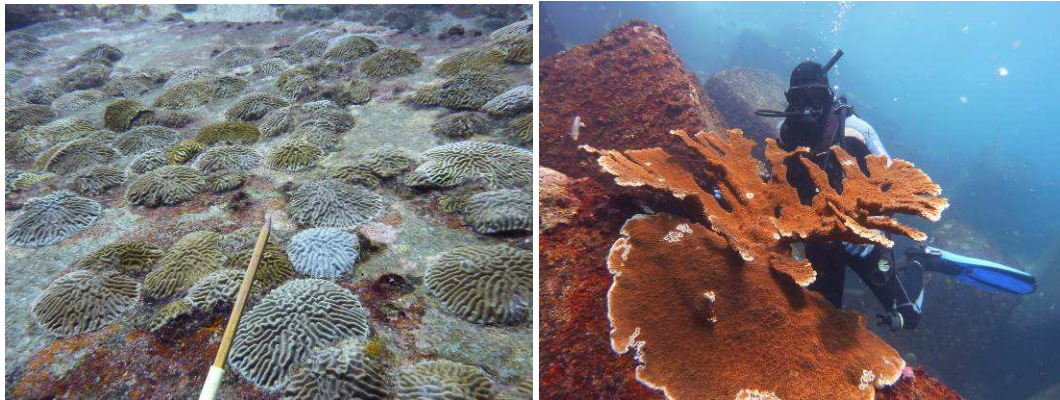
In some of the inspected sites like in the south of Dominican Republic, corals have developed below -3m because of wave agitation. Almost no coral colonies were observed on the range between the water level and 3m in depth. Most of the colonies have been observed from -3m to -12m. Examples of coral colonies are shown in Figure 19.

Figure 19: Massive corals at 10m below water (left), *Accropora Palmata* (right), both in Dominican Republic.
