RECOVERY OF SANDY BEACH BY GRAVEL NOURISHMENT - EXAMPLE OF NINOMIYA COAST IN KANAGAWA PREFECTURE, JAPAN

Keywords: Gravel nourishment; Ninomiya coast; BG model; beach changes; groins

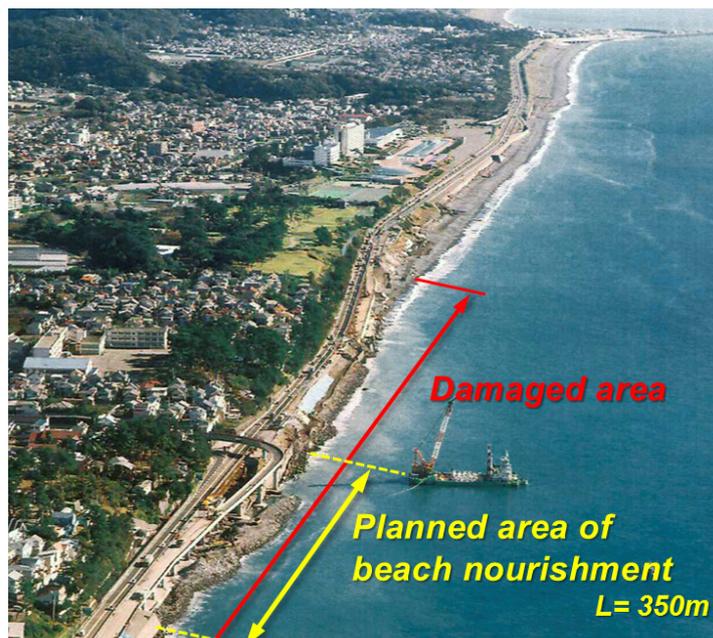
Fig. 2. Oblique aerial photograph of damaged Seisho Bypass taken on November 13, 2007.

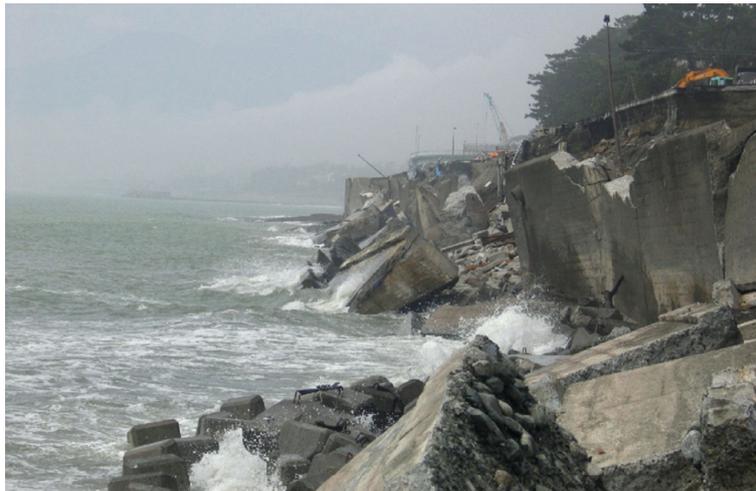
Fig. 3. Collapse of Seisho Bypass owing to storm waves associated with Typhoon 0709 hit on September 8, 2007.

Storm waves associated with Typhoon 0709 hit the Seisho coast facing Sagami Bay, as shown in Fig. 1, on September 7, 2007, resulting in severe erosion over an extensive area. In particular, the seawall protecting the Seisho Bypass was severely damaged and collapsed over a length of 1.1 km near the Oiso Interchange, as shown in Figs. 2 and 3, closing the highway to traffic for a long time (Serizawa et al., 2009). Serizawa et al. (2009) showed that the erosion of the coast was primarily triggered by the selective discharge of medium-size sand from the beach composed of both sand and gravel by offshore sand transport associated with the storm waves. After the storm, part of the medium-size sand transported offshore returned to the foreshore under normal wave condition. Although these beach changes were observed, part of the beach sand was assumed to be transported westward by longshore sand transport, and finally discharged into the deep sea through the submarine canyon offshore of the Morito River located 5 km west of the damaged area, as shown in Fig. 1, causing a net loss of sand. In the damaged area of approximately 1 km length on the Ninomiya coast, where the sandy beach has entirely disappeared and houses are located immediately behind the coastline, beach nourishment using coarse materials was planned to recover the sandy beach and prevent wave overtopping as a countermeasure against beach erosion (Fig. 2). In this plan, the beach width in front of houses to be recovered was determined to be 30 m, which was the necessary beach width to prevent wave overtopping. In the beach nourishment, high stability was required for the nourishment so as not to damage the highway again even in the case of storm wave action. In this study, the recovery of the sandy beach by beach nourishment using coarse materials was investigated using the BG model (a three-dimensional model for predicting beach changes based on Bagnold's concept) proposed by Serizawa et al. (2006).

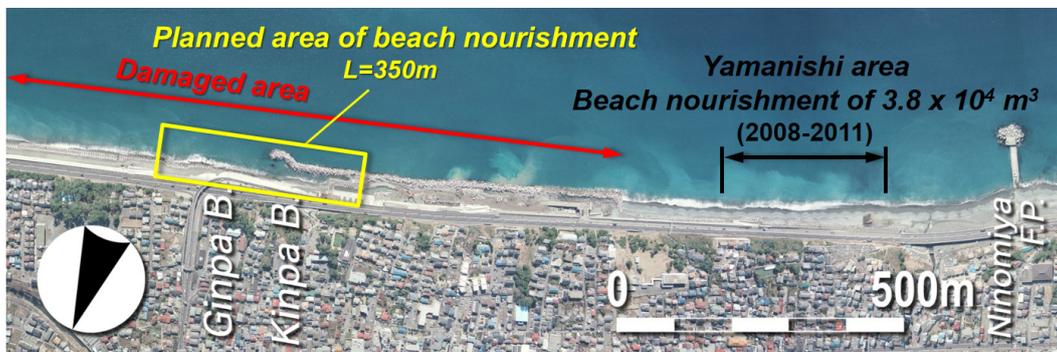
Fig. 4. Location of Yamanishi area where beach nourishment using coarse materials was carried out.

The 690 m stretch of the Yamanishi area between the west end of the damaged area of the Seisho Bypass and the Ninomiya fishing port had been eroded over time, although no erosion was reported during Typhoon 0709. The Kanagawa Prefectural Government carried out beach nourishment using coarse materials containing a large amount of gravel from March, 2008 as a measure against beach erosion. In this beach nourishment, nourishment materials were placed on the backshore along a length of 250 m immediately east of Ninomiya fishing port, as shown in Fig. 4. A total of $3.8 \times 10^4 \text{ m}^3$ of beach nourishment materials, which were transported from the Sakawa River, was used for nourishment between March 2008 and March 2011, which were initially placed forming a mound. The nourishment materials contained 40% gravel, and 60% fine and medium-size sand, as shown in Fig. 5. After the nourishment, a scarp was formed on the seaward slope of the m

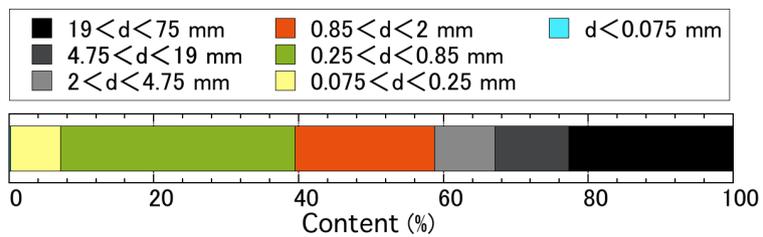
Fig. 5. Composition of beach nourishment materials used in Yamanishi area.

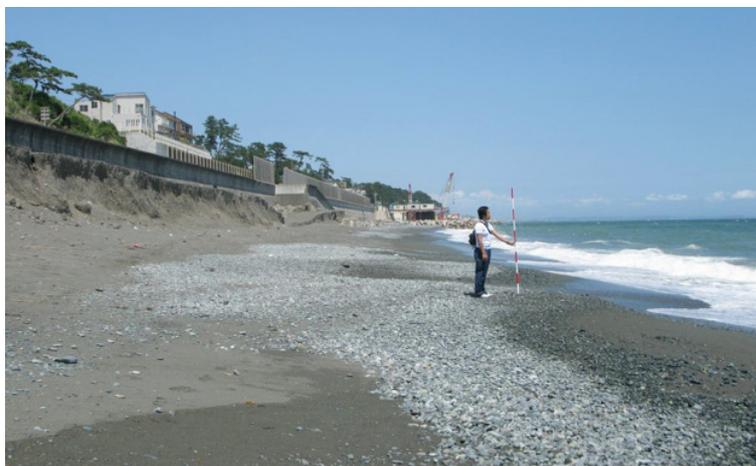
Fig. 6. Deposition of gravel on foreshore after nourishment (July 12, 2011).

ound, whereas gravel was selectively deposited on the foreshore, forming a berm because of the high gravel content, as shown in Fig. 6.

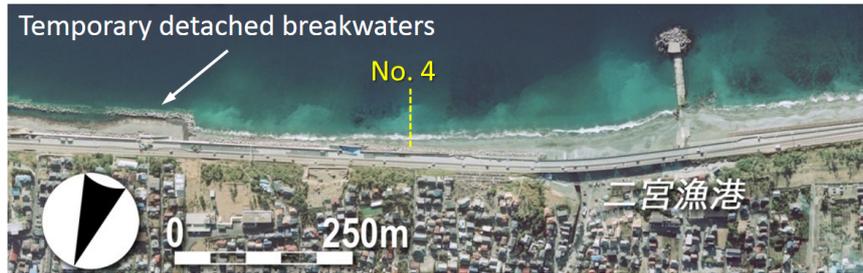
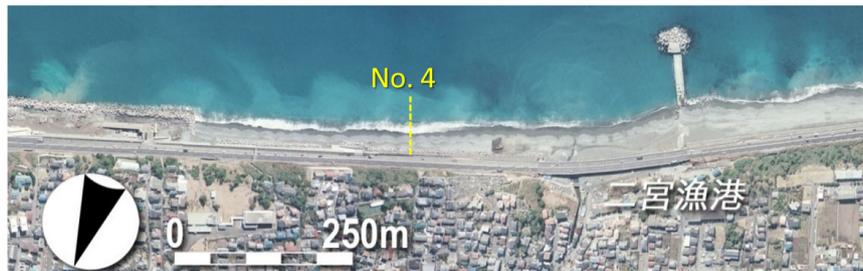
(a) After Typhoon 0709, Jan. 2008

(b) After Completion of beach nourishment of $3.8 \times 10^4 \text{ m}^3$ on March 2011

Fig. 7. Shoreline changes of Yamanishi area between January 2008 and March 2011.

Figure 7 shows aerial photographs of the Yamanishi area taken on January 2008 after Typhoon 0709 and on March 2011 after the completion of beach nourishment of $3.8 \times 10^4 \text{ m}^3$. In January 2008, detached breakwaters had already been constructed at a depth of 4 m along the coastline for the recovery works of the damaged highway. It can be seen that the foreshore width increased between January 2008 and March 2011 by comparing the beach width along transect No. 4, as shown in Fig. 7.

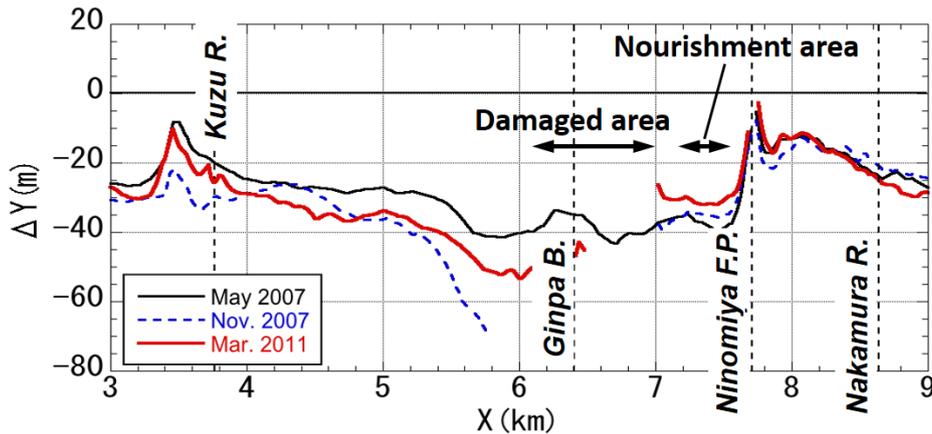
Fig. 8. Shoreline changes between Ninomiya fishing port and Kuzu River mouth with reference to shoreline in 1947.

Figure 8 shows the shoreline changes between 2007 and 2011 with reference to the position of the natural shoreline in 1947. The shoreline in the Yamanishi area had retreated by 2007 with a maximum recession of 40 m with reference to that in 1947. Although the retreated shoreline remained at the same location until November 2007, the shoreline had advanced by 10 m by March 2011 because of the beach nourishment.

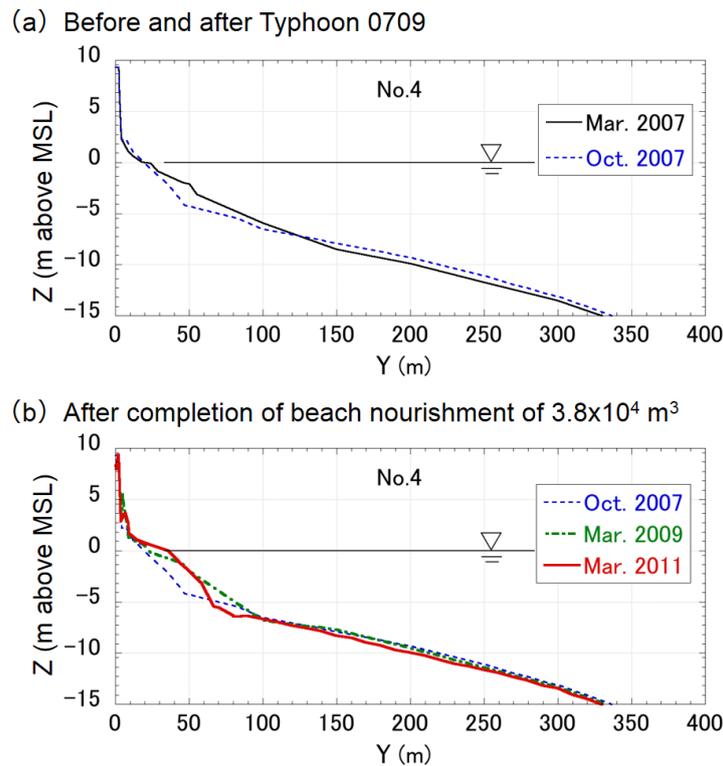
Fig. 9. Changes in longitudinal profile along transect No. 4.

The changes in the longitudinal profile along transect No. 4 across the center of the Yamanishi area (Fig. 7) are shown in Fig. 9. Although the shoreline did not change along this transect as a result of Typhoon 0709, which hit the coast on September 6, 2007, erosion occurred in the depth zone between the shoreline and -7 m with a maximum decrease of 2 m in seabed elevation, as shown in Fig. 9(a).

Then, sand deposition occurred owing to the effect of the beach nourishment up to March 2011, as shown in Fig. 9(b).

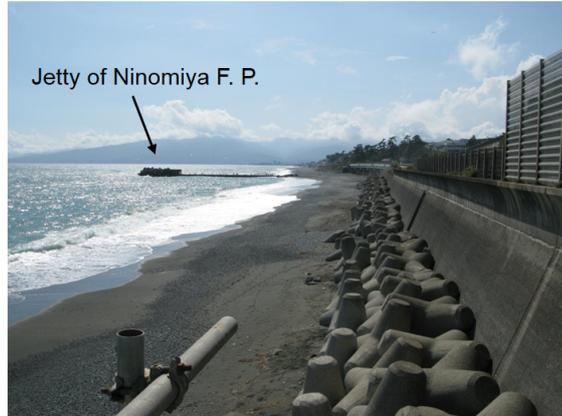
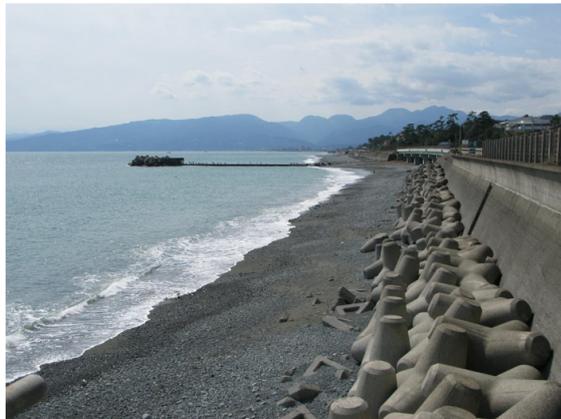
(a) Before Typhoon 1115 on Sep. 13

(b) After Typhoon 1115 on Sep. 24

Fig. 10. Foreshore change of Yamanishi area resulting from Typhoon 1115.

Figure 10 shows the foreshore changes of the Yamanishi area resulting from the storm waves of Typhoon 1115, which were taken from the top of the slope immediately east of transect No. 4, looking forward the jetty of Ninomiya fishing port. The shoreline on September 24 appears to have slightly retreated compared with that on September 13 because the tide level on September 24 was 0.32 m higher than +0.01 m above mean sea level on September 13. However, marked shoreline recession did not occur, as in the case of a sandy beach composed of fine sand, and instead, a large amount of gravel accumulated on the foreshore.

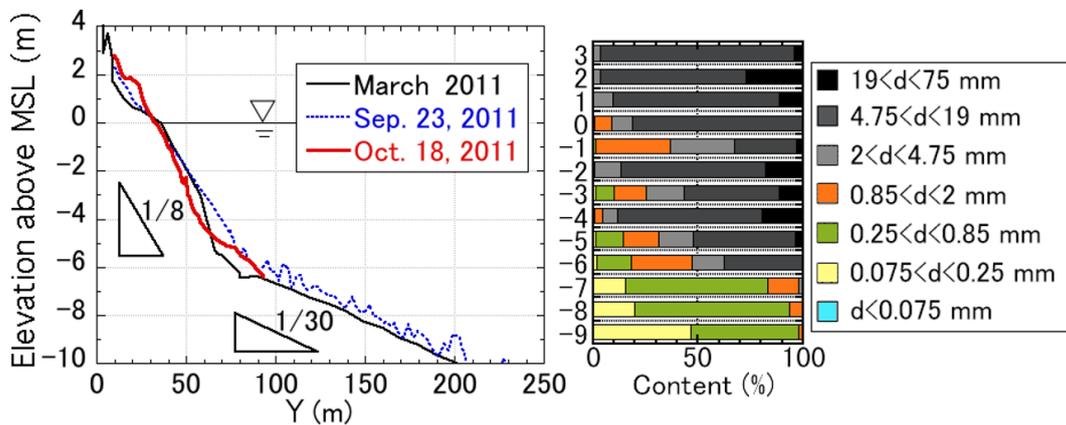
Fig. 11. Changes in longitudinal profile and depth distribution in composition of bed materials along transect No. 4.

Figure 11 shows the changes in the longitudinal profile along transect No. 4 resulting from Typhoon 1115 on September 21, and the depth distribution of the grain size composition of bed materials measured on October 18, 2011. The profile along transect No. 4 has a slope as steep as 1/8 between the shoreline and -6 m, with a gentle slope of 1/30 in the offshore zone. This steep slope near the shoreline is composed of gravel, whereas the offshore bed in the zone deeper than 6 m is mainly composed of medium-size and fine sand. As shown by the profile on September 23, 2011, after the storm waves, the shoreline was maintained and gravel was deposited on the foreshore. Thus, the sandy beach was well maintained by the deposition of gravel during Typhoon 1115. This strongly implies that beach nourishment using coarse materials containing a high gravel content is effective as a protective measure against beach erosion.

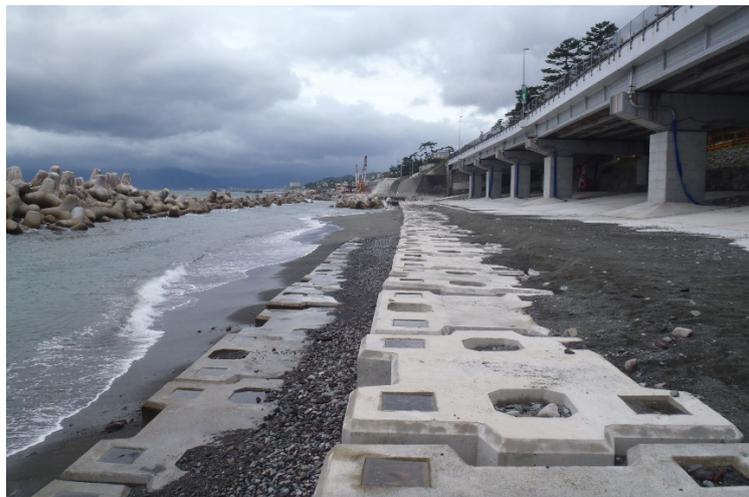
Fig. 12 Coastal condition of damaged area of Seisho Bypass (July 8, 2011).

In the area under investigation, a number of planar concrete blocks and detached breakwaters have been placed along the shoreline for the urgent construction works after Typhoon 0709, as shown in Fig. 12. The detached breakwaters are planned to be removed, whereas the planar concrete blocks will be left as they are, and are expected to be buried under the nourishment beach. Therefore, the initial profile was assumed to have the same slope of 1/30 as the offshore seabed slope between -4 m at the offshore toe of the detached breakwaters and the seawall. Figure 13 shows the initial bathymetry and the alignment of various coastal structures. The seabed was assumed to be a solid bed above which beach nourishment is carried out.

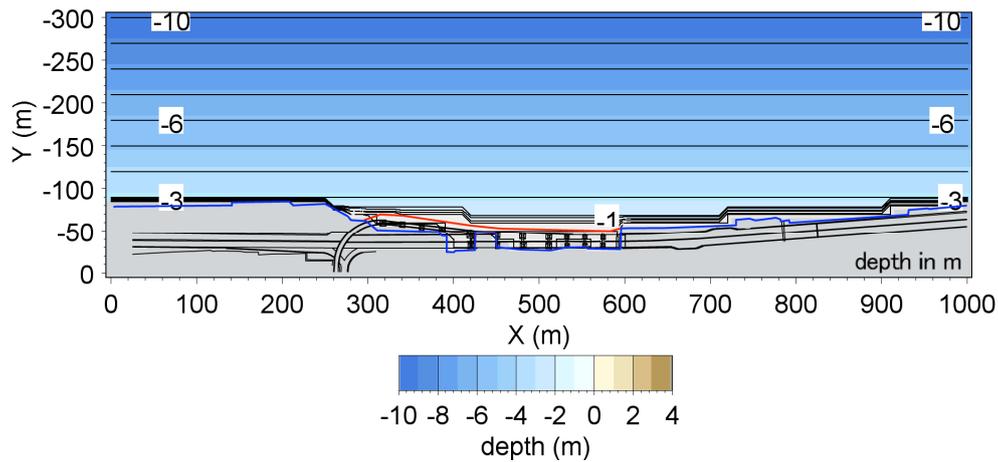
Fig. 13. Initial bathymetry of calculation domain.

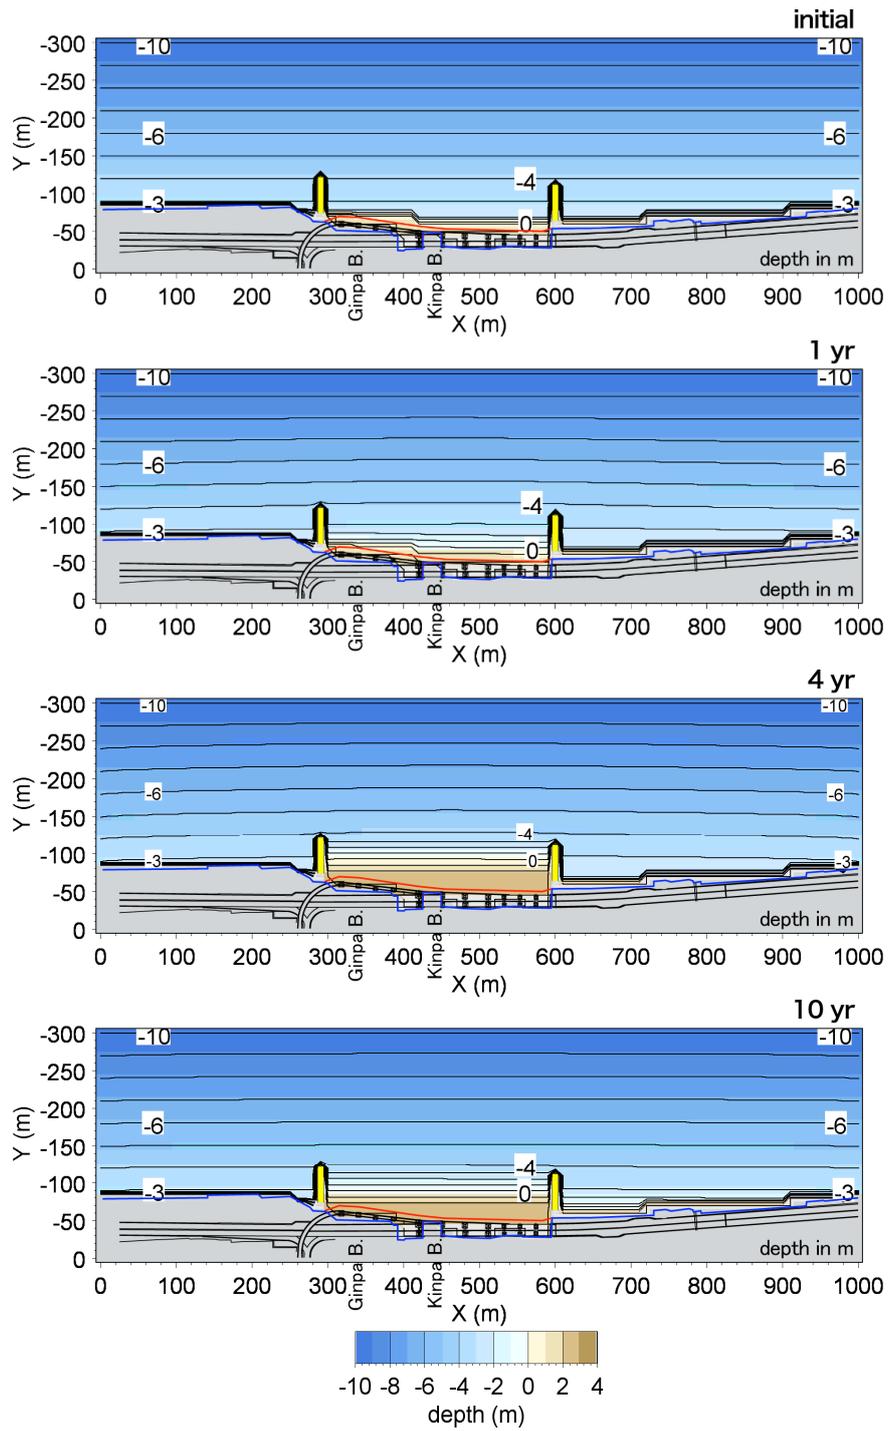
Fig. 14. Recovery of sandy beach by beach nourishment using coarse materials (Case 1).

Two groins with a point depth of 4 m and a length of 50 m were placed in the initial setup and then beach nourishment was carried out at a rate of 3×10^4 m³/yr for four years. After the completion of beach nourishment, beach changes for the next 10 years were predicted. The predicted bathymetry in Case 1 and the bathymetric changes with reference to the initial bathymetry are shown in Figs. 14 and 15, along with the shoreline changes and changes in longitudinal profile in Figs. 16 and 17, respectively. It is shown in these figures that, with beach nourishment at a rate of 3×10^4 m³/yr, a beach width of 30 m, which is the minimum required to protect the backshore, can be recovered at the center of the study site ($X = 440$ m), where houses have been built very close to the coastline.

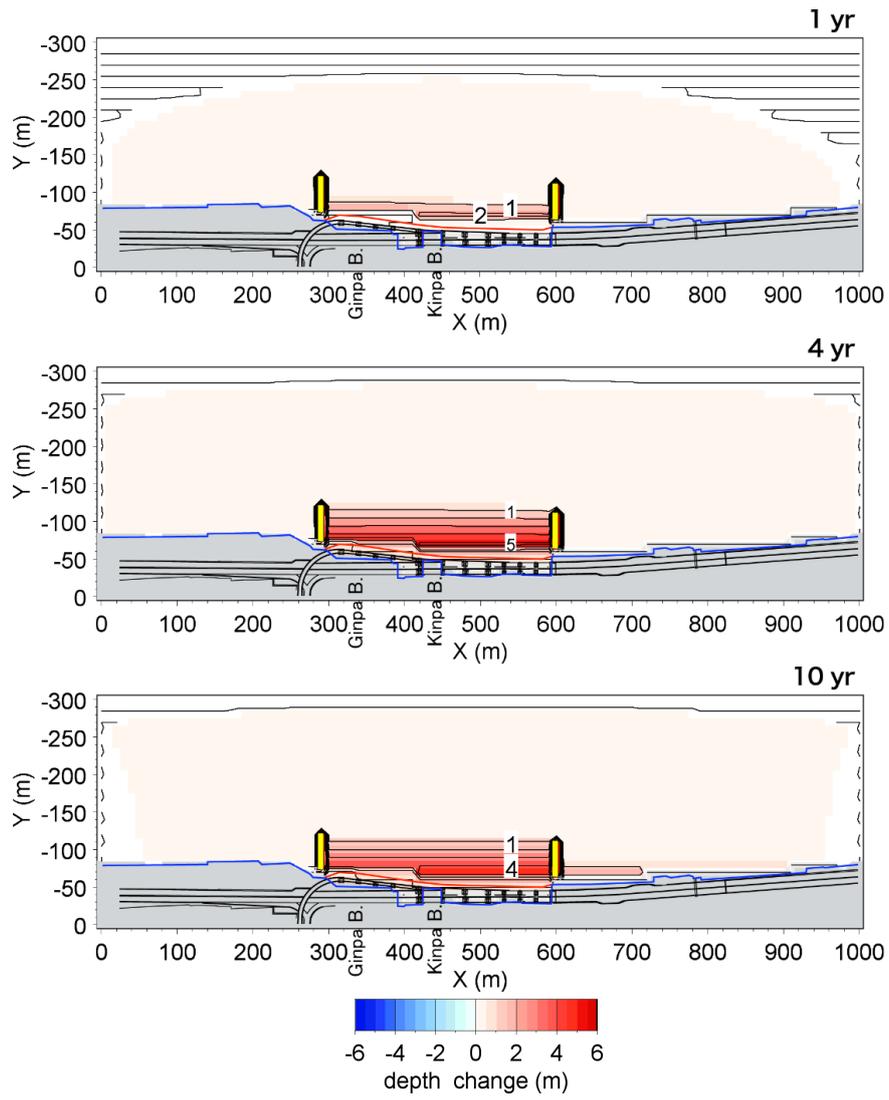
Fig. 15. Depth changes in Case 1 with reference to initial bathymetry.

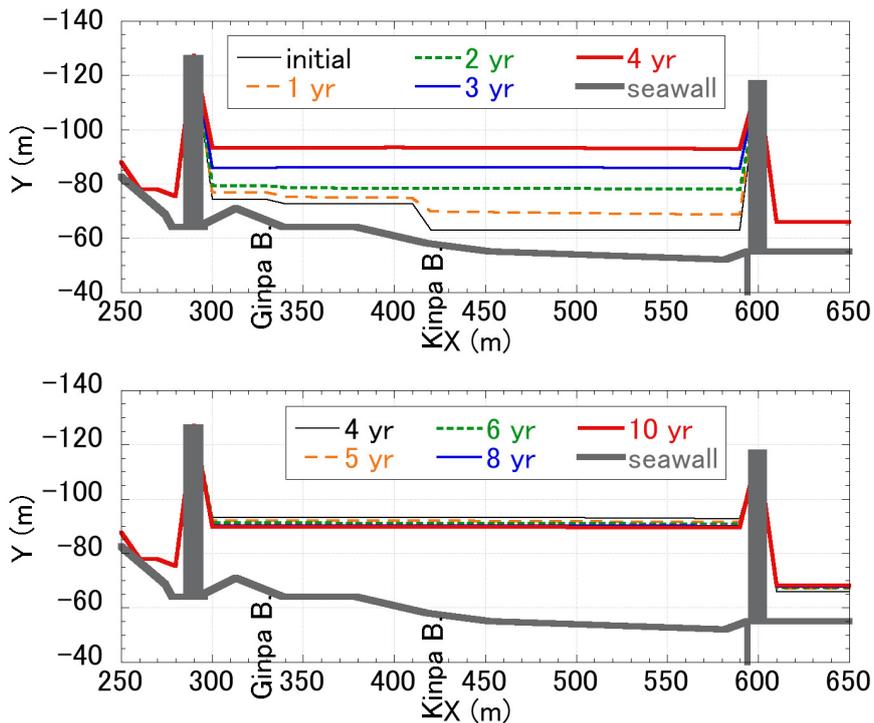
Fig. 16. Shoreline changes in Case 1.

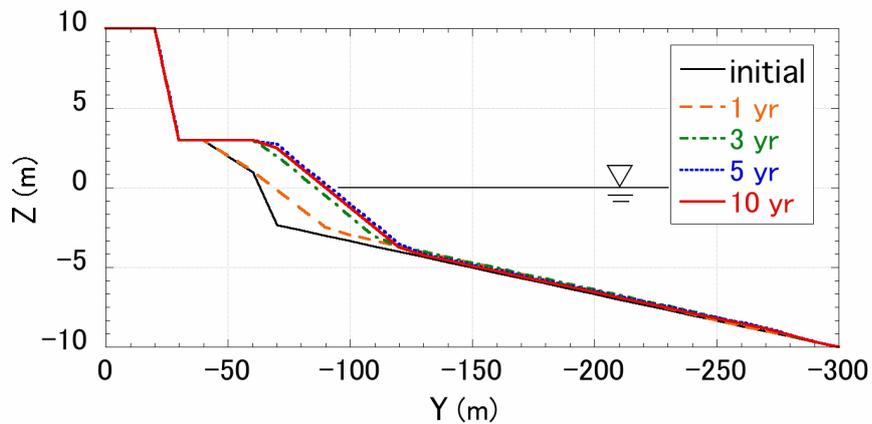
Fig. 17. Changes in longitudinal profile along transect X = 440 m (Case 1).

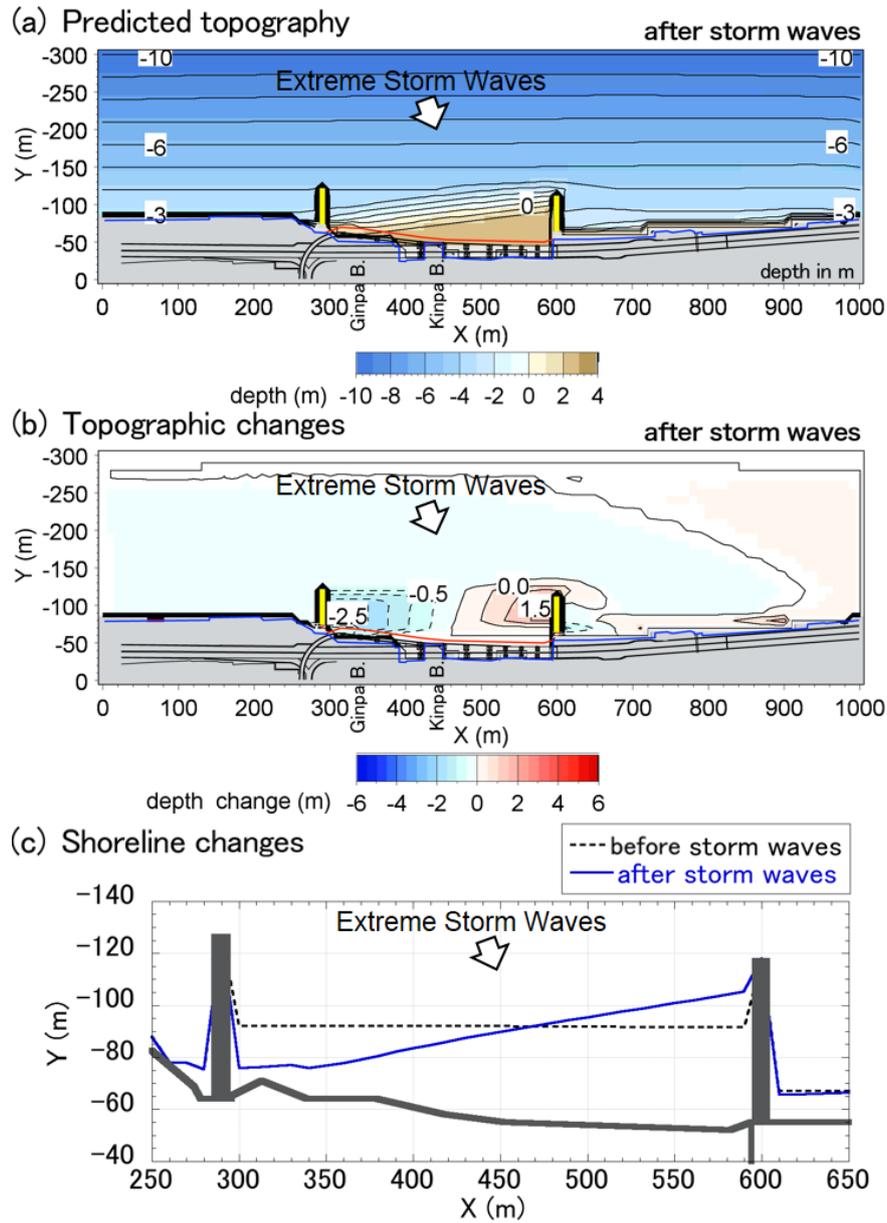
Fig. 18. Results of prediction when storm waves were obliquely incident from easterly direction (Case 2).

In Case 2, storm waves were incident to the beach topography after 10 years of the action of normal waves in Case 1 to investigate the stability of the nourishment beach under storm wave conditions. Figure 18 shows the results. In the beach nourishment area, the eastern part was eroded with accretion in the western part owing to the easterly incidence of storm waves, and the shoreline rotated counterclockwise. Part of the nourishment sand was considered to be transported westward while turning around the tip of the west groin because the contour lines meandered offshore of the tip of the groin. However, the seawall was protected without exposure to waves and a sandy beach of at least 30 m width was maintained at the central part. From this, it is shown that when two groins of 50 m length are constructed with an interval of 300 m, the nourishment beach can be maintained even when easterly extraordinary storm waves are incident.

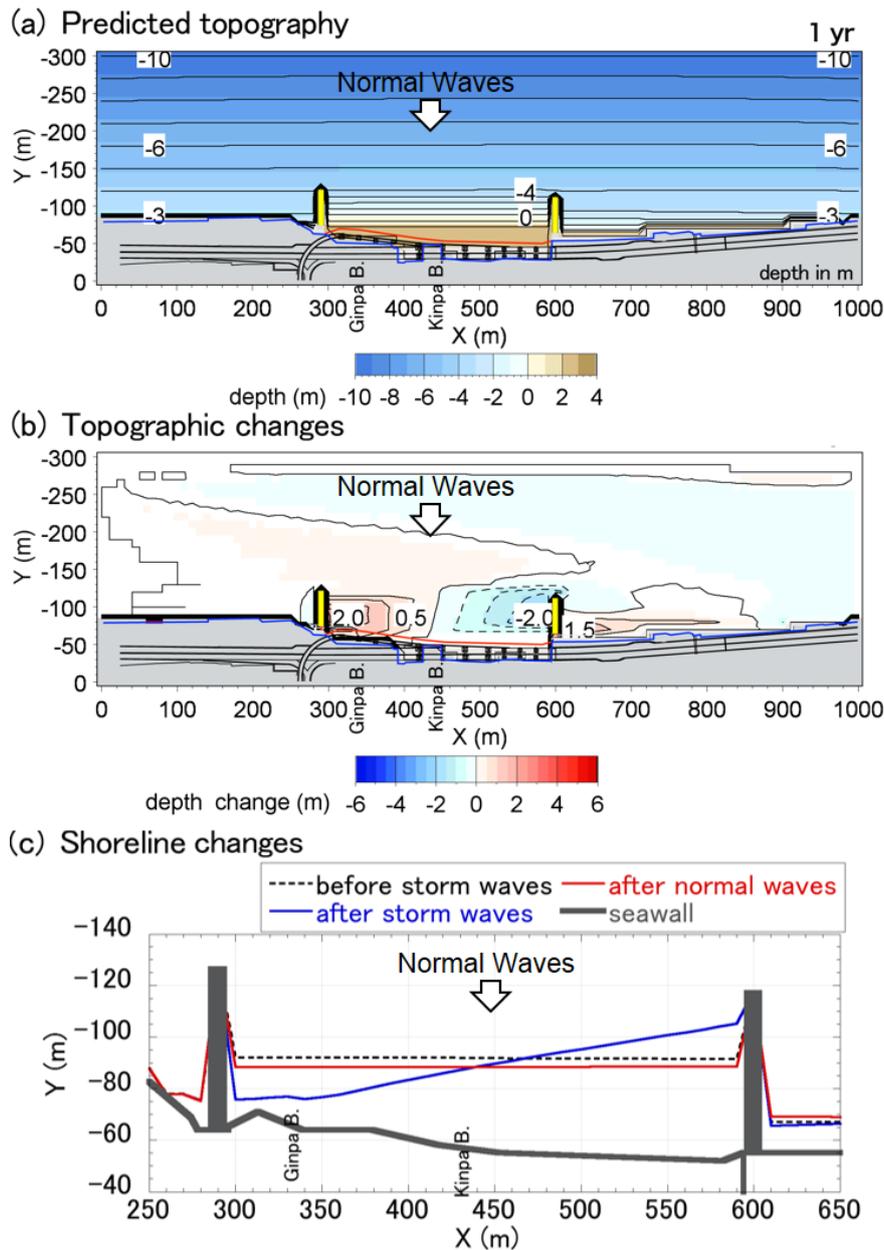
Fig. 19. Results of prediction when normal waves were incident from direction perpendicular to shoreline (Case 3).

Figure 19 shows the predicted bathymetry, the bathymetric changes with reference to the bathymetry in Case 2 and the shoreline changes in Case 3, in which normal waves are incident to the bathymetry in Case 2 for a year. The western part, where sand was deposited under the incidence of the easterly storm waves, was eroded, whereas the eastern part was accreted, resulting in the clockwise rotation of the shoreline. The shoreline, however, retreated by 3 m compared with that before the storm waves, as shown in Fig. 19(c), because of sand loss of 6600 m³ from the nourishment area. This sand

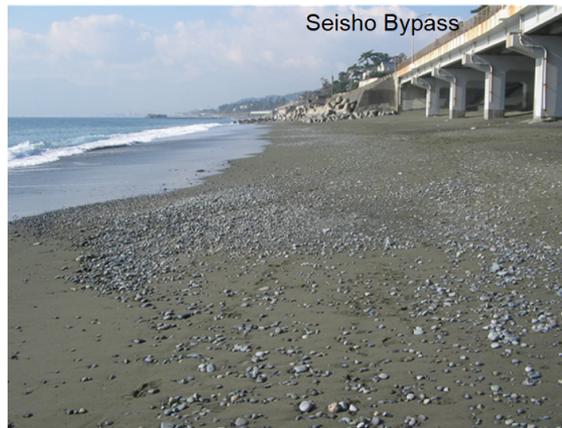
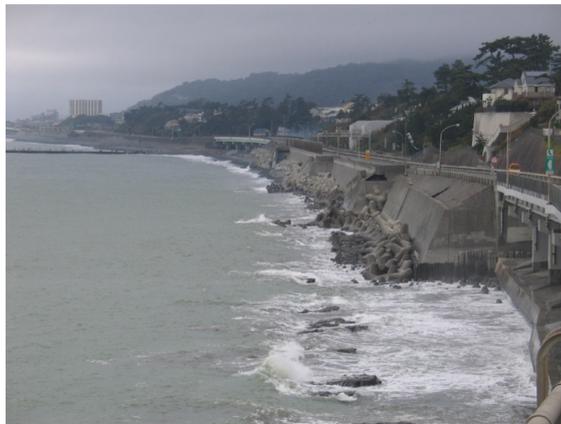
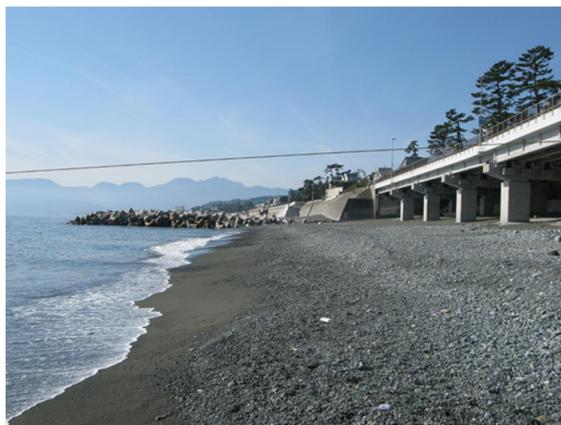
(a) Before Typhoon 0709 (Dec. 2006)

(b) After Typhoon 0709 (Sep. 2007)

(c) After Beach Nourishment (Nov. 2013)

Fig. 20. Changes in coastal condition of damaged area before and after beach nourishment.

In 2011, beach nourishment using coarse materials actually began after consensus building with many stakeholders on the basis of our study. Figure 20 shows the changes in coastal condition of damaged area before Typhoon 0709, immediately after the typhoon, and after the beach nourishment. A sandy beach has really recovered by November 2013.
