# FIELD INVESTIGATION OF LONG-TERM MOORING CHAIN SYSTEM DURABILITY OF THE GPS TSUNAMI-WAVE METER

### ◆ Structure of a GPS buoy in case of Muroto

## Pulled up GPS Buoy after Long-term Observation (2011/11/25)

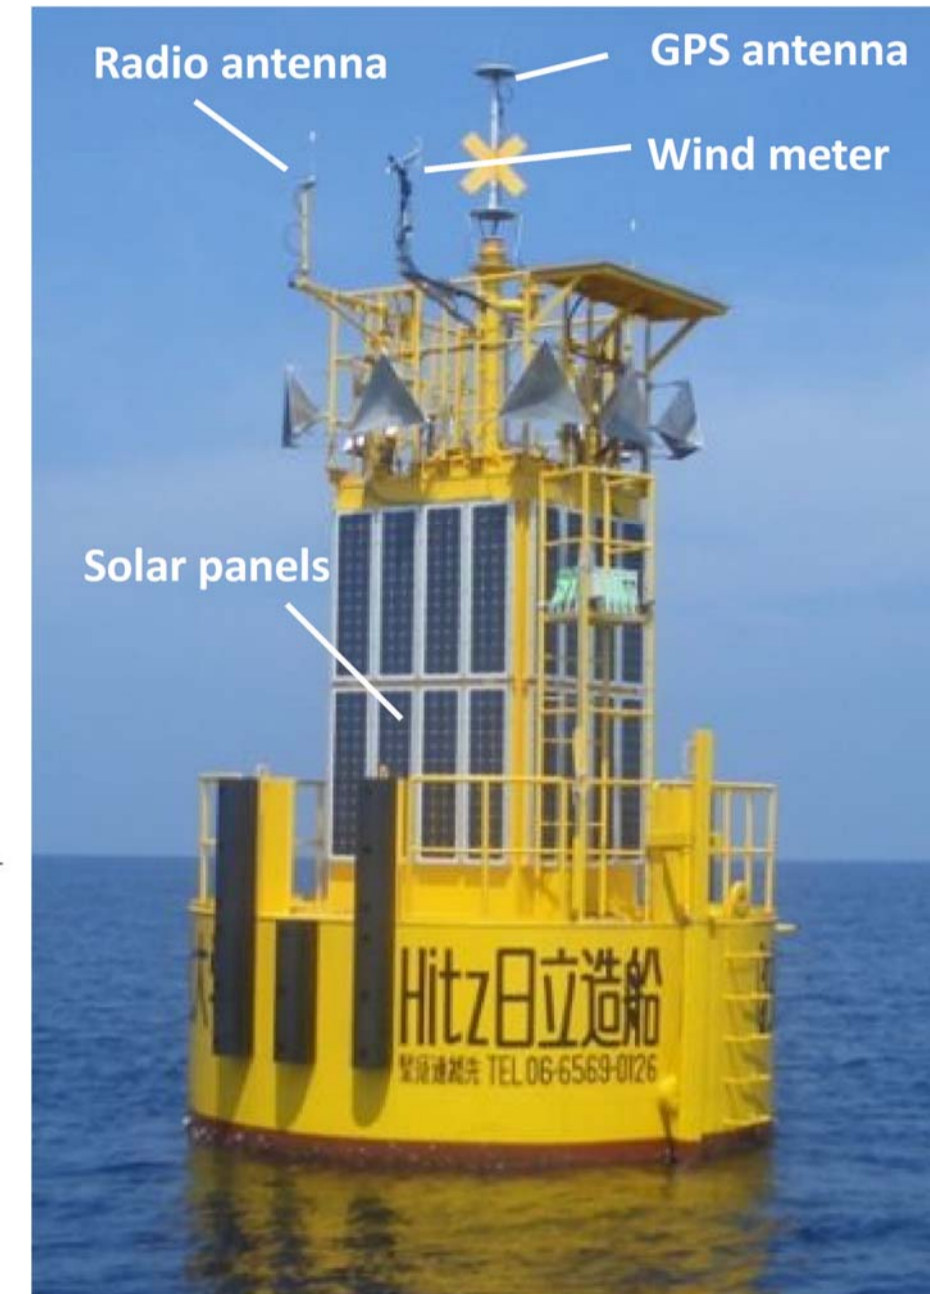
#### > Buoy body

Buoy Diameter	4.5m
Buoy Height	17.2m
Buoy Weight	38ton

Chain: 348m

Danforce Anchor: 27tons

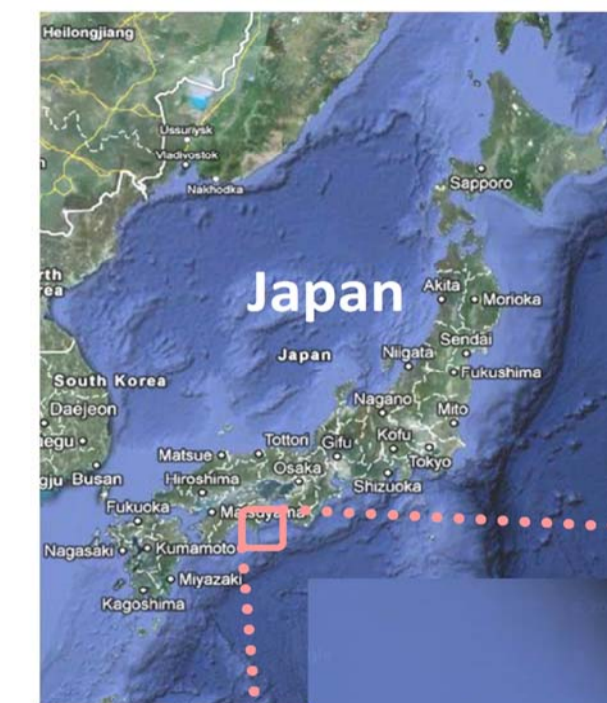
#### > Installation site

Latitude	33° 15' 55"
Longitude	134° 02' 15"
Offshore	13km
Water Depth	132m

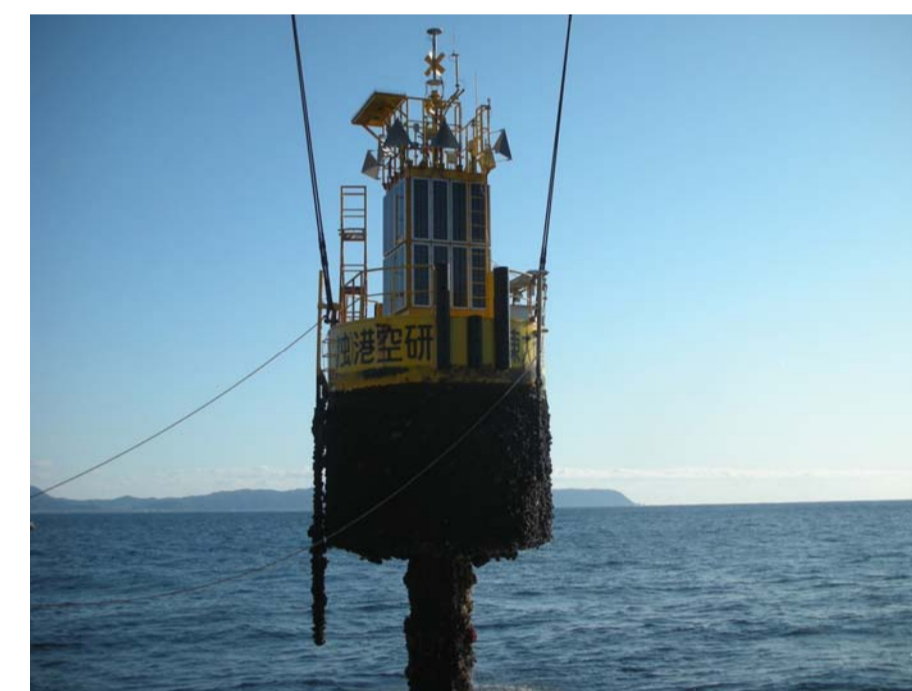
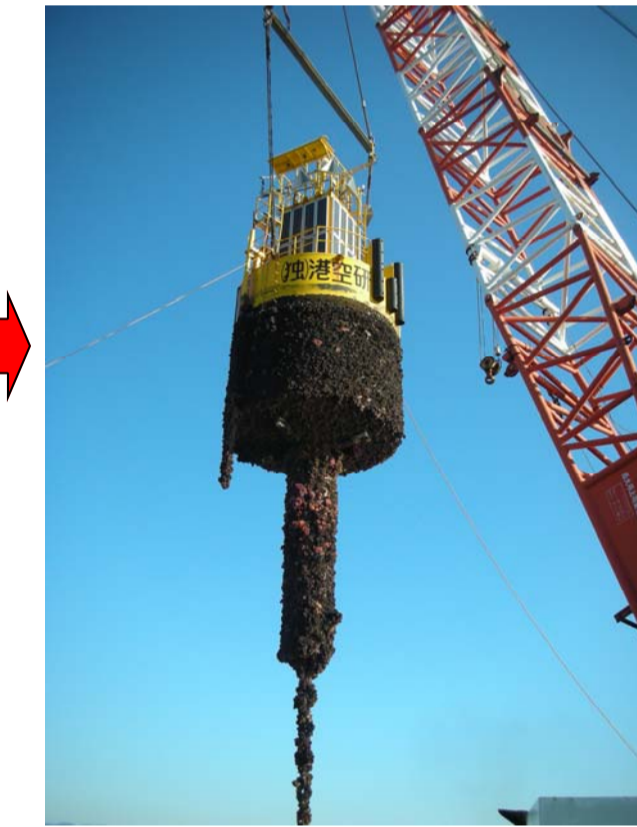
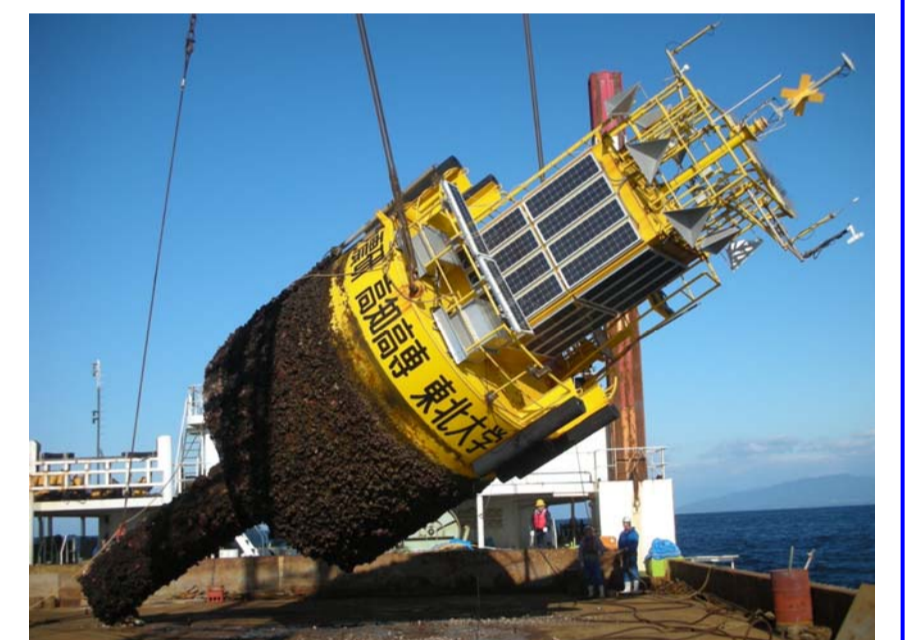
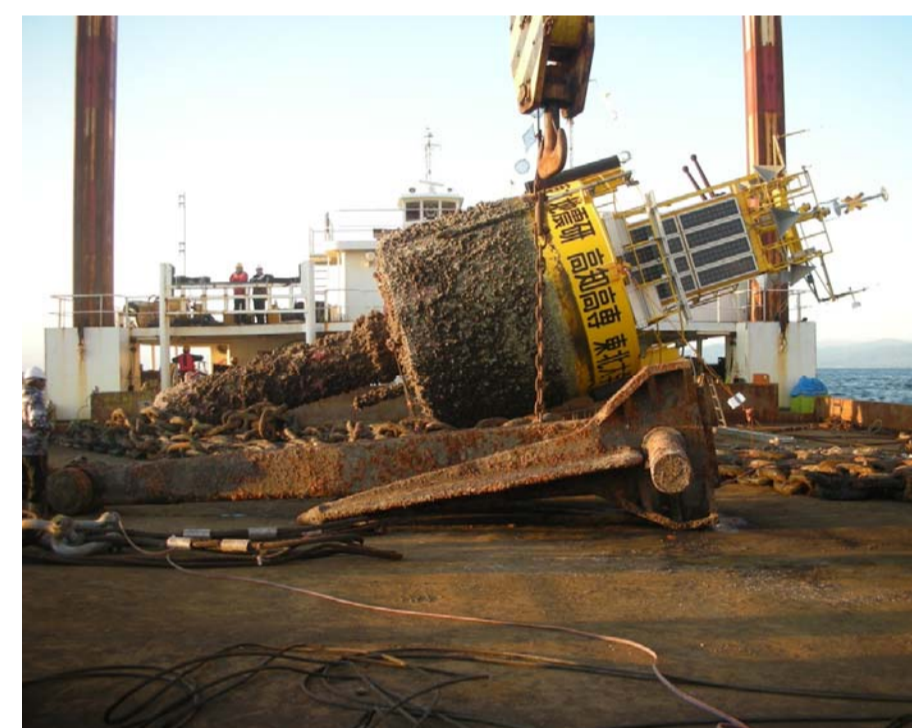
Photo shows situation of a buoy bottom end shackle and No. 1 chain when pulled up from the sea. Although large amount of the sea plants like shells can be seen on the shackle and chain, the mooring system seemed to keep good condition without losing its strength.

(1) Mooring chains stayed in good performance even after 3 years and 7 months of severe ocean field conditions, although they were covered by large amount of sea plants like shells and several studs disappeared from some of the chains located at frequently suffering from landing and dis-landing action by the buoy motion.

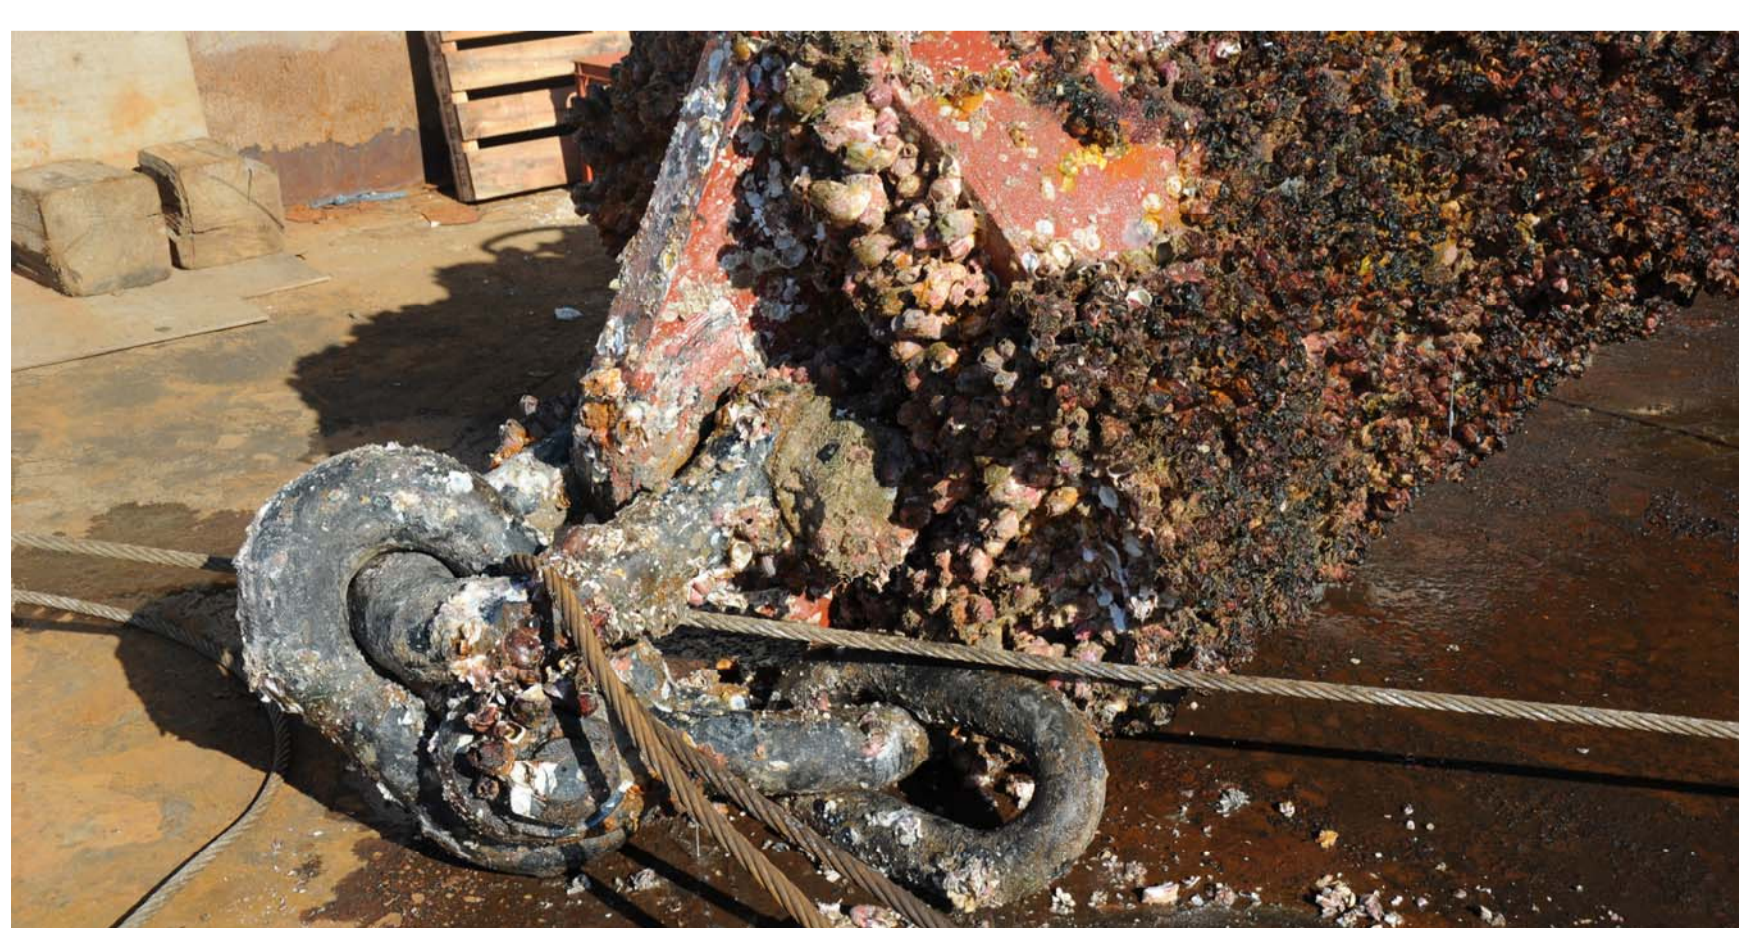
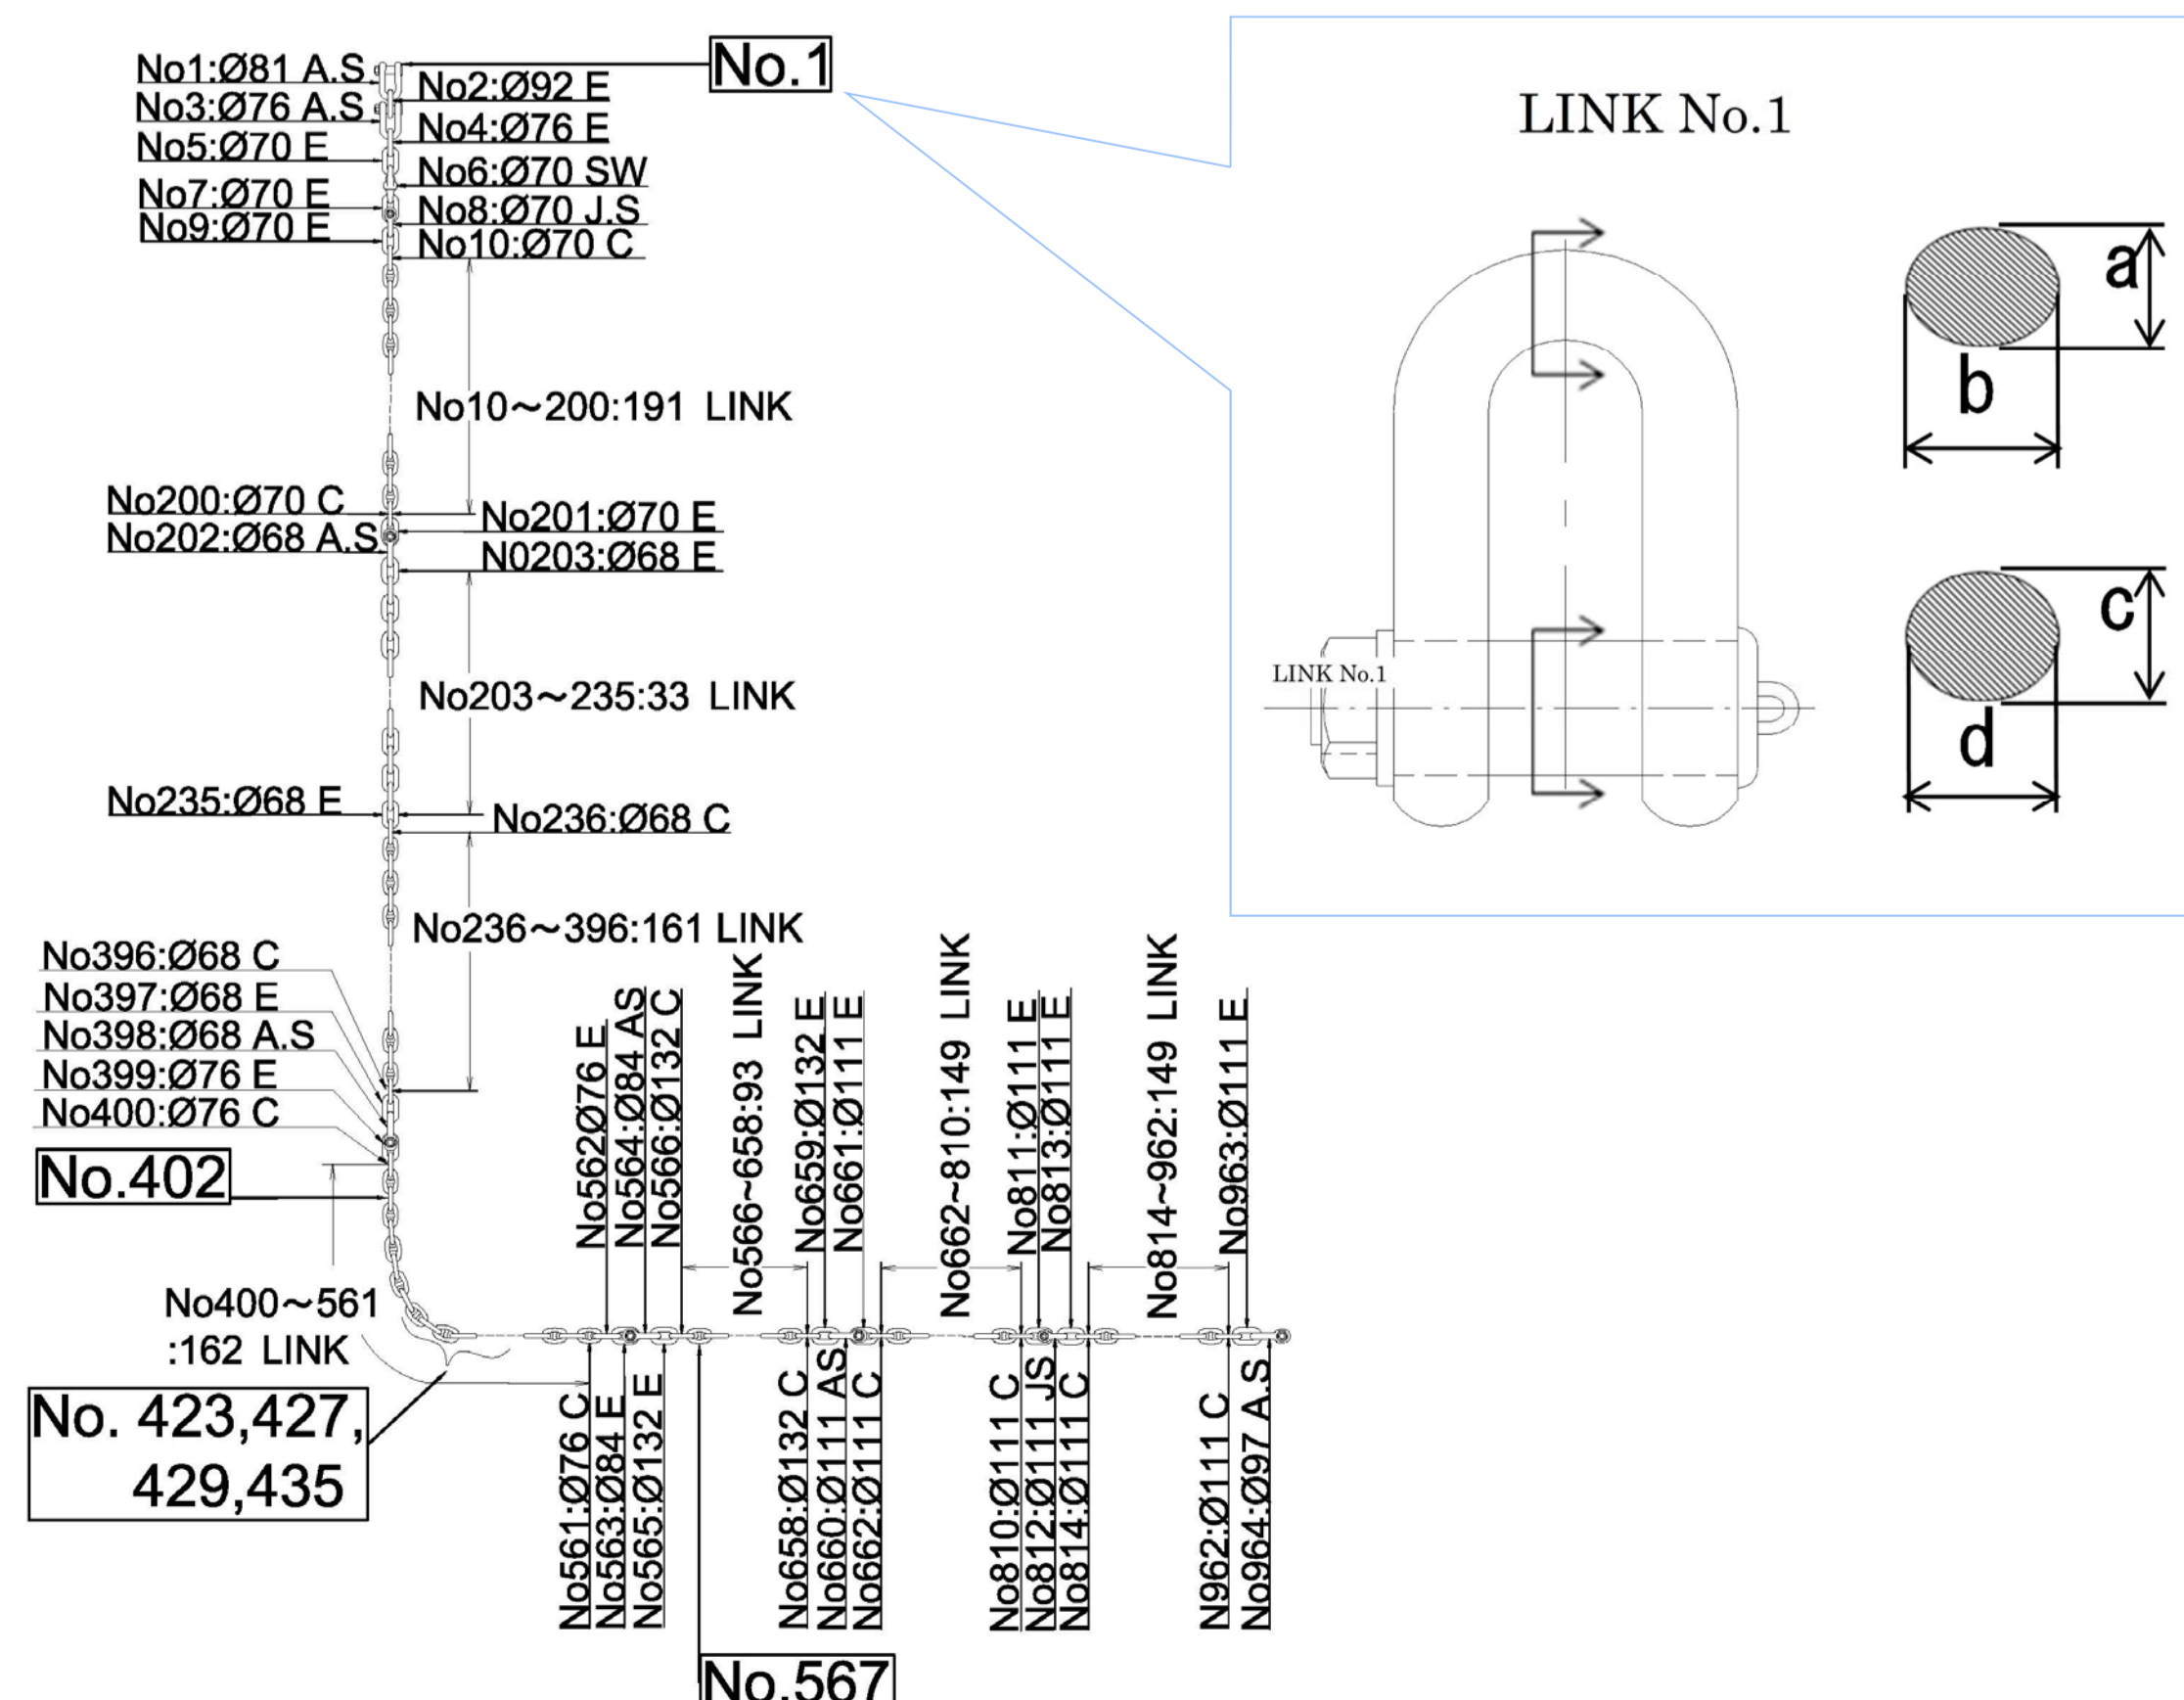
The detailed information of the mooring chain system is demonstrated, describing each chain thickness in millimeter. Thickness of the mooring chain of 348m in total length differs depending on the location.

The thickness of the chain No.1 was set as 139mm, considering that annual frictional wear rate is 10mm/year during 10 years design life term.

Thickness is constant (68mm) between the chain No.236 and No.396 (119.6m below the mean sea level), for these chains do not touch the seabed even at the expected maximum vertical motion of the buoy in the designed severe wave condition.

Thickness of chains No.400 to No.561 (169.8m downward from the mean sea level) were designed as 76mm, for those chains are expected to suffer larger frictional wear due to repeated landing and dis-landing by the buoy motion. The designed frictional wear rate of these chains was 3mm/year during 10 years design life term.

Thickness is constant (132mm) between the chain No.566 and No.658, and also constant (111mm) between the chain No.662 and No.962 (except No.811-813 connector chains), to suppress the chain rise from seabed by increasing its weight.

Definition of the measured thickness of the chain "a" and "b" is also demonstrated. Parameters "c" and "d" indicates thickness of the buoy bottom end shackle of the two different perpendicular axis.

The Table shows the result of the representative chains' measured thickness diameters just after the buoy and mooring chains were pulled up to the deck of the working vessel.

(2) The quantity of real frictional wear was considerably smaller than assumed one at all the part of the mooring system.

(3) Maximum real frictional wear was observed at chains located at frequently suffering from landing and dis-landing action by the buoy motion.
