# ANALYSIS OF TSUNAMI BEHAVIOR AND THE EFFECT OF COASTAL FOREST IN REDUCING TSUNAMI FORCE AROUND COASTAL DIKES

Shunya Matsuba<sup>1</sup>, Takahito Mikami<sup>2</sup>, Ravindra Jayaratne<sup>3</sup>, Tomoya Shibayama<sup>4</sup> and Miguel Esteban<sup>5</sup>

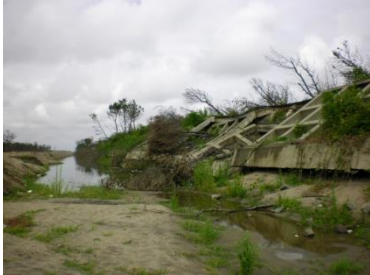
Fig. 1 Iwanuma city.

Details of the three coastal dikes surveyed are given in Figures 1-3, all of which were built on a 1:2 slope. The leeward slope and toe of the coastal dike at the Iwanuma city completely collapsed due to the effect of the tsunami attack. Most of the concrete superstructure fell down because the soil which was used in its core was washed away by the overflowing tsunami, as shown in Fig. 1.

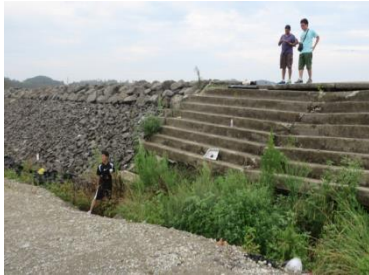
Fig. 2 Shichigahama city.

Damage to the coastal dikes in Shichigahama city was not as extensive as in Iwanuma city, though the leeward slope of the coastal dike collapsed in some places, as shown in Fig. 2. The dike was not so high in this location because people often use this beach for a variety of leisure activities, and thus the tsunami flooded over the dike easily.

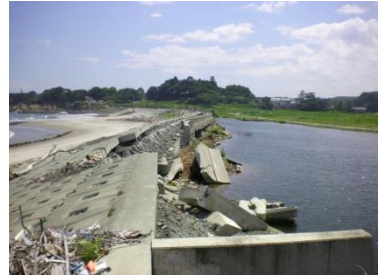
Fig. 3 Soma city.

The scale of the scour damage in Soma city was the largest amongst the dikes surveyed, measuring 31.78 m in width. At this location the coastal forest completely disappeared, while the

coastal forest had a depth of 60 m before the tsunami attack, as shown in Fig. 3. From this survey results, it was clear that there is a relationship between the damage to coastal forest and the progressive scour.

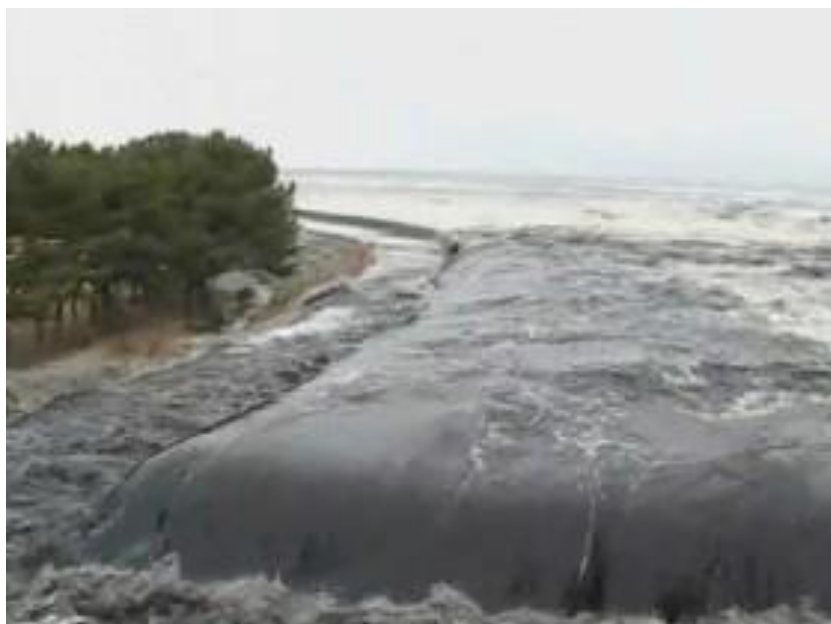
Fig. 4 Snapshot of recorded video clip at Oirase Town in Aomori prefecture (from video sharing website).

Some videos clips captured by people who experienced the 2011 Tohoku tsunami show the tsunami overflowing coastal dikes. Figure 4 shows a snapshot of a recorded video at Oirase Town, Aomori Prefecture. At this point the inundation height was 3.2 m behind the coastal dike, which had been built to a height of 6.0 m. The video clip shows that as the tsunami arrived to Oirase port the water depth gradually became higher, with the tsunami behavior looking like a long period flooding or flow, not a wave. The tsunami started to overflow the coastal dike 7 minutes after the first part of the wave reached this port. When the tsunami started to flow over the coastal dike a supercritical flow takes place, which has very high velocity at the leeward of the slope and toe.

However, paying attention to the tsunami behavior between the coastal forest and the coastal dike, the tsunami force looks as if it is being by the effect of the coastal forest, reducing in velocity and force as a consequence of it. About this tsunami reduction effect, Hatogai et al. (2012) suggested that the progress of scour can be reduced by a water cushion created due to obstacles located behind coastal dikes. In this video clip, the water gradually accumulated behind the dike due to the increased resilience provided by the coastal forest, and as a result there was no severe damage to the dike in this area.
