# ACCELERATED TEST FOR EVALUATING THE DURABILITY OF GEOSYNTHETICS ON COASTS

**Keywords:** geosynthetics, gravel, multivariate statistics, test method

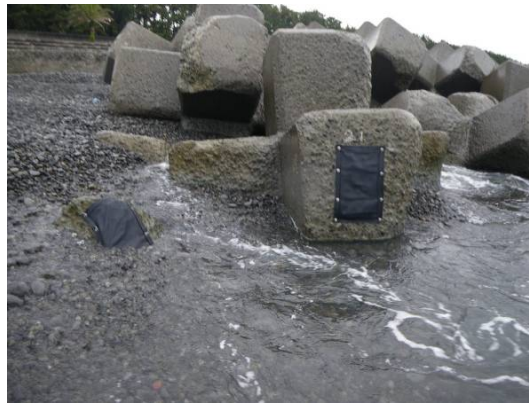
**Figure 3. Test pieces of geosynthetic materials attached on the surface of concrete block.**

To investigate the degradation by gravel attack and abrasion on shore, we attached 31 test panels onto the surface of concrete blocks positioned near the shoreline of the Suruga coast (Fig. 3). The duration of exposure ranged from 14 days to 275 days.

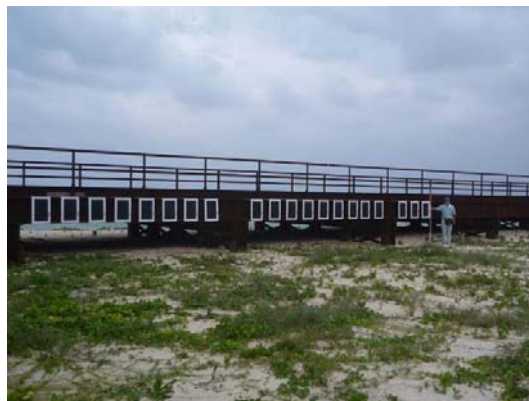
**Figure 4. Test pieces of geosynthetic exposed on backshore of Nagayamanohama beach.**

To investigate the degradation by weather factors, we also conducted field exposure tests on the back shores of the Shimoniiikawa coast and Nagayamanohama beach (Fig. 4). Test panels with a height of 60 cm and width of 40 cm were attached to places inland that would not be affected by abrasion caused by waves. The duration of exposure ranged from 38 days to 897 days. Nagayamanohama beach is located in a subtropical zone, and degradation due to ultraviolet light was considered to be severe on this beach.

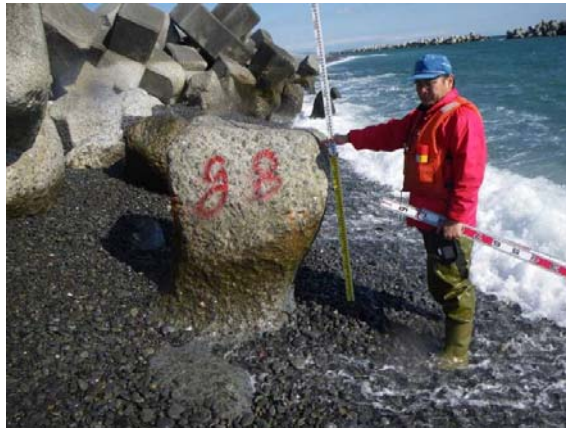
Figure 5. Erosion of concrete blocks settled on Suruga coast.

The concrete blocks were heavily eroded near the beach surface, and erosion was also observed on blocks settled at higher elevations (Fig. 5). The depth of erosion reached 500 mm on the most eroded blocks. Fig. 6 plots the relationship between the maximum depth of erosion on each concrete block and the duration of settlement. The maximum erosion depth was higher in older blocks and was higher on the Suruga-Fuji coast on than the Shimonikawa coast (Table 2).

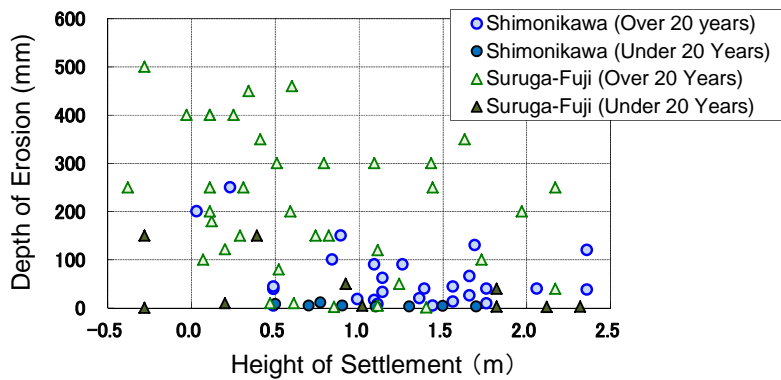
Figure 7. Relationship between elevation of settlement and maximum depth of erosion.

When we considered the blocks whose duration of settlement exceeded 20 years, the depths of erosion tended to be smaller at high elevations. However, there was a high variance in measured values, and those relationships were not so clear compared to the relationship between the erosion and duration of settlement (Fig. 7).

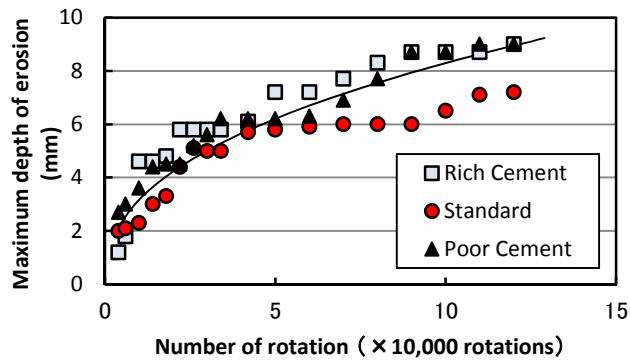
Figure 9. Relationship between number of rotations and maximum depth of erosion.

The maximum depth of erosion of each test piece rapidly increased up to 40,000 rotations. However, the rate of increase slowed down after 40,000 rotations (Fig. 9). The erosion depth throughout the entire experiment was greater in test pieces with a rich cement ratio and least in the standard test piece.

The progress of erosion on the concrete test piece gradually decreased corresponding to the number of drum rotations (Fig. 9.). The coastal sediments were suspected to also be damaged by impact with the concrete block; this decreased the grain sizes of the sediments and weakened the abrasion stress of each gravel attack during the test. The erosion of the standard test pieces tended to

The coefficients  $a$  and  $b$  were estimated to be 0.0674 and 0.418, respectively, based on the results for the three test pieces. Fig. 9 shows the calculated fitting curve using this equation; the  $R_2$  of the curve was 0.846. Using this equation and equation (1), we can correlate the observed erosion on the coast with the results of the accelerated test and imitate the abrasion stress in a laboratory.

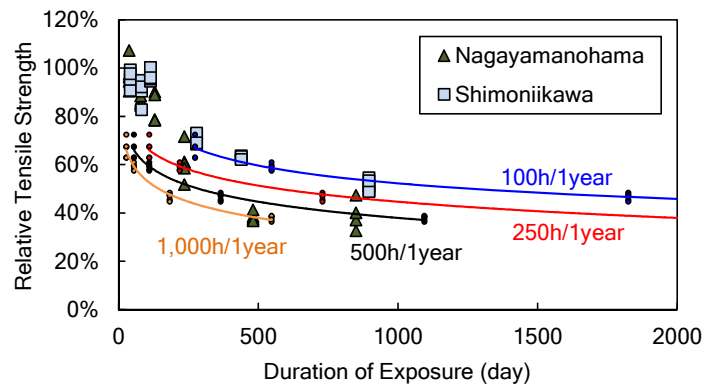
**Figure 11. Decrease in tensile strength of geosynthetic test pieces in exposure test on back shore. The lines on the graph were obtained by converting the durations of the accelerated tests to durations of exposure on the coast.**

Fig. 11 shows the results of the field exposure test on the degradation by weather factors. The tensile strengths rapidly decreased during the first 300 days, and the rates of decrease then gradually slowed down on both coasts. The degree of degradation was higher on the Nagayamanohama beach than on the Shimoniikawa coast.

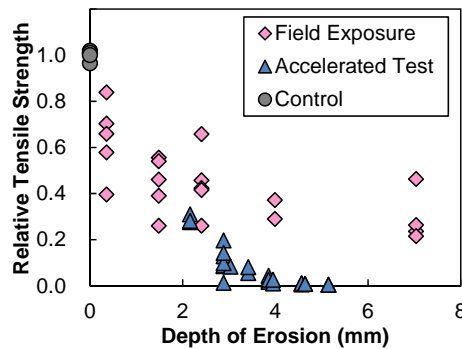
Figure 12. Relationship between results of field exposure and accelerated tests for geosynthetic test pieces.

Fig. 12 shows the relationship between the results of the field exposure and accelerated abrasion tests. The degree of abrasion stress was defined in terms of the depth of erosion of the concrete blocks. The result of the laboratory tests tended to be somewhat more severe than the field exposure test when the abrasion stress was high. However, the results of the field and laboratory tests were generally in good agreement.
