# RELATIONAL ANALYSIS BETWEEN TSUNAMI AND HOUSE DAMAGE AT THE INUNDATION AREA IN IWATE, JAPAN

The estimated tsunami height and inundation depth in March 11th, 2011 were shown and geographically analyzed. The spatial distribution of tsunami inundation and its height were visualized with GIS, and regional characteristics of representative areas were spatially examined. Considering the spatial distribution of inundation area, depth and house damage, it was separated by three groups having a similar characteristics. The zonal classification by house damage and typical inundation depth were clarified the regional features and differences.

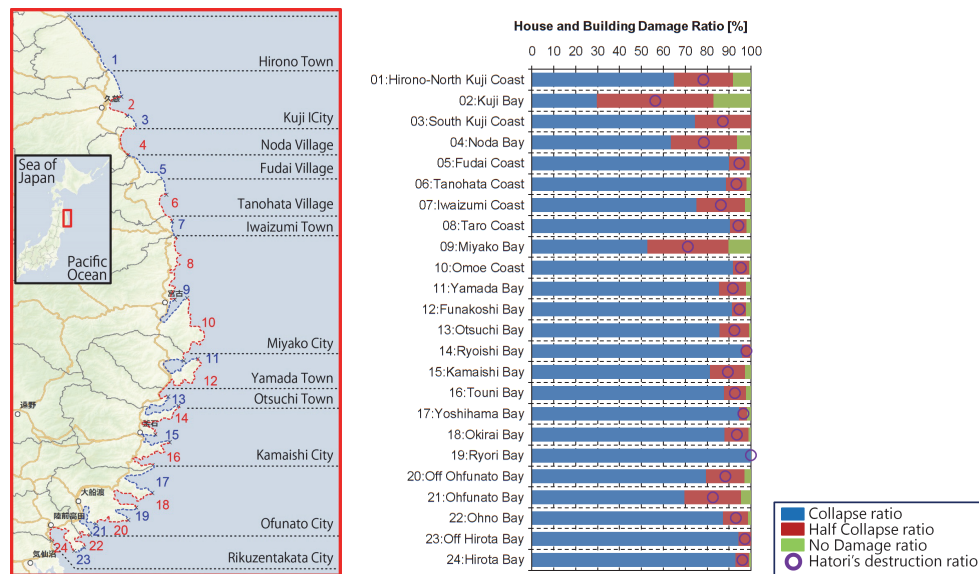
Figure 1. House and building damage (Collapse, Half Collapse, No Damage, Hatori's destruction ratio ) suffered by 2011 Tsunami at the 24 coastal areas.

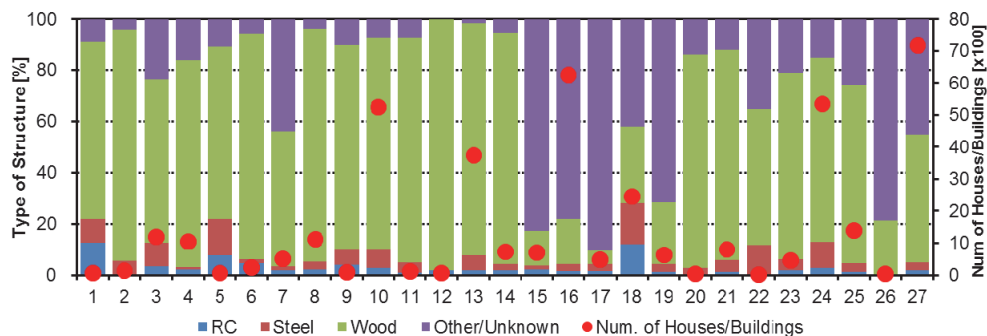
Figure 3. Number and ratio of classified houses and buildings in each target region.

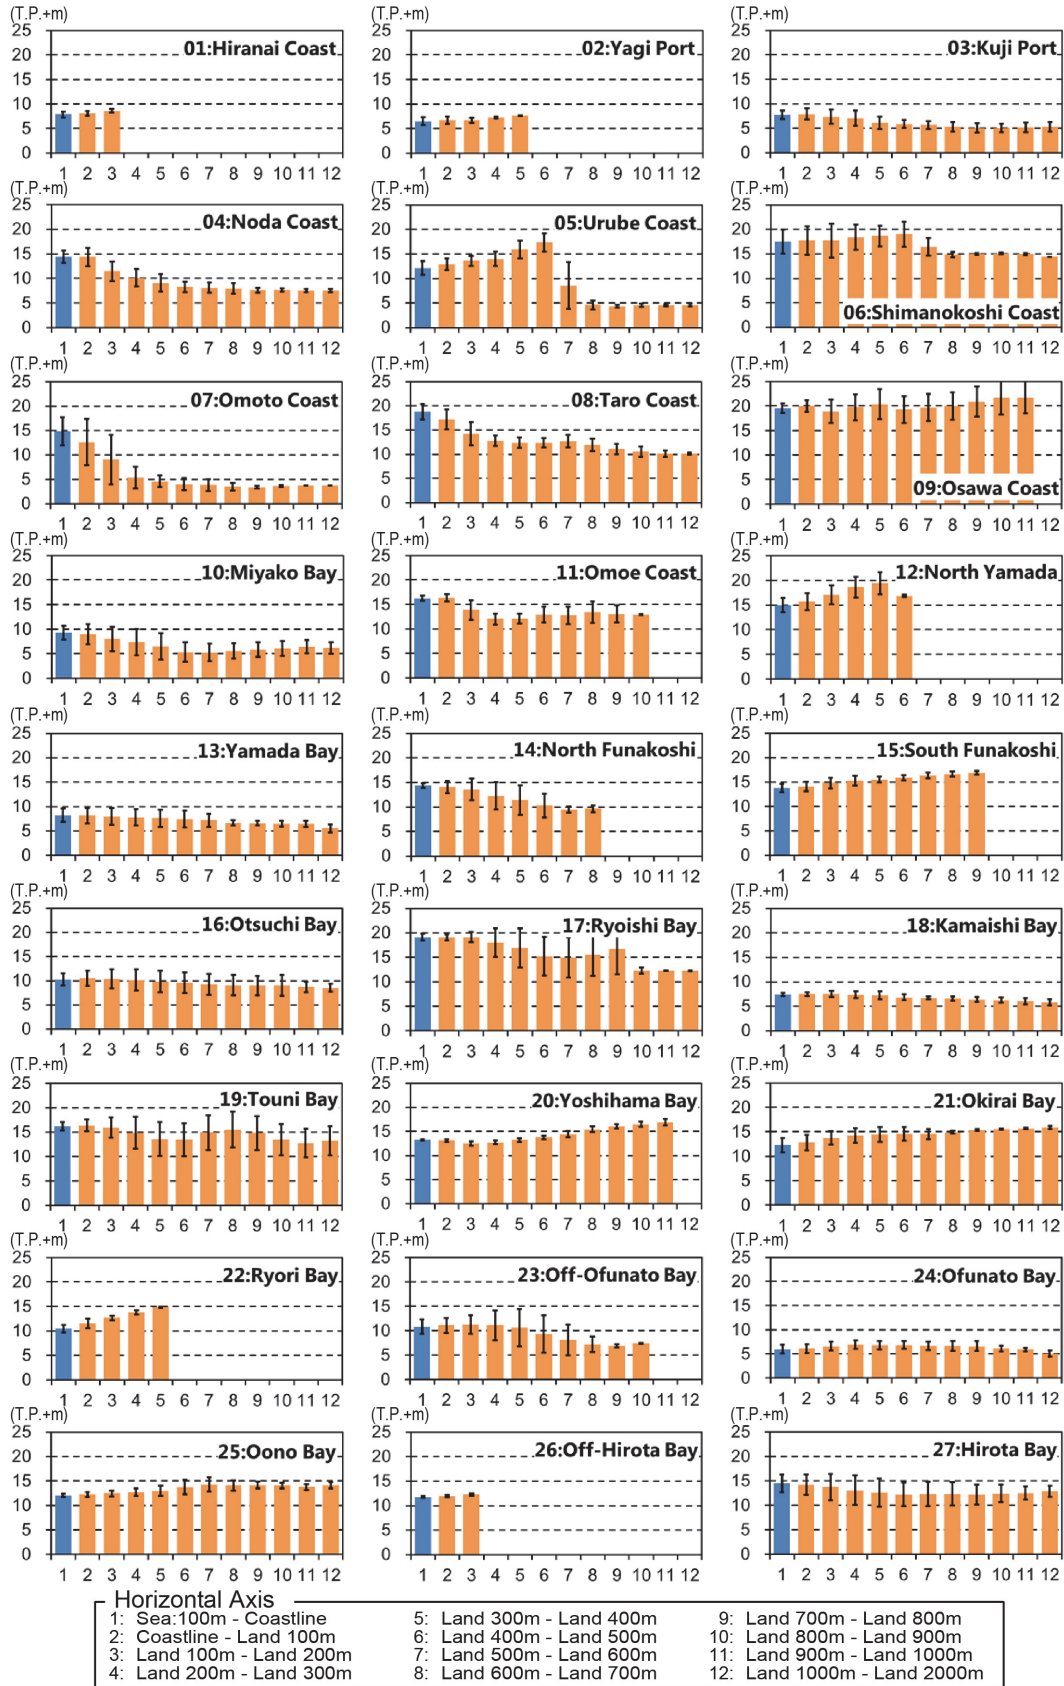
Figure 5. Estimated average maximum tsunami height and inundation depth. Vertical axis is based on Tokyo Peil (T.P.), the error bar is standard deviation. Horizontal axis is the distance of sea-land direction.

Figure 5 shows the estimated maximum wave height (tsunami height) and inundation height at the 27 regional areas to comprehend the tsunami run-up features. Grasping the overall trend, tsunami height at Shimanokoshi Coast, Taro Coast, Osawa Coast, Omoe Coast, Ryoishi Bay and Touni Bay were relatively higher than neighboring bay area. On the other hand, enclosed coastal bays like Kuji Port, Miyako Bay, Yamada Bay, Kamaishi Bay, and Ofunato Bay were lower. It was identified that there was a tendency that nearshore tsunami height is higher in areas directly facing the Pacific Ocean, or open coastal bays. The estimated tsunami heights in high order were T.P.+19.5m in Osawa Coast, T.P.+19.1m in Ryoishi Bay, T.P.+18.8m in Taro Coast and T.P.+17.5m in Shimanokoshi Coast. Tsunami height in the northern part of Iwate coast and inner area from the offshore breakwater was qualitatively low. For example, it was T.P.+6.0m in Ofunato Bay, T.P.+6.5m in Yagi Port and T.P.+7.4m in Kamaishi Bay.

With respect to tsunami height around the shoreline, there was no difference in the sea side and land side across the shoreline in most areas, but the land side's tsunami height was slightly higher in a relatively steep slope area (Osawa Coast, North Yamada, Okirai and Ryori Bay).

As a comparison of tsunami run-up height between the run-up end and the shoreline, 3 conditions were classified. "inland tsunami height > shoreline tsunami height" (hereinafter "inland > shoreline") is Yagi Port, Osawa Coast, South Funakoshi Bay, Yoshihama Bay and Okirai Bay and so on. "inland tsunami height  $\approx$  shoreline tsunami height" (hereinafter "inland  $\approx$  shoreline") is Omoe Coast, Touni Bay and Hirota Bay. "inland tsunami height < shoreline tsunami height" (hereinafter "inland < shoreline") is Kuji bay, Noda Coast, Taro Coast, North Funakoshi Bay and Ryoishi Bay and so on. Condition "inland > shoreline" area consisted of narrow inland residential area and steep slope, it is thought that tsunami water mass converged and proceeded to inland, and ran up the land slope with great force. Condition "inland  $\approx$  shoreline" area consisted of comparatively large and flat area than above condition. Tsunami water mass overflows the coastal protection facilities, and were estimated that tsunami proceeded to inland at a speed that only depends on the inundation depth. Almost all residential area except for the steep slope area were flooded. Condition "inland < shoreline" area was geographically same condition as "inland  $\approx$  shoreline". Tsunami overflow process over the tide wall and tsunami run-up speed was estimated almost same condition, but flooded area wasn't cover the whole residential area. It means that tide wall exerted the effect of tsunami defense to some extent, and tsunami run-up didn't reach to the end of residential area. In particular, tide walls in Urube and Omoto coast were not fully-destroyed, maximum tsunami height was drastically decreased at behind the tide wall.

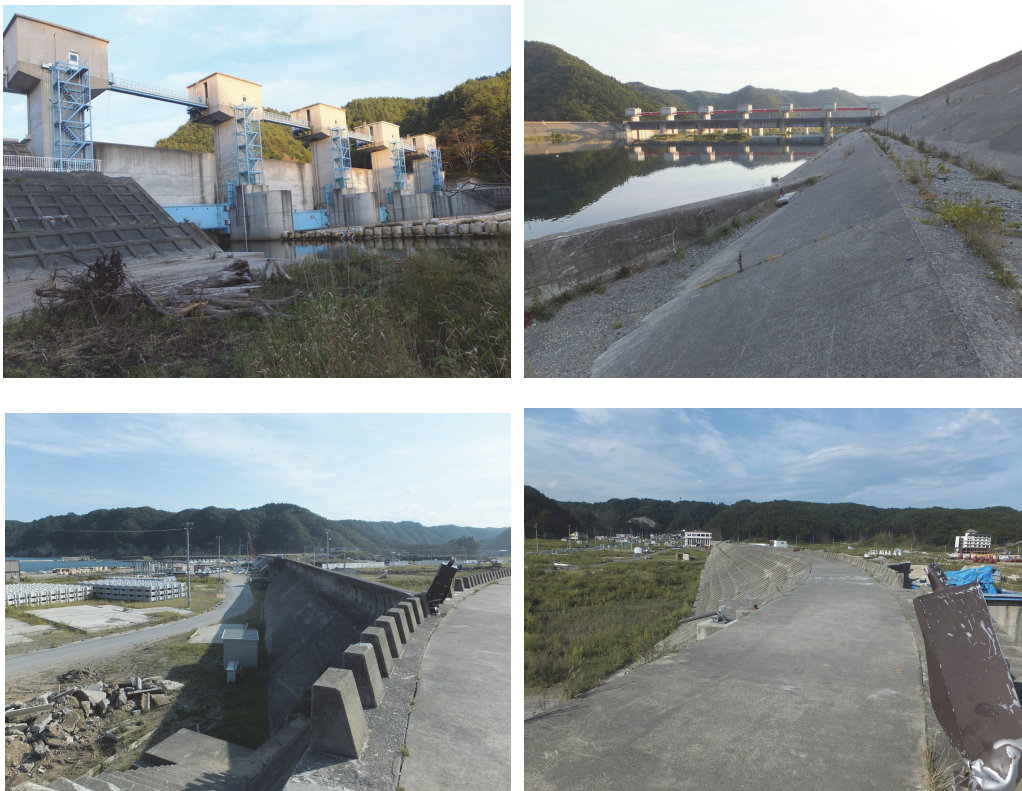
Figure 6. Snapshots of T.P.+15.5m Fudai flood gate (upper left), T.P.+12.7m Omoto flood gate (upper right), and T.P.+10m Tide Wall in Taro Coast (lower left is shoreside wall, lower right is 2nd wall ). Each pictures were taken in 2012.

At the shoreline around Urube, Omoto and Taro Coast, the great tide wall against tsunami greater than or equal to T.P.+10.0m had been installed in front of the residential area (Figure 6). The Fudai flood gate of T.P.+15.5m in Urube Coast and the Omoto flood gate of T.P.+12.7m in Omoto Coast were higher than other area's setting value. Therefore both tide wall prevented houses from fatal damage, and tsunami inundation height behind the tide wall significantly decreased. In Taro Coast, there were double tide wall with height T.P.+10m in front of the shoreline. Shoreside tide wall was broken down and tsunami water body overflowed the 2nd tide wall. Hence the inundation height at the inland area exceeded T.P.+10m. On the other hand, the lower design value facilities like in Yamada Bay, Kamaishi Bay, Ofunato Bay and Hirota Bay, tsunami height was above the wall crest considerably and destroyed, so the tide wall cannot work sufficiently.

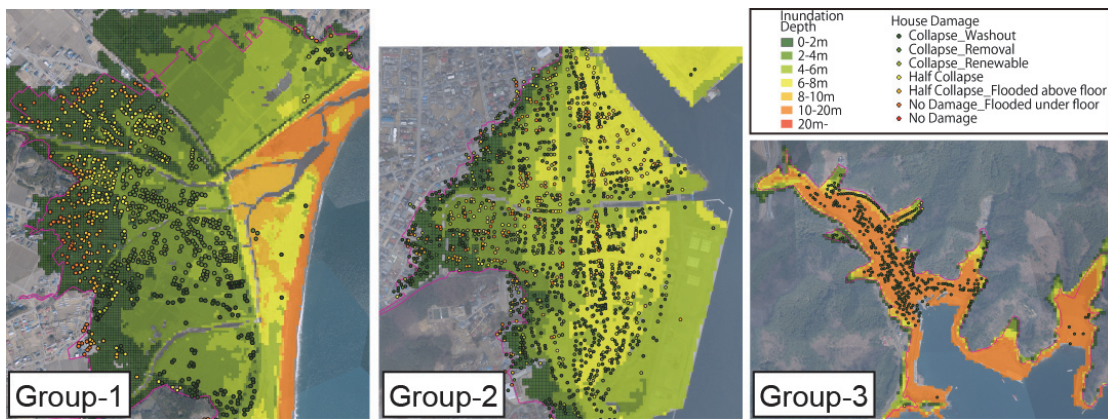
Figure 13. Examples of spatial distribution of inundation area, inundation depth and house damage of each group.

Considering the spatial distribution of inundation area, depth and house damage at 27 regional areas, it was separated by three groups having a similar characteristics. And then, in order to clarify the characteristics of the tsunami damage in multiple regions, the zonal classification by house damage and typical inundation depth were exerted in Table 4 and Figure 13.

Yagi Port, Kuji Port, Noda Coast, Urube Coast, Omoto Coast, Osawa Coast, Miyako Bay, Yamada Bay, Otsuchi Bay, Kamaishi Bay and Touni Bay. Nearshore tsunami height and inundation depth at the shoreline tended to be higher than that of run-up end. Typical inundation depth was lower than other groups. The inland inundation area did not reached the end of residential area. Houses around the shoreline was totally collapsed, with moving to the inland, collapse ratio was decreasing. The dominated houses structure was wood. Steel or RC structure houses almost didn't exist in the wood dense zone. Collapse ratio was relatively lower than that of other area.

Hiranai Coast, Okirai Bay, Off-Ofunato Bay, Ofunato Bay and Oono Bay. Nearshore tsunami height tended to be equal to the tsunami height at the shoreline. The inundation depth at the shore was almost same as that of run-up end. Spatial pattern of houses damage were obviously different from Group-1. Half collapsed or no damaged houses were dotted in the collapsed houses area. There were some robust RC/Steel buildings, multistory buildings in regions where wooden houses were concentrated. Or, Collapsed houses were dotted in no damaged houses area.

Shimanokoshi Coast, Taro Coast, Omoe Coast, North Yamada Bay, North Funakoshi Bay, South Funakoshi Bay, Ryoishi Bay, Yoshihama Bay, Ryori Bay, Off-Hirota Bay and Hirota Bay. The inundation depth at run-up end tended to be almost same as the shoreline or higher. Typical inundation depth was tend to higher than that of other group’s areas. Therefore, regardless of the variety of residential structure and its density, almost all houses were collapsed and devastating.

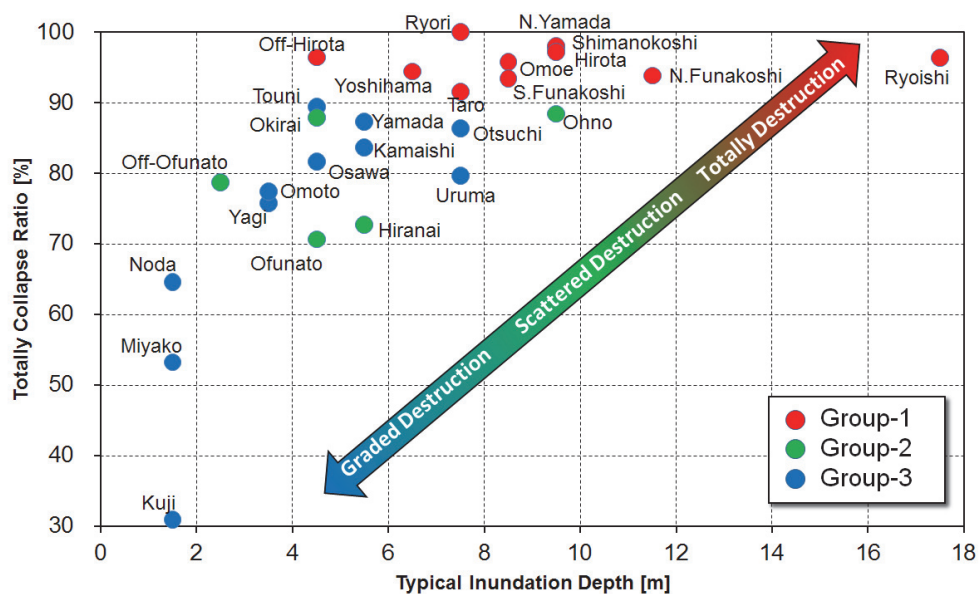
Figure 14. Regional characteristics of inundation and house damage in Iwate 27 regional areas.

Finally, the regional characteristics of typical inundation and house damage in 27 regional areas were organized by the point diagram (Figure 14). Vertical axis is the totally collapse ratio in each area. Horizontal axis is the typical inundation depth. Also, 3 types of group were colored in blue-green-red. In case the inundation depth is less than 2m, damage is "graded destruction type". Its type becomes higher damage at shoreline and lower damage at inland area. When the inundation depth is more than 2m, destruction type was mixed "graded destruction type" and "scattered destruction type". When the inundation depth was increasing and significantly more than the tide wall height, destruction type was "totally destruction type". From this figure, the regional features and differences in Iwate 27 regional areas were clarified.
