ECOLOGICAL ENGINEERING CONSIDERATIONS FOR CORAL REEFS IN THE DESIGN OF MULTIFUNCTIONAL COASTAL STRUCTURES

Michael Foley¹, Yuko Stender², Amarjit Singh¹, Paul Jokiel², and Ku'ulei Rodgers²

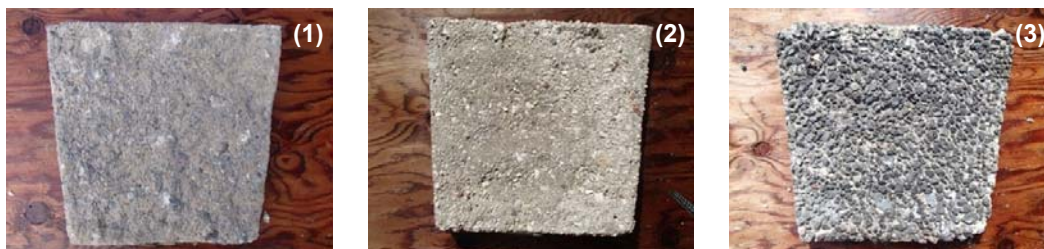
Figure 1. Three concrete test plate types were made with the same mix design and used (1) basalt, (2) limestone, and (3) recycled concrete/asphalt aggregate materials.

Each concrete mix was poured into formwork to produce multiple test plates (Fig. 1). The top surface of each plate was trapezoidal in shape with side lengths of approximately 30 cm x 33 cm x 23 cm x 33 cm for the long base, side one, short base, and side two, respectively. The calculated area of the top surface was about 870 cm². Each plate was about 4 cm thick, so the total surface area was about 2,215 cm². The concrete formwork was coated with a retarder to prevent the cement from setting on the surface of the plates. The plates were later power-washed to expose the aggregate material beneath the surface, resulting in a rough surface finish. This texture was desirable because significantly higher coral settlement has been reported on surfaces that contain micro-crevices and small spaces (Nozawa et al. 2011). By exposing the coarse aggregate, the surface area of each plate was increased along with the likelihood of small spaces for coral recruits. The plates were labeled individually using unique identification numbers.

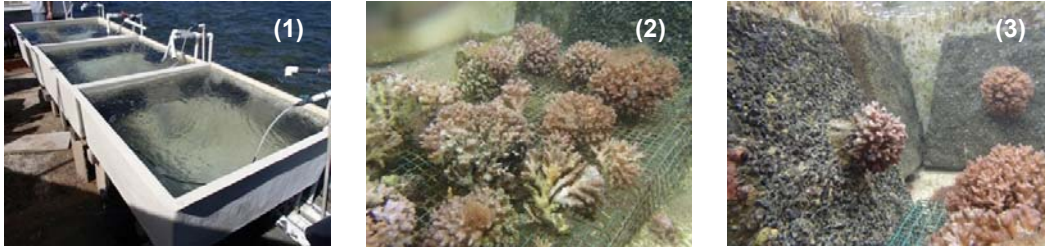
Figure 2. (1) Concrete plates were deployed in seawater test tanks in the laboratory experimental setup. (2) *P. damicornis* were placed in the center of each tank, and (3) were also cemented on half of the test plates.

upright along the four walls of the tank for a total of 12 plates in each tank. To ensure larval settlement, adult colonies of lace coral, *Pocillopora damicornis*, were placed on the bottom of each tank. Half of the plates from each mix type also had adult corals cemented in the center of the top surface while the other pair had none.

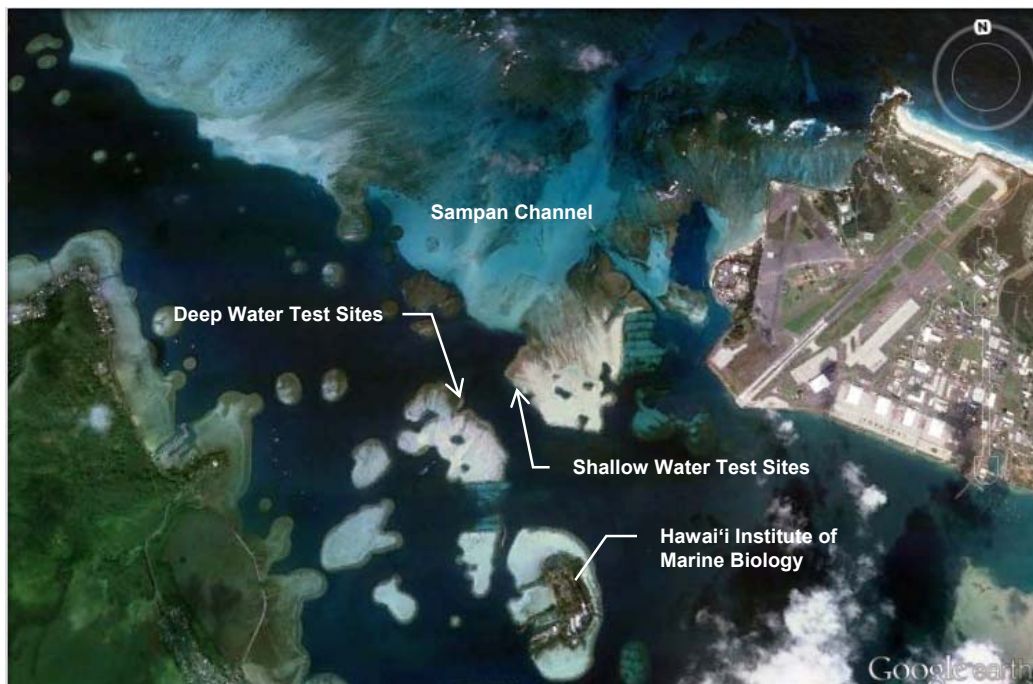
Figure 3. Map of the deep and shallow field experiment test sites located at patch reefs in Kāneʻohe Bay, Oʻahu (Google Inc. 2014).

The field experiments took place at two patch reefs located near the Sampan Channel in Kāneʻohe Bay (Fig. 3). The wind and wave exposure, water circulation, habitat type, likelihood of coral larval availability and settlement, and accessibility were considered upon the selection of these locations. The environmental conditions at the chosen reefs are similar to those at Kahului Bay because they are exposed to trade wind and constant water motion through the channel. Placing the experiment in a central reef location within Kāneʻohe Bay also exposes it to greater larval availability and settlement than northern or southern reef locations (Hodgson 1985; Kolinski and Cox 2004). The habitat composition at the selected locations are relatively homogeneous and are mainly characterized by a mixed bottom of live corals (10 to less than 50% cover, Battista et al. 2007), coralline and turf algae, rubble, and unconsolidated substrates. Two experiment sites were established at each location. The ‘deep’ and ‘shallow’ site locations were at average depths of 6.5 m and 1.0 m, respectively. A total of five plots were selected within each of the four sites. Two plates of each aggregate type were randomly assigned to a plot, thus six plates for each plot (Fig. 4).

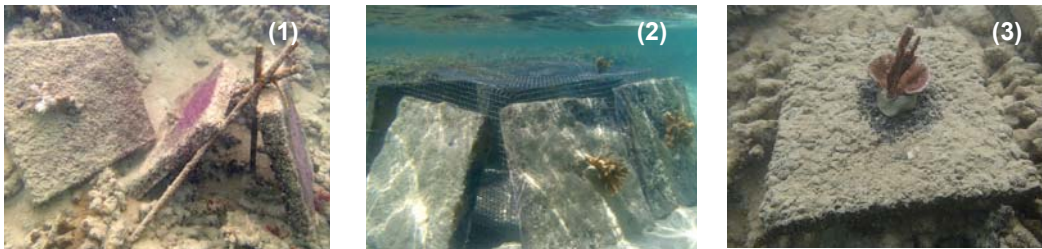
Figure 4. Concrete plates were deployed in plots of six on the sea floor in the field experimental setups at the (1) deep and (2) shallow sites. (3) *M. capitata* were cemented on half the test plates.

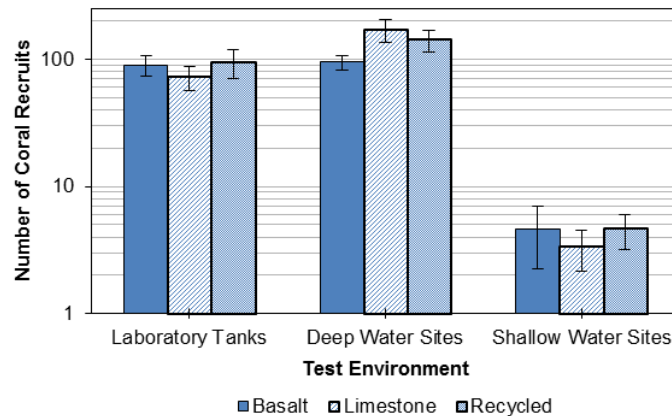
Figure 6. Mean coral recruitment on the three types of concrete plates located within each of the three testing environments. The error bars represent one standard error.

A total of 3,088 and 8,321 coral recruits were identified at the conclusion of the experiment on the surfaces of the concrete plates deployed in the laboratory and field setups, respectively. Of the total coral juveniles identified on the plates deployed in the field, 8,070 recruits were found on the deep water test plates, while only 251 were found on the shallow water plates. The abundance of coral recruits on each type of concrete and within each test environment is illustrated in Figure 6.

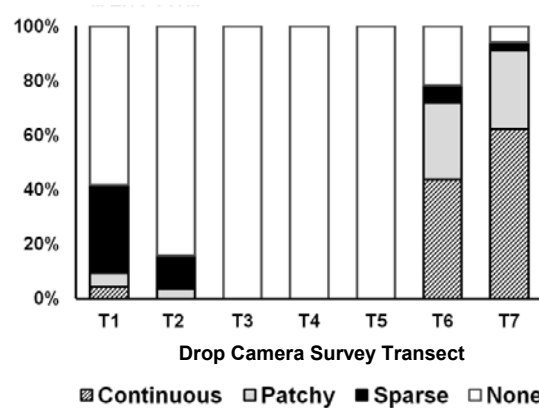
Figure 8. Relative occurrence of live coral coverage in photographic data collected during the camera surveys. The X-axes indicate transect IDs, y-axes show relative occurrence of cover type and abundance (Stender et al. 2014b).

The observations of the seafloor showed that the macrotopography for the majority of T6 and T7 was characterized by high relief spur and groove features (Fig. 8). The natural reef areas of T1 and T2 were characterized by pavement geomorphology, and had less topographic relief on the macroscale than the spur and groove formations. The seafloor topography observed in T3, T4, and the majority of T2 consisted of sparse carbonate rocks and reef rubble mixed with sand. The seafloor in transect T5 consisted entirely of sand. These areas had little macrotopographic relief and, in general, the bathymetry gradually sloped downward to the northeast at a rate of about 2%.
