ANALYSIS OF SHORELINE BEHAVIOR ON SENDAI COAST BEFORE AND AFTER THE 2011 TSUNAMI

Hoang Cong Vo¹, Yuta Mitobe¹ and Hitoshi Tanaka¹

Keywords: tsunami; shoreline change; EOF analysis; recovery;

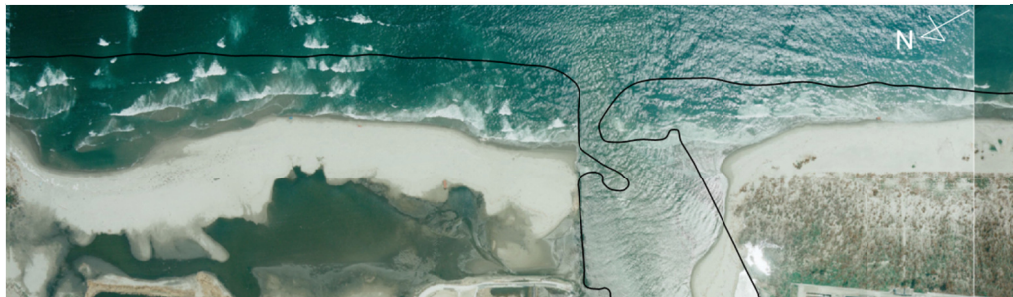
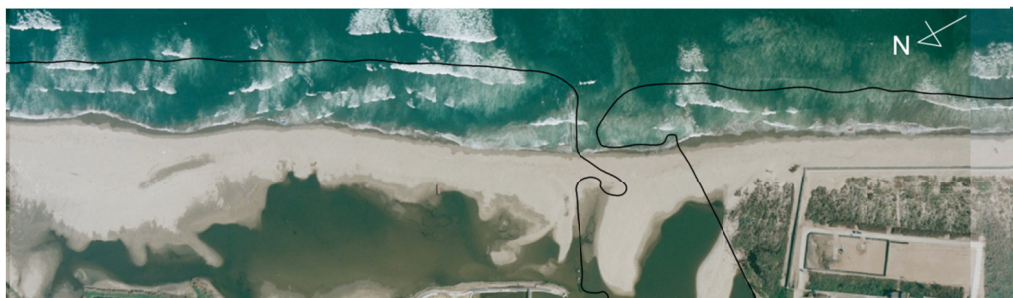
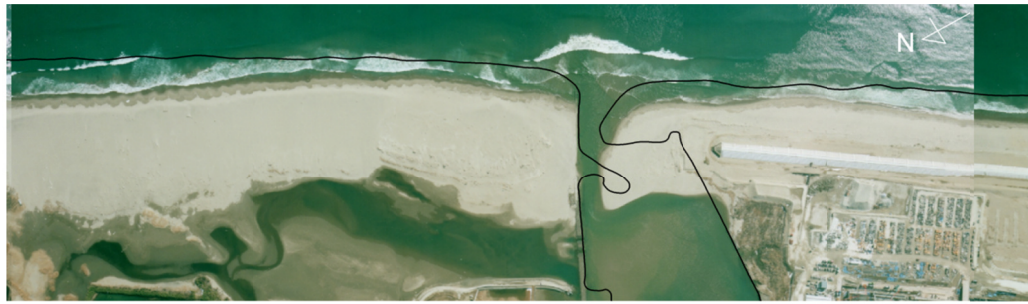
Figure 2. Morphological changes at the Nanakita River mouth (to be continued in the next page) (Black solid line is the shoreline position on March 6th, 2011)

According to Pradjoko and Tanaka (2012), before the tsunami shoreline around the Nanakita River mouth area was in the dynamic equilibrium. The left side had more fluctuation than the right side. The morphological changes and subsequent recovery after the tsunami in this area were reported by Tanaka et al. (2012). In that study, the recovery of morphology in longer time period is introduced. However, in order to make it more clear, then some key points of the significant changes and subsequent recovery process are also reintroduced. Figure 2 shows the morphological changes around the Nanakita River mouth for the both periods before and after the tsunami. As can be recognized from Figure 2(a) and Figure 2(b), the tsunami caused the severe erosion of the sandy beach, the flushing of sand spit located

in front of the river mouth and the disappearance of the sand bar in front of the Gamo Lagoon. Due to these damages, the Nanakita River mouth has concave landform after the tsunami. This landform plays the role as the sink of sediment and causes the erosion of the adjacent areas. The severe erosion occurred subsequently and on both sides of the river mouth (Figure 2(b), Figure 2(c)). Adityawan et al. (2013) has discussed clearly the erosion mechanism of the shoreline on the left side. The recovery process caused the sediment movement from the north to the south filling into the concave shape. This direction of sediment movement is contrary with the normal direction of longshore sediment transport in this area, which is from the south to the north. The erosion propagation of the beach on the right side was investigated by Hoang et al. (2014). During the subsequent recovery process, sand spit intrusion into the river mouth can be observed (Figure 2(c)). The depth of river mouth is deeper than the depth of closure induced by the tsunami and return flow is the reason of this intrusion (Tanaka et al., 2013). Figure 2(d) shows the completed closure of the Nanakita River entrance in September, 2011. The mechanism of this closure has been discussed by Tanaka et al. (2012). The photography taken in February, 2014 [Figure 2(f)] shows that shoreline has not reached the position before the tsunami. Detected shoreline positions extracted from some selected photographs are presented in Figure 2(g). The tsunami caused the large amount of retreat of shoreline. The subsequent recovery took place. The

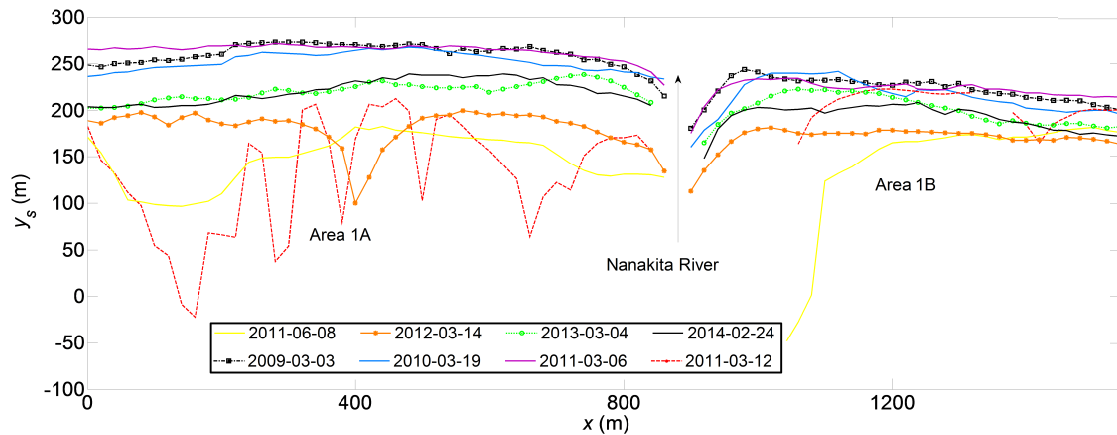
(g) Detected shoreline positions around the Nanakita River mouth

recovery process at this area is quite fast. However, until February, 2014, shoreline still remains 50m to 80m to reach the position before the tsunami.

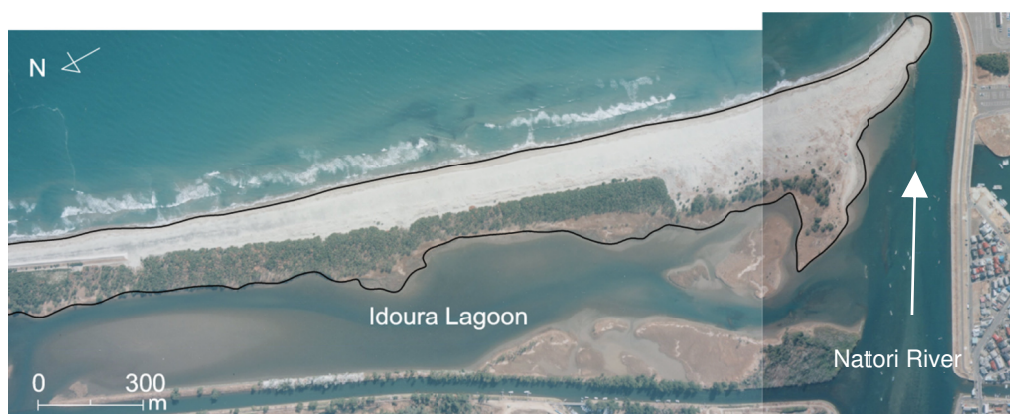
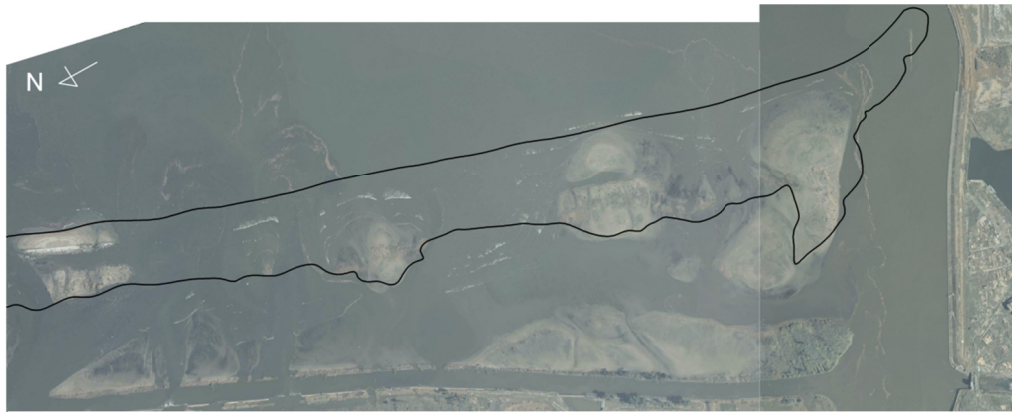
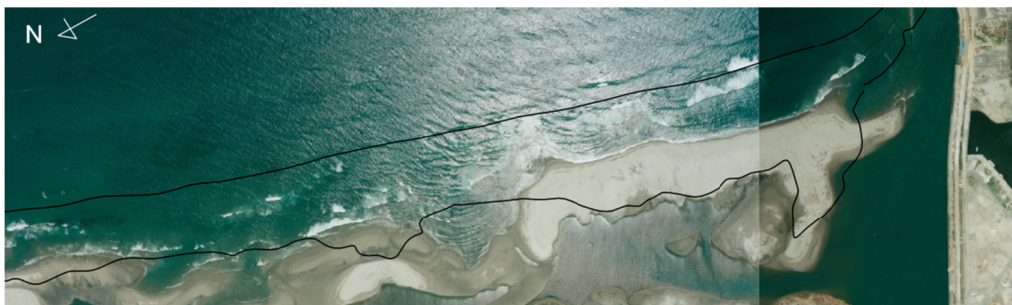
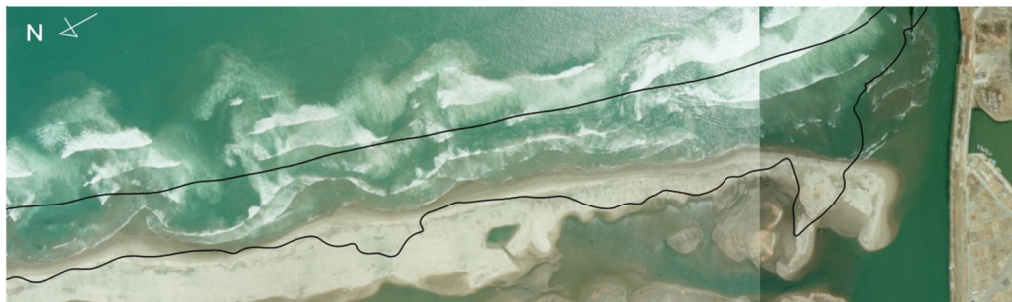
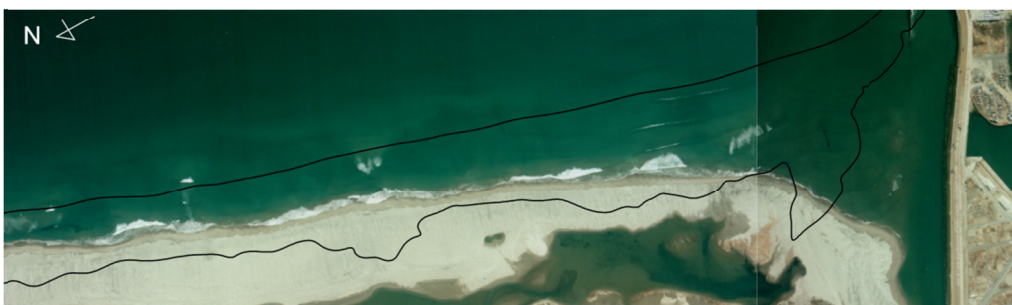
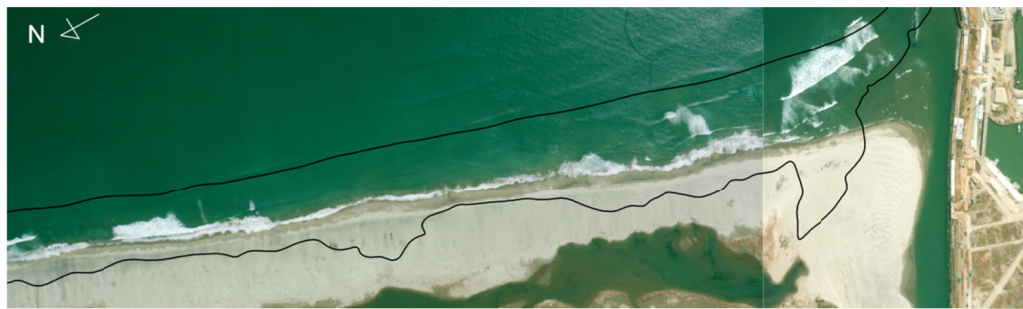
Figure 3. Morphological changes at the Natori River mouth (to be continued in the next page)

Figure 3 shows the morphological changes at the Natori River mouth. It is similar to the case of the Nanakita River mouth, tsunami also caused severe damages at this river mouth. Sandy beach erosion, flushing of sand spit and disappearance of sand barrier also can be observed (Figure 3(a), Figure 3(b)). However, the recovery of the morphology in this area is in different aspect compared to the recovery at the Nanakita River mouth. Due to the interruption on longshore sediment transport from the south of the breakwater at Yuriage Port and the retained sand of wave-dissipating blocks on the left, then the recovery is very slow (Hoang et al. 2014) (Figure 3(c), Figure 3(d)). During the recovery process, the sand spit intrusion into the river mouth area also can be observed (Figure 3(e)). Figure 3(f) shows the morphology of this river mouth in February, 2014. Shoreline has not reached the position before the tsunami; a big gap still remains. The evolution of shoreline at this river mouth area is revealed more details from detected shoreline positions extracted from aerial photographs and presented in Figure 3(g). It clearly shows that, a large retreat still remains behind the position of shoreline before the tsunami. The value of shoreline change rate for both periods before and after the tsunami is also computed for this area. Before the tsunami, change rate of shoreline far away the river mouth is almost stable. While the part, which is adjacent to the river mouth, has very large value of shoreline change rate. This can be related to the effect of river mouth and the developing of the sand spit in front of this river mouth. The average value of shoreline change rate of this area before the tsunami is 2.8m/year. The value of shoreline change rate is different in the period after the tsunami, the part of shoreline which is far away from the river mouth, has large positive value of change rate, while the part, which is adjacent to the river mouth, has negative value of change rate. This could be related to the sand spit intrusion into the river mouth. The average value of shoreline change rate of this area after the tsunami is 10m/year. This value is much lower than the average change rate at the Nanakita River mouth.

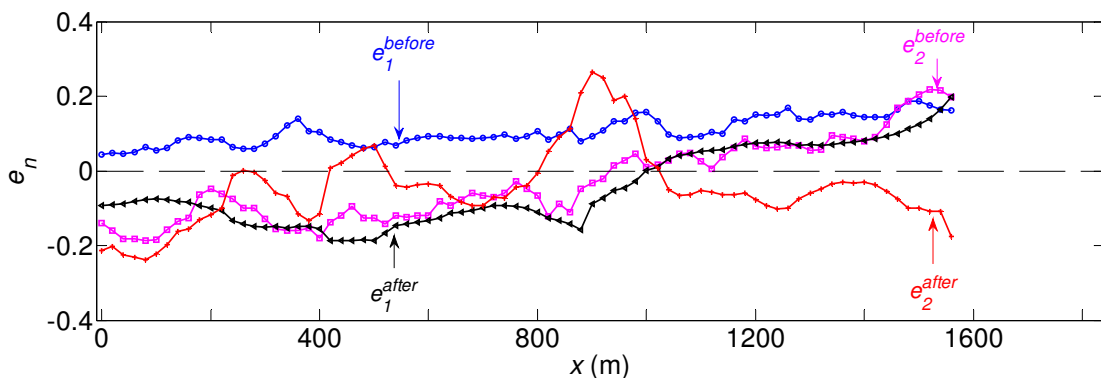
Figure 9. Spatial eigenfunctions of the first two components at the Natori River mouth both before and after the tsunami

The value of spatial eigenfunction of the first component at Area 2 before the tsunami is almost constant in the longshore direction (Figure 9). While the temporal eigenfunction fluctuates up and down around 0. The combination of the temporal eigenfunction and spatial eigenfunction also shows the fluctuation up and down of the shoreline. Hence, the first component at Area 2 is similar to the first component at Area 1. It relates to the cross-shore movement. The contribution of this component is 66%. The first dominant component in this area is same with the one in Area 1A and Area 1B. The contribution of the first component is almost same between Area 1A, Area 1B and Area 2.

The value of spatial eigenfunction of the second component is almost constant in the area far from the river mouth (Figure 9). It increases from the middle area to the river mouth. The value of temporal eigenfunction fluctuates up and down and also almost opposite with the first component. The combination of temporal eigenfunction and spatial eigenfunction show the shoreline far away from the river mouth fluctuates up and down. However at the area close to the river mouth, the evolution of shoreline is different. In this case, the second component can be related to the cross-shore movement with strongly effect of the river mouth, jetty or breakwater. Its contribution is about 18%.

The value of spatial eigenfunction of the first component after the tsunami is completely different with the first component before the tsunami. However, its tendency is similar to the second component before the tsunami (Figure 9). The value of temporal eigenfunction decreases from just after the tsunami up to the time of about 400 days. After that, it is almost constant (Figure 12). The combination of temporal eigenfunction and spatial eigenfunction is increasing but only at the area far away from the river mouth. On the other hand, at the area adjacent to the river mouth, that value is decreasing (Figure 13). Hence, the first component can be related to the cross-shore movement, the slow recovery of the area far from the river mouth and the retreat at the area adjacent to the river mouth due to the sand spit intrusion into river mouth. The contribution of this component is 77%.
