LONG-TERM SHORELINE CHANGES ON MARGINAL COAST OF TIDAL FLAT IN TOKYO BAY AND RAPID DEFORMATION OF SAND BARS OWING TO TSUNAMI

Yasumitsu Mikami¹, Akio Kobayashi¹, Takaaki Uda² and Yasuhito Noshi¹

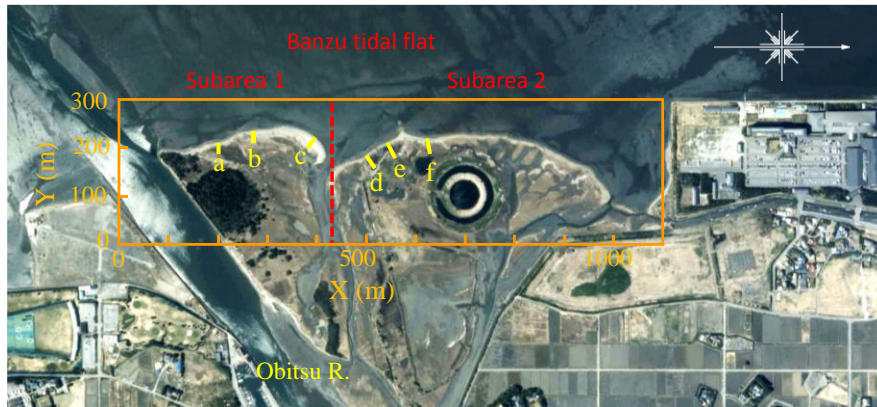
Figure 2. Location of study area in Banzu tidal flat, coordinate system, and location of transects a-f.

To investigate the beach changes on the marginal coasts of the Banzu tidal flat, aerial photographs were collected and the shoreline changes were examined using these photographs. The rectangular area in Fig. 2 is the study area, which is subdivided into subareas 1 and 2. Field observation was carried out in these subareas on April 19, 2014 and April 17, 2016. Transects a, b, and c were set between the Obitsu River and the north tributary, as shown in Fig. 2, together with transects d, e, and f north of the tributary, and the longitudinal profiles along these transects were measured on November 5 and 6, 2014. Simultaneously, vertical holes were excavated at several points along each transect, and the elevation above mean sea level (MSL) of the boundary between the sand and the mud layers composed of cohesive material was measured.

Figure 22 shows the beach profiles measured along transects **a** - **f**, as shown in Fig. 2, together with the boundary between the sand and mud layers. Along transects **a** and **b**, a triangular sand bar (barrier) was formed with berm heights of 1.18 and 1.9 m, respectively. In contrast, the berm height decreased to 1.04 m along transect **c**, while the width of the sand bar increased to 47 m with two berm peaks. The elevation of the boundary between the sand and mud layers was $Z = 0.5$ m along transects **a** and **b**, and $Z = 0.4 - 0.6$ m along transect **c**; both are in good agreement with the HWL of +0.5 m above MSL. Similarly, the elevation of the boundary between the sand and mud layers was $Z = 0.4 - 0.6$ m along transects **d**, **e**, and **f** north of the tributary. The maximum thicknesses of the sand layers were 0.6 (transect **a**), 1.3 (**b**), 0.7 (**c**), 0.6 (**d**), 0.7 (**e**), and 0.9 m (**f**).

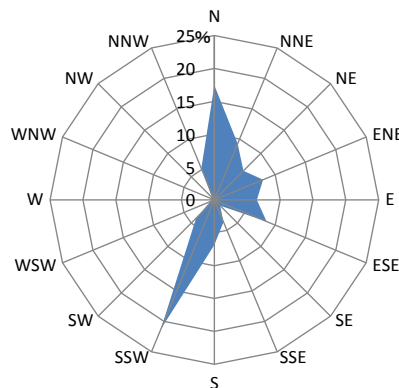
Figure 3. Wind rose at Kisarazu Port.

The wave rose at Kisarazu observatory was used as a reference, because the study area is located in the middle of Tokyo Bay, as shown in Fig. 1, and wind waves are predominant. Referring to the results of the meteorological observation between 2000 and 2012, Fig. 3 shows the mean wind rose in the entire period. The maximum probability of the wind direction is 21.2% in the SSW direction, followed by 17.4% in the N direction. The shoreline of the marginal coasts of the Banzu tidal flat extends in the S-N direction with some irregularities, as shown in Fig. 2, and thus the easterly wind can be neglected when considering the development of wind waves incident to the Banzu tidal flat, and the predominant wind directions become SSW and N. Of the two directions, the wind fetch in the N direction is 25.3 km, as shown in Fig. 1. On the other hand, because the wind fetch to SSW is truncated by reclaimed land, the wind fetch to SW is calculated instead of that to SSW. The resulting wind fetch to SW is 24.5 km. Moreover, a large area of reclaimed land is located 1.1 km north of the Obitsu River mouth, as shown in Fig. 2, protruding 60 m into the bay relative to the west boundary of the coast, and northerly waves can be sheltered by this reclaimed land. Regarding the tide level at Kisarazu Port, the high and low water levels (HWL and LWL) at the Banzu tidal flat are +0.5 and -0.5 m above MSL, respectively.

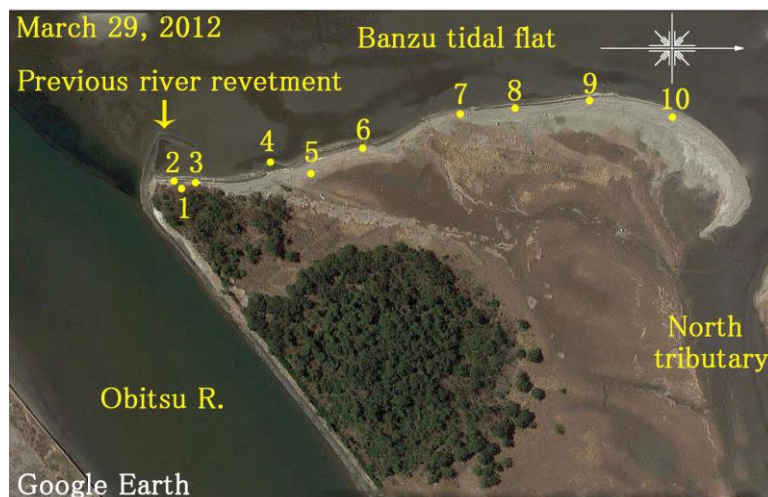
Figure 4. Satellite image of subarea 1 and locations of Sts. 1-10.

Shoreline changes and the exposure of the previous tidal flat composed of cohesive material to waves were investigated. Figure 4 shows a satellite image of the subarea 1 between the Obitsu River and its north tributary, taken on March 29, 2012, and the station number (St.) in the field observation on April 19, 2014. The straight revetment along the right bank of the Obitsu River turns to the right at the river mouth, then extends northward, forming an L-shaped structure. A concave shoreline has formed north of this revetment, the shoreline gradually curves rightward with increasing distance from the river mouth and is connected to a sand spit formed on the left bank of the north tributary. The formation of this sand spit at the north end clearly explains the predominance of northward longshore sand transport in this area.

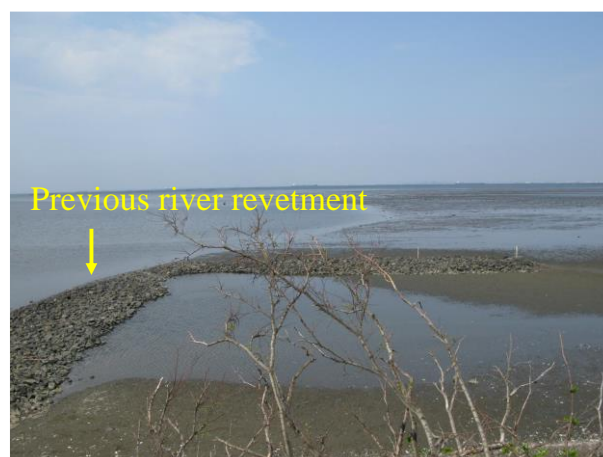
Figure 5. Photograph of L-shaped revetment, taken from the top of the mound immediately north of Obitsu River mouth.

Immediately north of the Obitsu River, there is an artificial mound from which a good view of the tidal flat is obtained. Figure 5 shows the view of the tidal flat and the L-shaped structure on the tidal flat, taken from St. 1 on the top of this mound. A revetment with a low crown height made of stones extends with a lagoon behind the revetment, whereas severe erosion has occurred at St. 2, forming a high scarp of 2 m height landward of the L-shaped revetment, and many trees have fallen over (Fig. 6). From this observation, it was assumed that the revetment was constructed to protect the land from erosion, and it was left behind because the area behind the revetment was eroded away. Figure 7 shows the receded concave shoreline at St. 3 immediately north of the L-shaped revetment. A wide tidal flat extends offshore of the shoreline, which is clearly separated from the foreshore by a line formed by a sharp break in the slope. Figure 8 shows a photograph of an exposed half-consolidated layer composed of cohesive material with many vegetation roots, taken at St. 4. Because a layer composed of cohesive

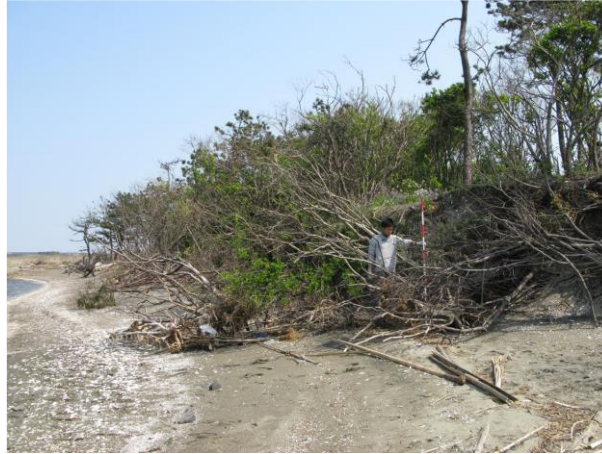
Figure 6. Scarp with 2 m height formed by erosion.

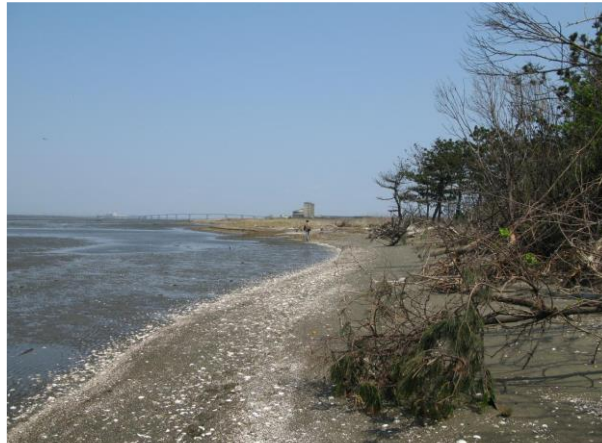
Figure 7. Concave shoreline extending from north end of L-shaped revetment.

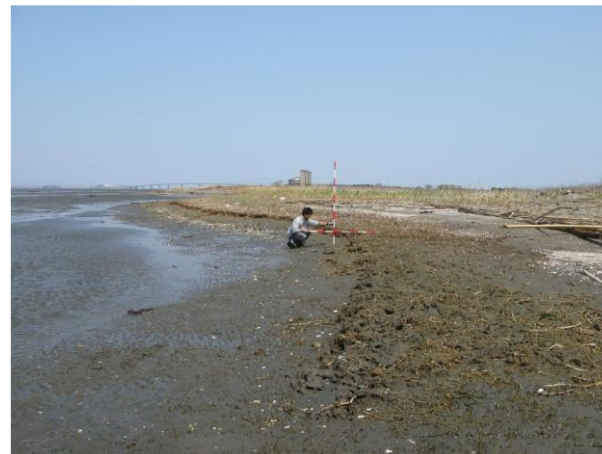
Figure 8. Photograph of exposure of tidal mud layer and roots of vegetation.

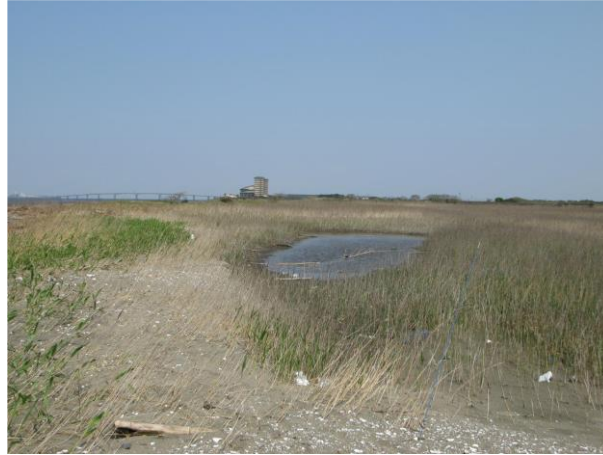
Figure 9. Lagoon behind barrier island covered with vegetation.

A sand bar has developed with a lagoon behind it, and reeds are abundant at St. 5, as shown in Fig. 9. This is the evidence that this lagoon was enclosed behind the present sand bar by the successive

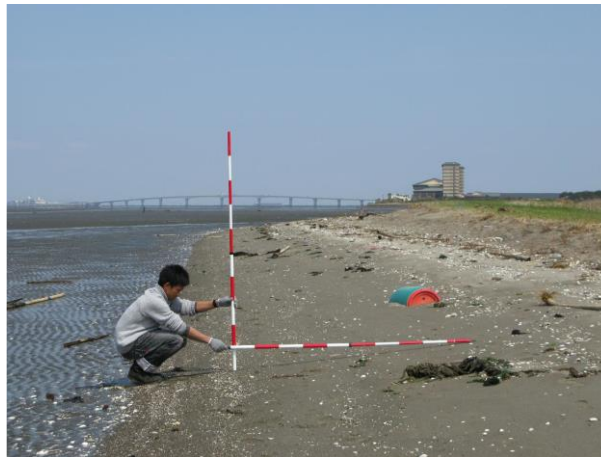
Figure 10. Tidal flat and foreshore of 1/10 slope clearly separated by the line formed by a sharp break in the slope.

recession of the shoreline around this area. Figure 10 shows the low-tide shoreline with a sharp break in the slope between the tidal flat with a gentle slope and a steep foreshore with a slope of 1/10 at St. 8. This separation of the foreshore with a steep slope of 1/10 and the offshore mud flat with a very gentle slope is one of the common characteristics observed on the marginal coasts of tidal flats, such as those in the Suo-nada Sea and elsewhere (San-nami et al. 2015). Furthermore, north of St. 8, the shoreline is significantly curved, as shown in Fig. 11, because of the development of a sand spit.

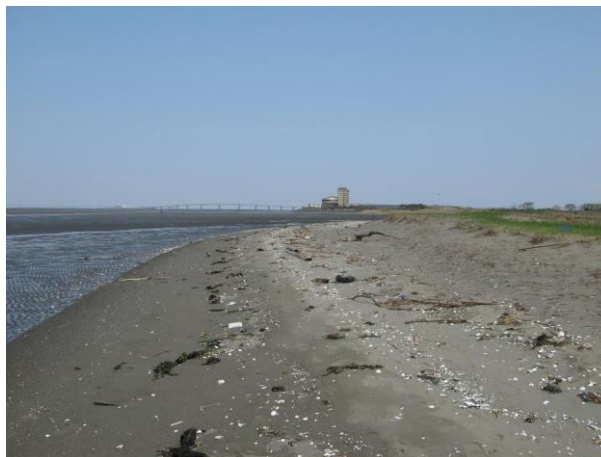
Figure 11. Convex profile formed by successive deposition of sand.

The shoreline positions were determined from the aerial photographs, and the shoreline positions were corrected to match the MSL using a foreshore slope of 1/10, which was determined by a beach survey and from the tide level. Figure 21 shows the shoreline changes between 1980 and 2010. Here, the shoreline changes since 1980 in the area north of point P were determined as the distances in the direction normal to the shoreline in 1980. We examined the changes along transects A, B, and C at $X = 100$, 180, and 285 m, respectively, as shown in Fig. 21. The shoreline at $X = 100$ m retreated by 65 m between 1980 and 2010. It was found that a scarp with 2 m height, as shown in Fig. 6, was formed near transect A because of the marked shoreline recession. Along transect B at $X = 180$ m, although the shoreline advanced by 25 m between 1980 and 2000, it has been retreating since 2000, resulting in shoreline recession by 40 m in 2010 compared with that in 2000. The erosion in the vicinity of transect B associated with the shoreline recession can be confirmed from the exposure of the cohesive mud layer with many truncated roots of reeds, as shown in Fig. 8. Although no large shoreline changes were observed along transect C at $X = 280$ m until 1990, the shoreline has rapidly advanced since 2000, and had advanced by 40 m by 2010 compared with the shoreline in 1990. Because of the formation of a sand spit at the north end, a curved shoreline with an upward convex profile was formed, as shown in Fig. 11. As shown by these photographs, the shoreline changes in subarea 1 were found to be mainly

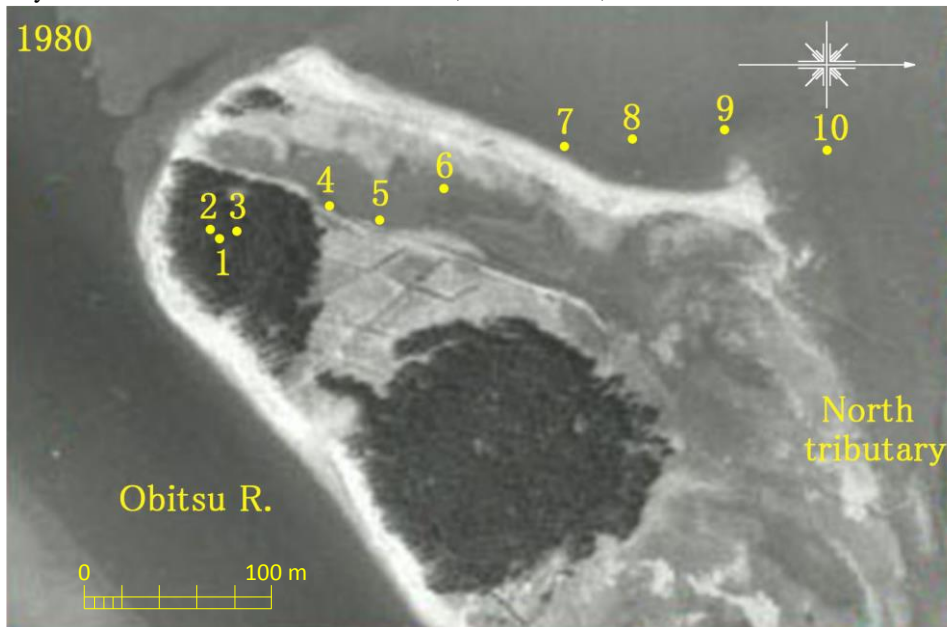
Figure 12. Aerial photograph taken in 1980 and locations of Sts. 1-10.

Figures 12-15 show aerial photographs taken in 1980, 1990, 2000, and 2010, respectively, together with the shoreline configurations in 2014 and 2016 and the location numbers of the site photographs taken on April 19, 2014. In 1980, the shoreline protruded significantly immediately north of the Obitsu River mouth, as shown in Fig. 12. At this time, Sts. 2 and 3 were located in a pine tree forest, whereas St. 4 with the exposed past mud layer was located close to a lagoon surrounded by a barrier island, and fine material was being deposited in the lagoon. Furthermore, Sts. 7-10 were located offshore of the shoreline in the tidal flat and were exposed to waves. By 1990, the sand bar located immediately north of the Obitsu River had moved northward and the curvature had increased (Fig. 13). At this time, the wetland area was narrowing because of the landward movement of the sand bar from the southwest side, but Sts. 4 and 5 were still located inside the lagoon. However, St. 6 was buried in the sand bar because of the further development of the sand bar. By 2000, the semicircular sand bar in 1990 had moved northward as a whole (Fig. 14). Beach erosion had intensified in front of St. 2 and the lagoon was buried by the sand bar near St. 4. Furthermore, Sts. 7 and 8, which were located in the tidal flat until

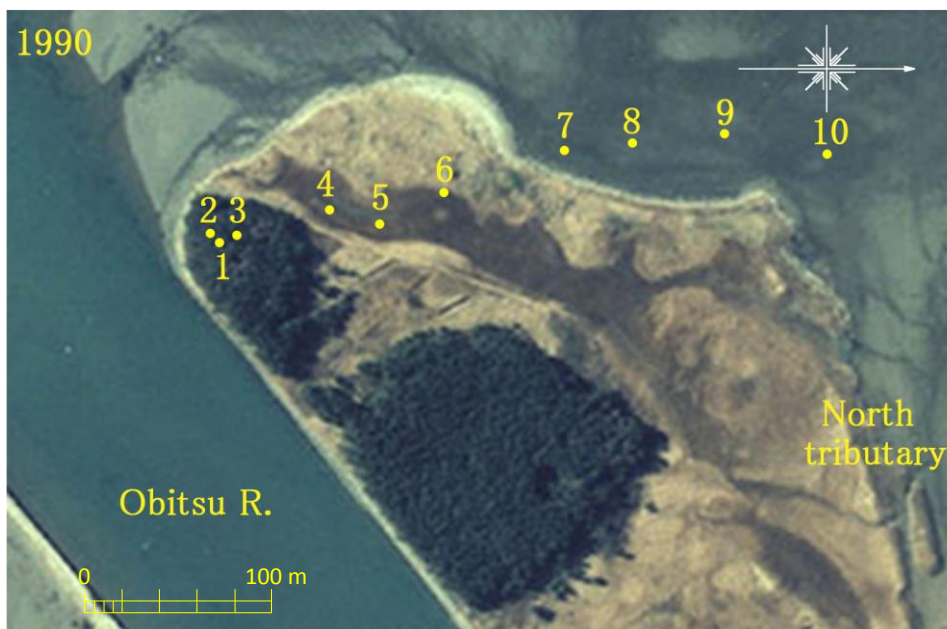
Figure 13. Aerial photograph taken in 1990 and locations of Sts. 1-10.

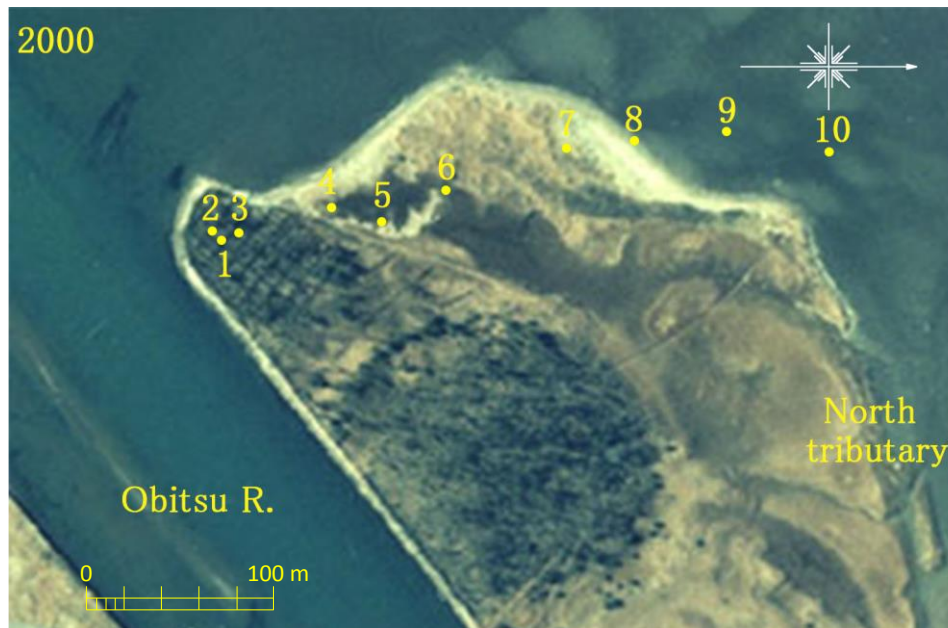
Figure 14. Aerial photograph taken in 2000 and locations of Sts. 1-10.

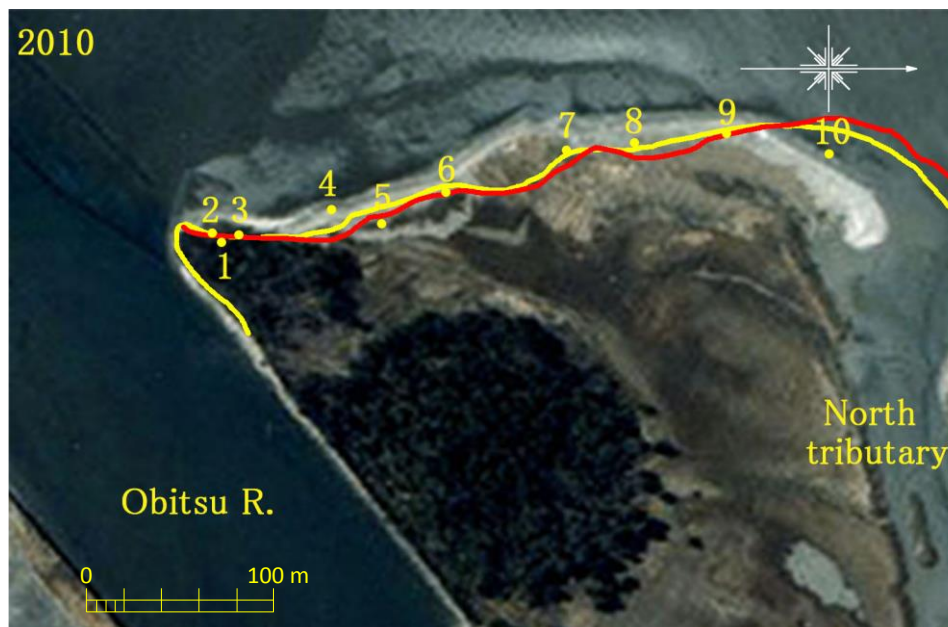
Figure 15. Aerial photograph taken in 2010 and locations of Sts. 1-10.

1990, were now in the sand bar. By 2010, the protrusion that had formed offshore of Sts. 4-7 in 2000 had disappeared. Instead, sand was being deposited in the vicinity of St. 9, resulting in the extension of the sand spit near St. 10 (Fig. 15). The overall shape of the sand bar was similar to the present form.

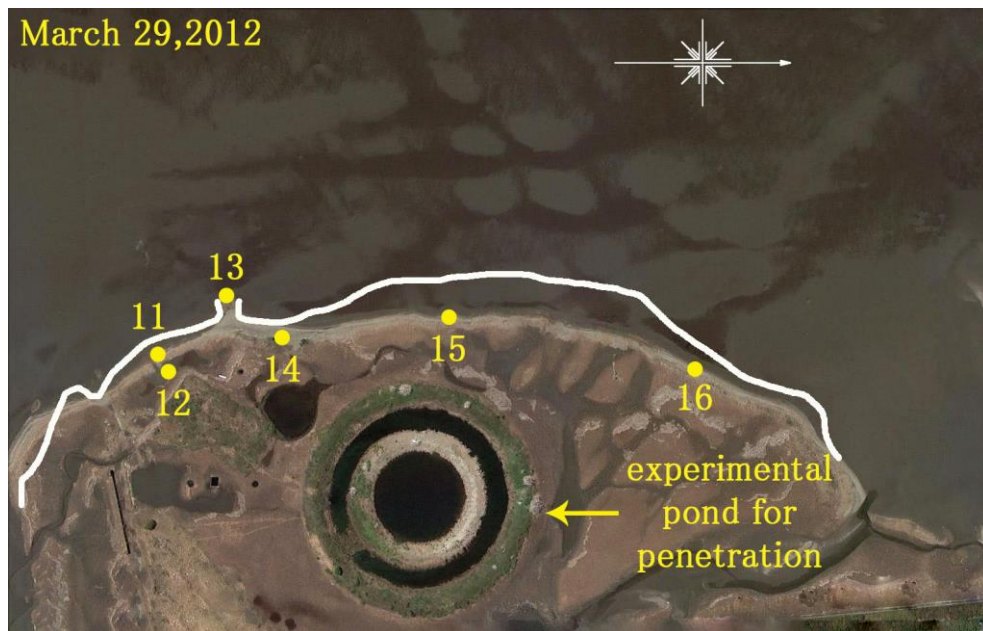
Figure 16. Satellite image of subarea 2 and locations of St. 11-16.

Figure 16 shows a satellite image of subarea 2 together with the shoreline in 2000 and the locations of the observation sites Sts. 11-16. A curved shoreline extends in this area, and a slender barrier encloses the salt marshes, as shown in the satellite image. First, at St. 11, north of the mouth of the tributary, many roots of the vegetation that have grown on the mud layer composed of cohesive material were truncated along the high-water shoreline, as shown in Fig. 17. In contrast, at St. 12, immediately landward of St. 11, a large amount of sand has been transported into the lagoon over the vegetation zone (Fig. 18). Since the disappearance of the sandy beach seaward of the vegetation zone is in marked contrast to the deposition of a large amount of sand immediately landward of the vegetation zone, it is

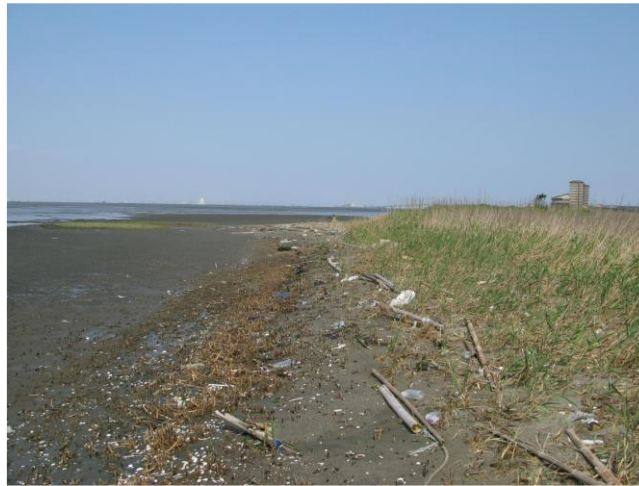
Figure 17. Many truncated roots of coastal vegetation grown on the mud layer composed of cohesive material along the high-water shoreline (St. 11).

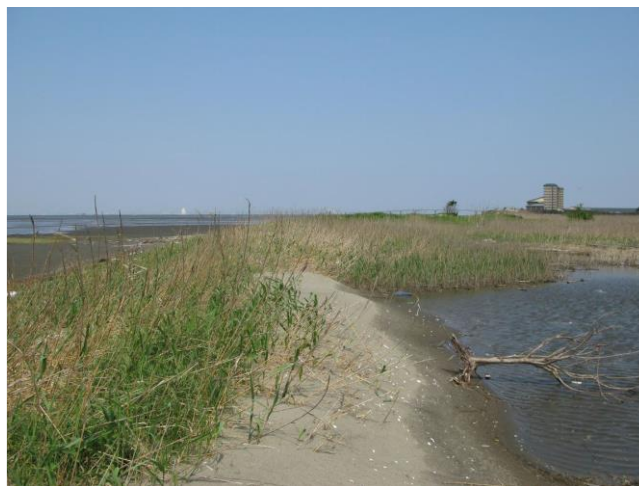
Figure 18. Deposition of sand behind vegetation zone caused by landward movement of sand (St. 12).

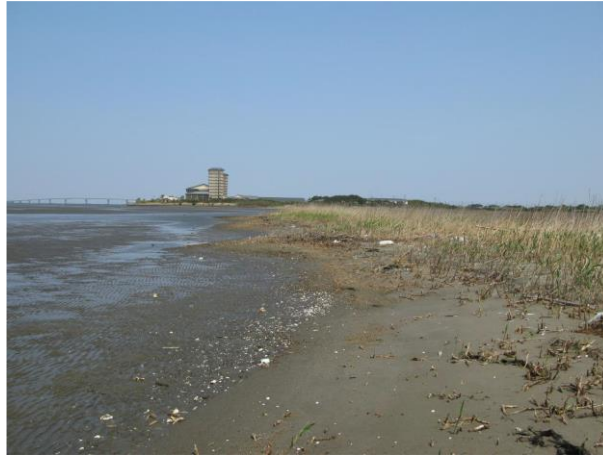
Figure 19. Eroded beach and exposure of many vegetation roots (St. 15).

concluded that a large amount of sand was transported landward in the cross-shore direction. Similarly, at St. 15, 165 m north of the protruding vegetation zone, the beach was eroded and many vegetation roots were exposed, and a very gentle slope was left offshore of the vegetation zone (Fig. 19). Finally, at St. 16, sand had been transported landward and the reed field behind the previous sandy beach was buried by sand, implying the occurrence of landward sand movement across the sandy beach and vegetation area (Fig. 20).

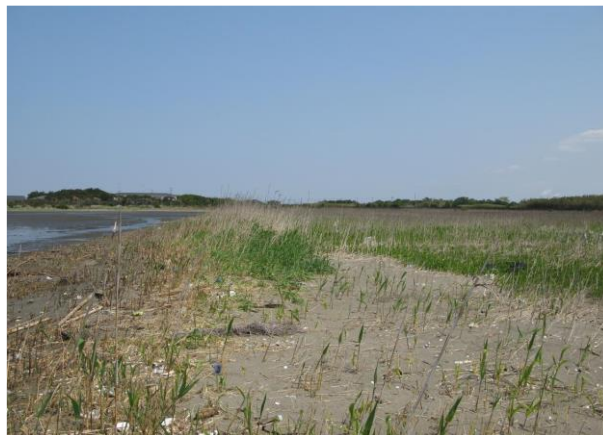
Figure 20. Deposition of sand inside vegetation zone (St. 16).

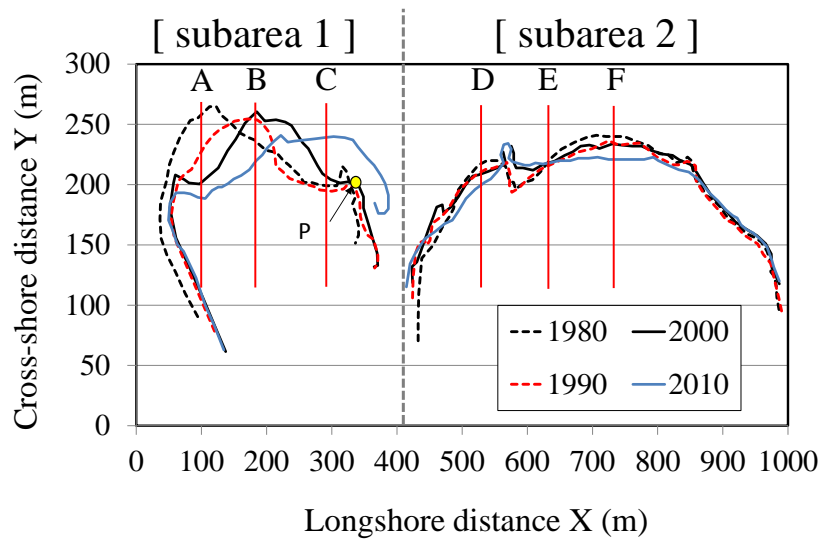
Figure 21. Long-term shoreline changes between 1980 and 2010.

triggered by northward longshore sand transport. In contrast, the entire shoreline has receded since 1980 in subarea 2.

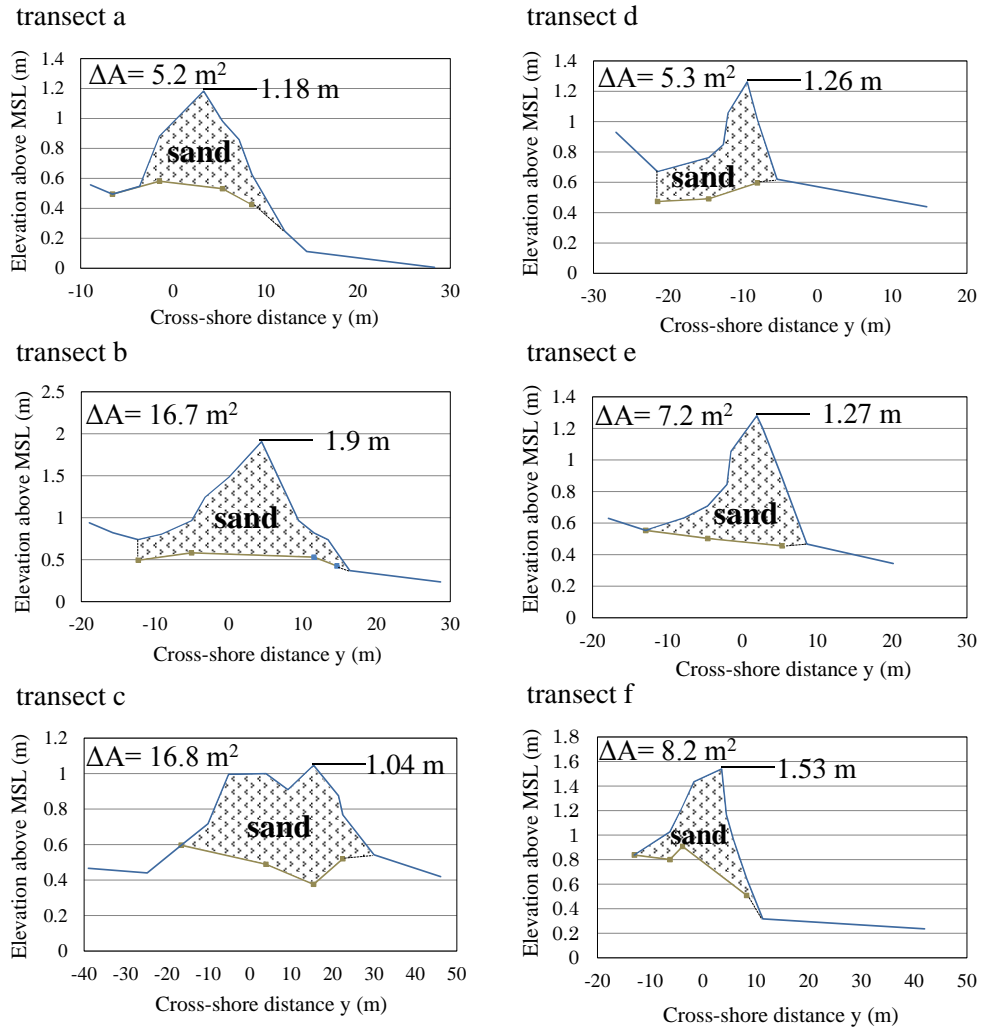
Figure 22. Cross sections of beach ridges along six transects.

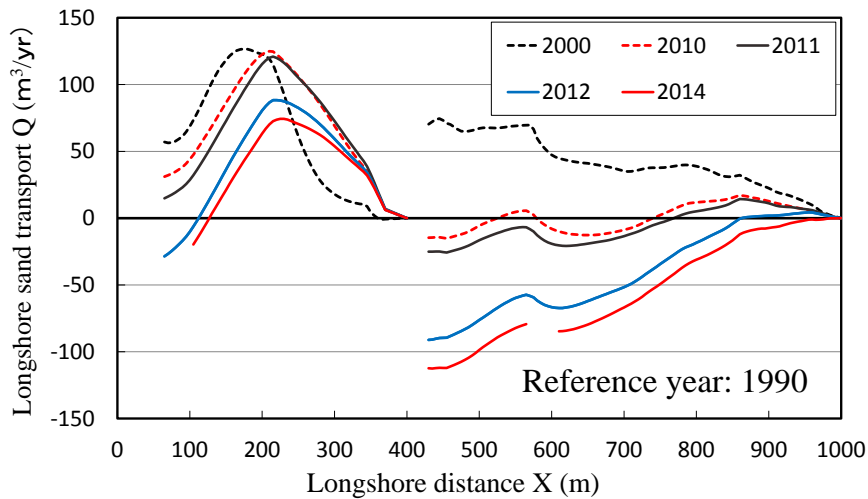
Figure 23. Distribution of longshore sand transport.

The shoreline changes between 2000 and 2014 were calculated with reference to the shoreline in 1990, and the change in the foreshore area was calculated by integrating the shoreline change alongshore, selecting the upstream end of the sand spit ($X = 370$ m) at the mouth of the tributary as the reference point and $X = 1,000$ m at the north end of the study area, where longshore sand transport is assumed to be 0. Then, by transforming the change in the foreshore area into the change in volume by multiplying it by the characteristic height of the beach changes (0.37 m), and dividing by the elapsed time, the distribution of longshore sand transport was calculated (Fig. 23). The distribution of longshore sand transport in the south area corresponds well to the beach changes, where the beach is eroded immediately north of the Obitsu River, whereas a sand spit elongates at the mouth of the tributary. The location of maximum sand transport gradually moved northward from $X = 175$ m in 2000 to $X = 230$ m in 2014, and the maximum amount was reduced over time from $Q = 127$ m³/yr in 2000 to 74 m³/yr in 2014.

In the area north of the tributary, northward longshore sand transport prevailed in 2000, but it had decreased to a negligible amount by 2010, and thereafter, southward longshore sand transport appeared to be taking place in 2014. Since an artificial mound was left at $X = 570$ m north of the tributary, which

locally prevented longshore sand transport by waves incident from the southwest, a slight change in longshore sand transport can be observed. In conclusion, it appears that the direction of longshore sand transport reversed over time, which cannot be observed under ordinary conditions, north of the tributary.

Because of this parallel movement of the shoreline, an apparent change in the foreshore area occurred, resulting in a decrease in the sand volume, and the distribution of longshore sand transport shown in Fig. 23 was obtained in the area north of the tributary. Although in subarea 1 sand movement similar to that in subarea 2 occurred owing to the tsunami, as shown in Fig. 23, large longshore sand transport masked the shoreline changes.

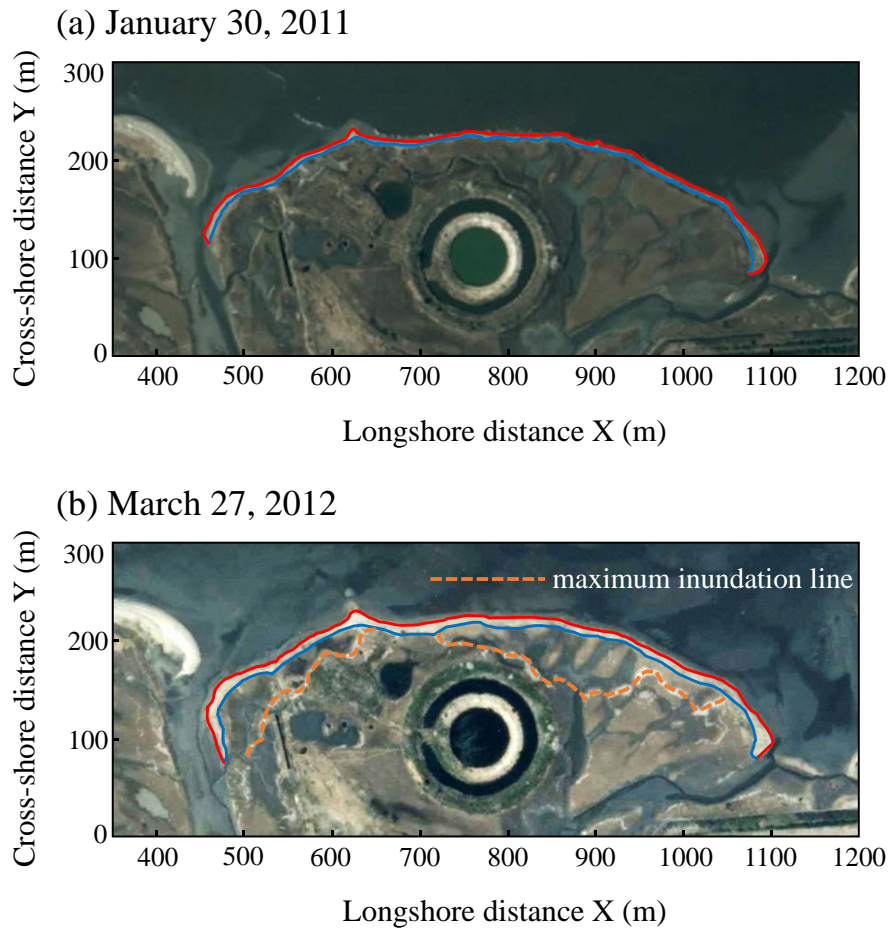
Figure 24. Aerial photographs taken before and after tsunami.

During the 2011 Great Earthquake on March 11, 2011, the resulting tsunami propagated deep into Tokyo Bay. At Futtsu point, a tsunami run-up height of approximately 2 m was measured (Mita et al. 2014). Also, a 1.3-m-high tsunami was measured at Harumi (Japan Meteorological Agency 2011), as shown in Fig. 1. Thus, a tsunami of a similar magnitude inundated the Banzu tidal flat and was assumed to cause topographic changes. Therefore, this situation was investigated using aerial photographs taken before and after the tsunami. Figure 24 shows aerial photographs taken on January 30, 2011 and March 27, 2012. In each photograph, the seaward and landward boundaries of the beach ridge extending along the shoreline are denoted by red and blue lines, respectively. Also, the maximum inundation line, which can be identified by the deposition of debris, is shown by a thick broken line in Fig. 24(b). Debris was carried landward over the lowland by the tsunami.

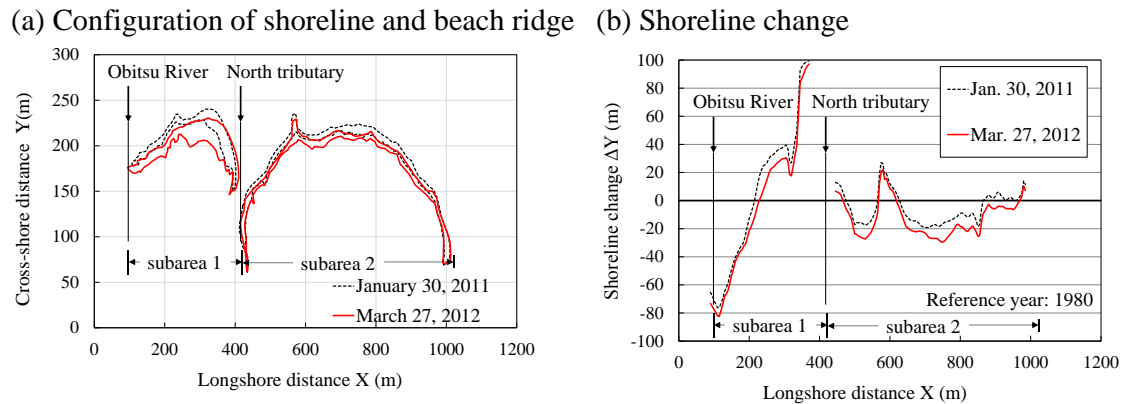
Figure 25. Changes in configuration of shoreline and beach ridge.

Figure 25 shows the seaward and landward boundaries of the sand bars on January 30, 2011 and March 27, 2012, respectively, and the shoreline changes in subarea 1 and 2 with reference to 1980. It was found that in subarea 2 the sand bars had moved landward by 7 m on average parallel to the shoreline, together with a 27 m extension of the southern tip of the sand bar. In this case, the peripheral length of the sand bars was almost constant: 2008 m in 2011 and 2049 m in 2012. Moreover, the planar areas of the sand bars were $1.25 \times 10^4 \text{ m}^2$ in 2011 and $1.08 \times 10^4 \text{ m}^2$ in 2012. This means that the sand bars moved landward while maintaining an almost constant volume of sand, that is, the cross section of the sand bar moved in the same direction. Sand was only deposited on the mud layer composed of cohesive material and formed a small hump, as shown in Fig. 20. The parallel movement of the shoreline occurred with the landward movement of the sand bars. In Fig. 17, the roots of the vegetation were truncated, whereas in Fig. 18 immediately landward of the site, a large amount of sand was deposited on the lagoon over the vegetation zone. The disappearance of the sandy beach seaward of the vegetation zone can be successfully explained by this landward transport of sand by the tsunami.
