CASE STUDY: STABILISATION OF A RAPIDLY ERODING POINT USING AN INSITU-FILLED GEOTEXTILE CONTAINER GROYNE FIELD

Bobbie Corbett¹, Nicholas Wellwood², David Shing³ and Leslie Angus Jackson⁴

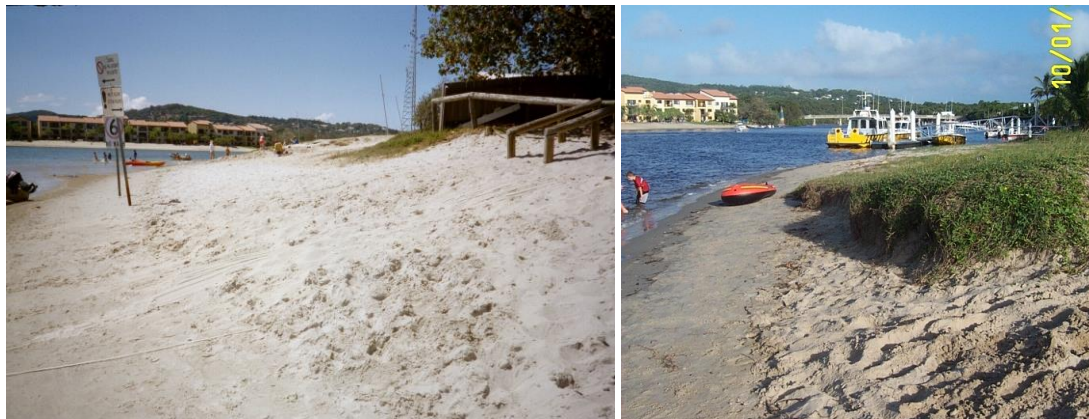
Figure 3. Performance of Nourishment (left: post-nourishment Sept 2004; right: Jan 2006)

Erosion of Munna Point beaches was first observed in 1988. This was managed through bi-annual maintenance nourishment with volumes up to 5,000m³. Nourishment longevity was reported to be typically less than 6 months, resulting in high maintenance costs (Figure 3). Nourishment volumes were reduced since 2001 and ultimately suspended in 2010 due to high long-term costs.

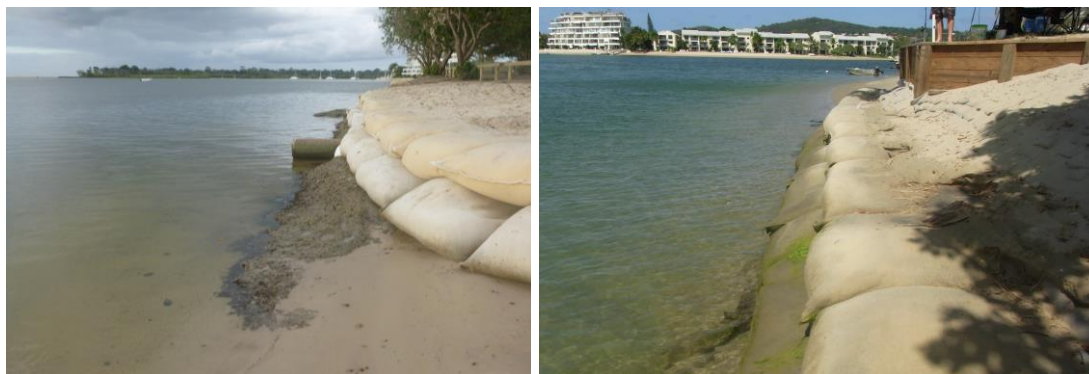
Figure 4. Emergency Seawall

Nourishment was suspended, but erosion continued. In 2013, infrastructure was threatened and an emergency seawall approximately 1.5m in height was constructed using 0.75m³ sand-filled geotextile containers (Figure 4).

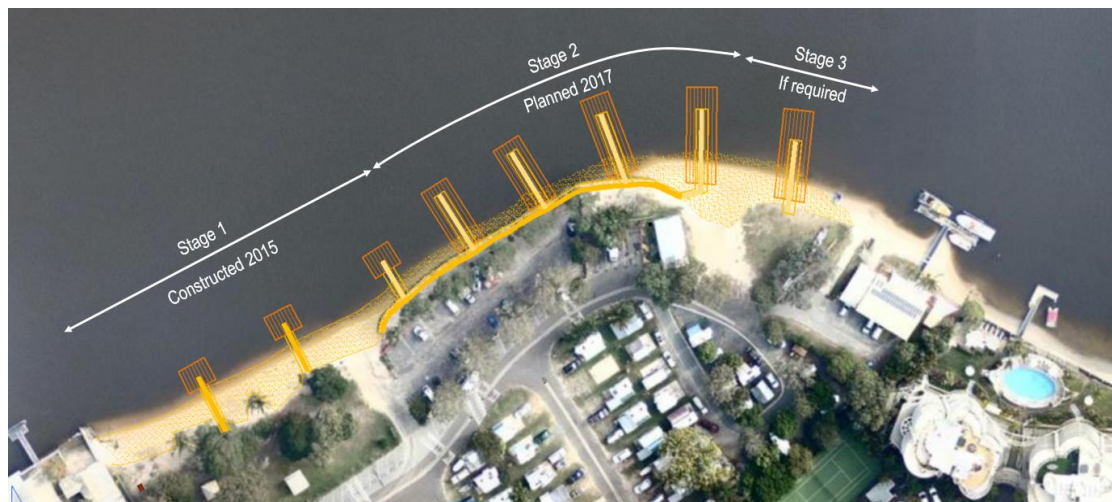
Figure 5. Design Concept

As such, beach nourishment was proposed with construction of a groyne field to stabilize the beach profile and extend the longevity of the placed nourishment. The groyne field included up to 8 groynes some 13 - 20m in length (Figure 5).

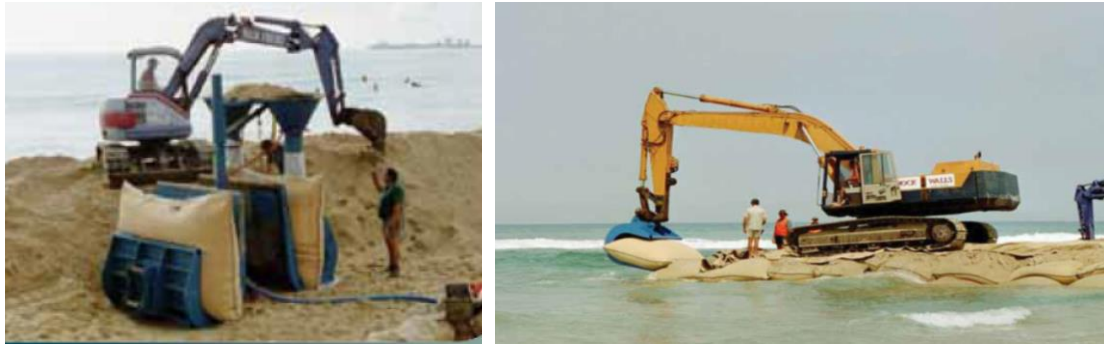
Figure 7. Traditional Method of Filling Sand-Filled Geotextile Containers

Traditionally in Australia, sand-filled geotextile containers of this size are filled in a hopper and placed with a large excavator from shore (Figure 7) (Restall et al, 2001). This construction method would have been difficult for this design as the lower crest and length of the groyne would have required a reach beyond that of excavators typically used, even at low tides.

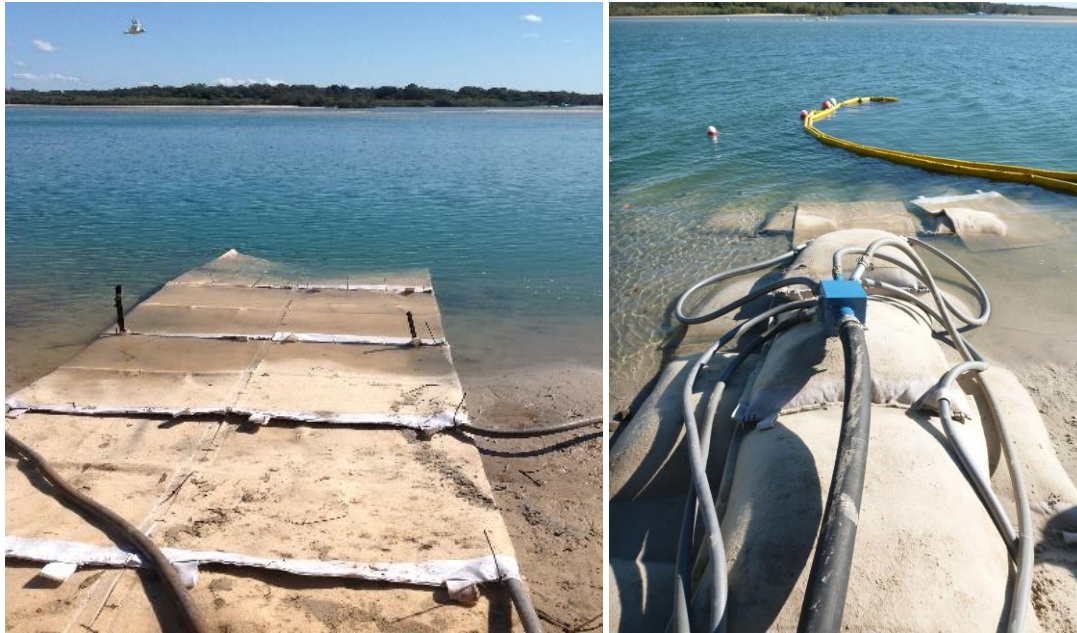
Figure 8. Novel Method of Filling Sand-Filled Geotextile Containers In-Situ

Construction of the first stage was undertaken in August 2015. The construction methodology involved the placing of pre-fabricated and pre-connected containers in the correct position and alignment with in-situ filling of both geotextile containers and scour mattresses using a small 6/4" dredge with a splitter box (Figure 8). This technique is more typical for larger mega-containers and its innovative application to the custom scour mattresses and smaller containers proved to be very successful provided containers were manipulated during the filling process to ensure adequate container shape and interlocking.

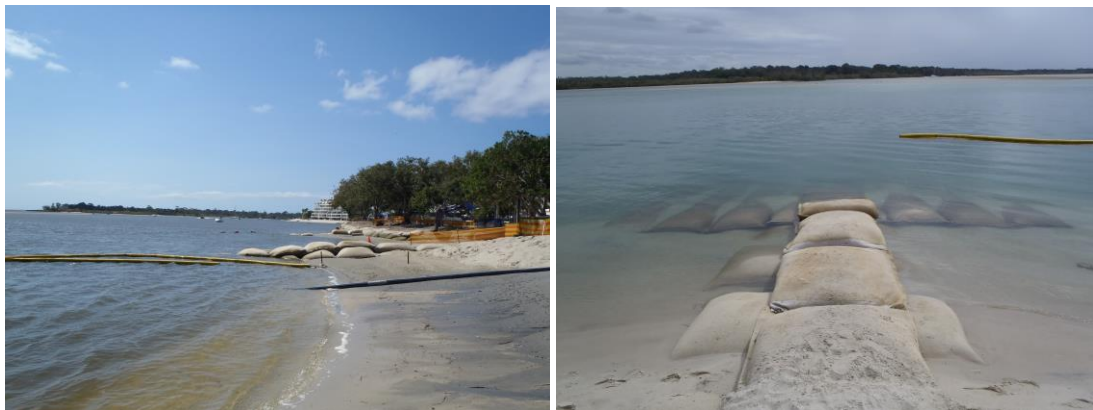
Figure 9. Completed Stage 1 Groyne

The completed works were successfully completed (Figure 9) and were relatively low profile even prior to nourishment resulting in burial of the works.

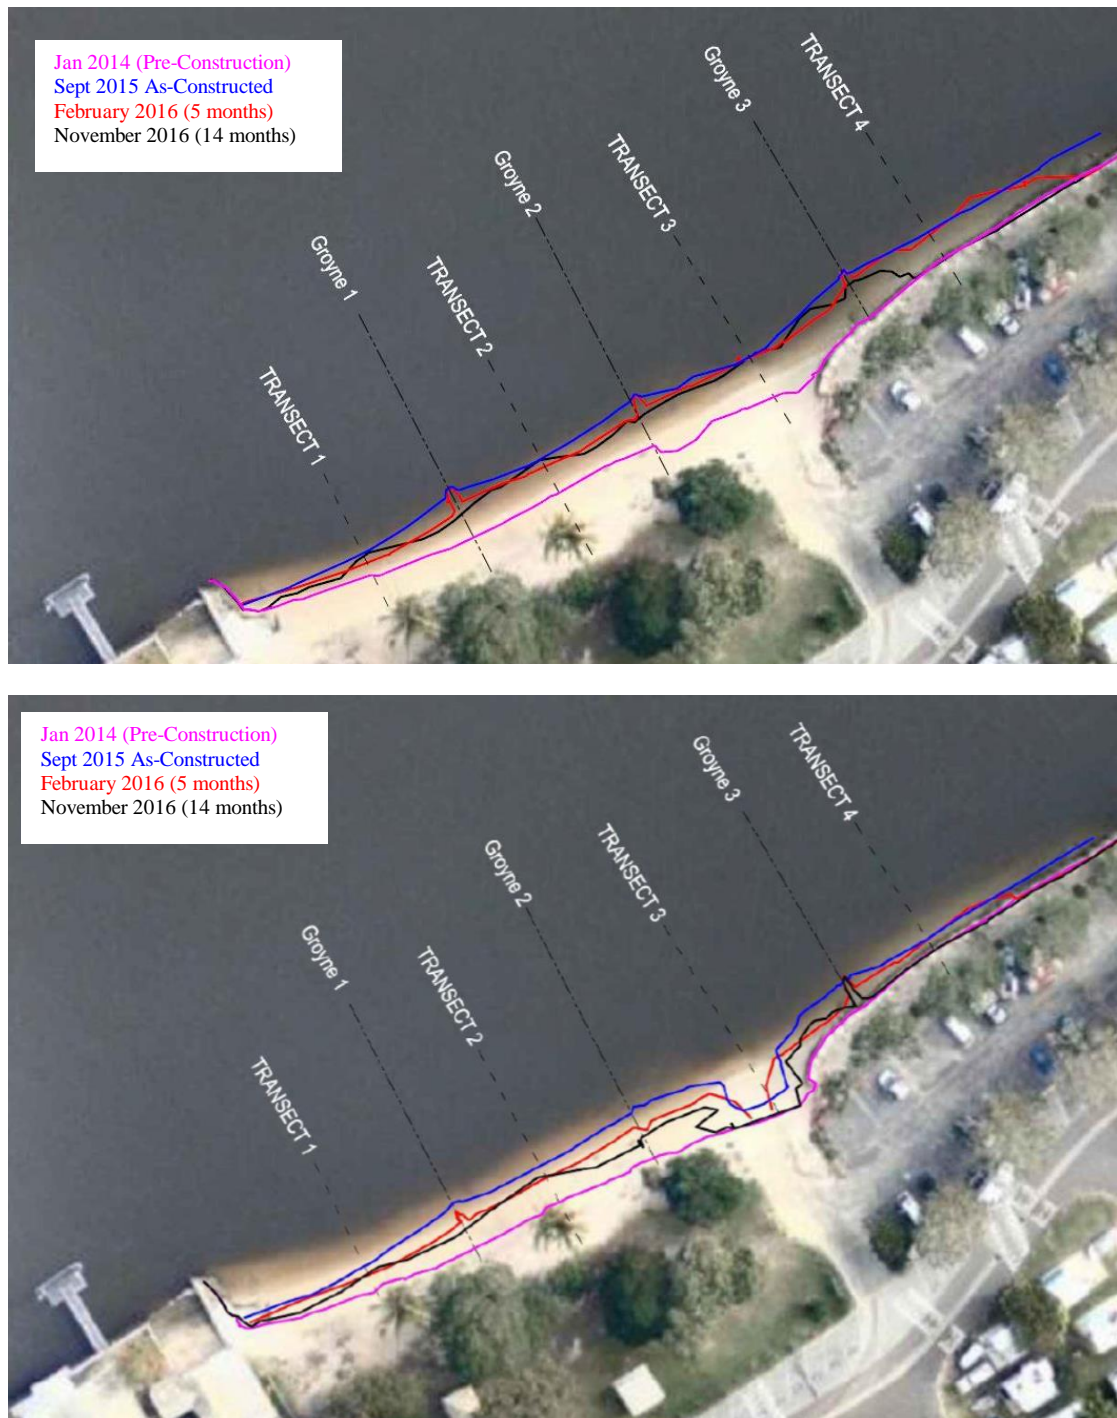
Figure 10. Monitoring Survey showing Transect Location and Planform Shape of the Beach at Mid Tide (top) and High Tide (bottom)

Review of survey data within the footprint of the Stage 1 works over a 14 month period (Figure 10 and Figure 11) indicates that the mid to high tide beach is 3 – 4m wider and the whole profile is 9 – 12m³/m larger than the pre-construction condition. The intertidal nourished profile experienced some minor reprofiling as expected (<1m³/m change) in the first 5 months but has since remained essentially stable. Observed widening of the profile below low tide could be the result of natural processes or the migration of nourishment downstream of the groyne field (which was not stabilized).

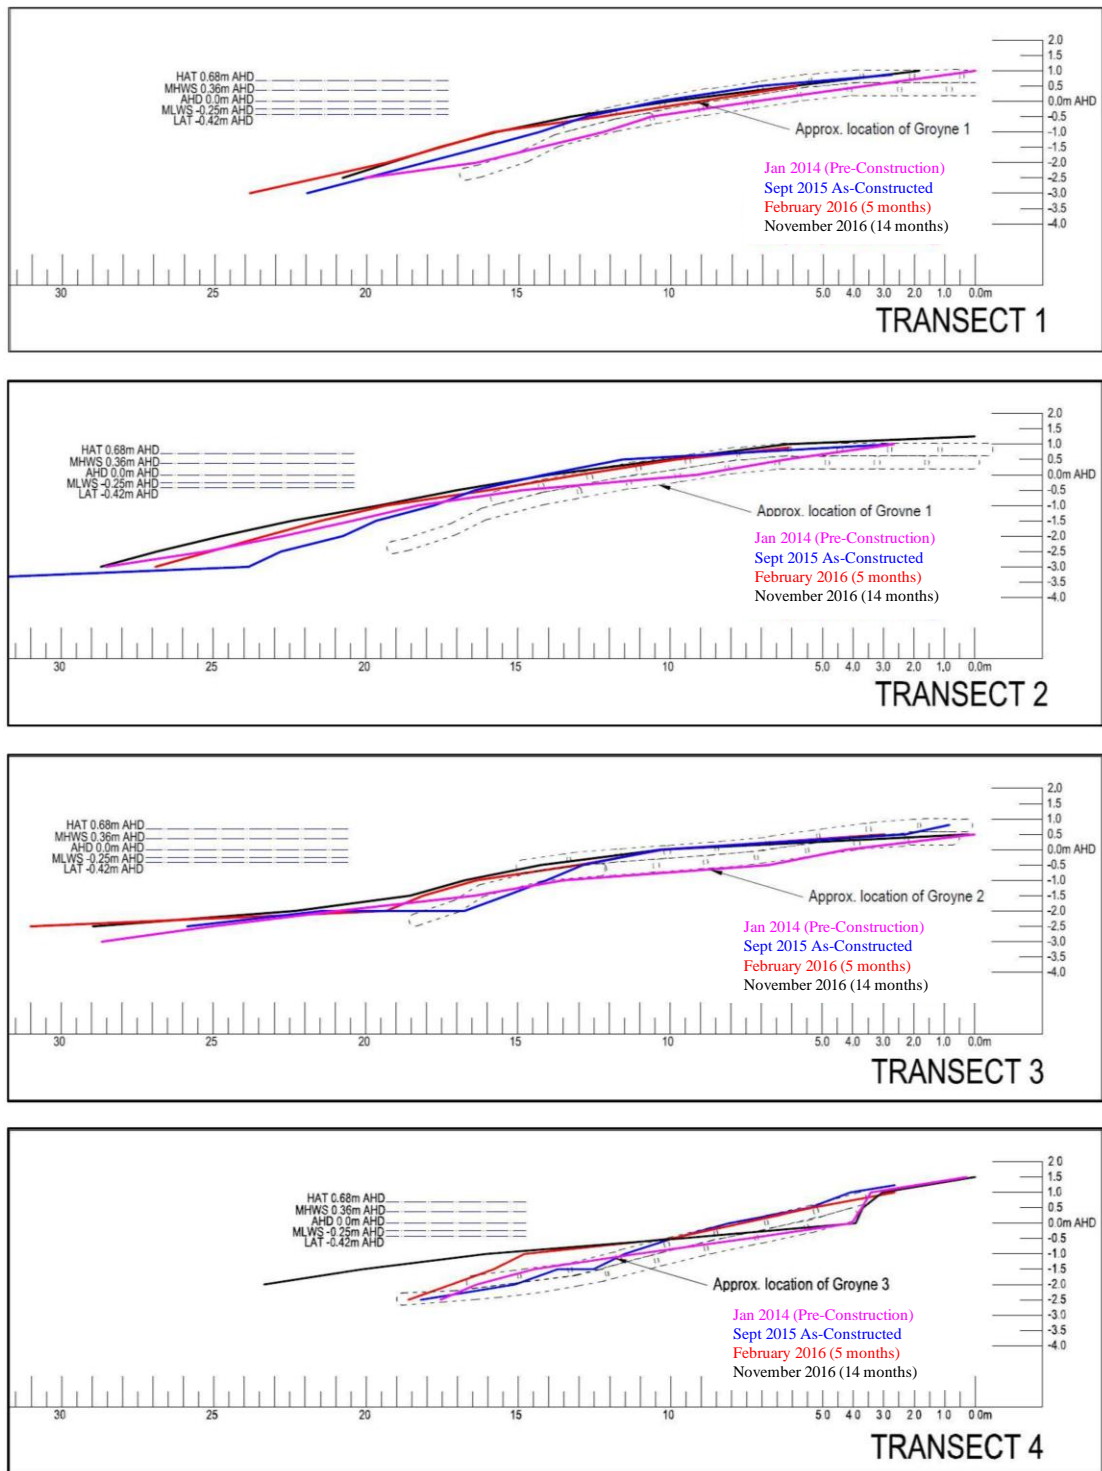
Figure 11. Comparison of Monitoring Surveys showing Beach Profiles at Relevant Transects. Location of Transects shown in Figure 10.

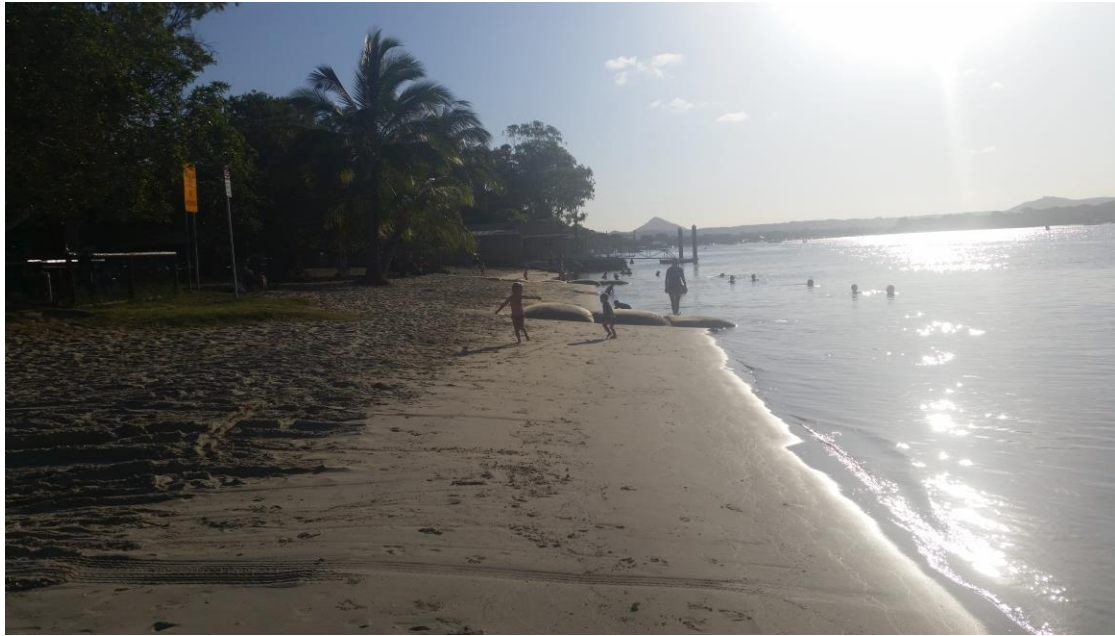
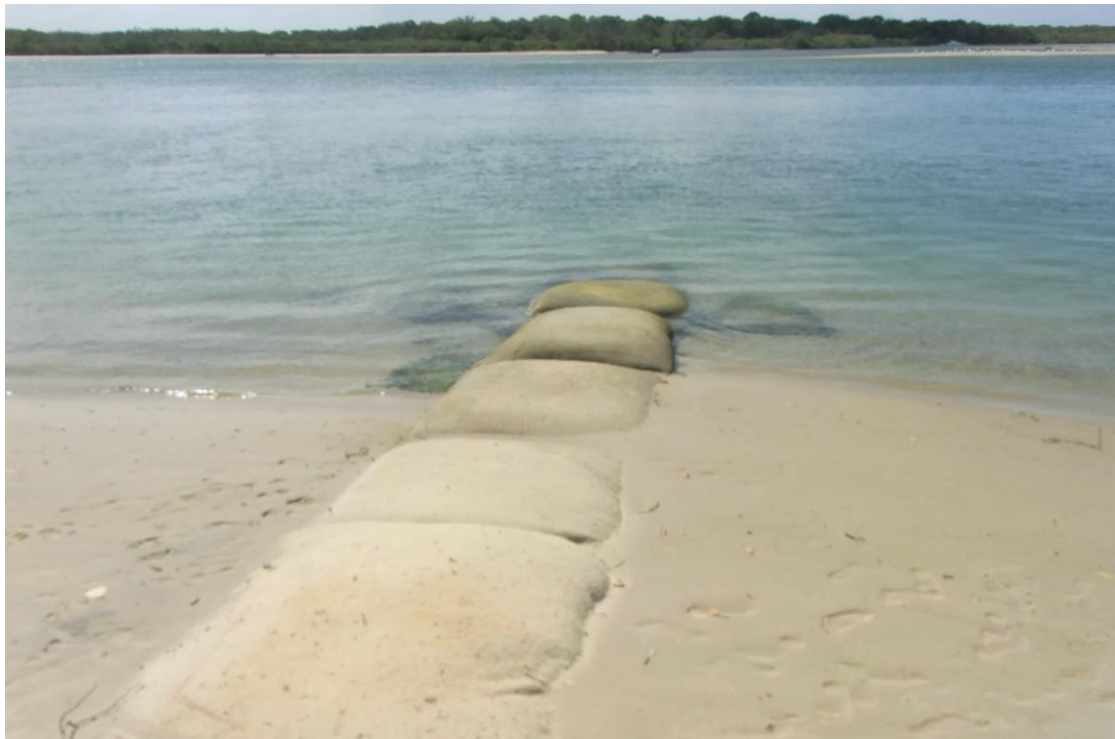
Figure 12. Photos showing up to 2m change in beach width and up to 0.2m change in beach height at Groyne

The planform shape of the beach is generally consistent with bi-directional sediment transport and a nett upstream (Westerly) sediment transport direction. The observable “groyne effect” is limited by the bi-directional nature of the sediment transport, the relatively narrow design beach width and the low-crested nature of the groynes which allow overpassing. At the groynes themselves, this is

characterised by up to 2m difference in beach width and up to 0.2m difference in beach height (Figure 12).

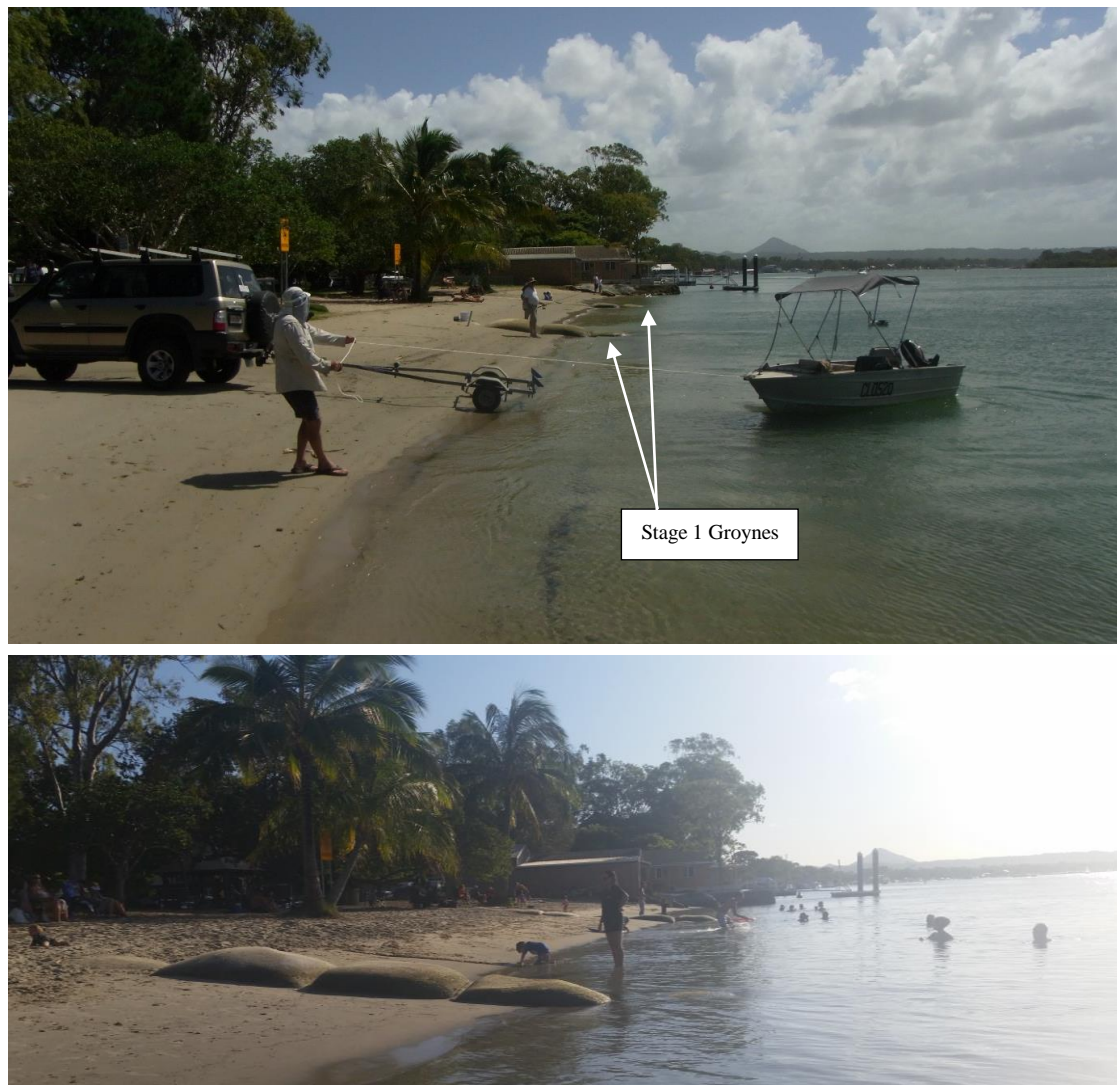
Figure 14. Beach Usage and Low Visual Impact after construction of Stage 1

Since construction, the structures have remained predominantly buried. As such, they remain very low impact visually. Recent inspection of the beaches (Figure 14) indicates that the beaches have been very busy and support a wide range of recreational usage including swimming, fishing and boating. As the groynes are soft and only slightly extend above the beach profile, accessibility across and along the foreshore is safe and essentially unimpeded. The groynes are not creating any dangerous currents or eddies.

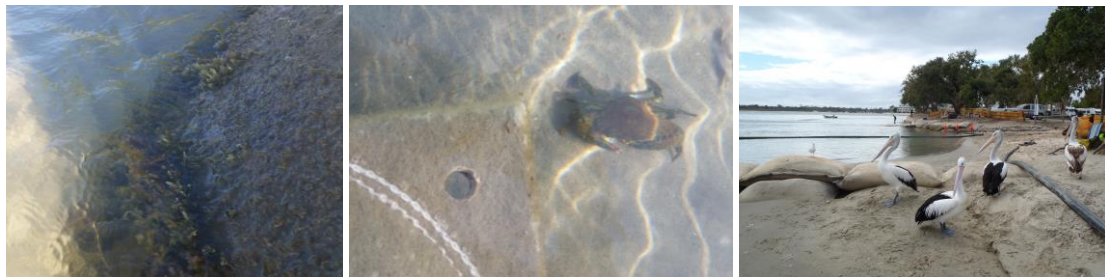
Figure 15. Environmental Outcomes from using sand-filled geotextile containers

To minimise the visual impact of structures on the foreshore and retain the recreational amenity and accessibility of the beach, the structures were designed to be low-crested and constructed using softer, safer and more user-friendly sand-filled geotextile containers (Figure 15). Both 0.75m³ and 2.5m³ containers were utilized and all containers were fabricated using a non-woven needle punched composite geotextile for maximum durability (Heerten et al. 2001). Due to the proximity of the main channel and the high degree of natural variability of the Noosa River, a custom sand-filled scour mattress was specified to protect the toe of the structure and ensure that the structure remained robust and effective throughout its life.

While environmental concerns are not an objective of the project, sand-filled geotextile containers are known to promote marine growth (Jackson et al 2004 and Corbett et al. 2010) and this project has been no exception. Where containers are exposed, algae were observed to establish within days of placement and over time have developed into a range of macroalgae species (Figure 15). The works also support a number of fish, stingrays and crabs as well as being friendly to birds.
