36TH INTERNATIONAL CONFERENCE ON COASTAL ENGINEERING 2018

Interconnectivities between Shoreline Type and Structural Vulnerability

Shoreline Archetypes and Damage Observations

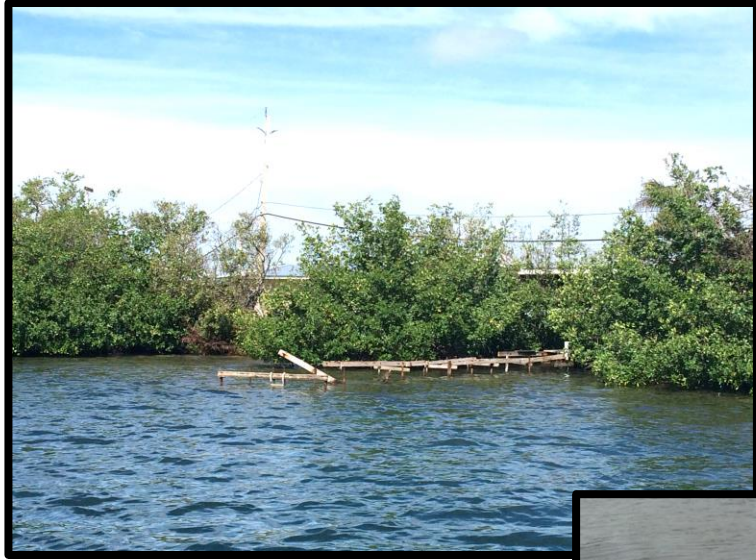
Mangrove: broken branches, loss of foliage, regrowth

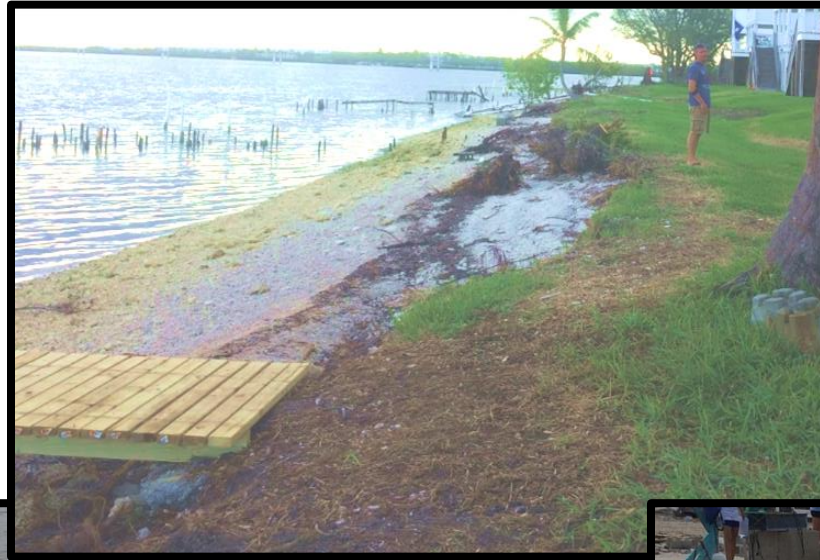
Sandy Beaches: erosion

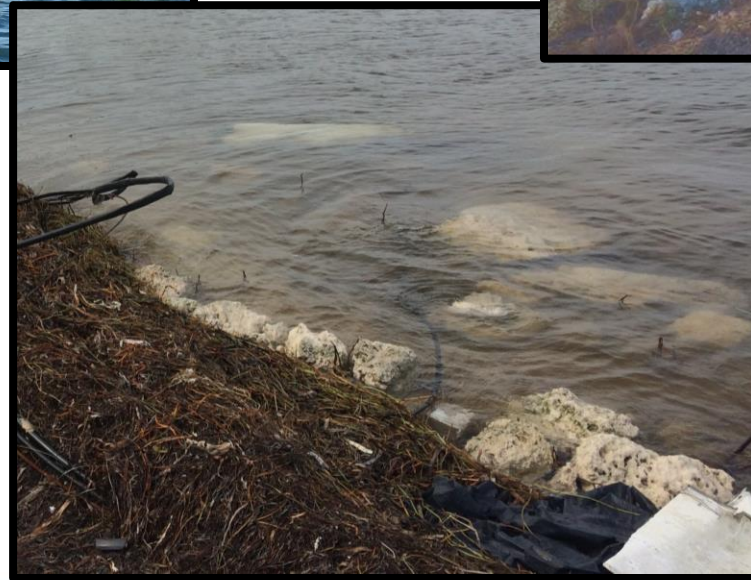
Revetment: armament displaced

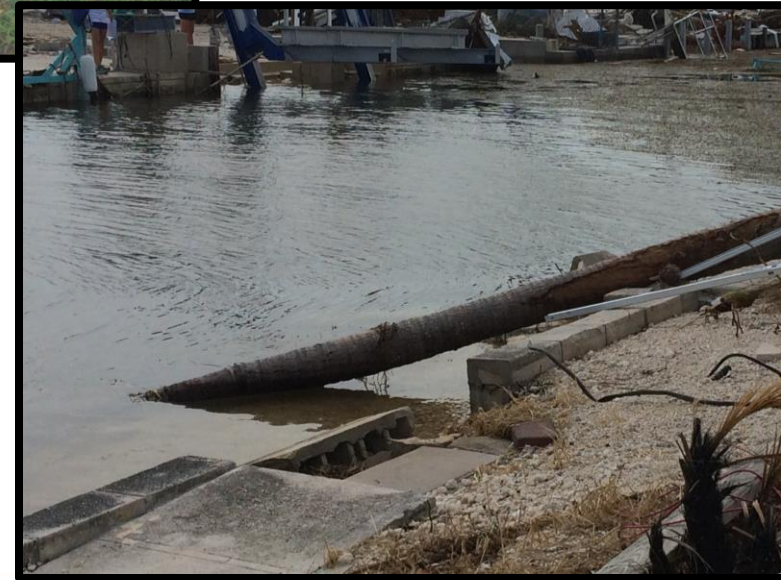
Bulkhead: cracks, undercutting, collapse

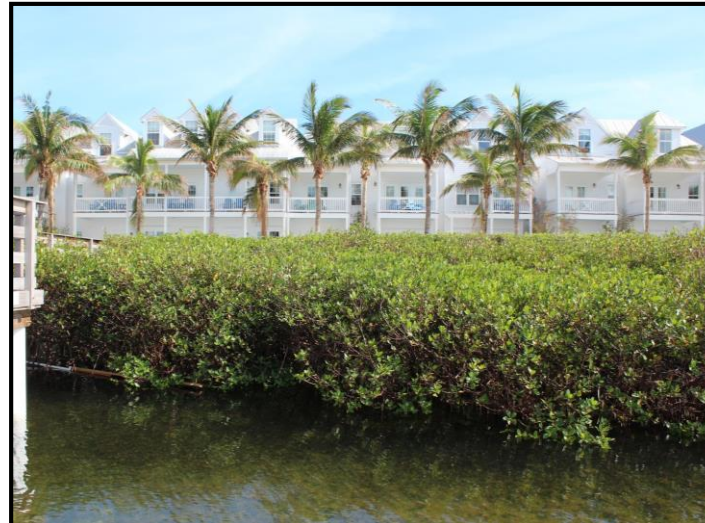
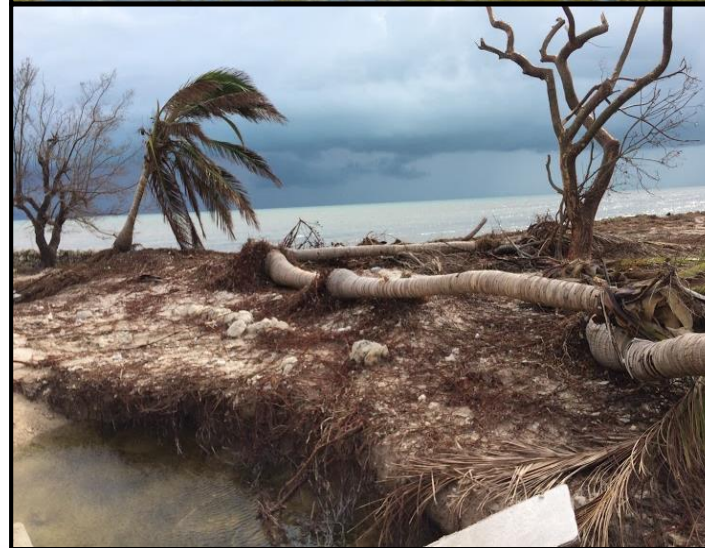
Standardized Shoreline Damage Assessments

- 56 surveyors, 12 shorelines
- 95 % Confidence Intervals > 0.5 DS
- Larger variation for intermediate damage states

- DS0
- DS1
- DS2
- DS3
