36TH INTERNATIONAL CONFERENCE ON COASTAL ENGINEERING 2018

MORPHOLOGIC RESPONSE OF BEACHES AND TIDAL INLETS TO HURRICANE IRMA IN SOUTHWEST FLORIDA, USA

Mohamed Dabees, Ph.D. PE. D.CE.

Humiston & Moore Engineers

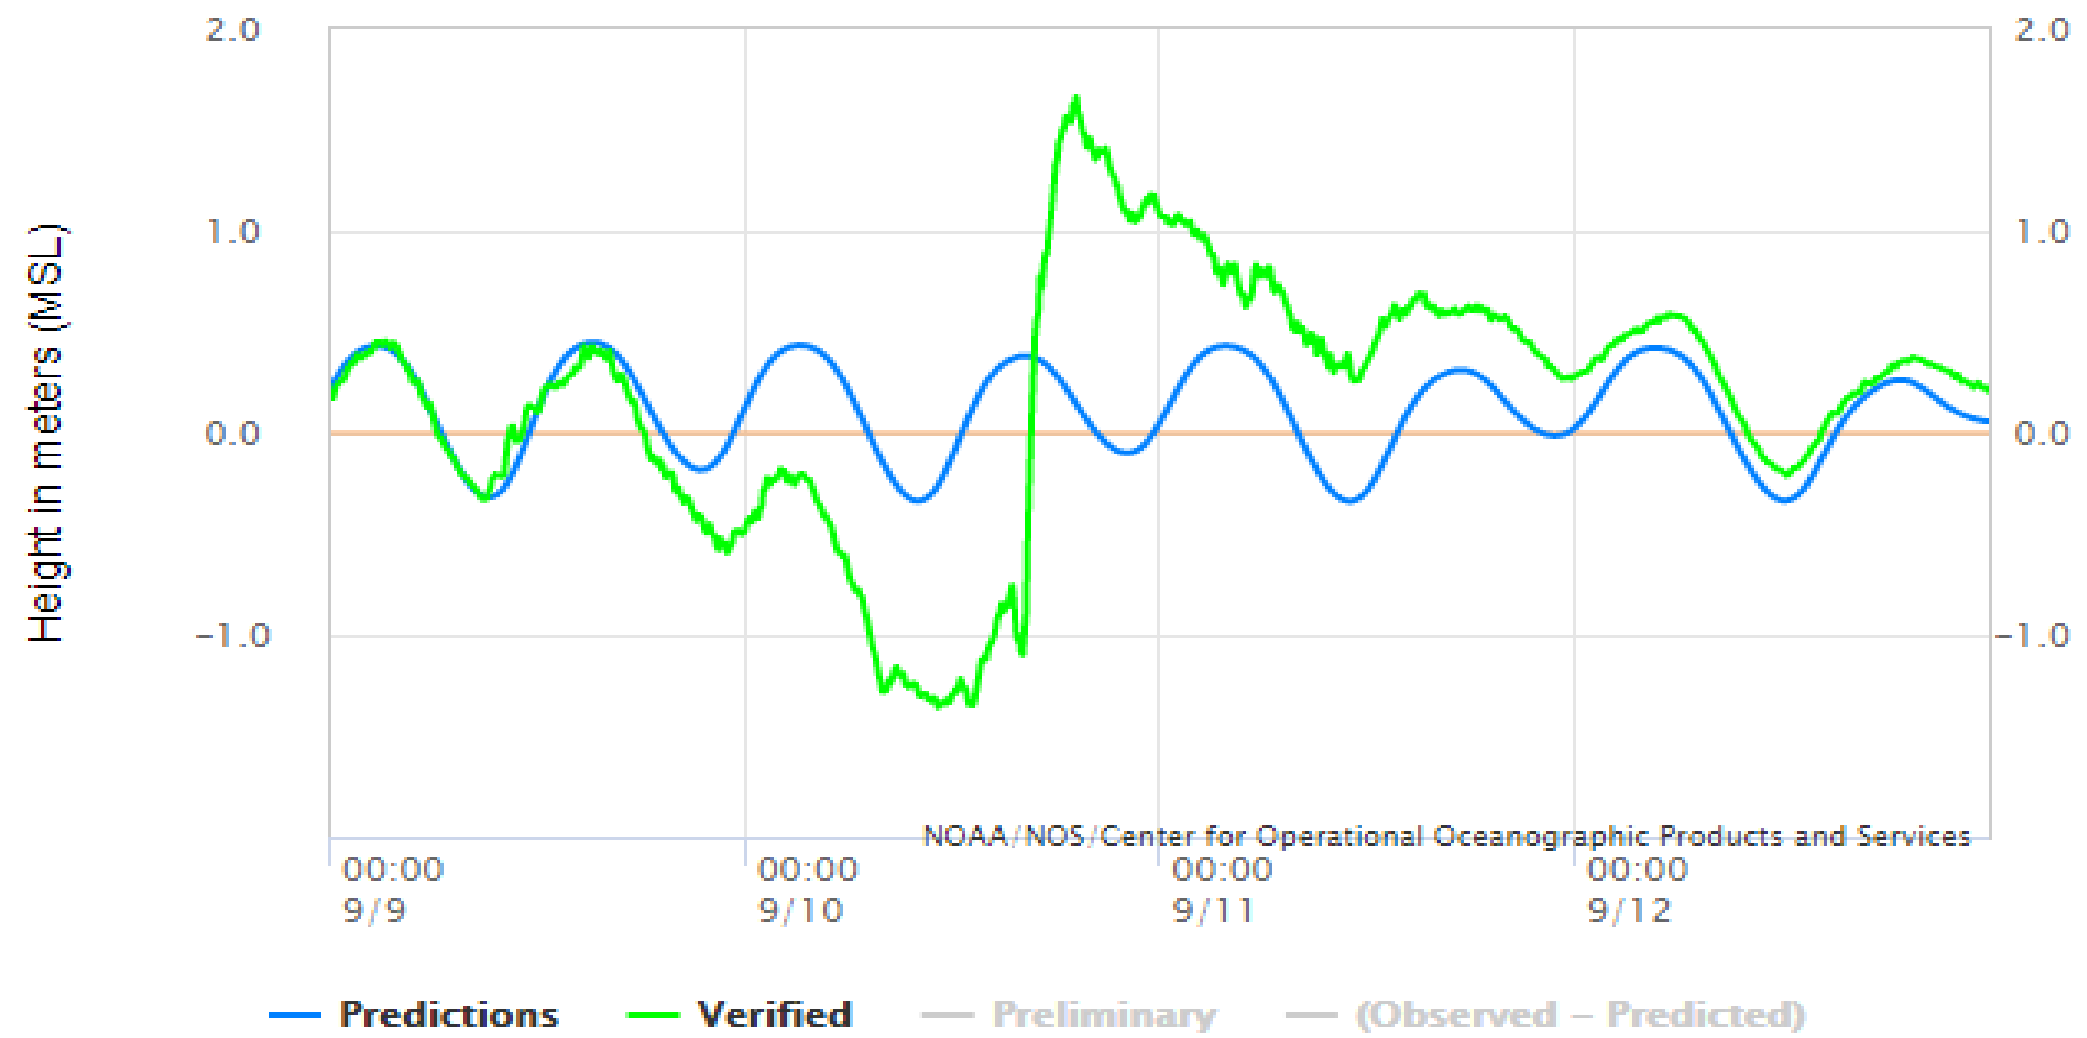
NOAA/NOS/CO-OPS
Observed Water Levels at 8725110, Naples, Gulf of Mexico FL
From 2017/09/09 00:00 LST/LDT to 2017/09/12 23:59 LST/LDT

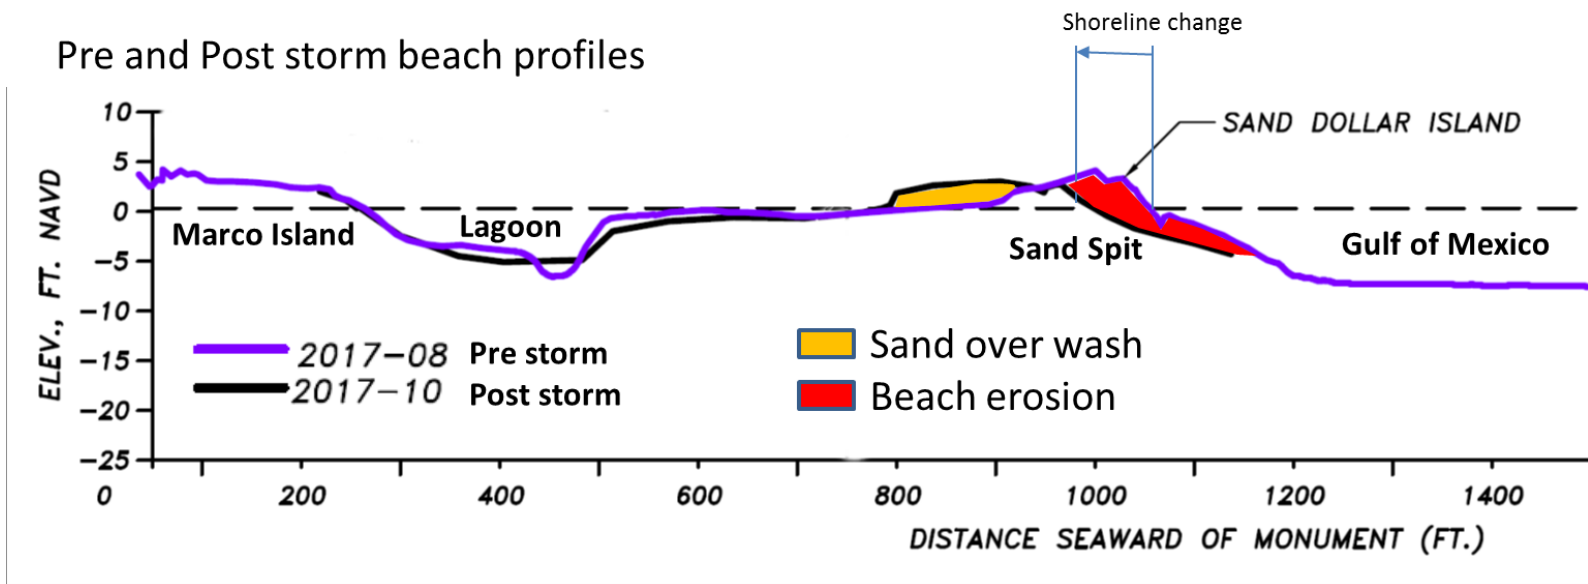
Pre and Post storm beach profiles

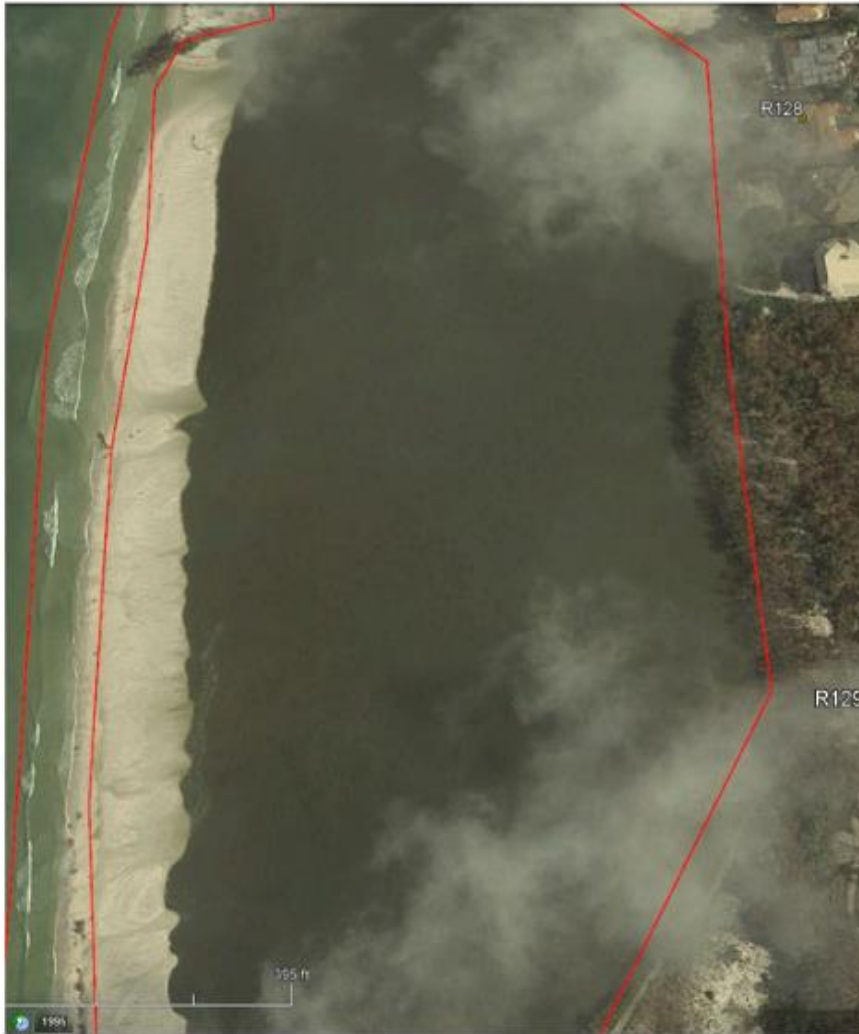
Sep 14, 2017

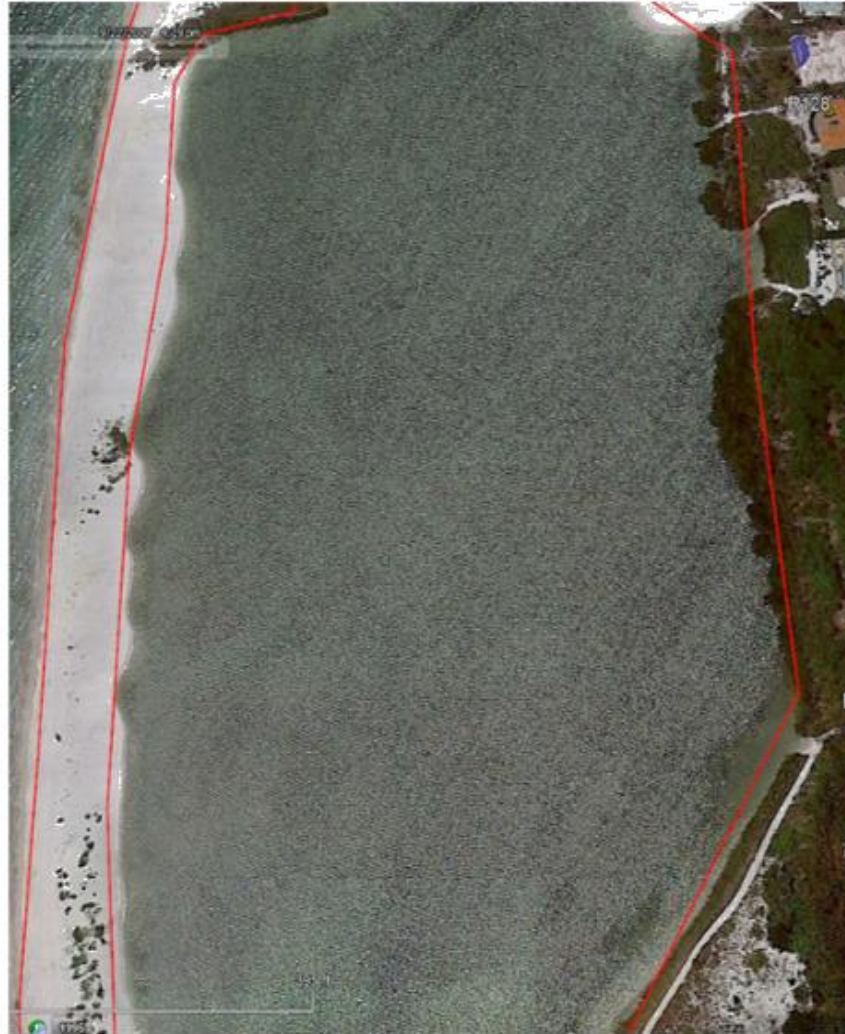
May, 2017

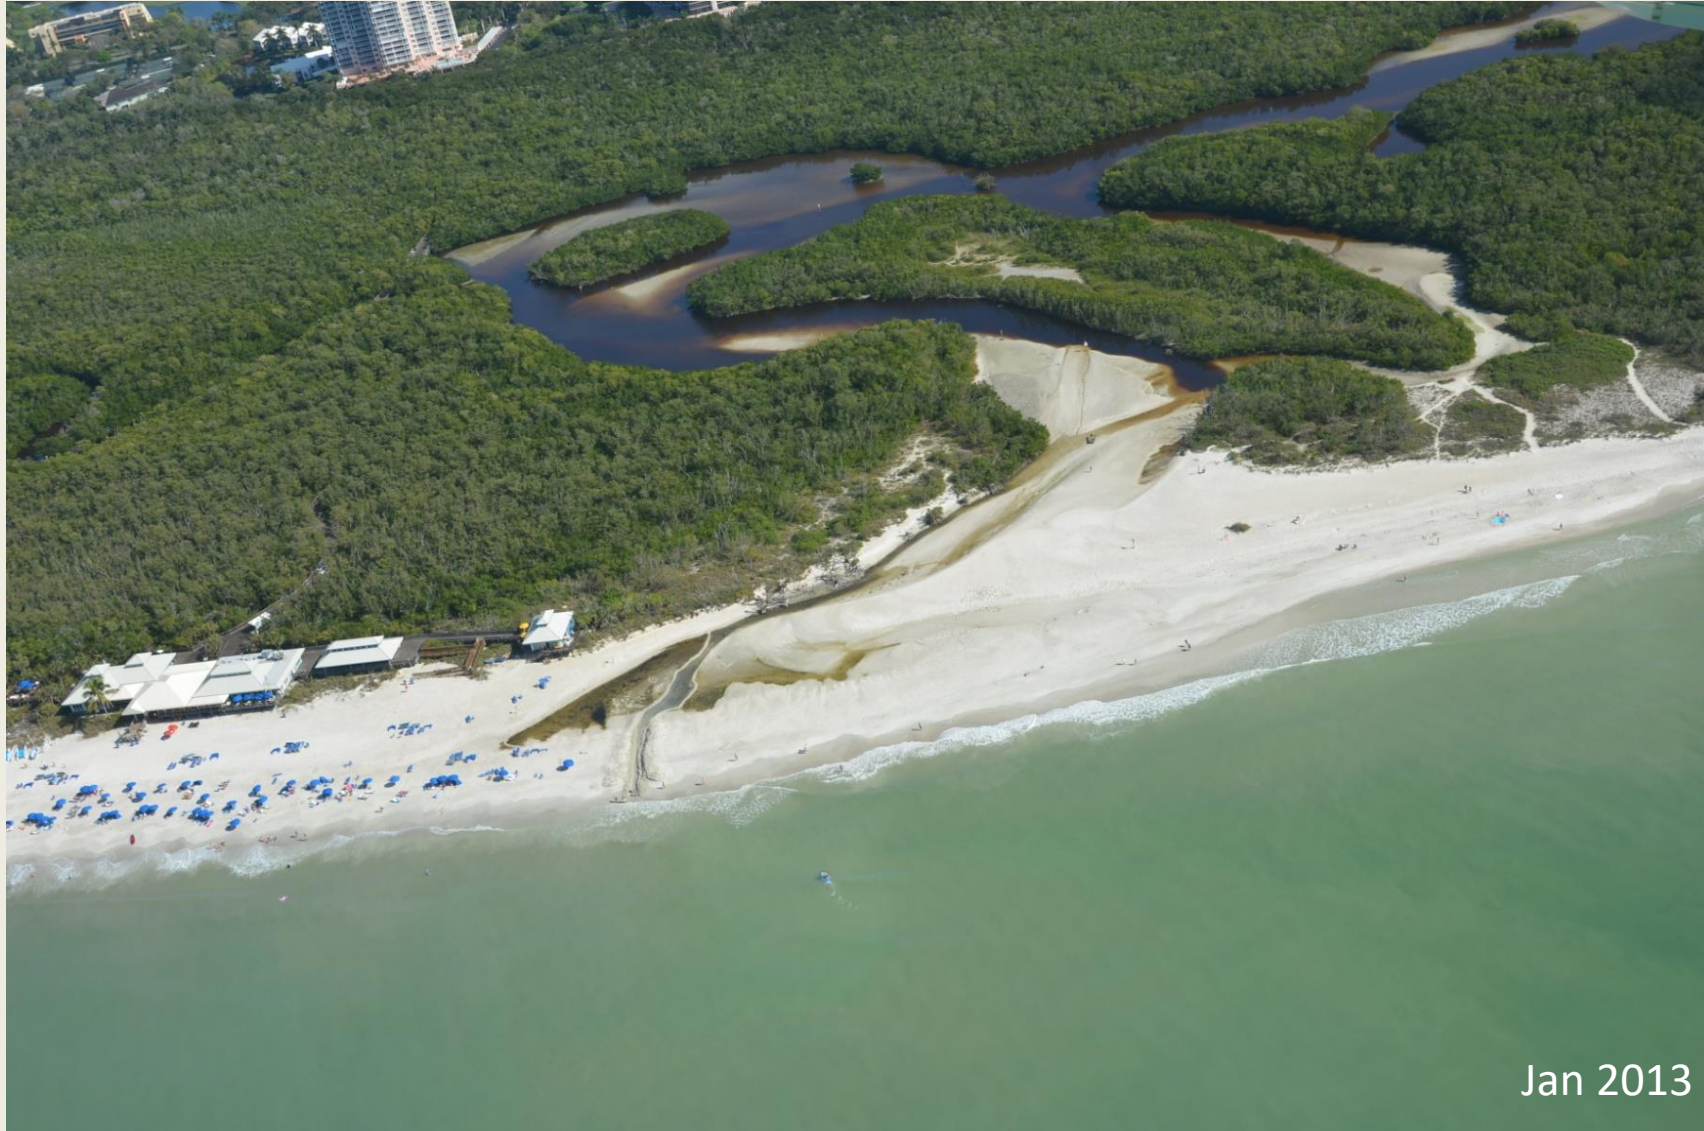
Jan 2013

Clam Pass closed following 2012 tropical storms Debbie and Isaac

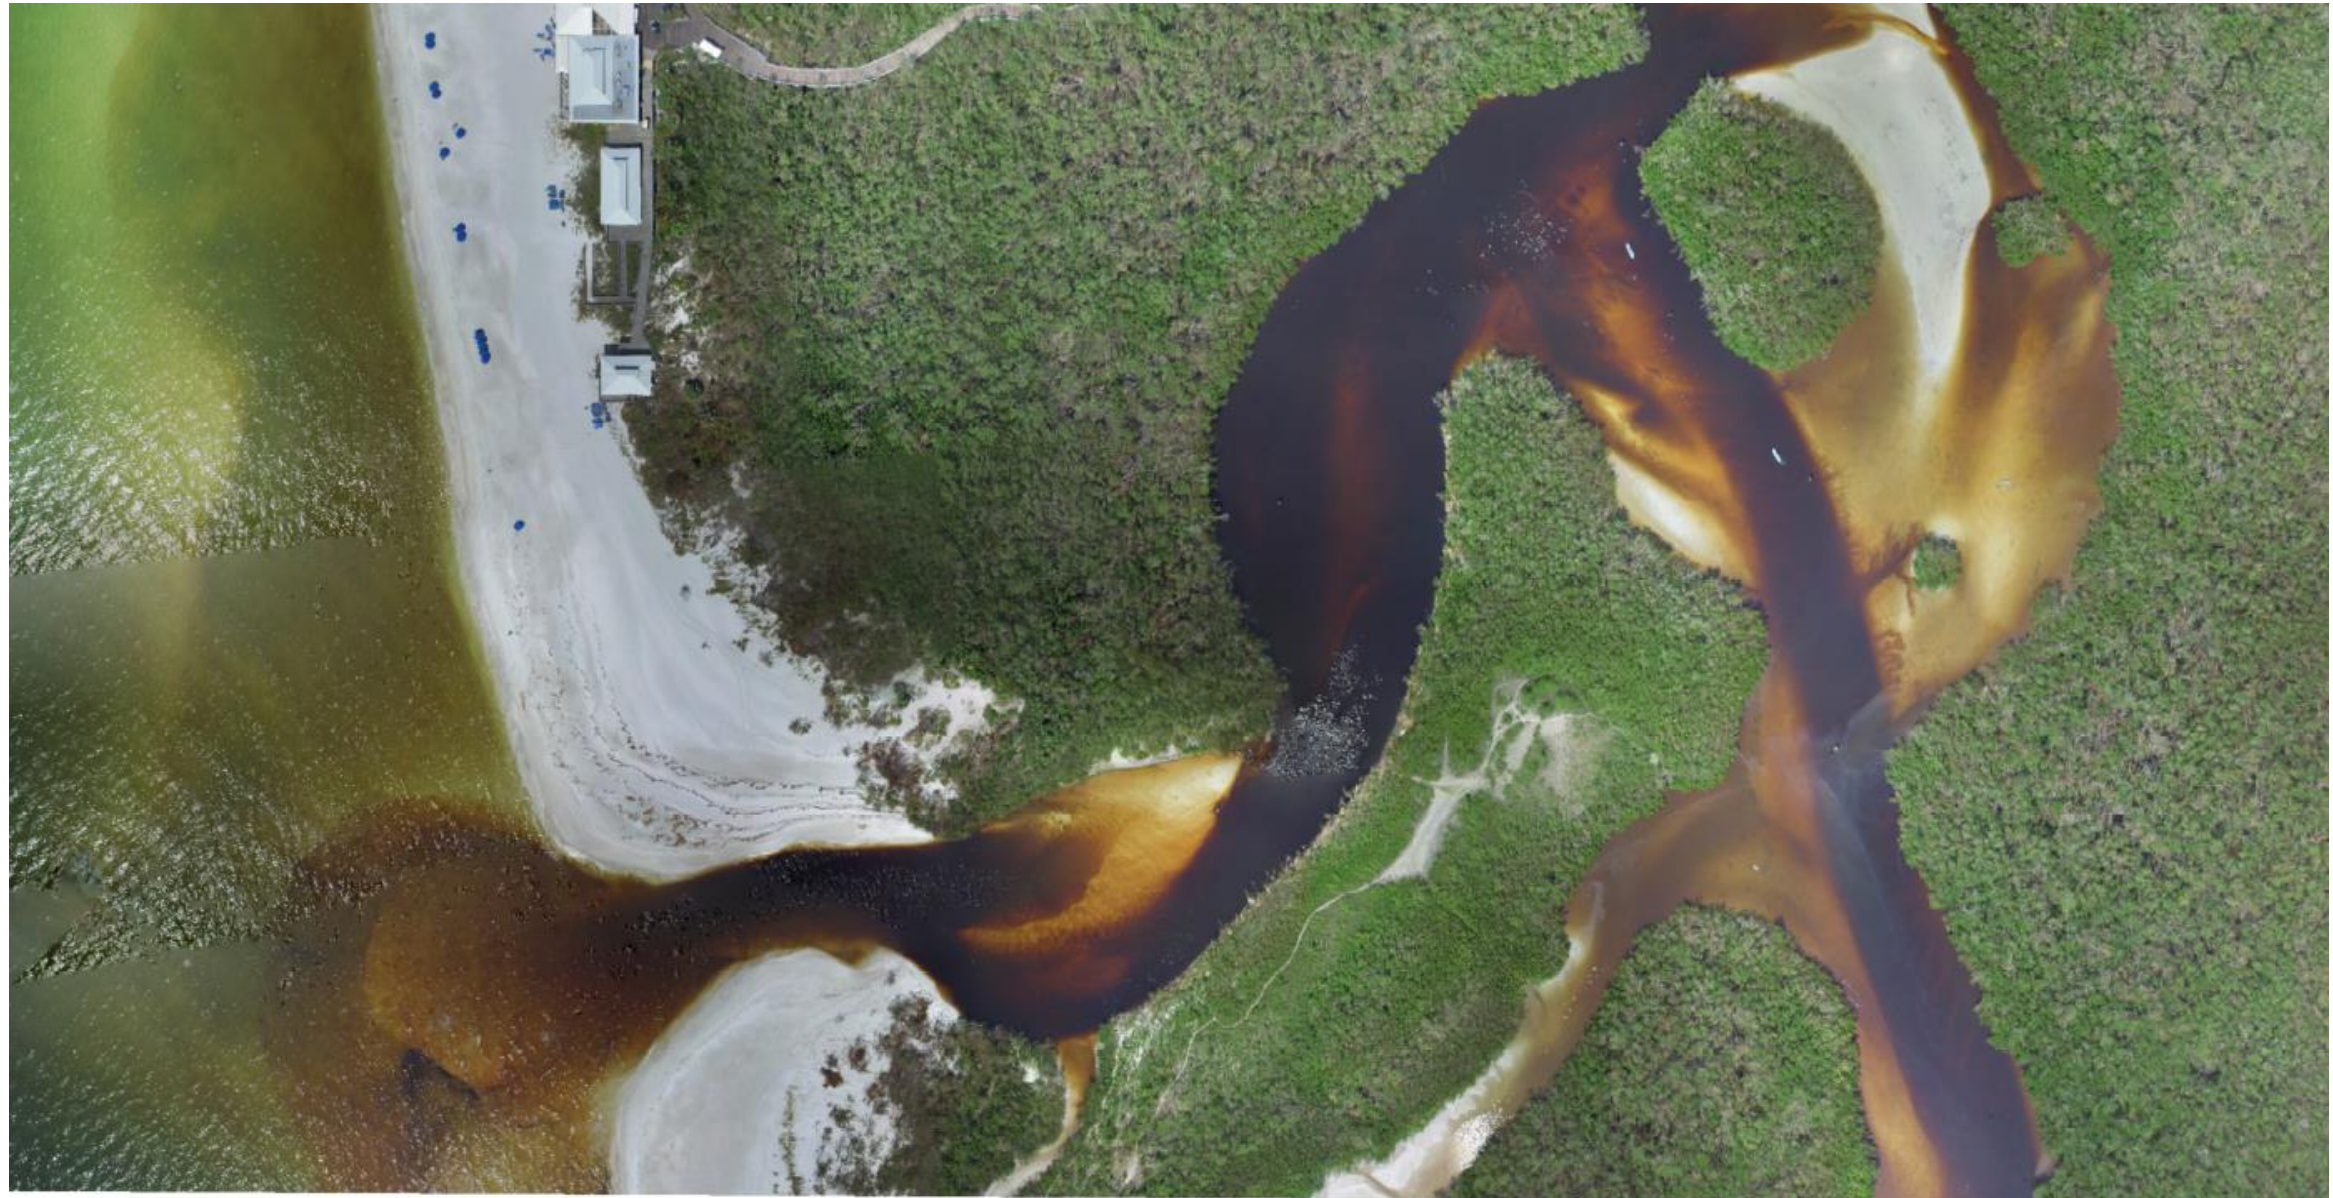
Clam Pass post Hurricane Irma

September 18, 2018

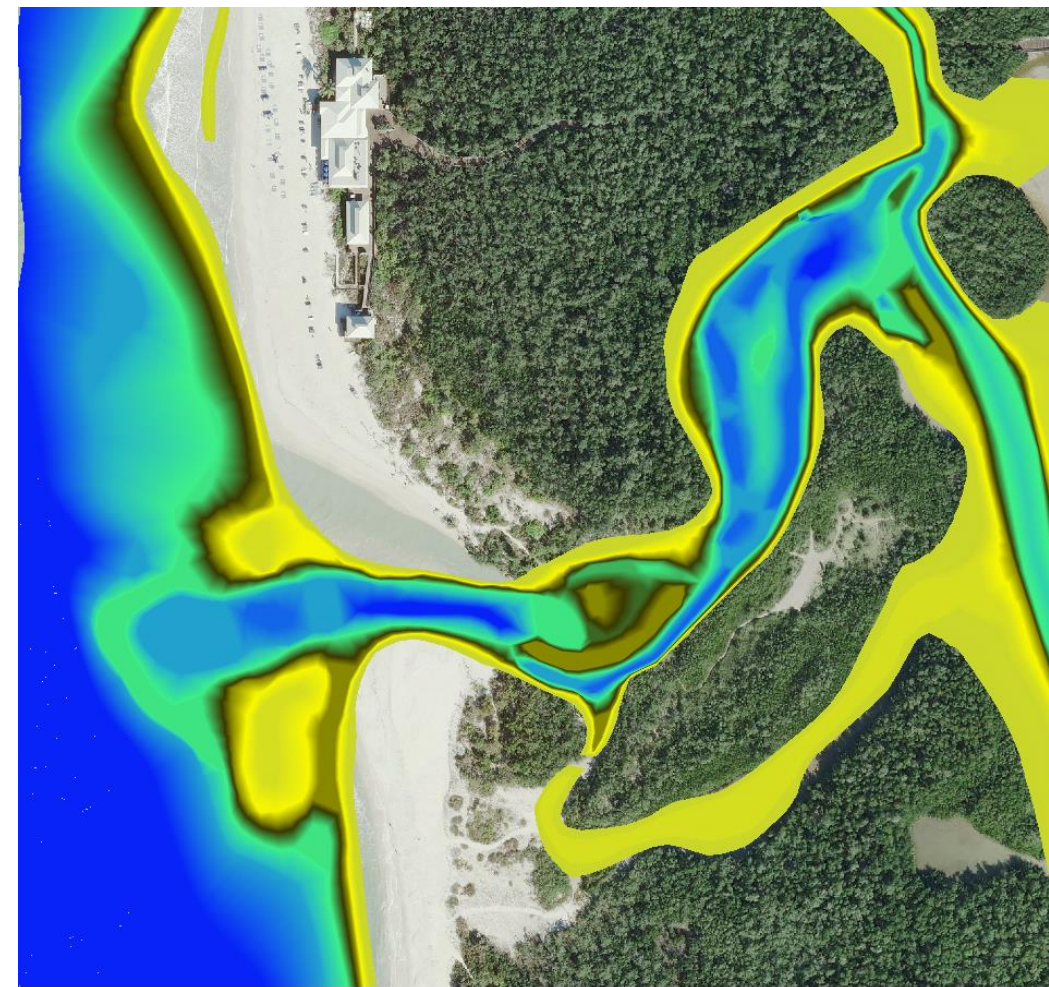
Pre-Irma (August 2017 conditions)

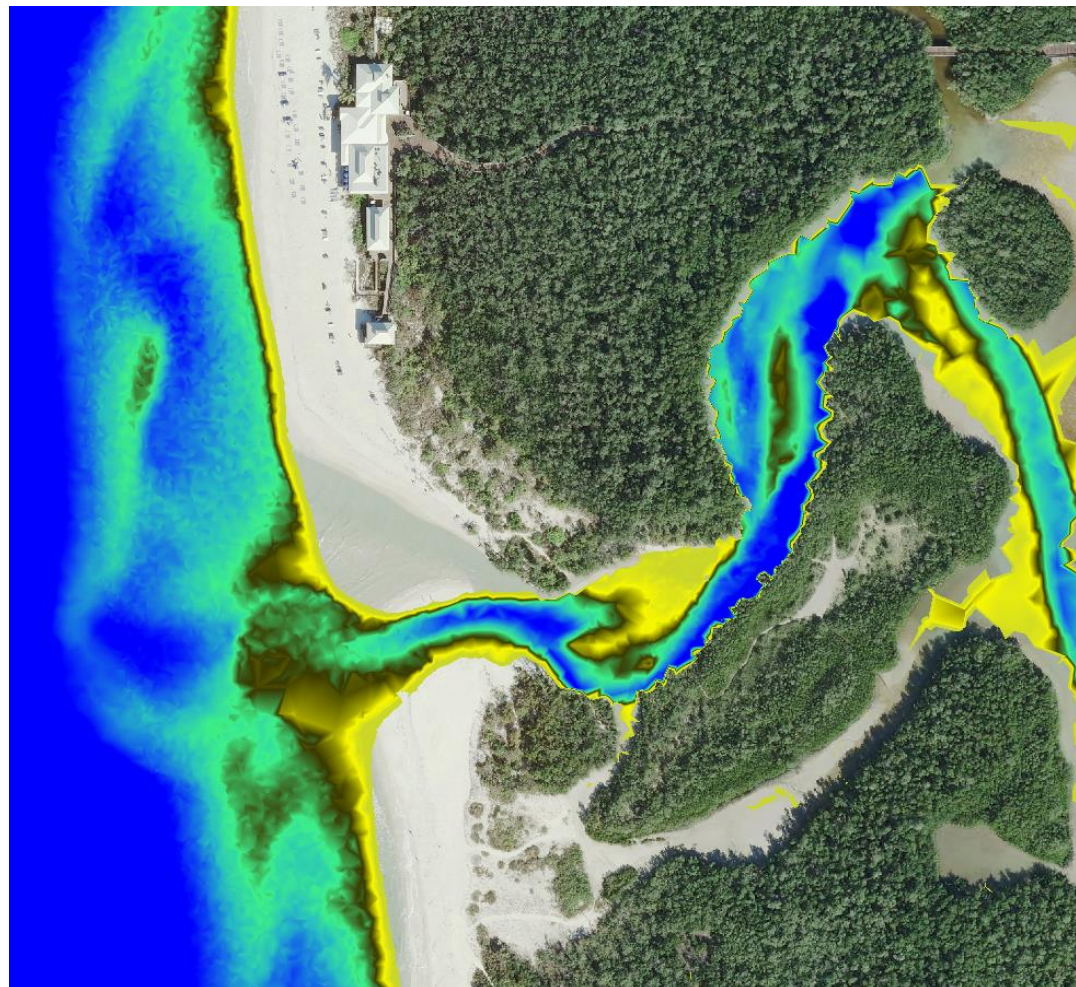
Post-Irma (September 2017 conditions)

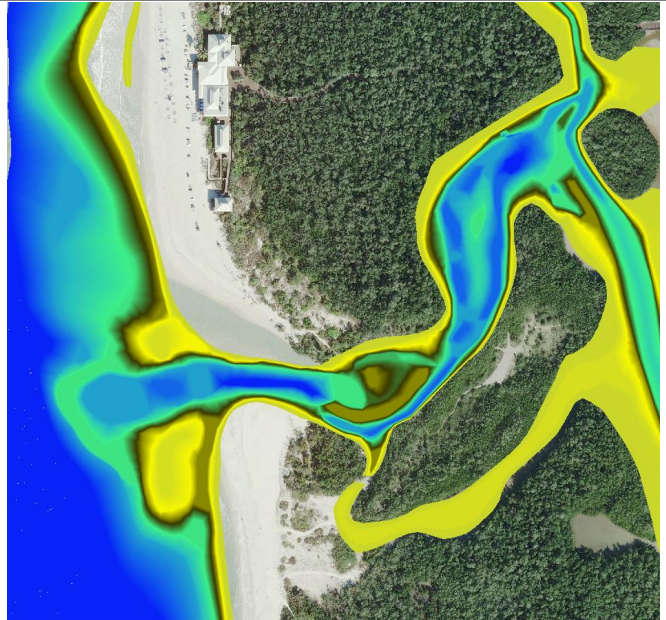
Pre-Irma (August 2017 conditions)

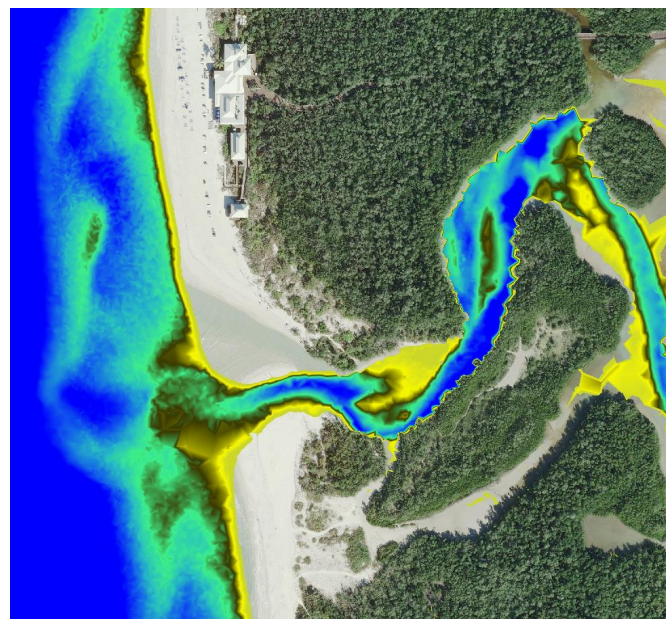
Post-Irma (September 2017 conditions)

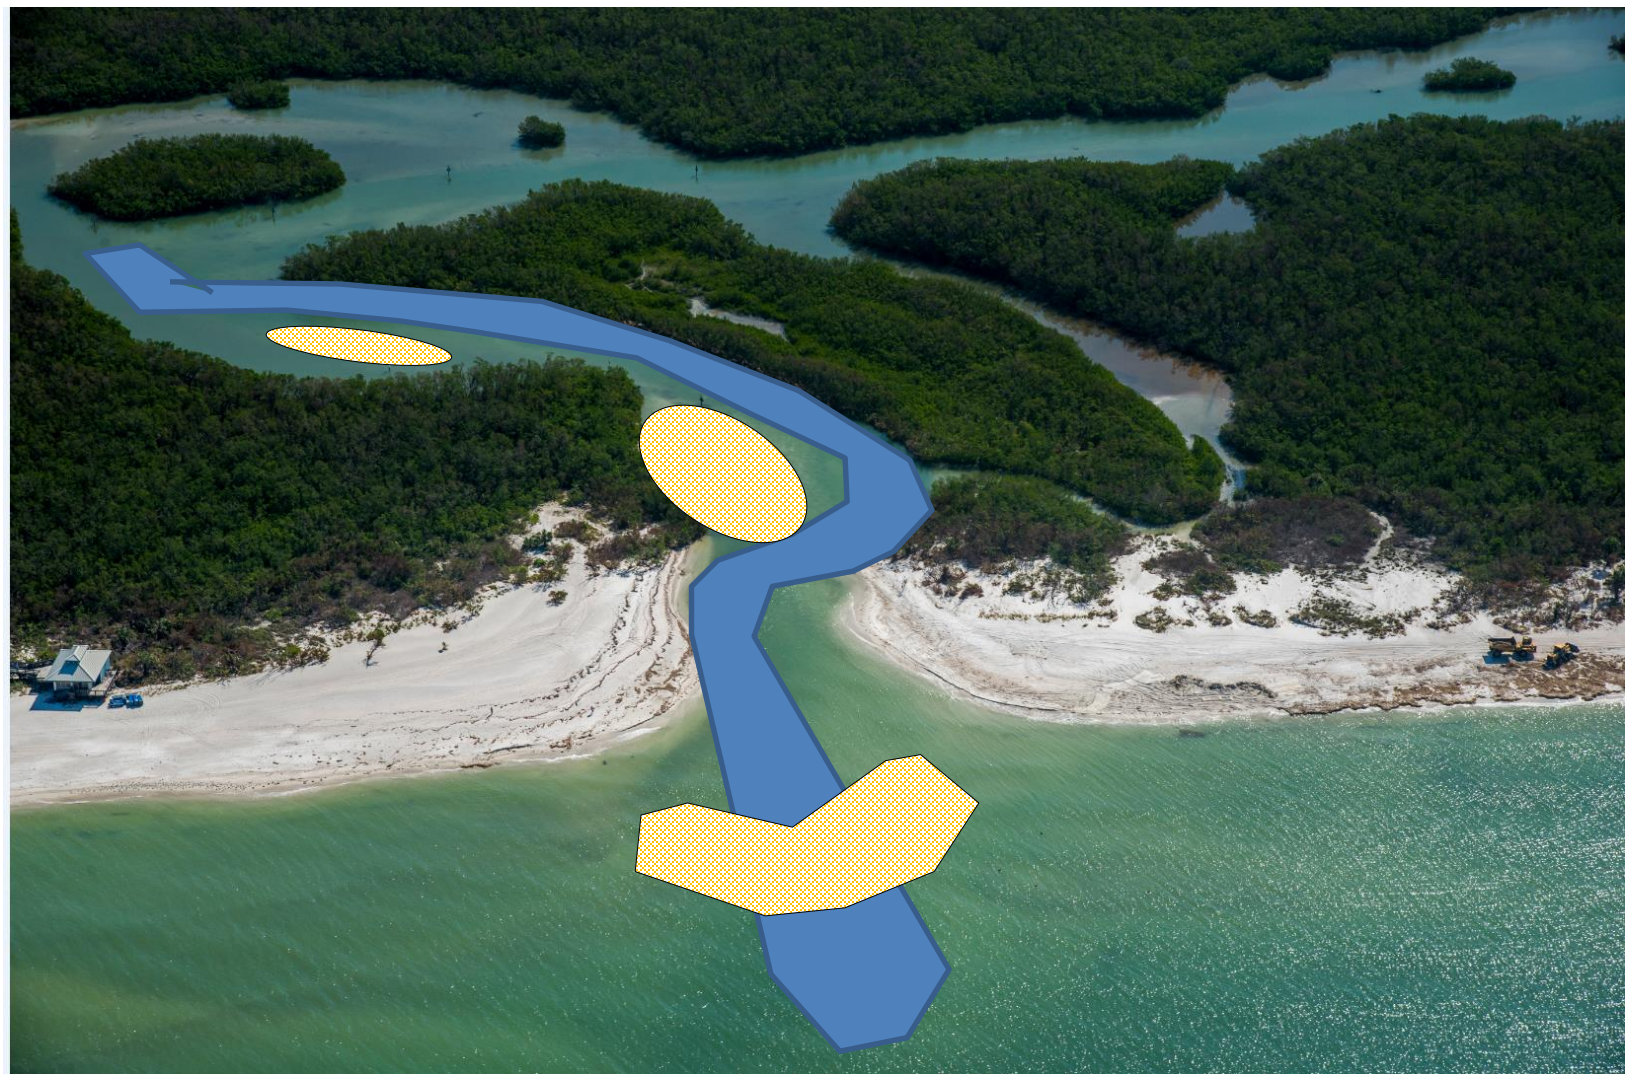
Scour

Deposition

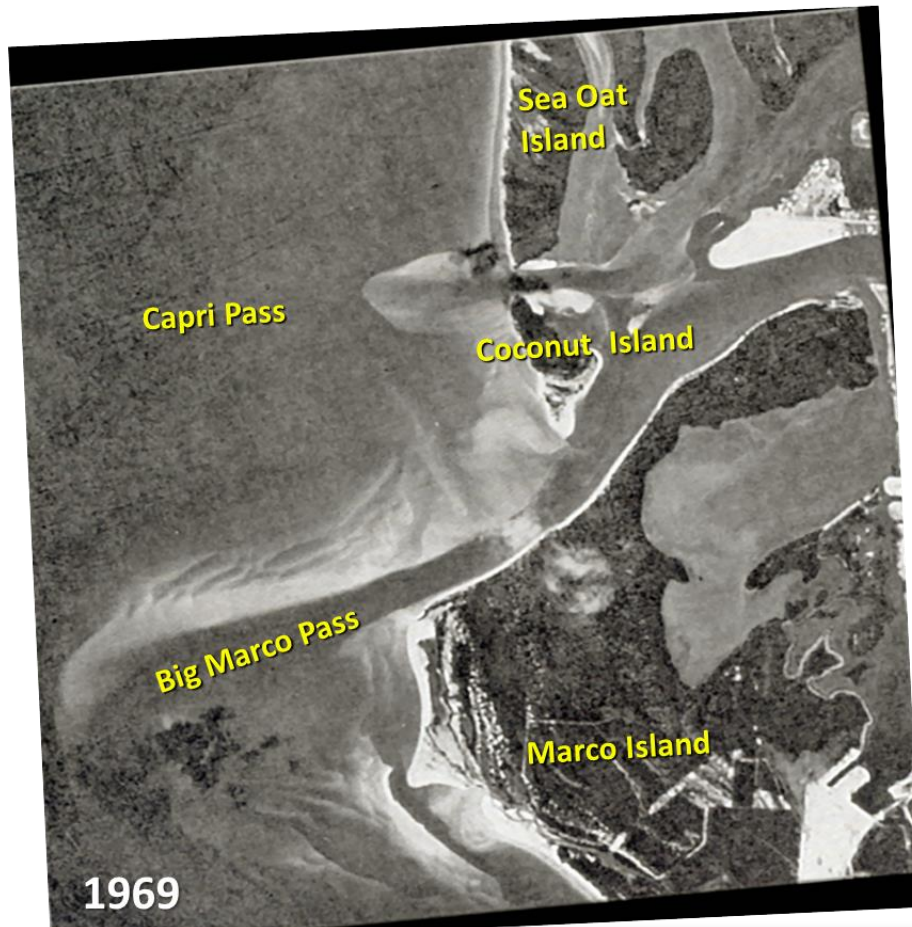
Natural inlet migration up-drift
Up-drift erosion and downdrift sand spit growth
