ORPHAN BREAKWATERS: COLLAPSE AND TRANSMISSION REDUCTION.

William ALLSOP, PhD student, University of Edinburgh, w.allso@ed.ac.uk; Director, William Allsop Consulting Ltd
Tom Bruce, Professor, School of Engineering, University of Edinburgh;
Adrian Pearson, Engineer, Moffatt & Nichol, New Orleans,

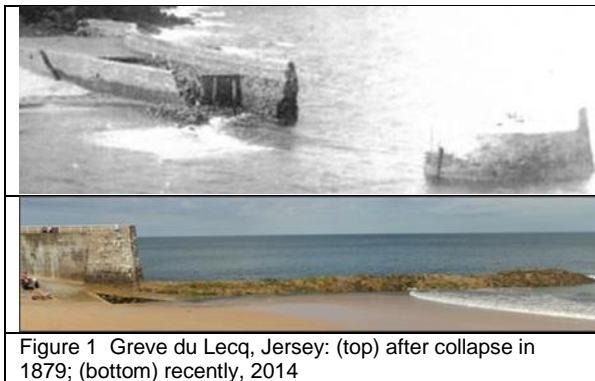
Figure 1 Greve du Lecq, Jersey: (top) after collapse in 1879; (bottom) recently, 2014

Even after collapse, some wave reduction will however still be afforded by the relict structure, see example in Figure 1.

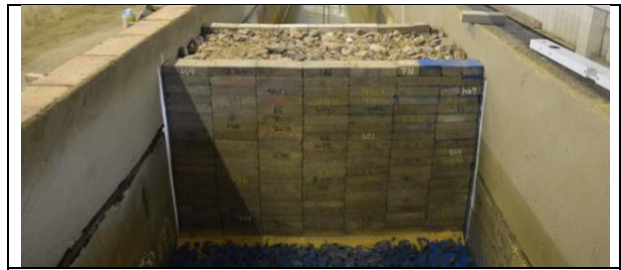
Figure 2 Example blockwork breakwater before testing

When the tests were designed, it was not known how many structure variations could be tested. In the event, 6 different structures were tested with 200 individual tests. An example structure is shown in Figure 2.

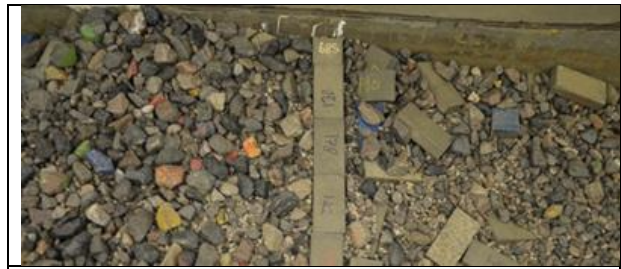
Figure 3 Example collapsed breakwater

A collapsed breakwater is then shown in Figure 3. The crest of the collapsed mound is towards the left of the picture. The lower part of the seaward wall is in the centre, a feature found in the remains of the breakwater at Skateraw (Figure 4) abandoned since about 1860.

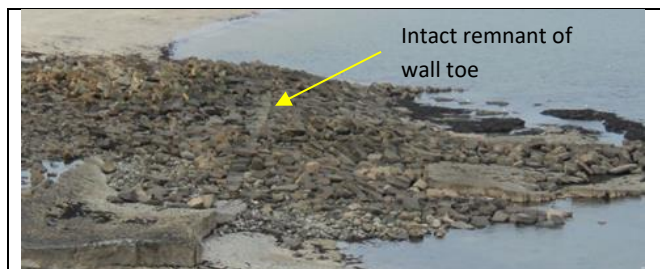
Figure 4 Collapsed breakwater, Skateraw, East Lothian, Scotland

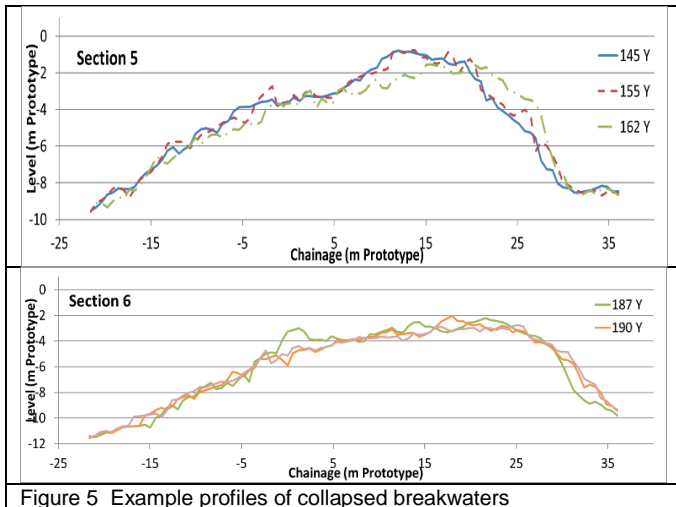
Figure 5 Example profiles of collapsed breakwaters

For the model tests, the changes to crest levels from post-test profile measurements (Figure 5) have been analysed relative to various crest recession prediction methods.
