# 36TH INTERNATIONAL CONFERENCE ON COASTAL ENGINEERING 2018

## STORM-INDUCED EROSION OF NOTSUKEZAKI SAND SPIT, JAPAN

**Seiya Itori**, Kazuki Yagisawa, Takayuki Sasaki

Alpha Hydraulic Engineering Consultants Co., Ltd

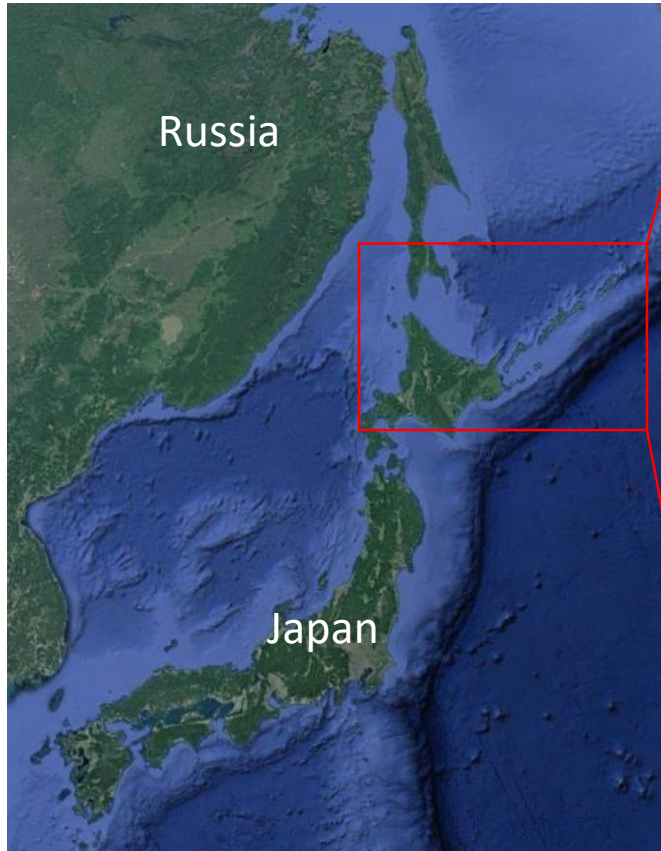
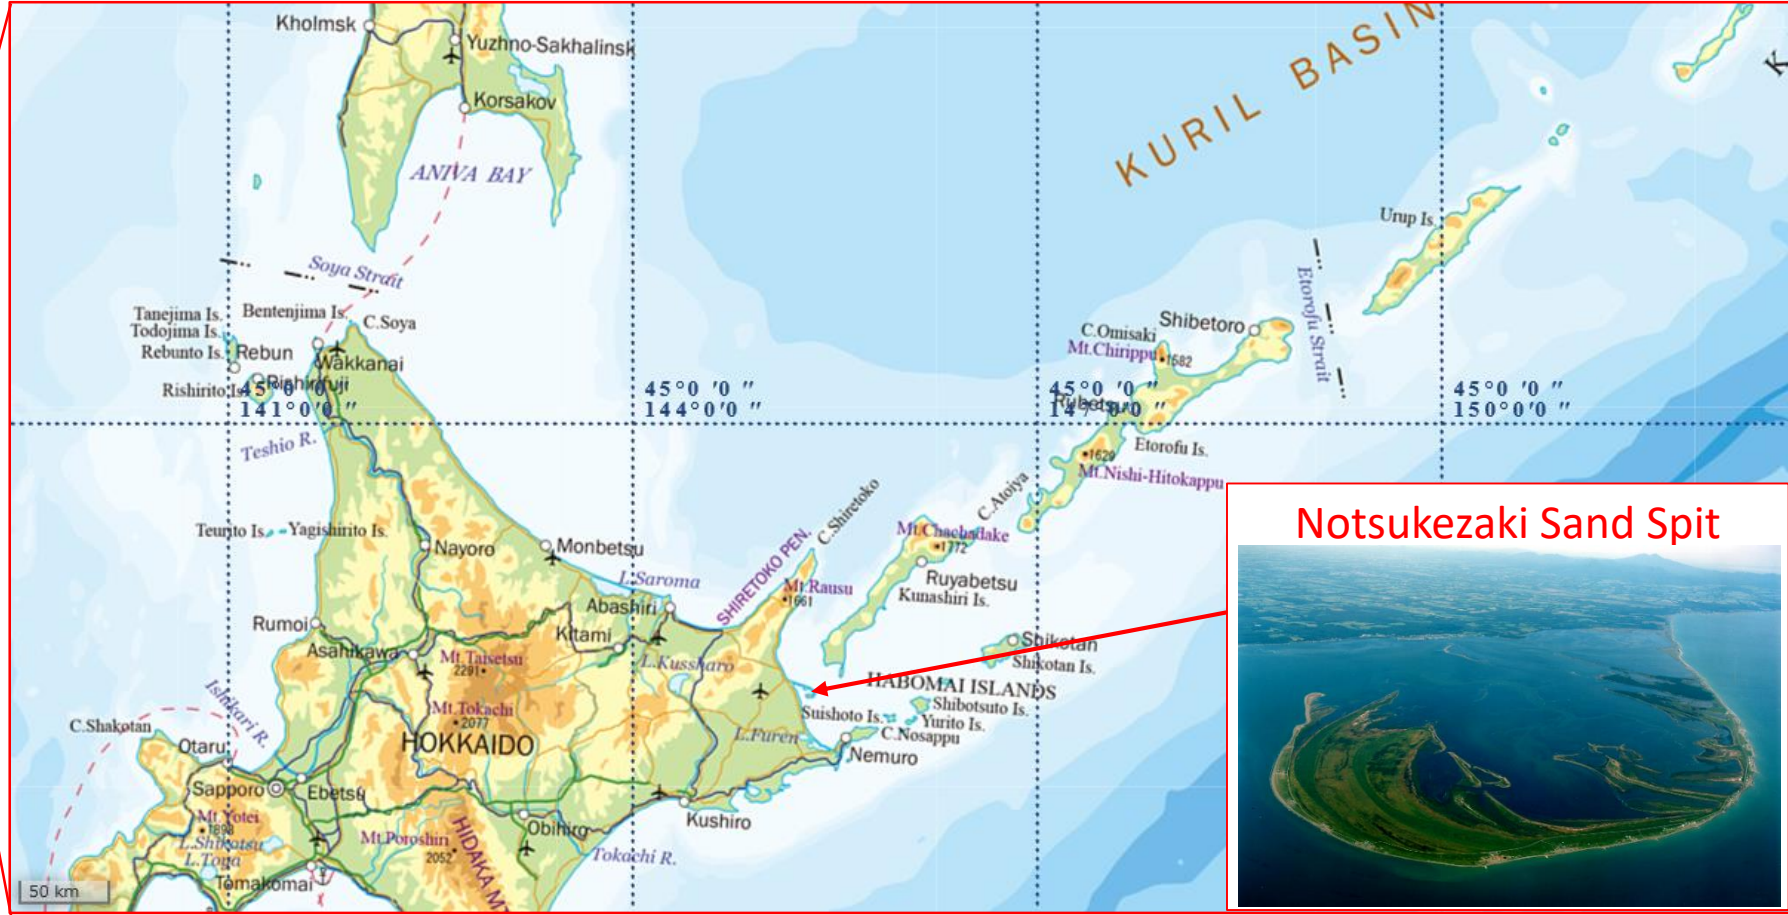
## ( 1 ) Location of Notsukezaki Sand Spit

- Notsukezaki Sand Spit is the **largest sand spit in Japan**, which is located in the eastern Hokkaido, Japan.
- The length of the sand spit is about **26 km** from the Shibetsu fishing port. Every winter, **drift ice floating** from the Ohktsuku sea covers the Nemuro Strait. The **tidal range is 1.6 m**.

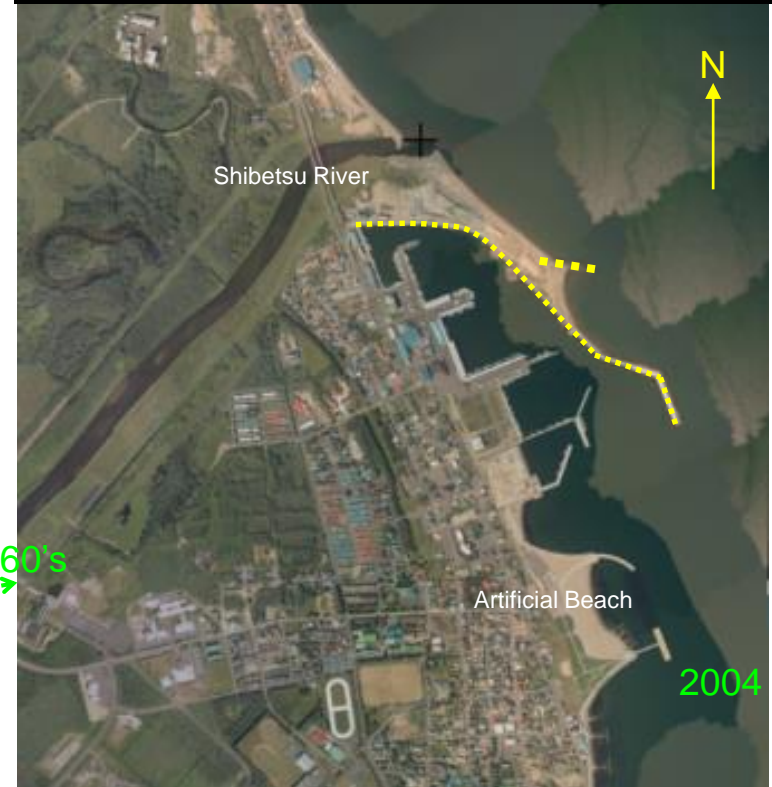
### Construction of Shibetsu Fishing Port

Severe Erosion had started in front of continuous seawall and detached breakwaters

Reduction of Sediment transport in 1990's

Natural longshore sediment transport toward sand spit = 0

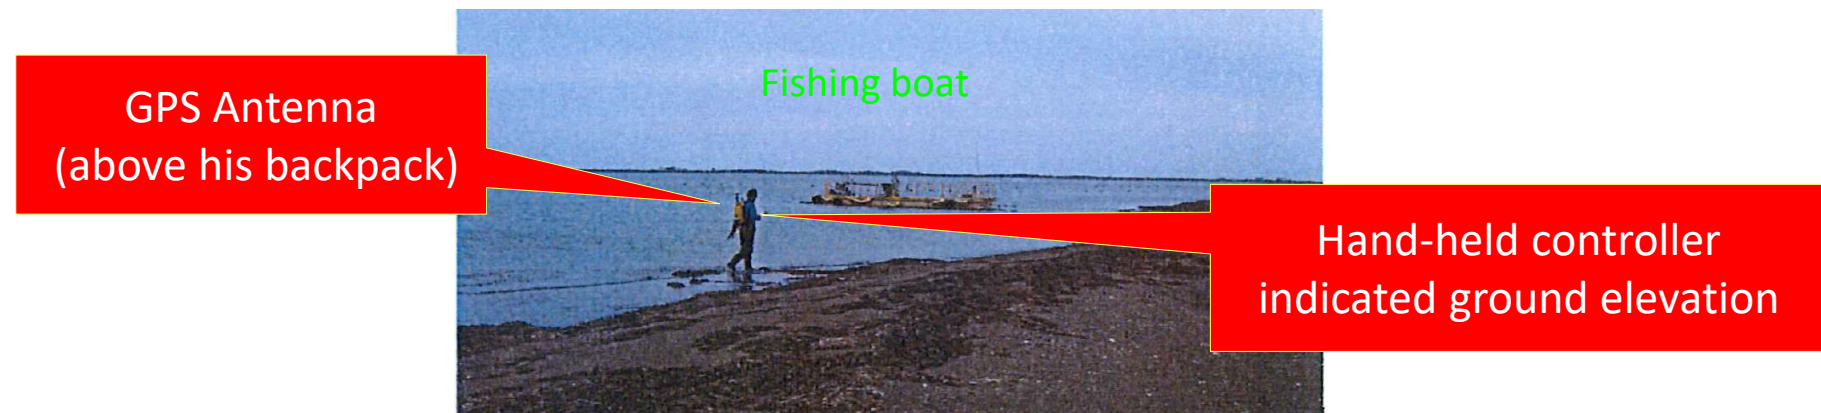
How do we get shoreline position (ground height  $\approx$  0m) and boundary of vegetation ?

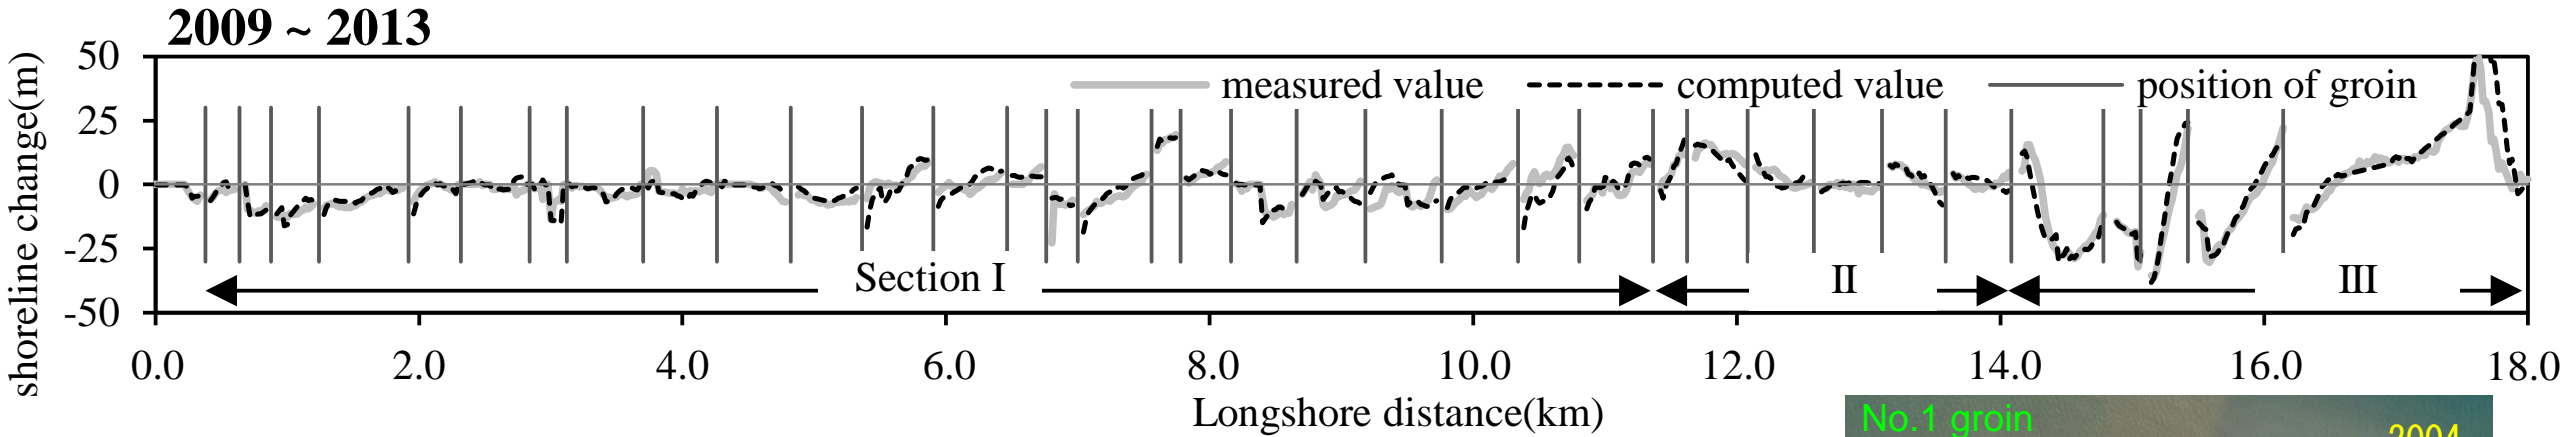
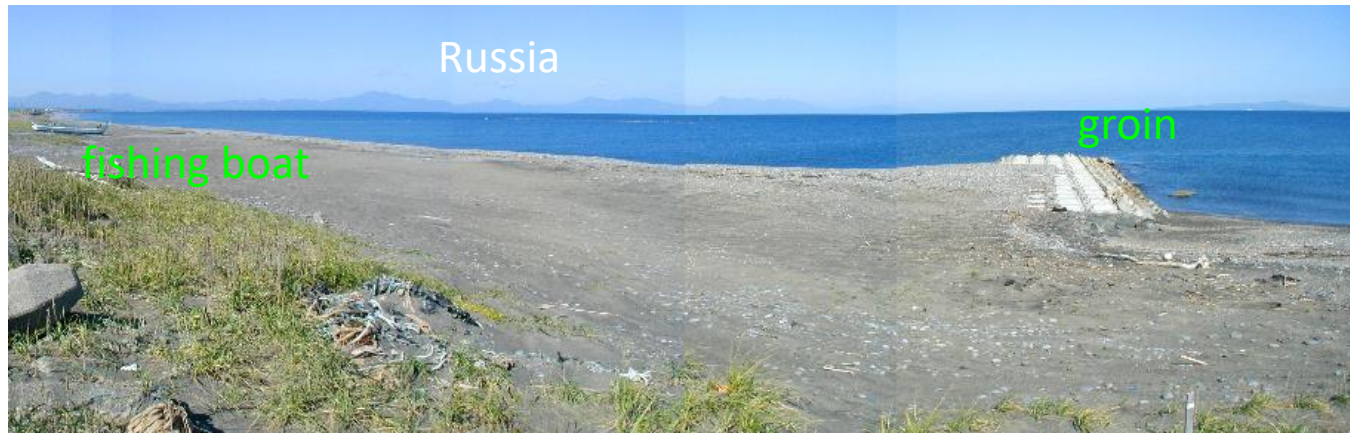
Reproduction of shoreline changes using one-line model

One-line model calibrated using mean tide level does not predict beach profile changes during storms

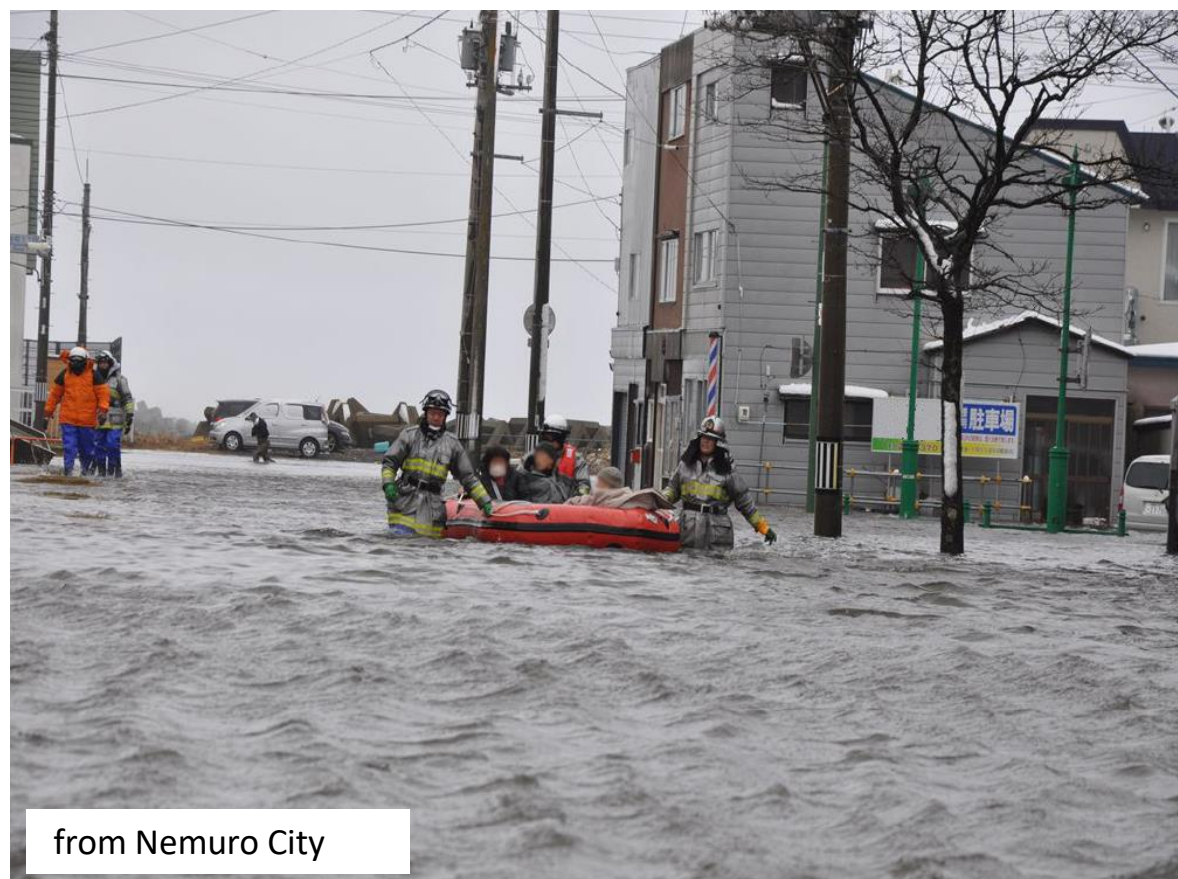
- In December 2014, a remarkable high tide occurred in Nemuro region due to the approach of rapidly developing low pressure
- In Nemuro city, total of 95 buildings flooded due to storm surge

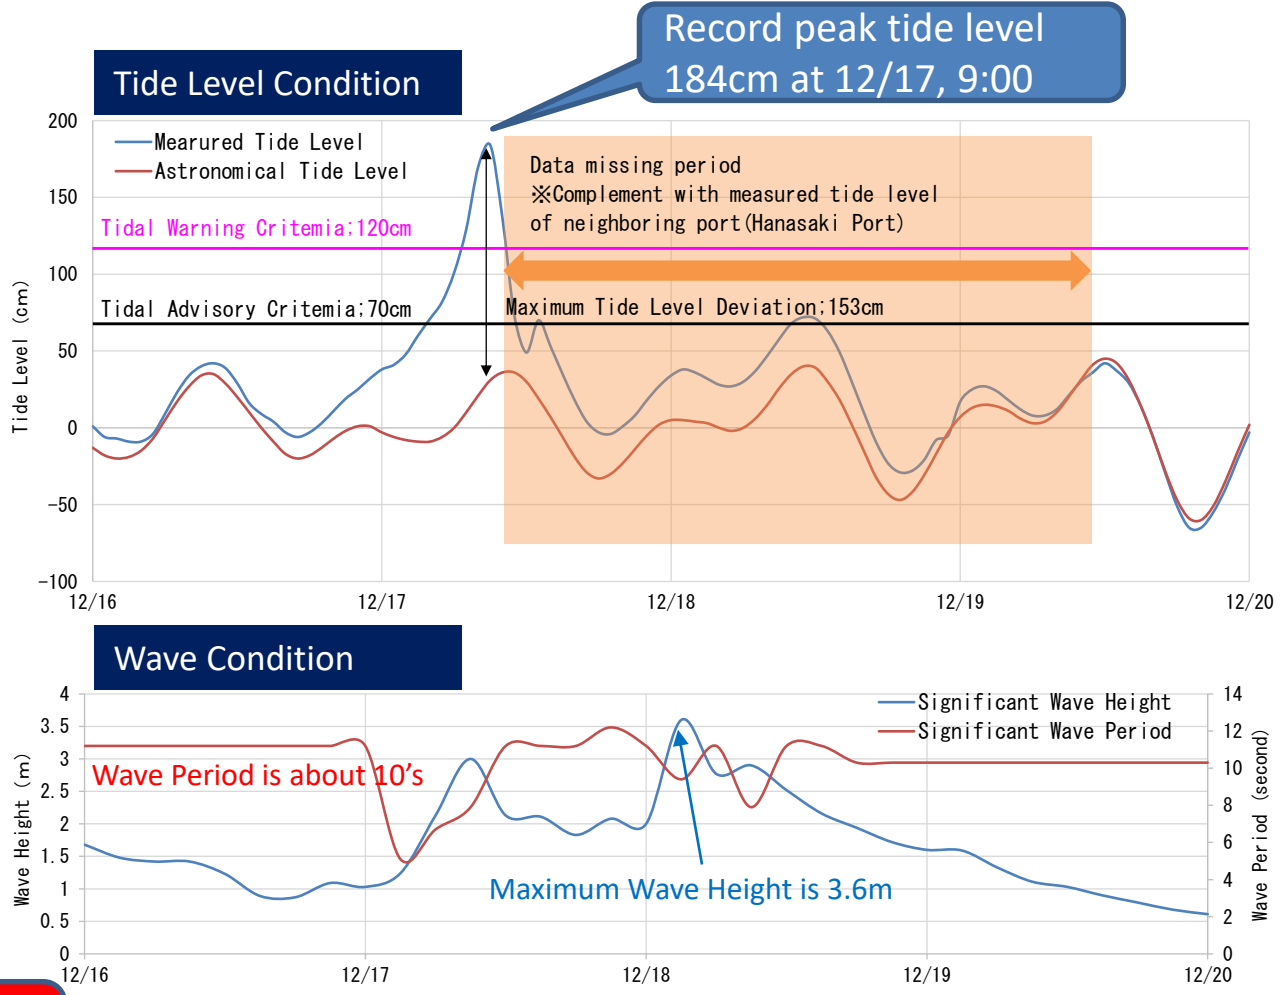
### Tide Level Condition

**Record peak tide level 184cm at 12/17, 9:00**

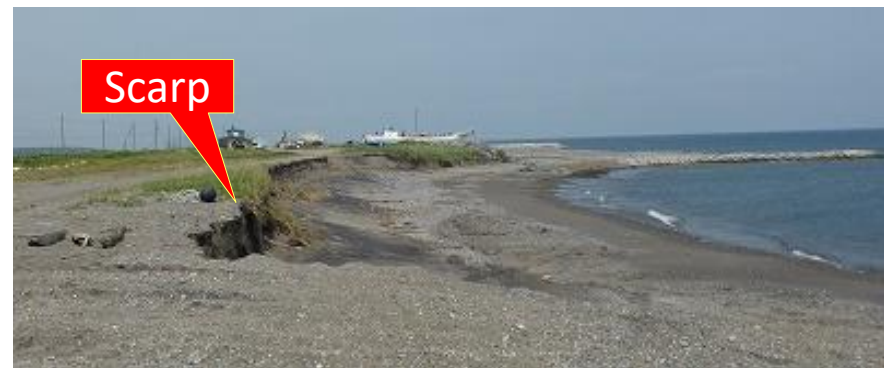
Geomorphological Change from 2014 to 2015

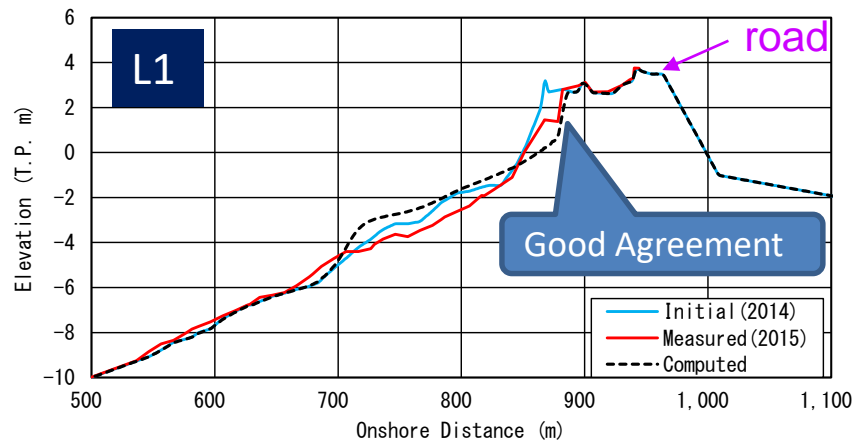
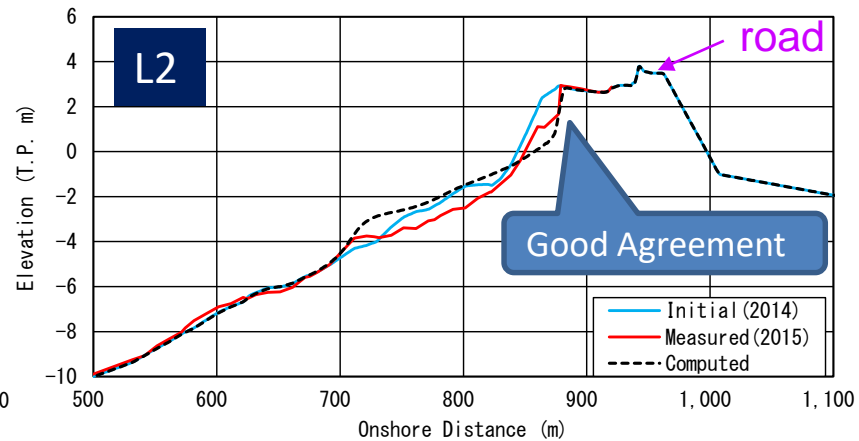
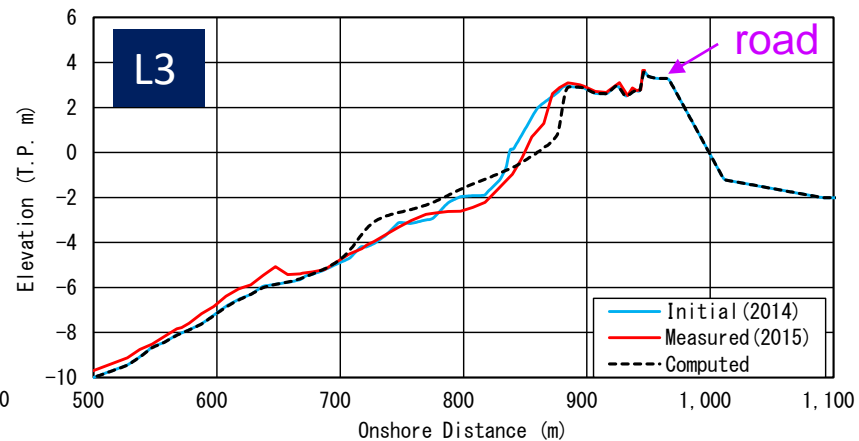
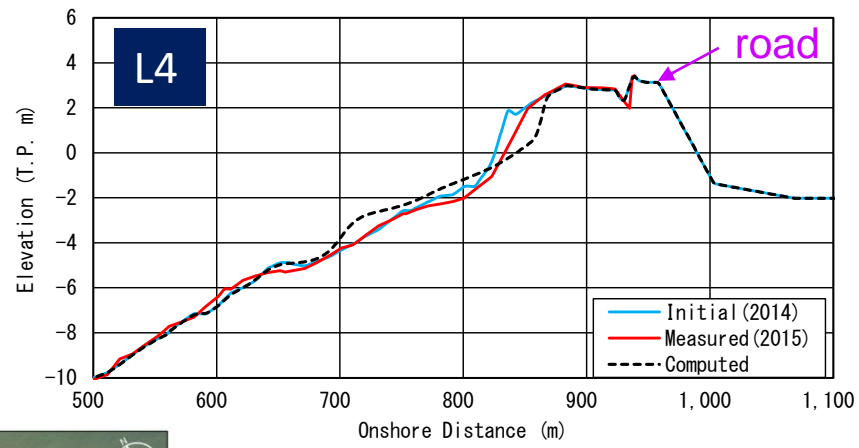
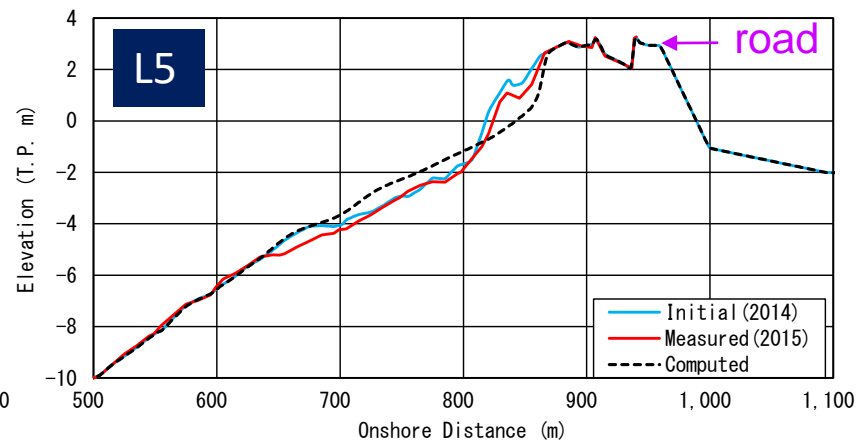
## ( 4 ) Computed (using CSHORE) Beach Profile Evolution

Measured 6 months after Nemuro Storm Surge

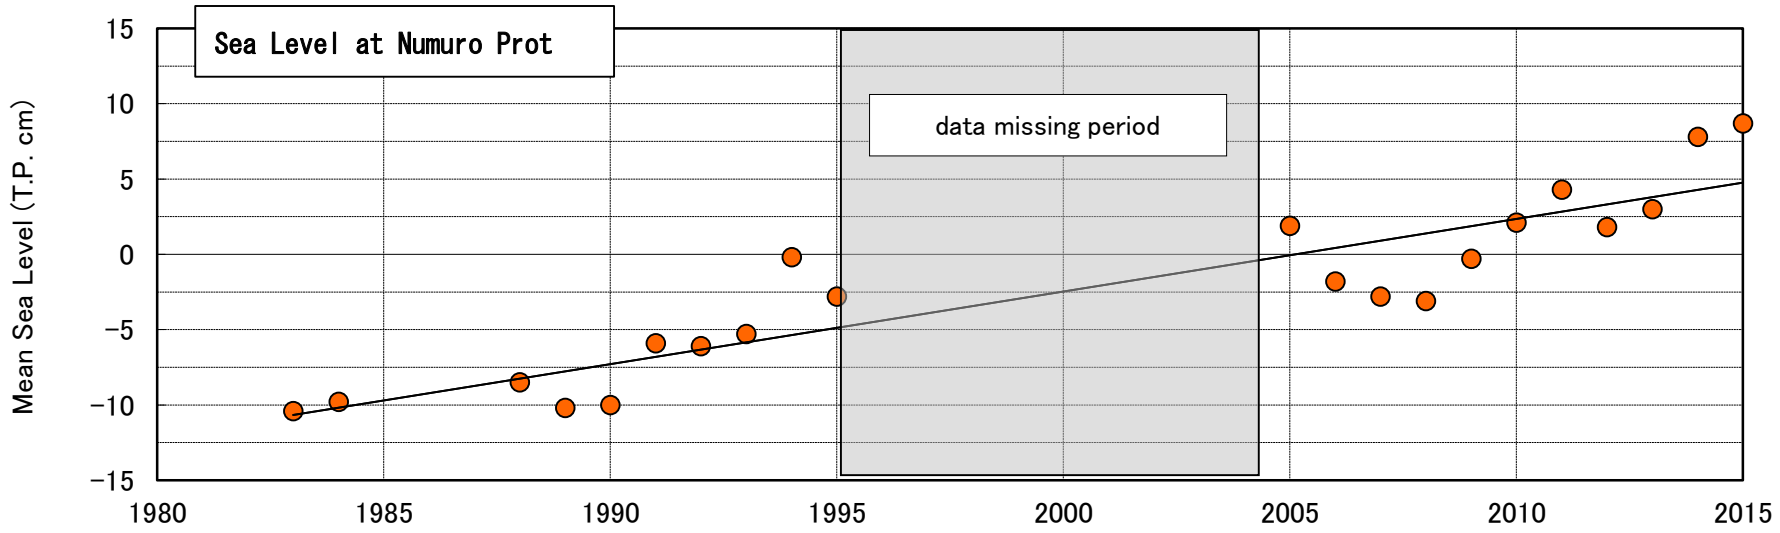
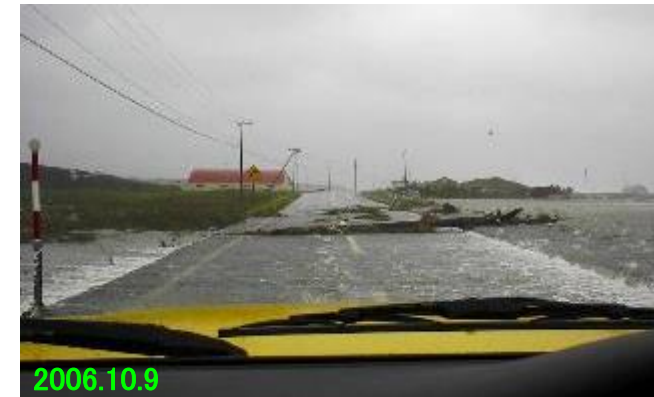
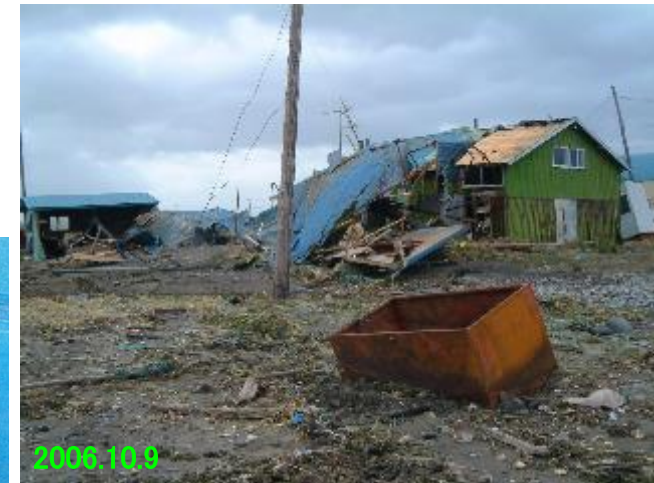
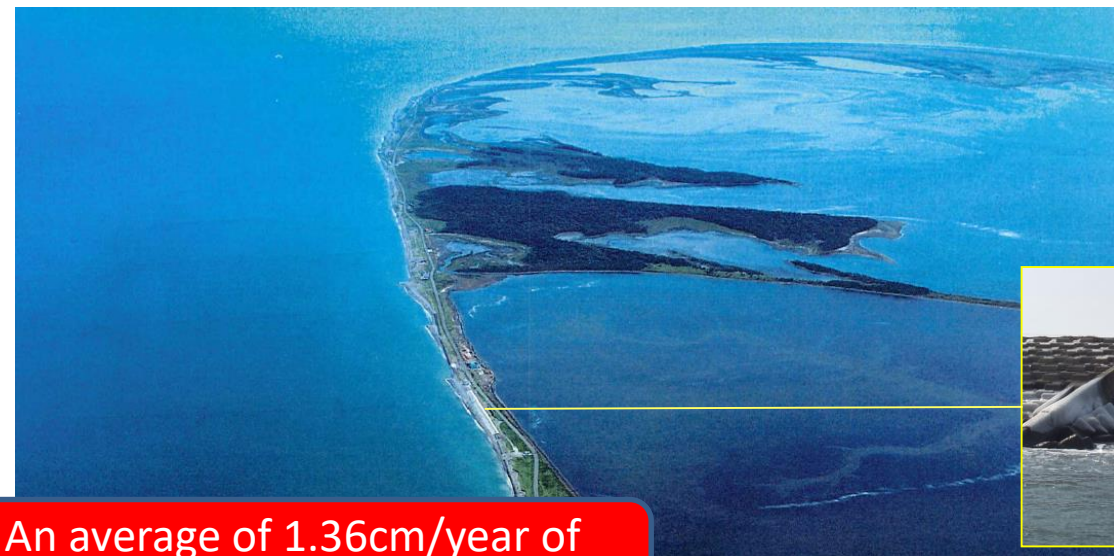
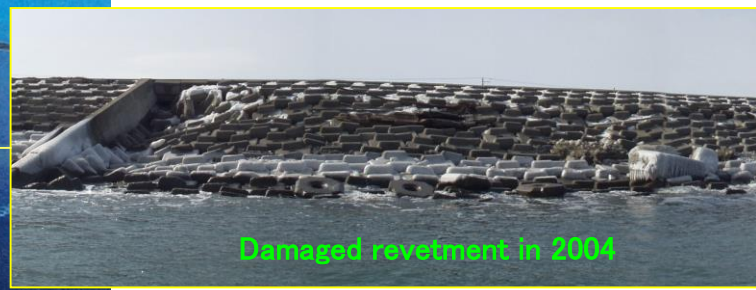
## (5) Risk Assessment of Sand Spit Breach

An average of 1.36cm/year of land subsidence has occurred

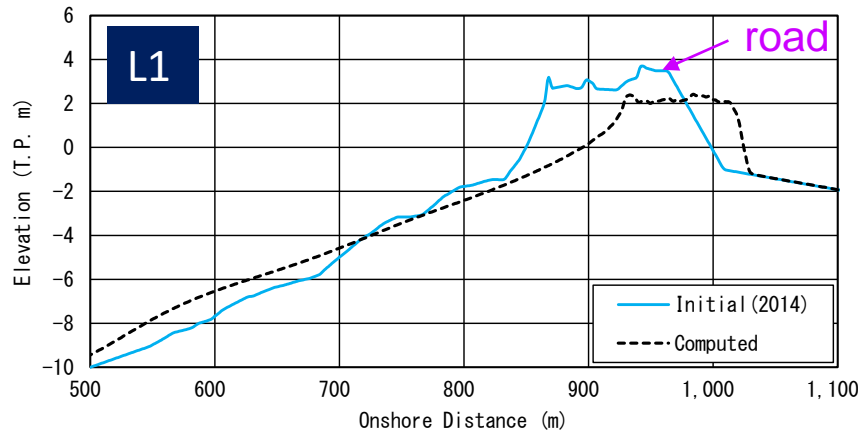
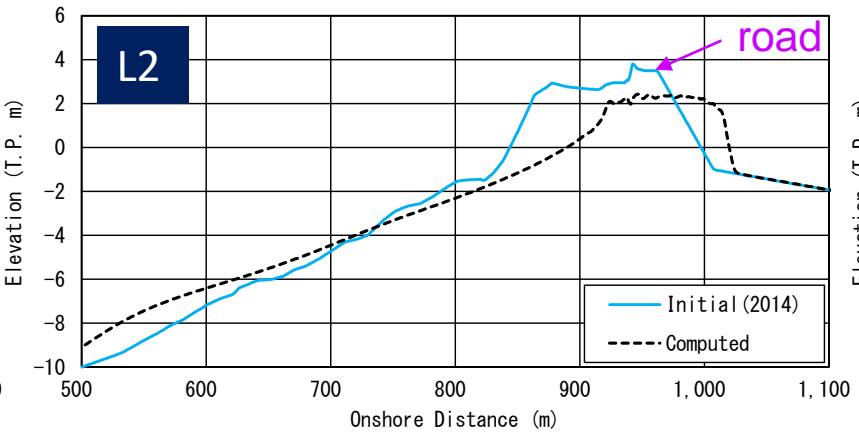
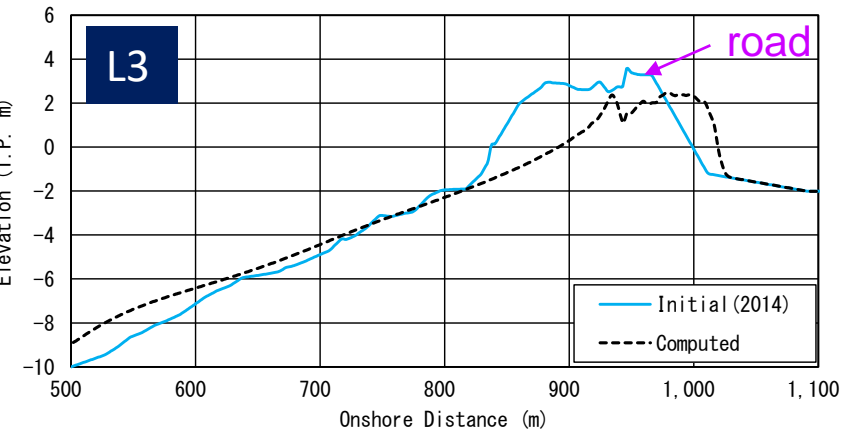
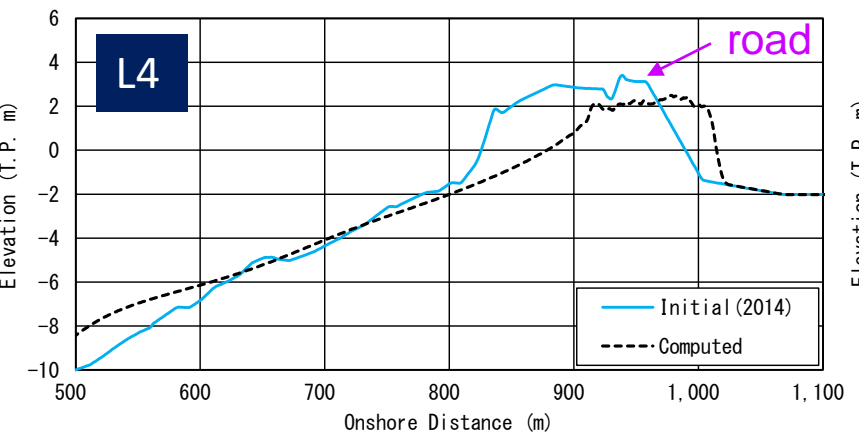
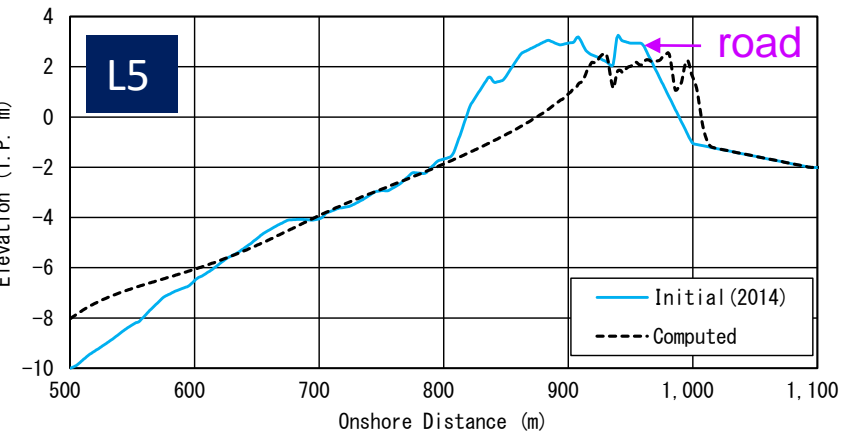
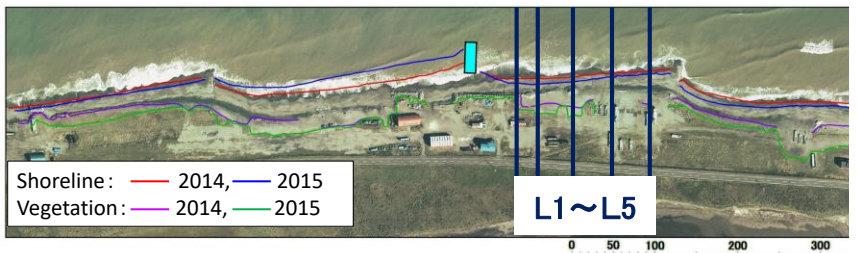
## ( 5 ) Risk Assessment of Sand Spit Breach

**【Tide Level Condition】**Nemuro Storm Surge + 0.7m (1.36cm/year × 50year)  
**【Wave Condition】**50 year Storm Wave (Significant wave height : 5.4m, Significant wave period : 11.4s)

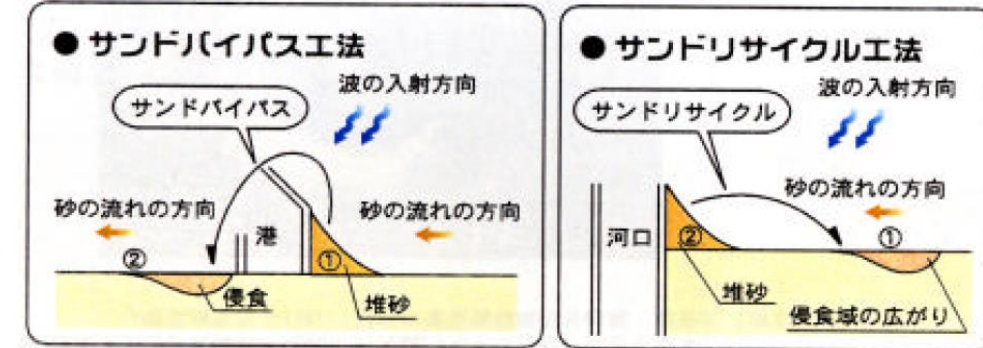
① Sand recycle system or extension of groins will be required for management of longshore sediment transport to sustain Notsukezaki sand spit.

Beach materials offshore of the 4-m closure depth should be included in sediment analysis
