# 36TH INTERNATIONAL CONFERENCE ON COASTAL ENGINEERING 2018

## Recession of Predominantly Sandy Bluffs

**Mahsa Ghazian Arabi, Ph.D. student**

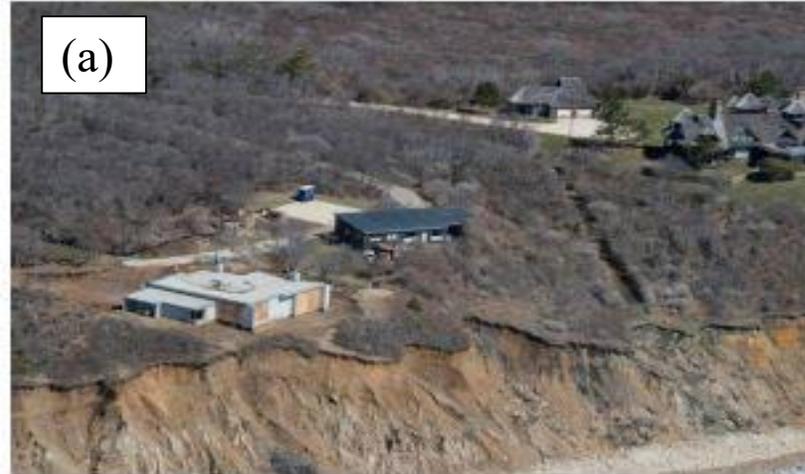
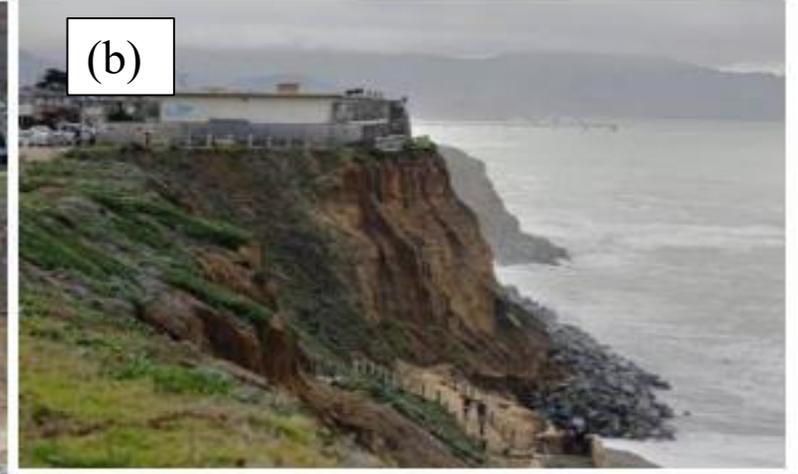
Bluff Recession in Montauk, NY (image Credit: Photo Credit: Doug Kuntz, Newsday); (b) Pacifica, CA (Image Credit: Credit Eric Risberg/AP)

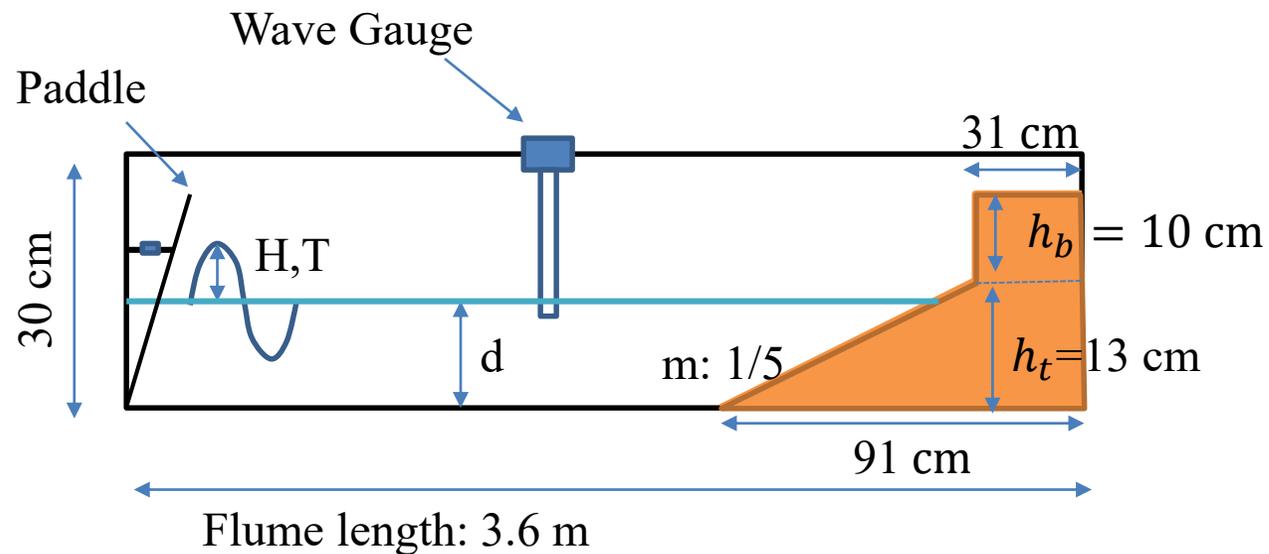
**Schematic of Experimental Setup**

- Monochromatic waves generated using flume's flap-type paddle
- Instantaneous water surface elevation measured using a resistive wave gauge
- Beach and bluff profile Evolution recorded using GoPro Hero 5 Black

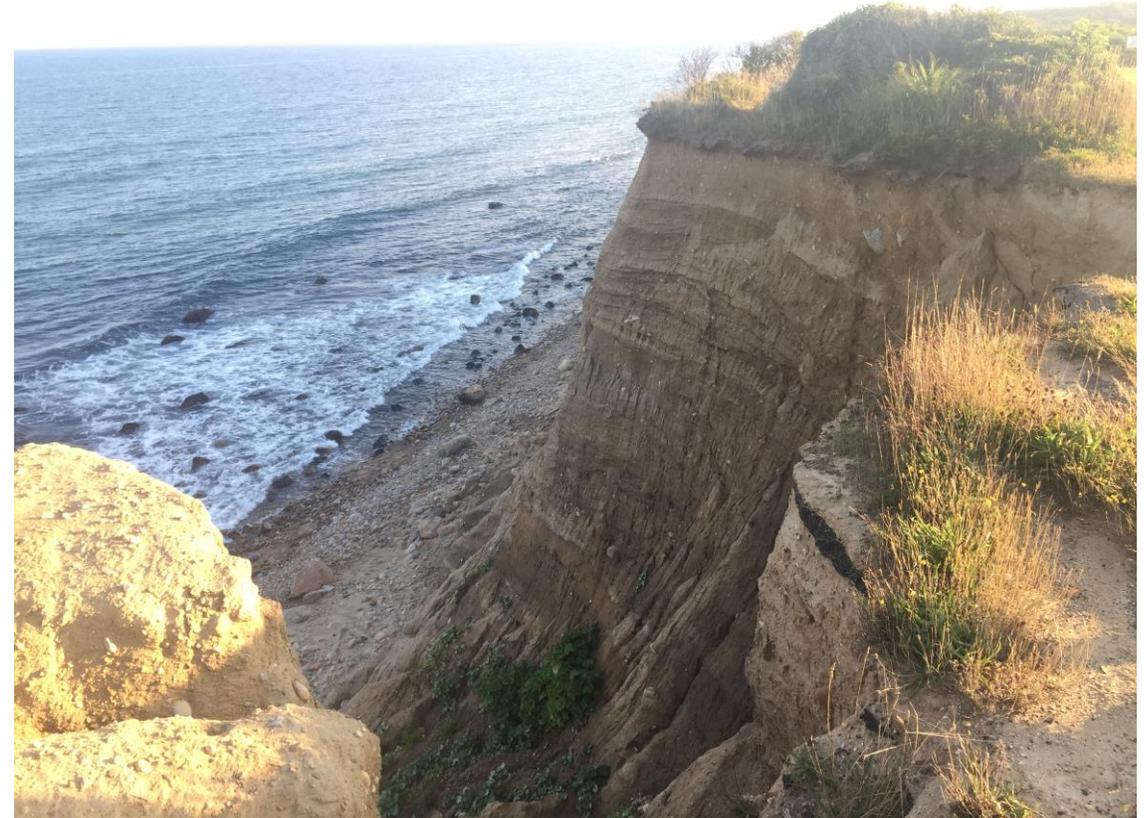
Montauk Point Bluff

- Sample materials were taken from a bluff site on south shore of Long Island, NY.
- The Montauk bluffs are predominantly sandy, steep or even vertical with a height ranging from about 6 m to more than 30 m.
- Bluffs are constantly being eroded by wave and surge attacks from Atlantic Ocean.

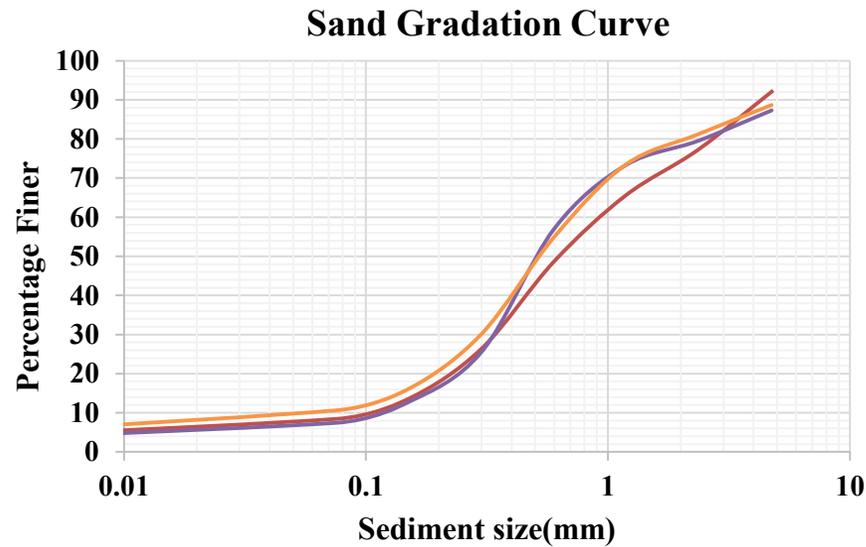
Field sample properties

- Field materials were analyzed in the lab for their geotechnical properties.

Gs	2.52-2.56
Water content	4-17%
Void ratio	0.36-0.64
Dry Density	1.43( $\text{gr}/\text{cm}^3$ )
$e_{\min}$	0.30
$e_{\max}$	0.68
$I_D$ (Relative Density)	0.1-0.86
$w_{opt}$	11-13%
PL	18.2-21.1%
LL	35.7-36.7%
PI	14.6-18.5%

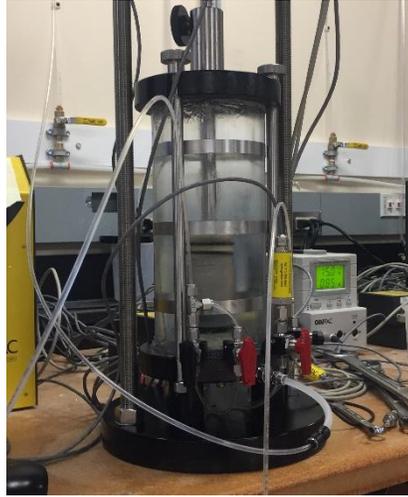
- Triaxle tests were conducted to obtain sample materials strength indices.

Sample No.	Clay Content (%)	$C'$ (kPa)	$\Phi'$	$C$ (kPa)	$\Phi$
1	0	0.15	33.3	0.18	32.8
2	5	1.01	28.8	1.75	28.5

- Clay content increases undrained shear strength under normal stresses lower than 15.5kPa
- Clay content reduces undrained shear strength under normal stress higher than 15.5kPa

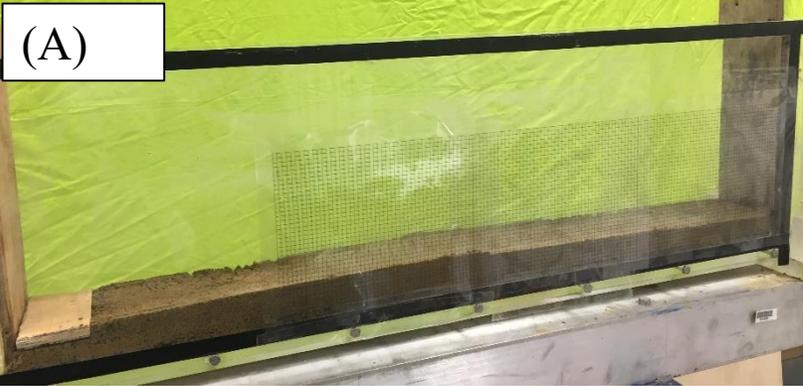
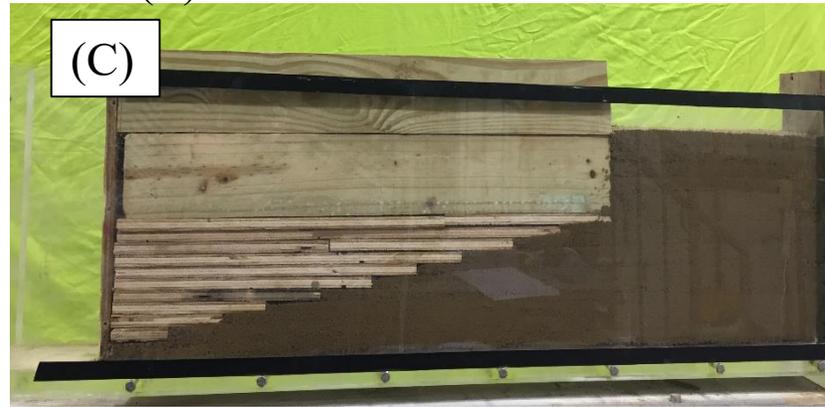
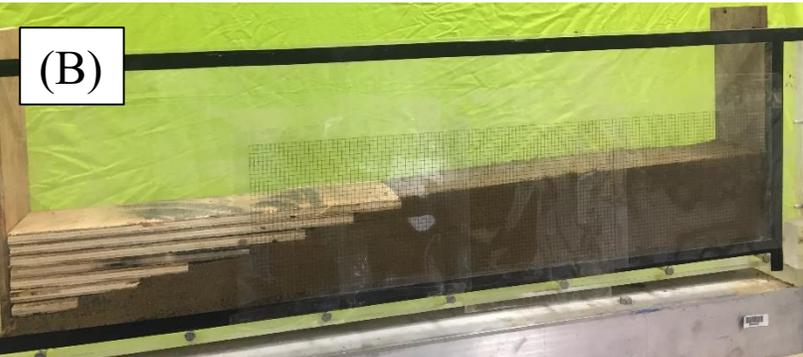
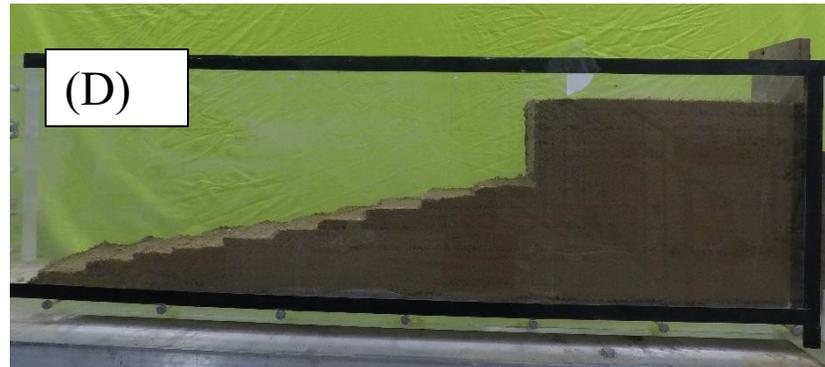
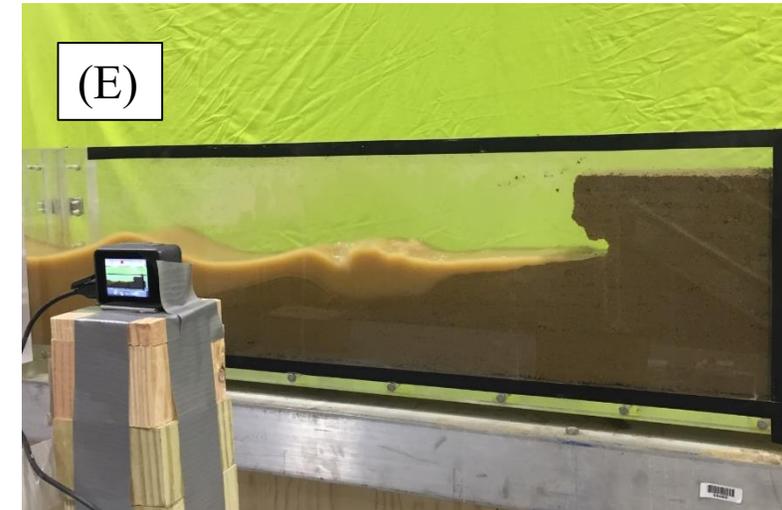
- Soil was mixed with specific amount of water to reach the target water content
- Soil compacted layer by layer based on volume control method for the target density (A-D)
- Water level was gradually risen to target level
- Pictures were taken for profile measurements (E)

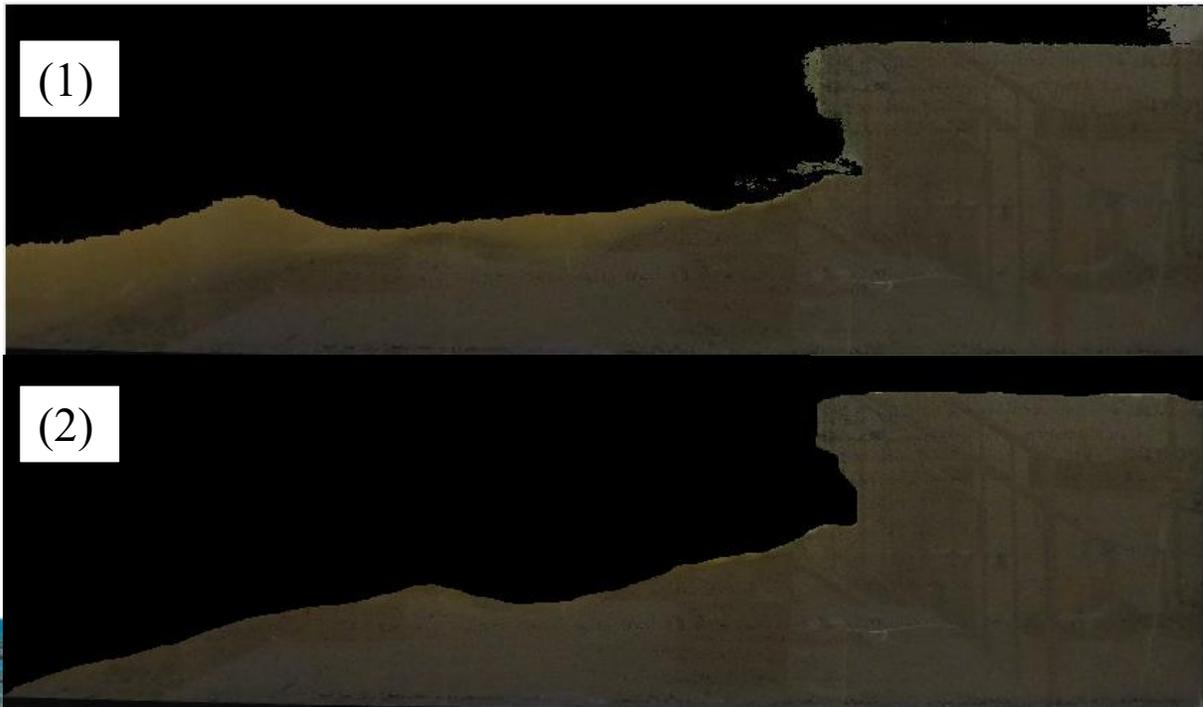
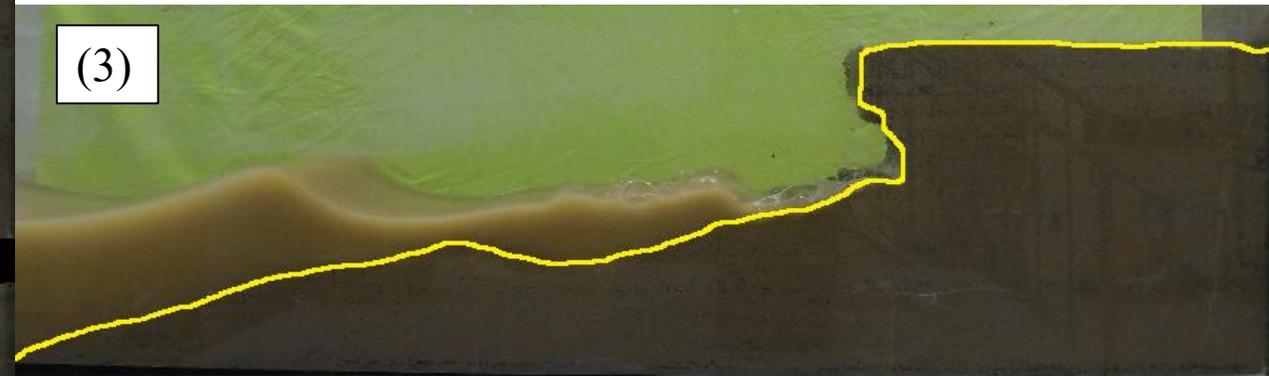
- Image Processing utilized by three different toolbox in MATLAB R2017a.
- First camera has been calibrated and then images were wrapped.
- Secondly, beach and bluff edges were captured using a color threshold technique (1).
- Then, image region analyzer used to delete the noises, and,
- Finally, Image segmentation technique was used to eliminate farther edge of the bluff visible due to camera angle relative to the bluff (2).

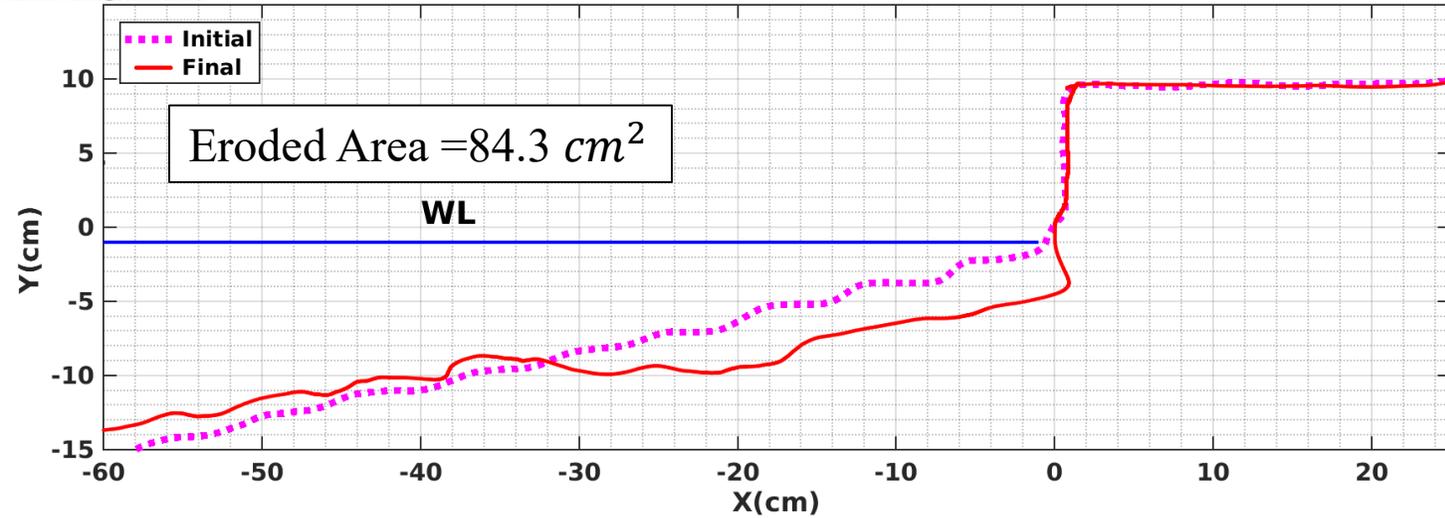
Clay Content: 0%

## Stage 1: Initial and final profile of beach and bluff

Sample with pure sand:  $A_e = 84.3$  cm<sup>2</sup>

- Beach erosion for purely sandy bluff was more than double that with 5% clay content.
- In First stage, sample with no clay shows bottom lowering at the toe(2.5 cm). However, the second case with 5% clay content shows a small deposition due to bluff downcutting (less than 1 cm).

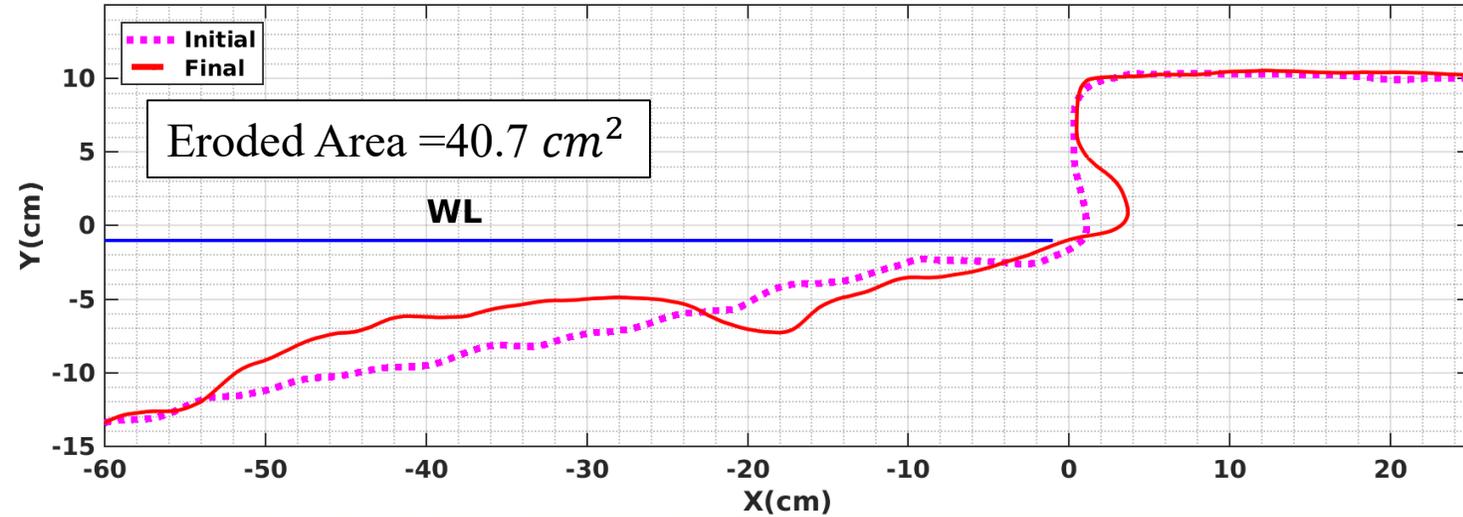
Clay Content: 5%

Sample with 5% clay content:  $A_e = 40.7$  cm<sup>2</sup>

- Unlike for the purely sandy bluff, the down cutting ( $10.4 \text{ cm}^2$ ) happened for the bluff with 5% clay content during Stage 1 which can be because of the stiffness of the beach which allows plunging waves runup to reach the bluff more energetically as opposed to the sandy beach where breaking wave energy is spent on the transport of sands on the beach.

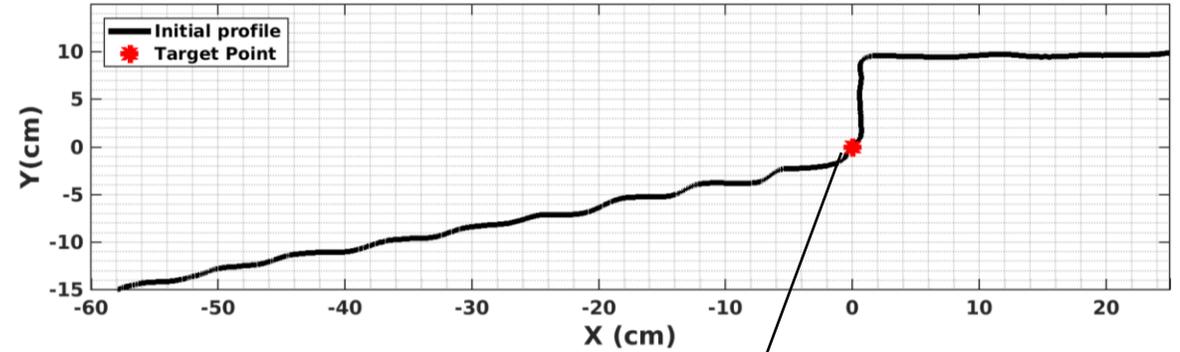
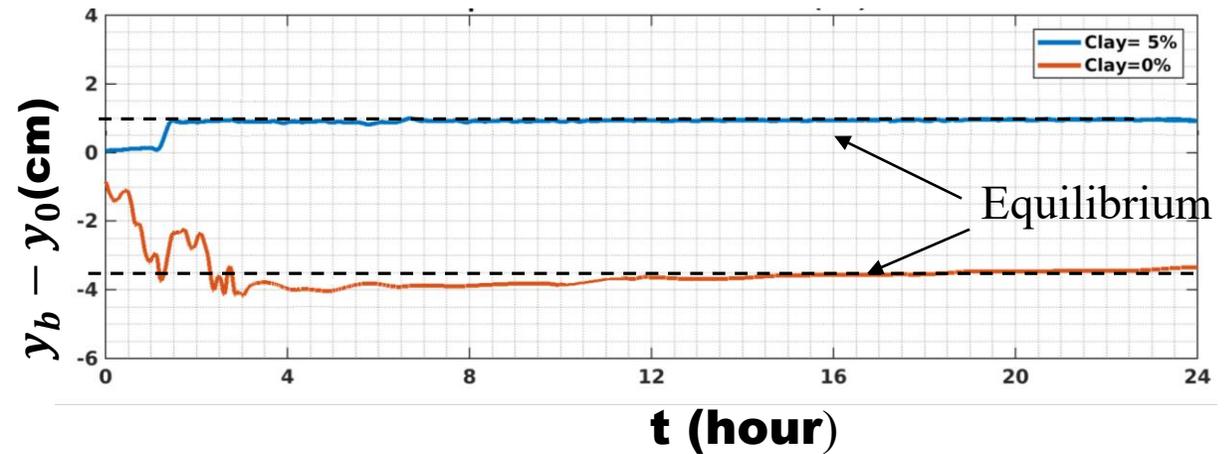
Time history of bottom variations at the toe of bluff for the samples with pure sand and that with 5% clay content

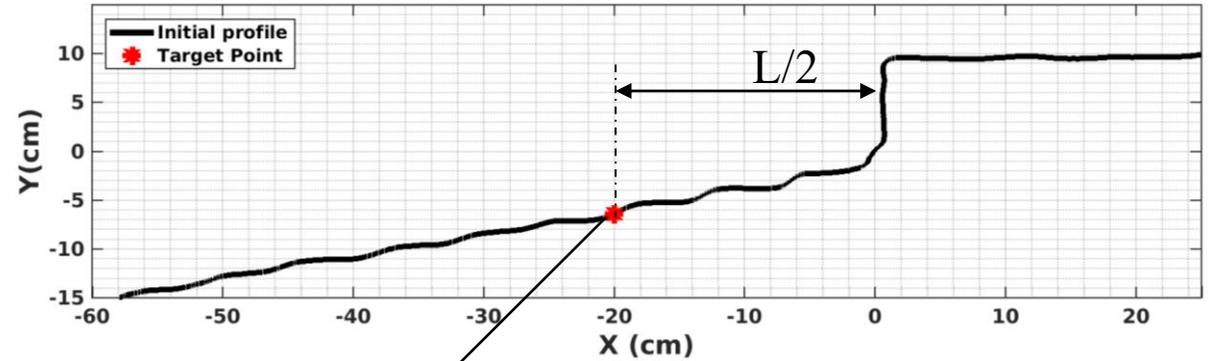
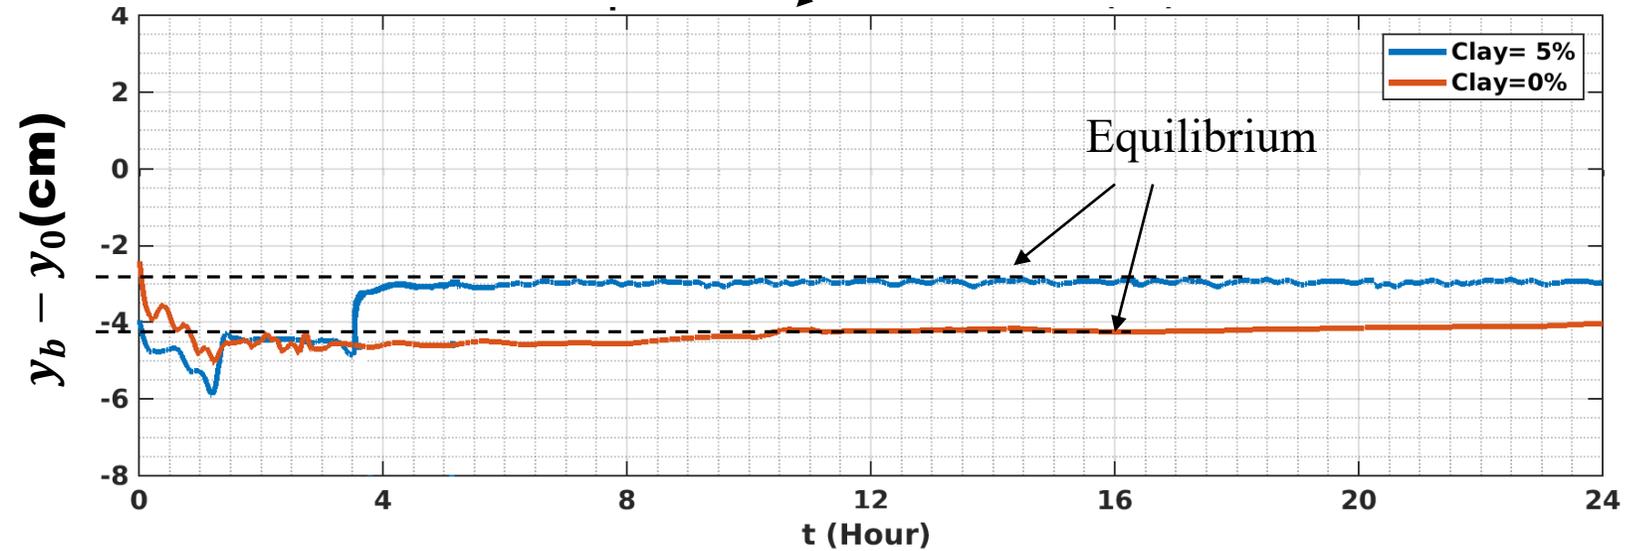
Time history of bottom variations at a distance equal to half-wave length from the toe of bluff for the samples with pure sand and that with 5% clay content

- During Stage 1, the bottom elevation at L/2, for the sample with 5% clay content rose by 1 cm following an erosion due to the bluff failure.
- Total crest recession for purely sandy bluff was 27 % higher than that with 5% clay content.

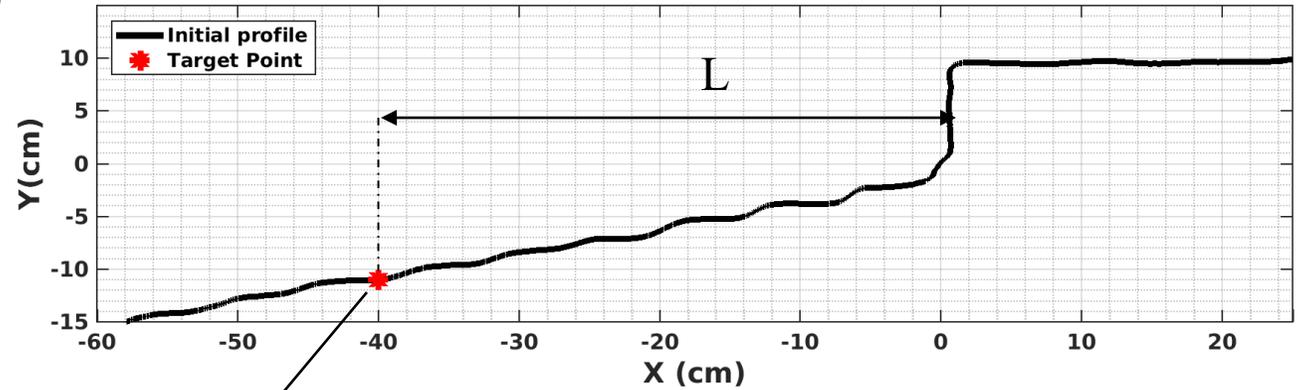
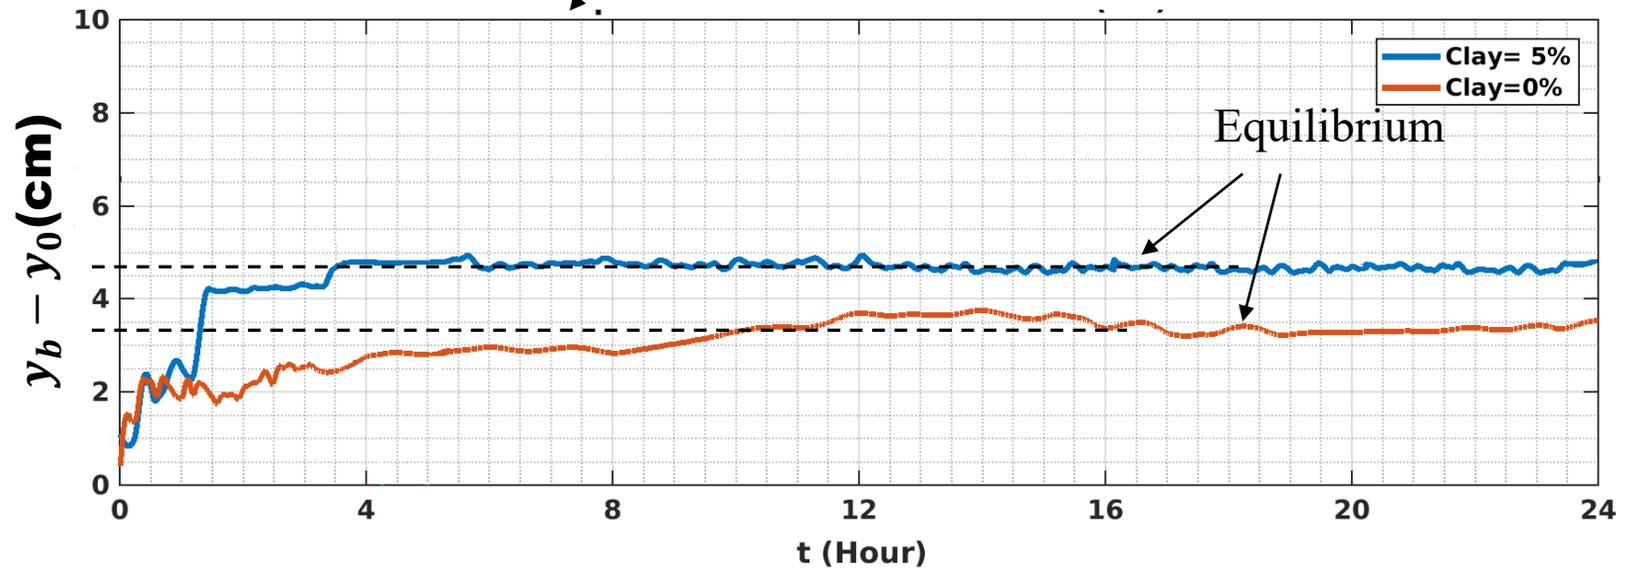
Time history of bottom variations at a distance equal a wave length from the toe of bluff for the samples with pure sand and that with 5% clay content

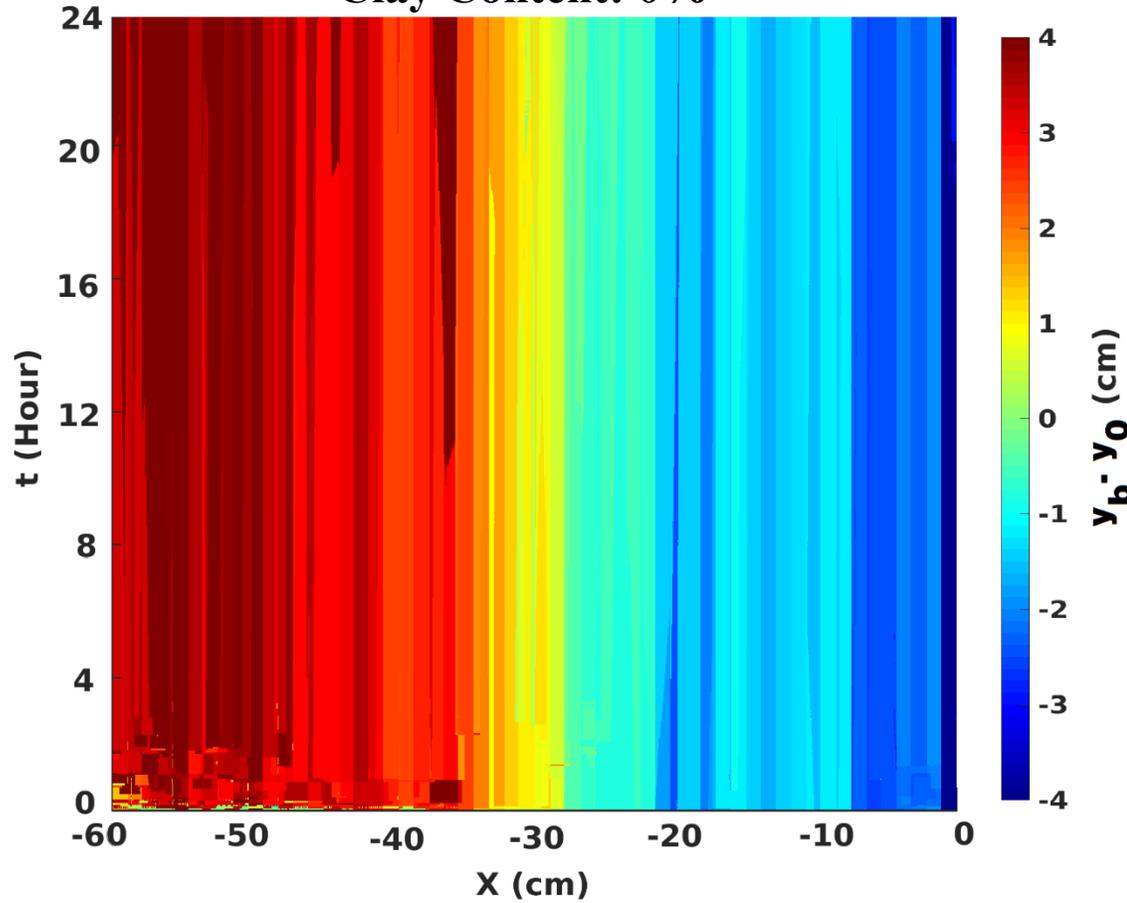
Clay Content: 0%

### Time-stack of Bottom Elevation Variation

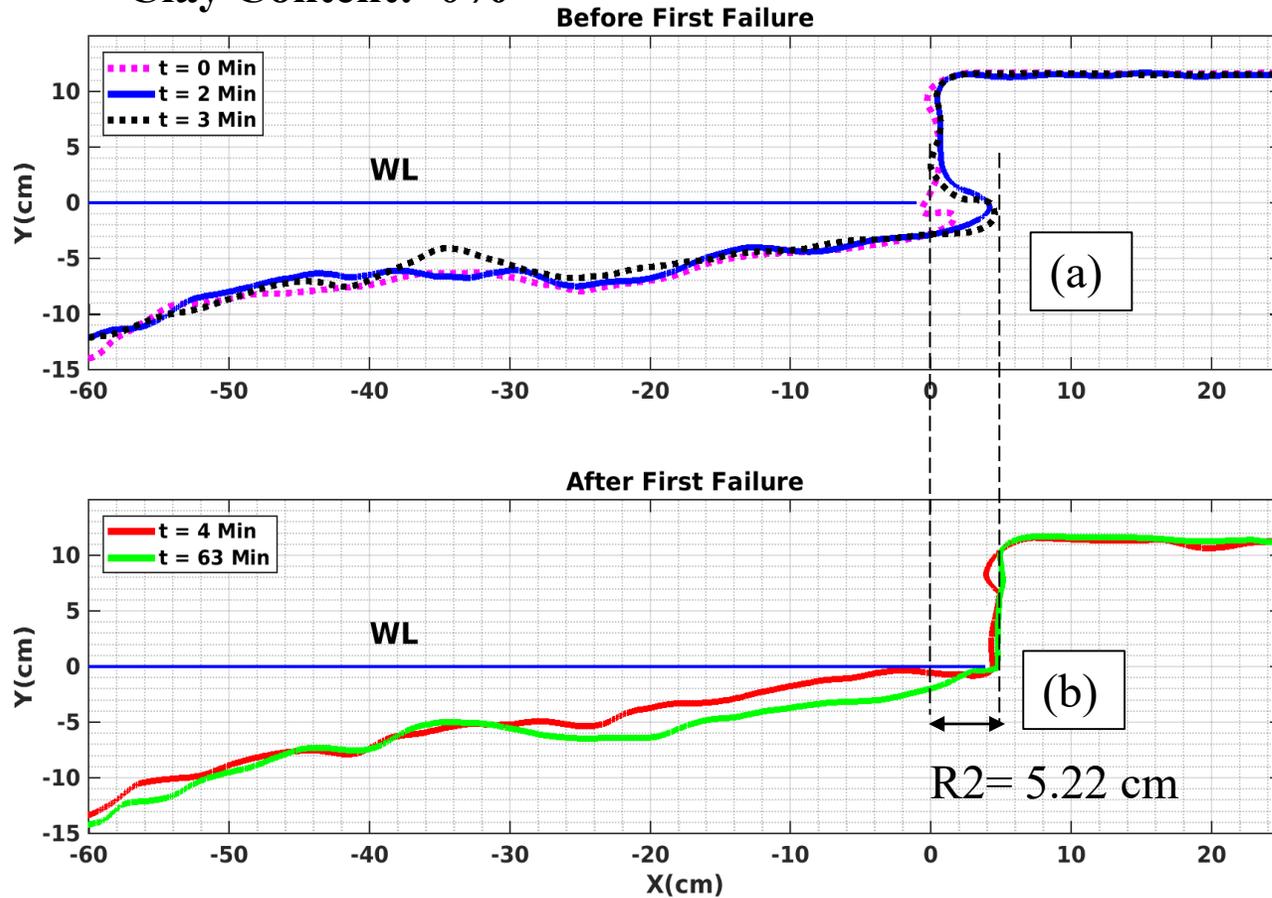
Clay Content: 0%

- Stage 2: Beach and Bluff Erosion: First Failure

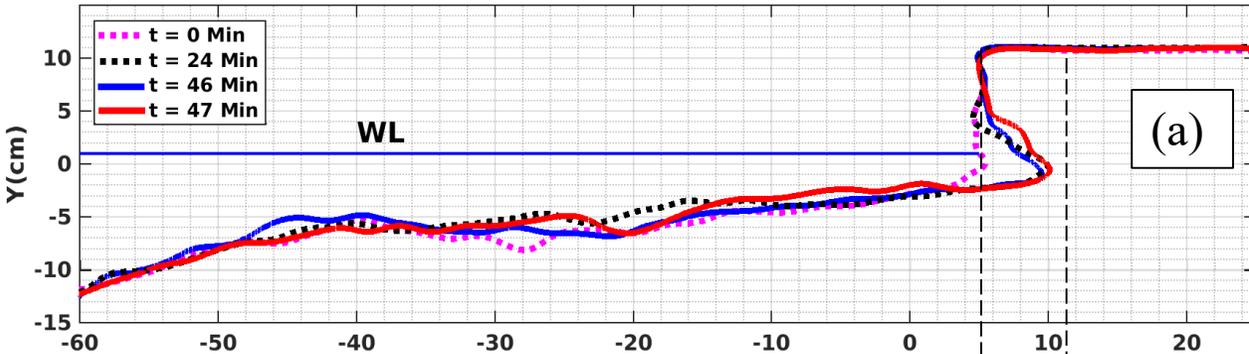
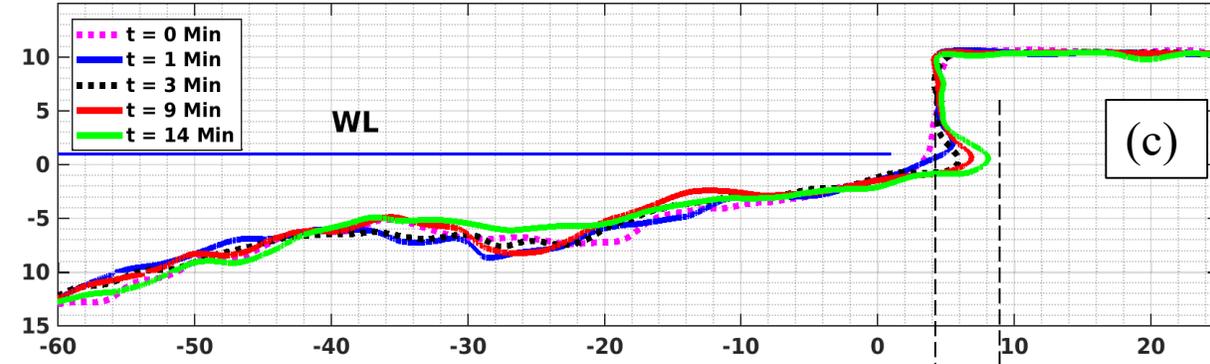
Before Second Failure

• Stage 3: Beach and Bluff Erosion: Second Failure

- The amount of bluff volume loss are 50 % and 100% higher during Stage 3 for sample without clay and with 5% clay, respectively. Perhaps this is due to large waves more directly attacking the bluff front.
