Adaptation to a Changing Climate in the Coastal Zone – A Case Study of Prime Hook National Wildlife Refuge

Jeff Tabar, PE, D.CE

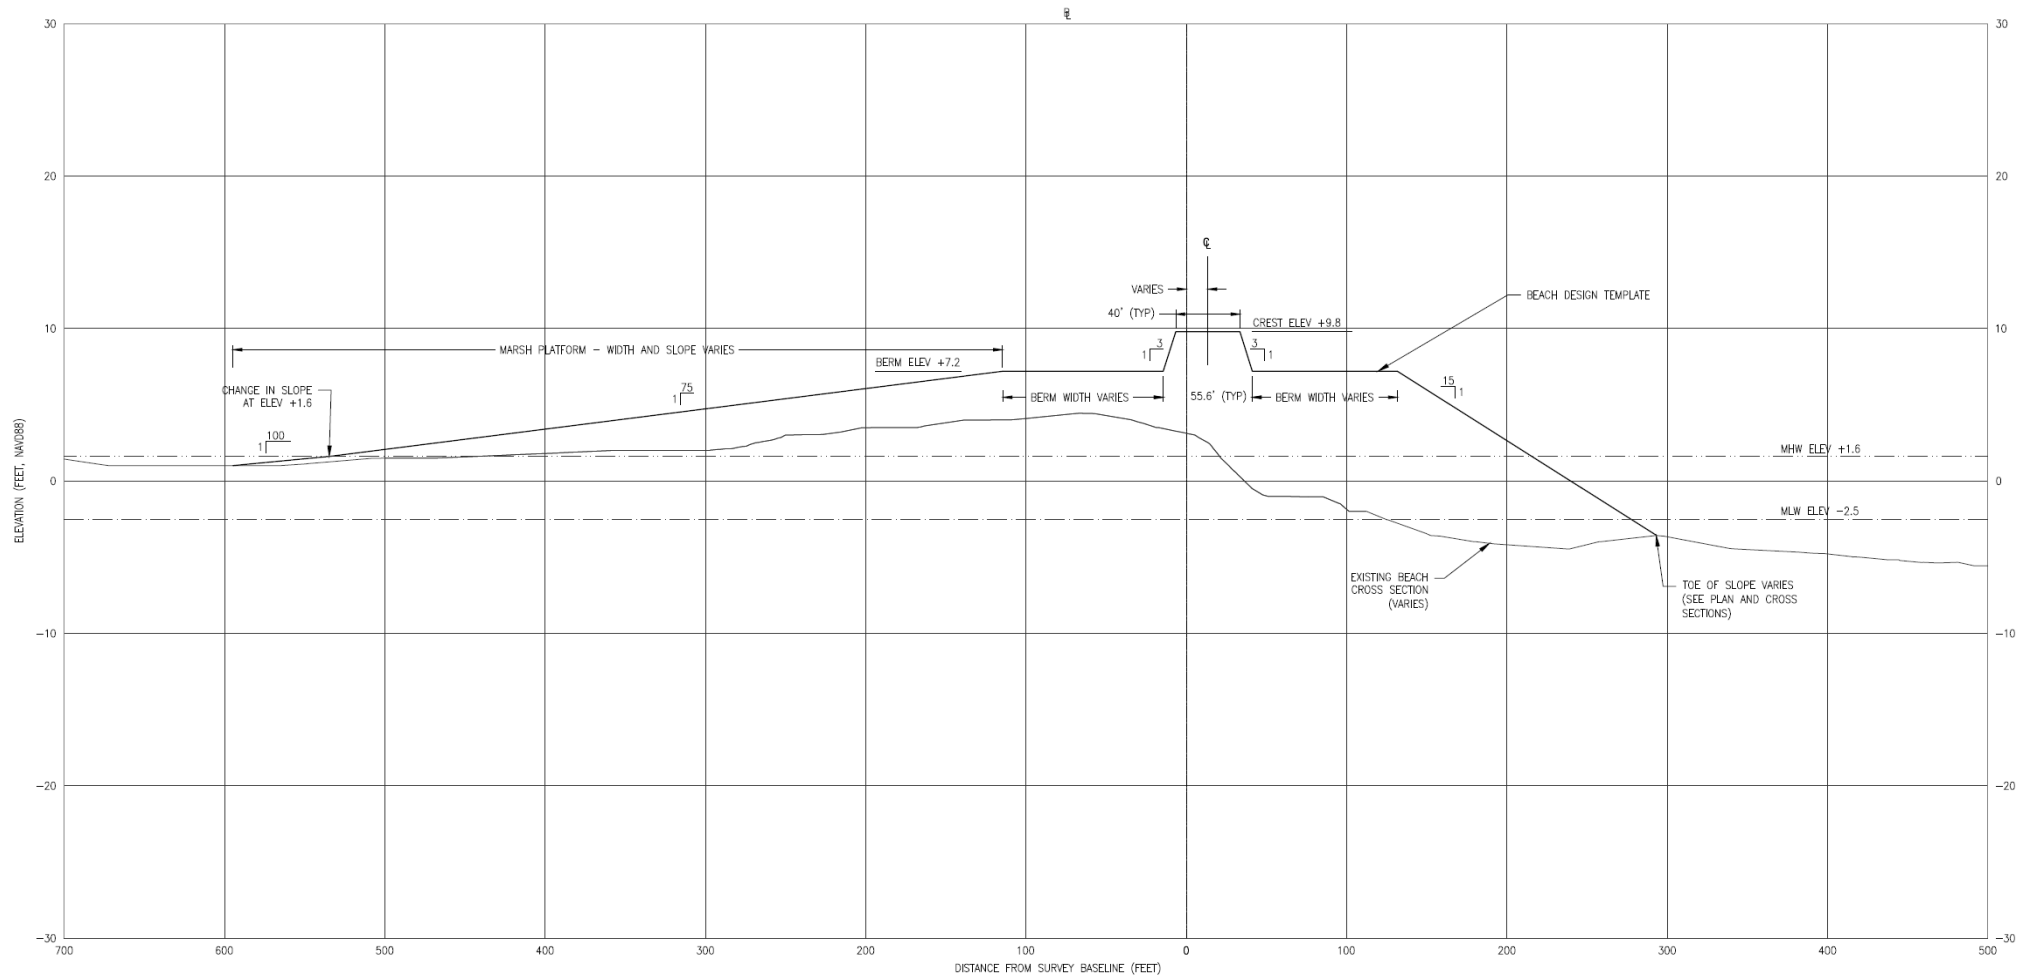
1 TYPICAL SECTION - PRIME HOOK
SCALE: AS SHOWN

Typical Section

Beach, Dune and Back-Barrier Restoration Sandy Recovery Project

- Close breaches, Restore dunes
- *1.41* Million cubic yards of sediment
- About 8,900 linear feet

- Create marsh platform (bac-barrier) behind restored dune
 - 60 total acres
 - Extend about 100 to 600 feet into back barrier marsh

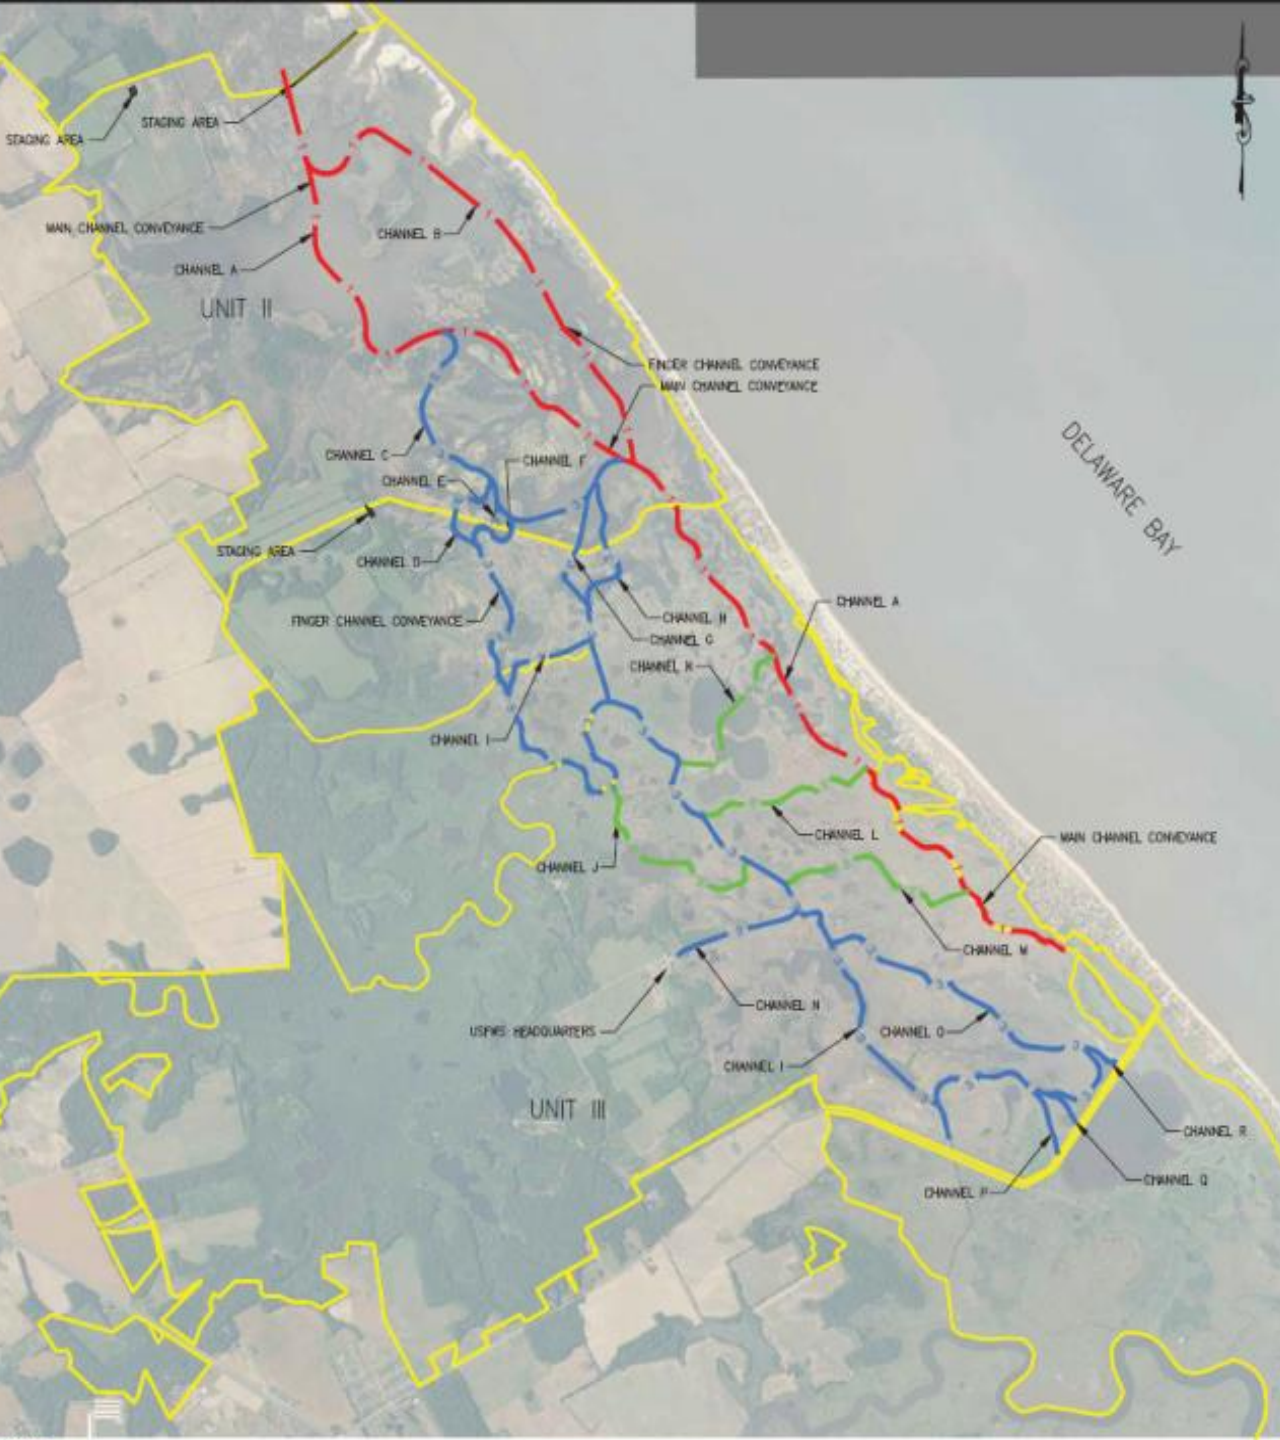
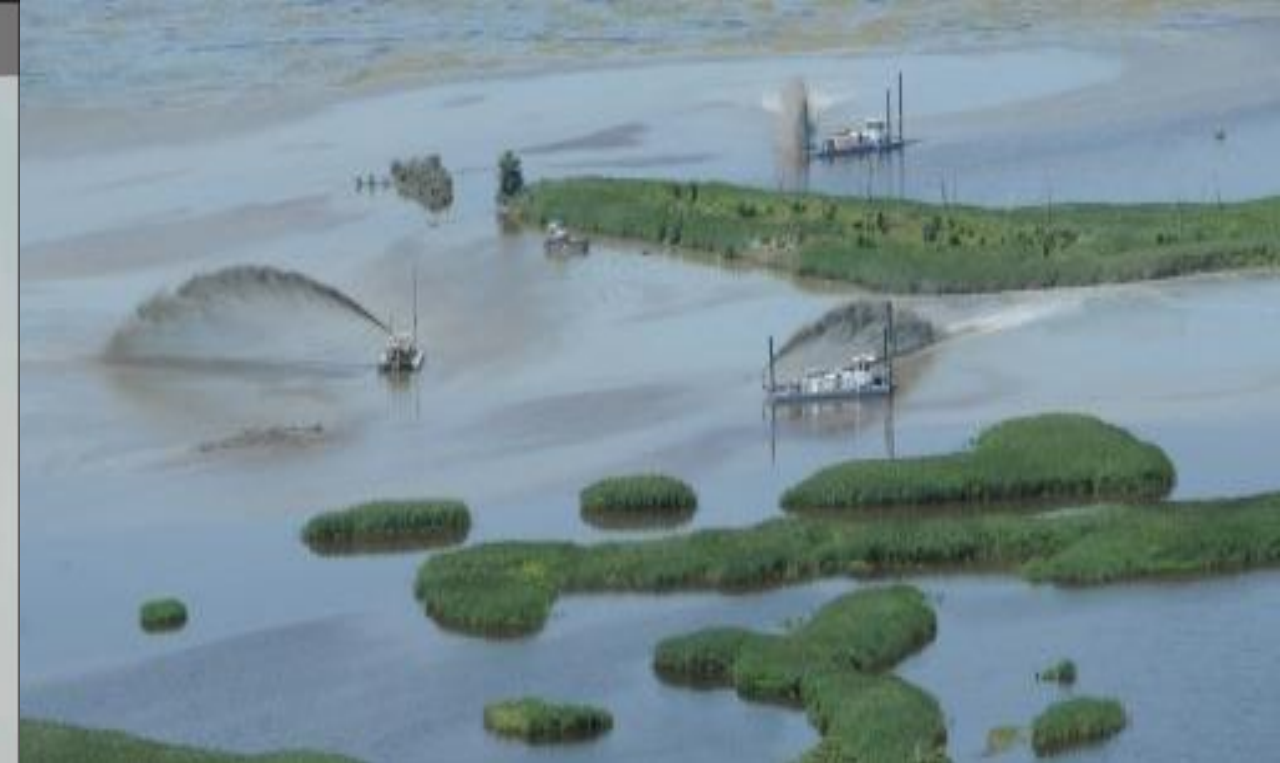
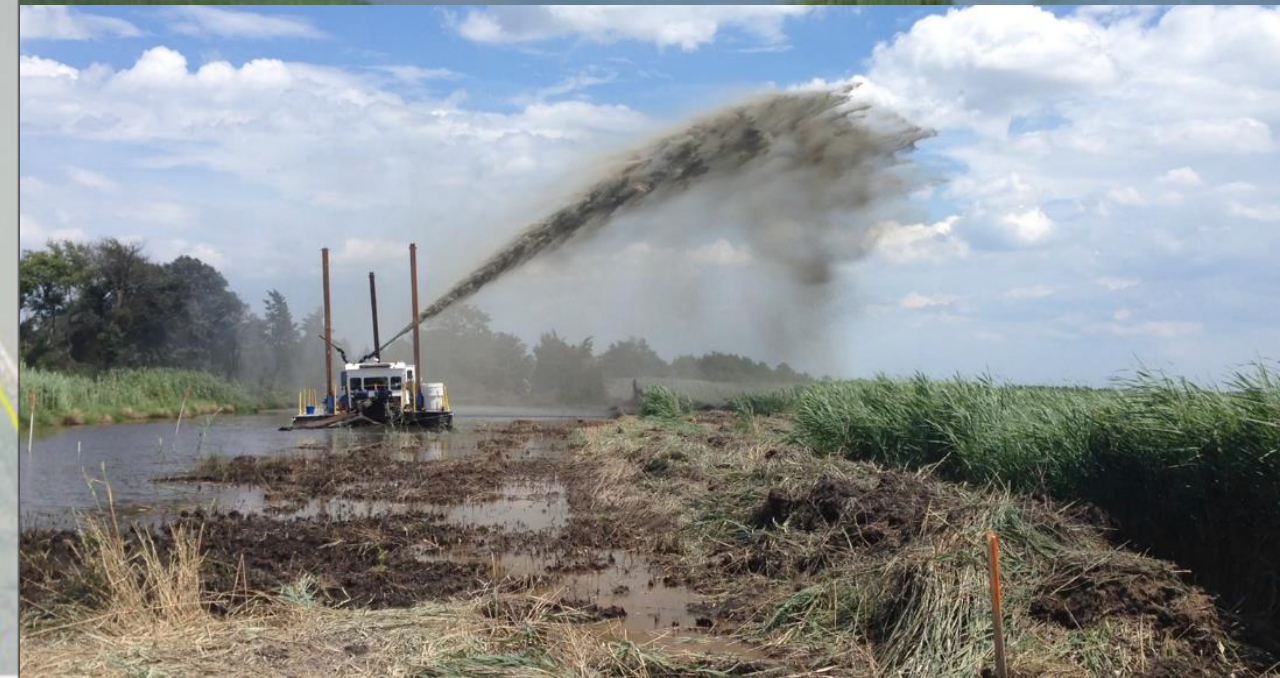
Marsh Interior Restoration Sandy Resiliency Project

- *Begin to rebuild ecosystem processes*
- Improve tidal circulation by creating conveyance channel network
 - ~ 25 Miles of channels -
- Use material from on-site dredging work to restore lost elevation in some areas of the marsh interior (thin-layer application)
 - Kinda.....more of a disposal mechanism
 - ~600,000 cy
