ICCE  
2018

# On the assesment of detached breakwaters on a sea-breeze dominated beach

Alec Torres-Freyermuth, Gabriela Medellín, Tonatiuh Mendoza, Elena Ojeda & Paulo Salles

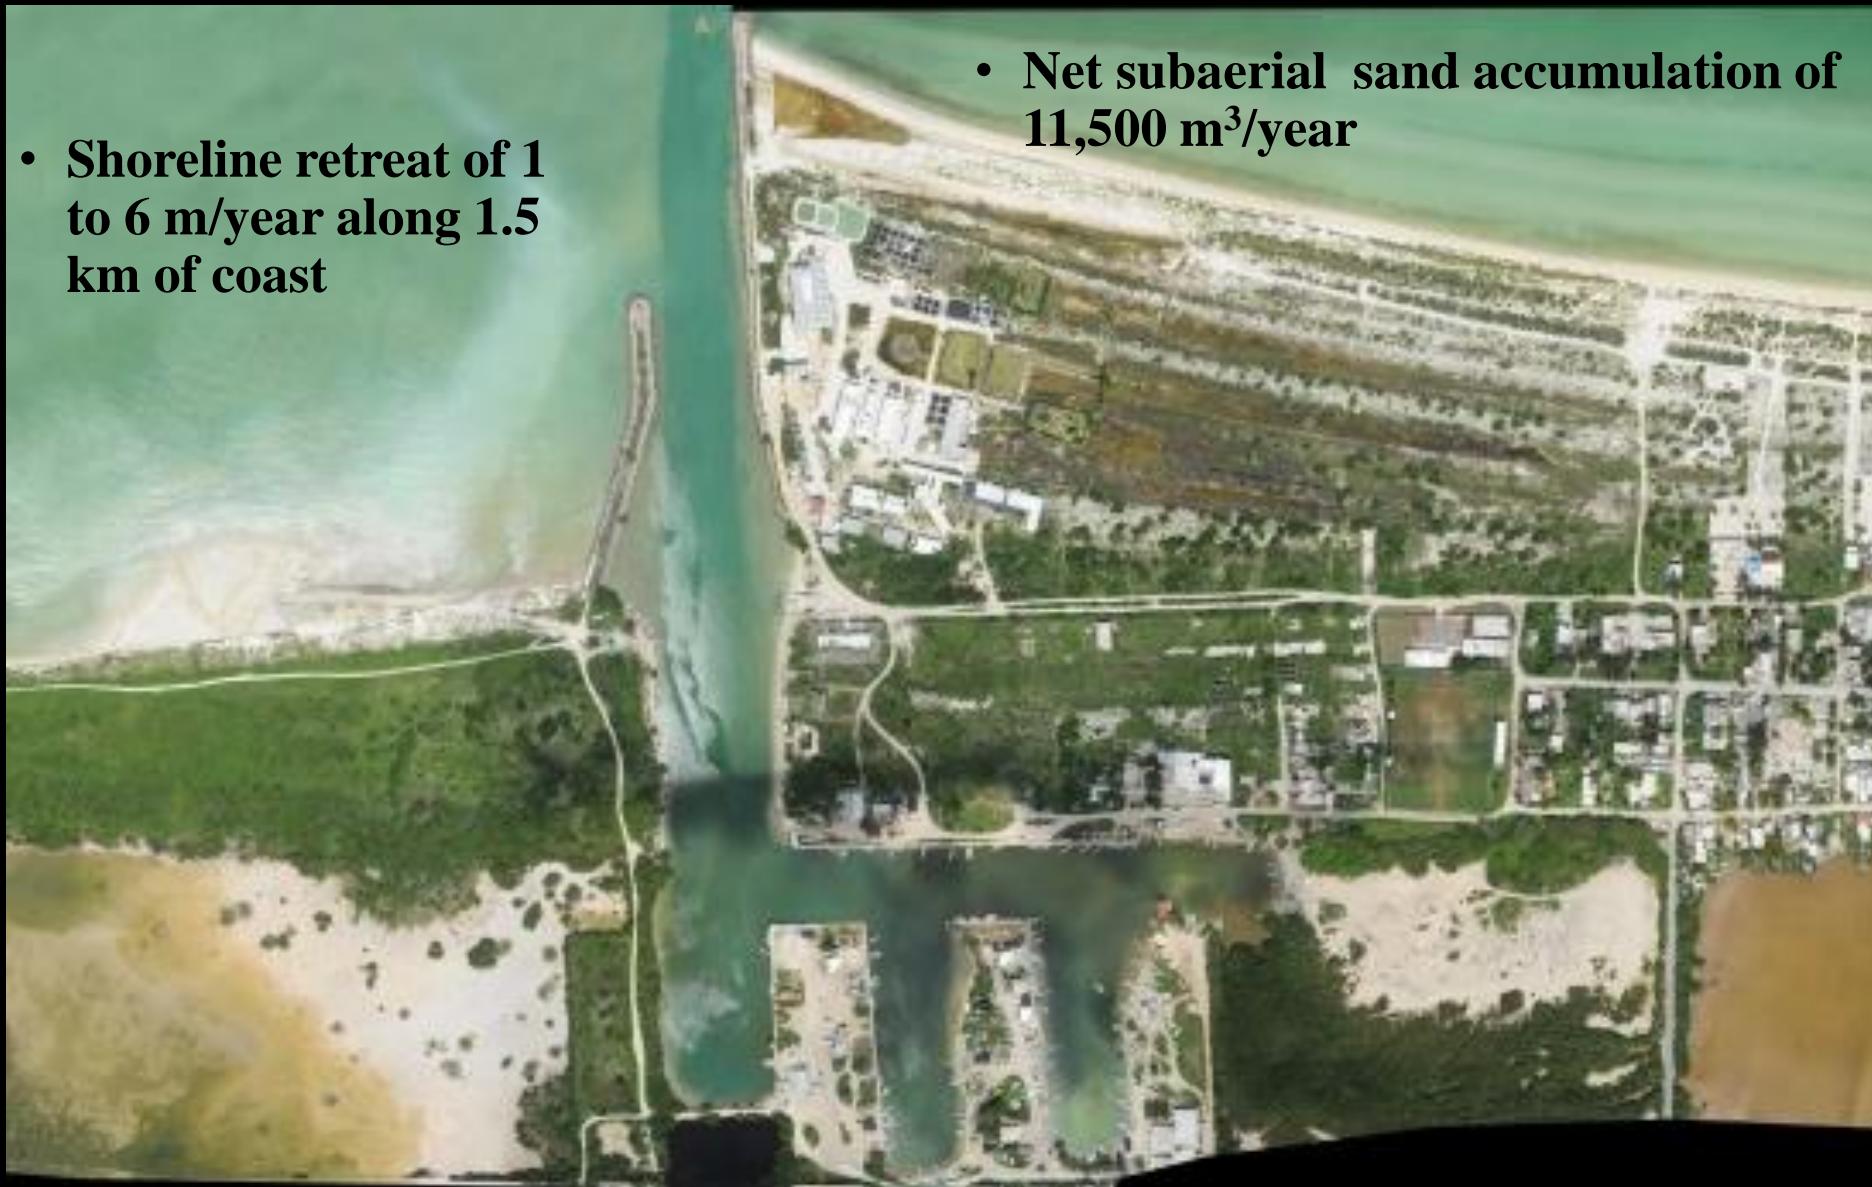
# Ports impoundment (Abstract #1146)

- Shoreline retreat of 1 to 6 m/year along 1.5 km of coast

- Net subaerial sand accumulation of 11,500 m<sup>3</sup>/year

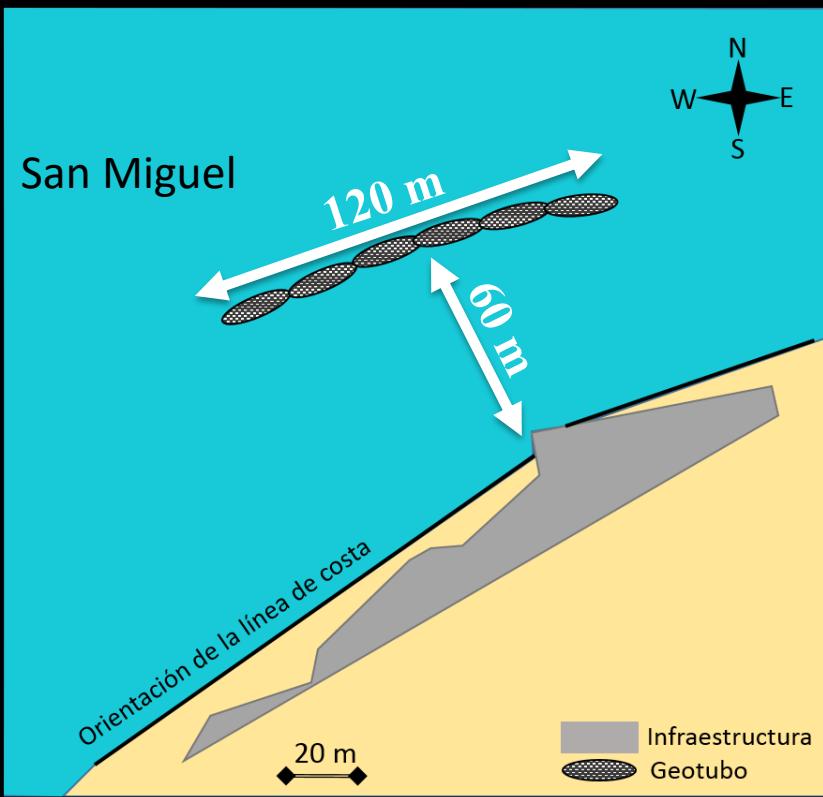
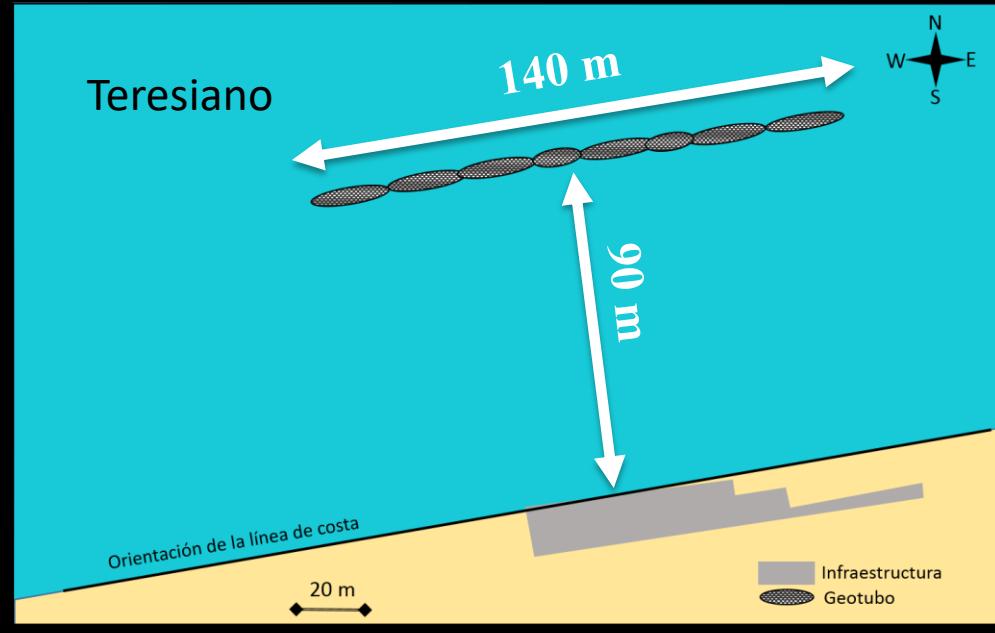
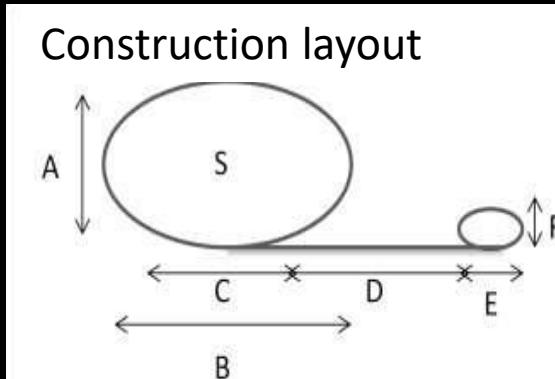
# Impermeable breakwaters characteristics

- Geotextile sections 20 and 10 m long
- 0.90 m high
- Filled with sand taken on site (600-700 m<sup>3</sup>)

A	0.90 m
B	1.83 m
C	1.27 m
D	2.0 m
E	0.4 m
F	0.2 m
S (70% LLENO)	1.40 m

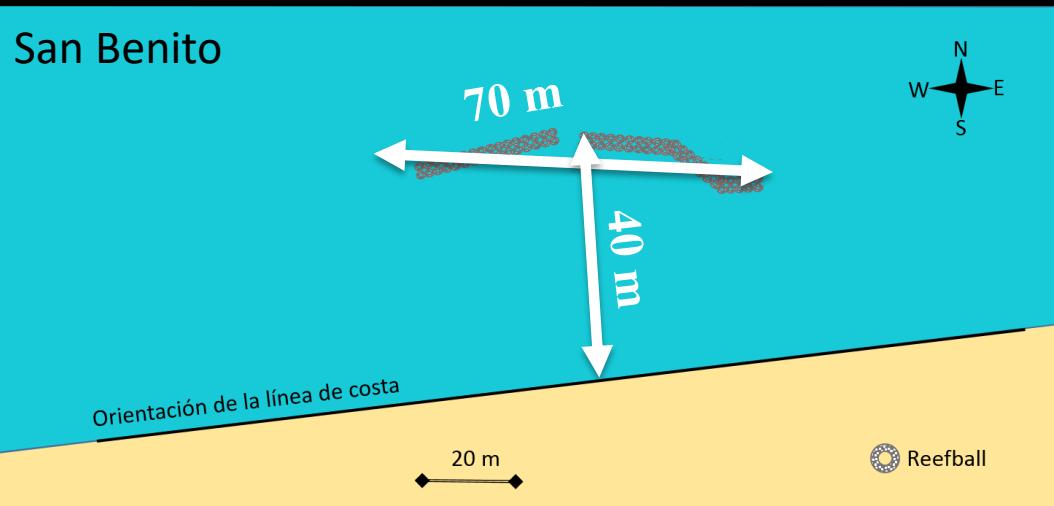
San Benito

# Permeable breakwaters characteristics

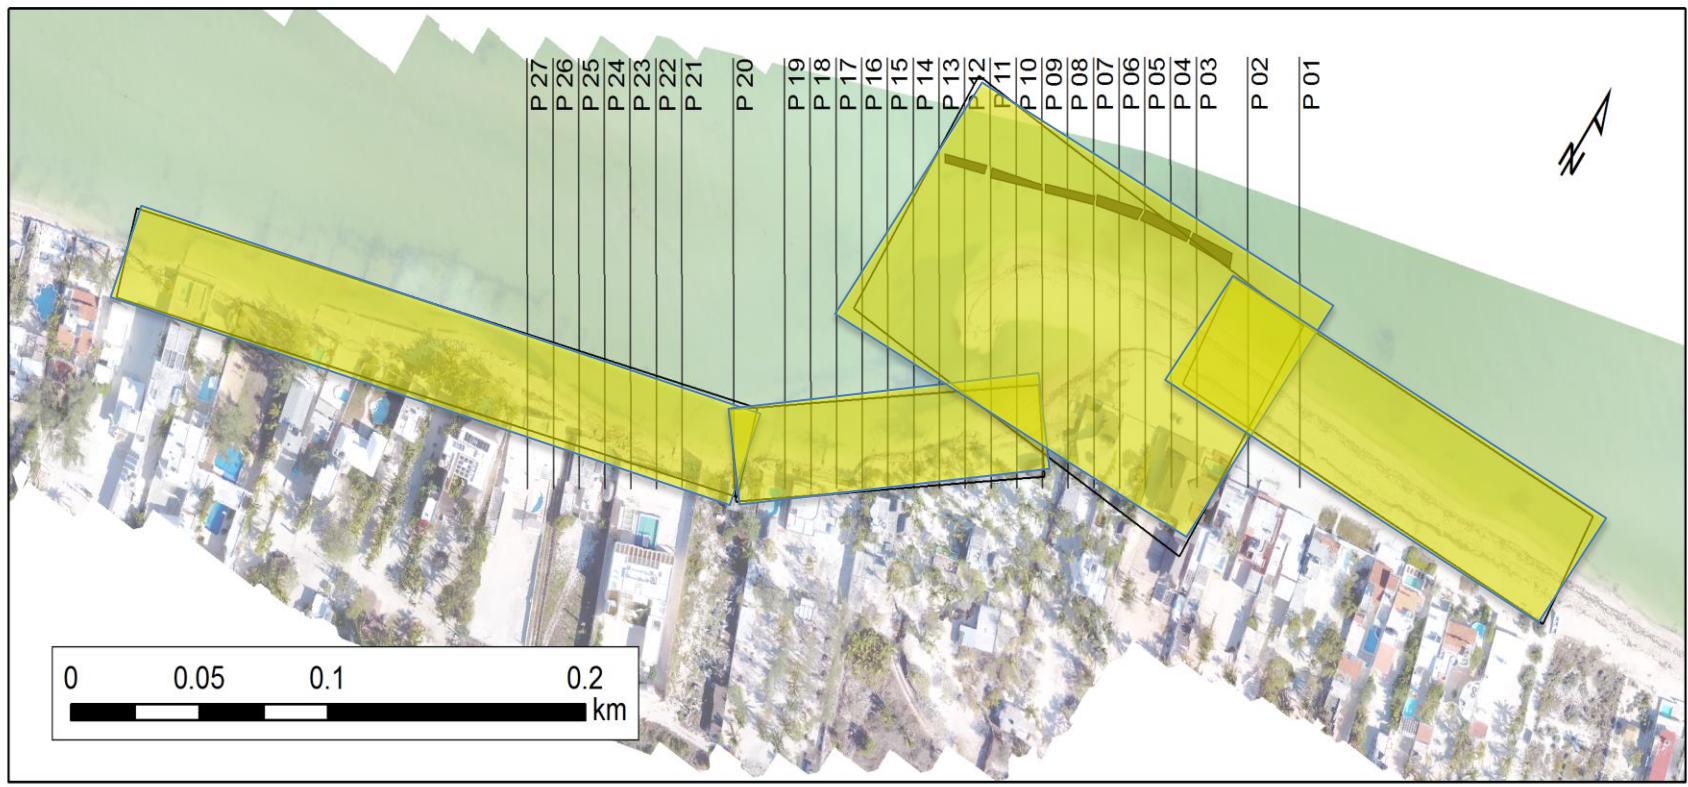
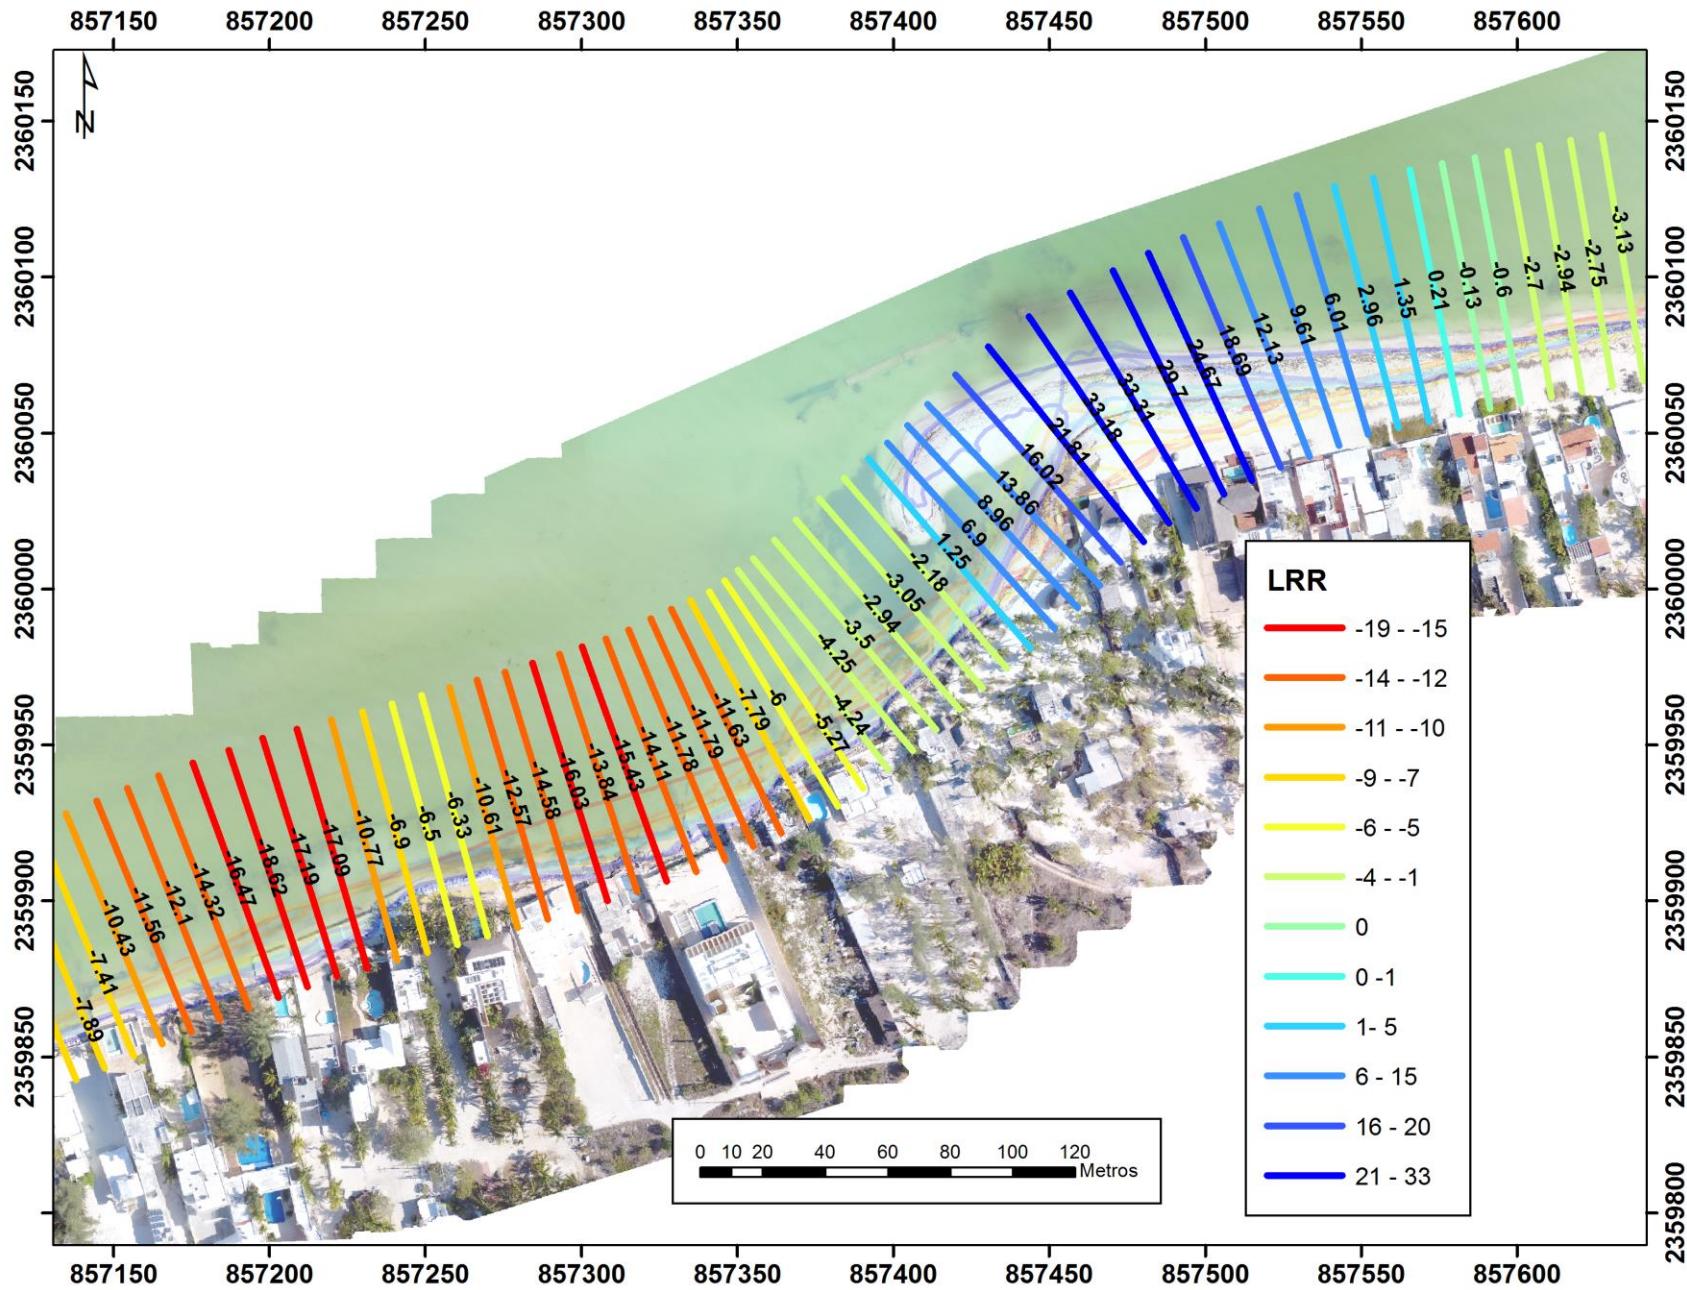
# Data collection: experimental setup

- High-resolution beach profiles
- UAVs flights with control ground points
- Breakwater surveys (freeboard, length, orientation, etc.)
- Total of 57 beach surveys and 51 UAVs flights.

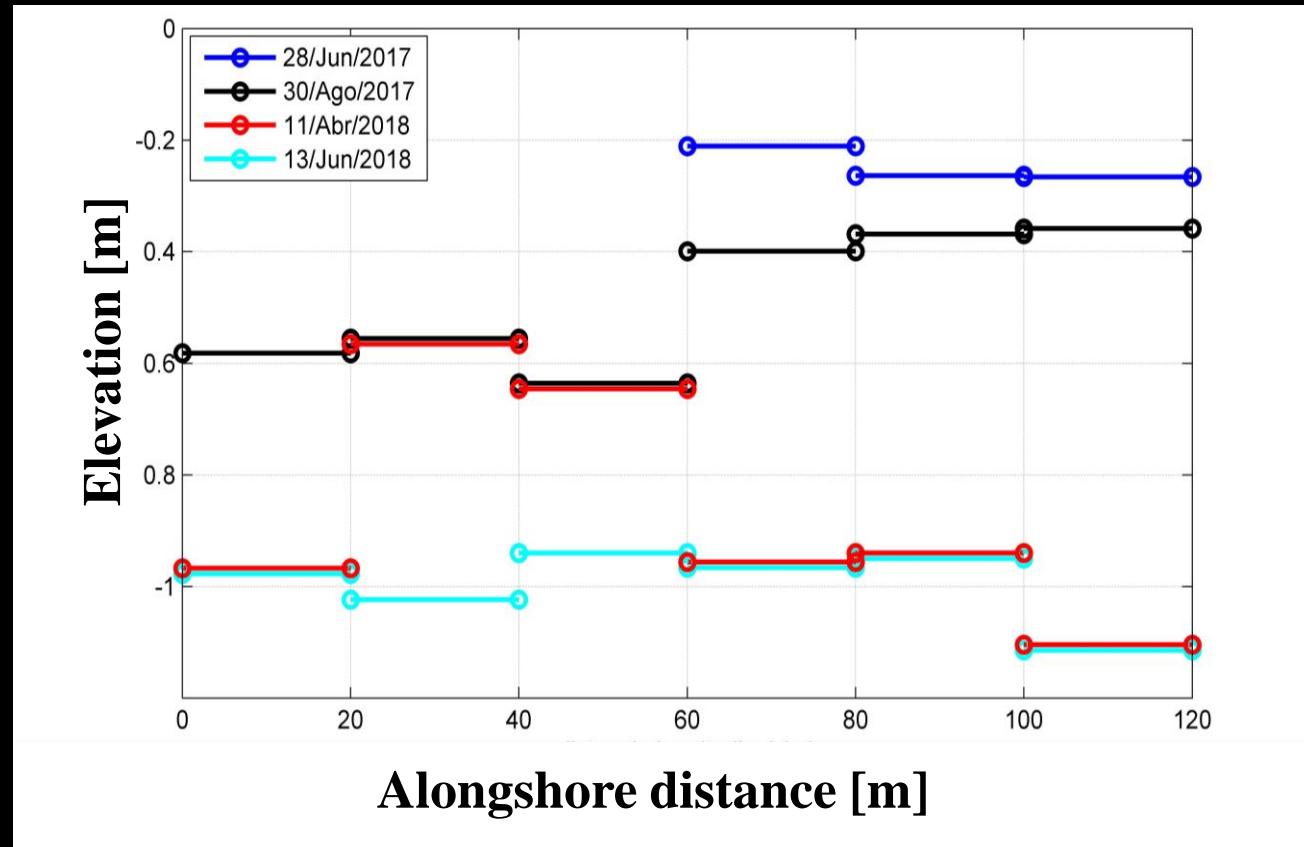
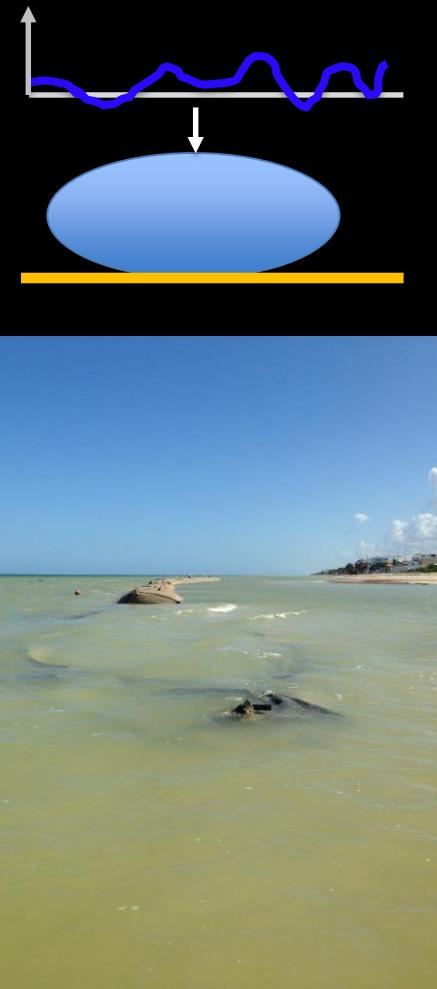
# Stability analysis: San Miguel

- Non-uniform elevation along the structure
- Significant freeboard change in 2 months
- Partially destroyed 9 months after deployment
- Fully destroyed one year after deployment.

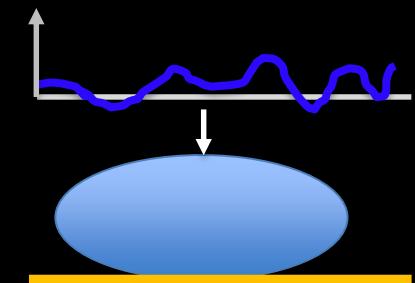
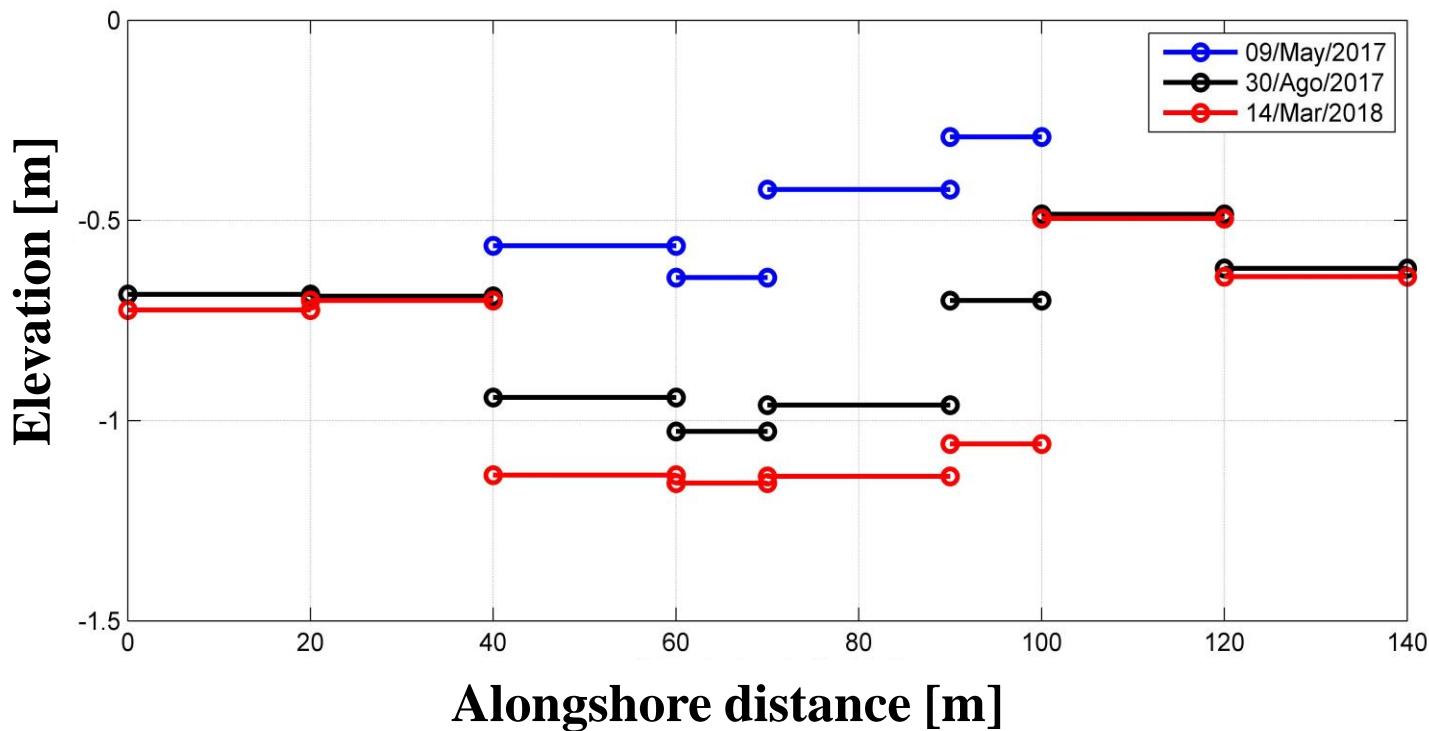
# Stability analysis: Teresiano

- Non-uniform elevation along the structure (max differences of 0.5 m)
- Significant freeboard change in 2 months at the mid sections
- Middle section almost completely destroyed after 10 months.

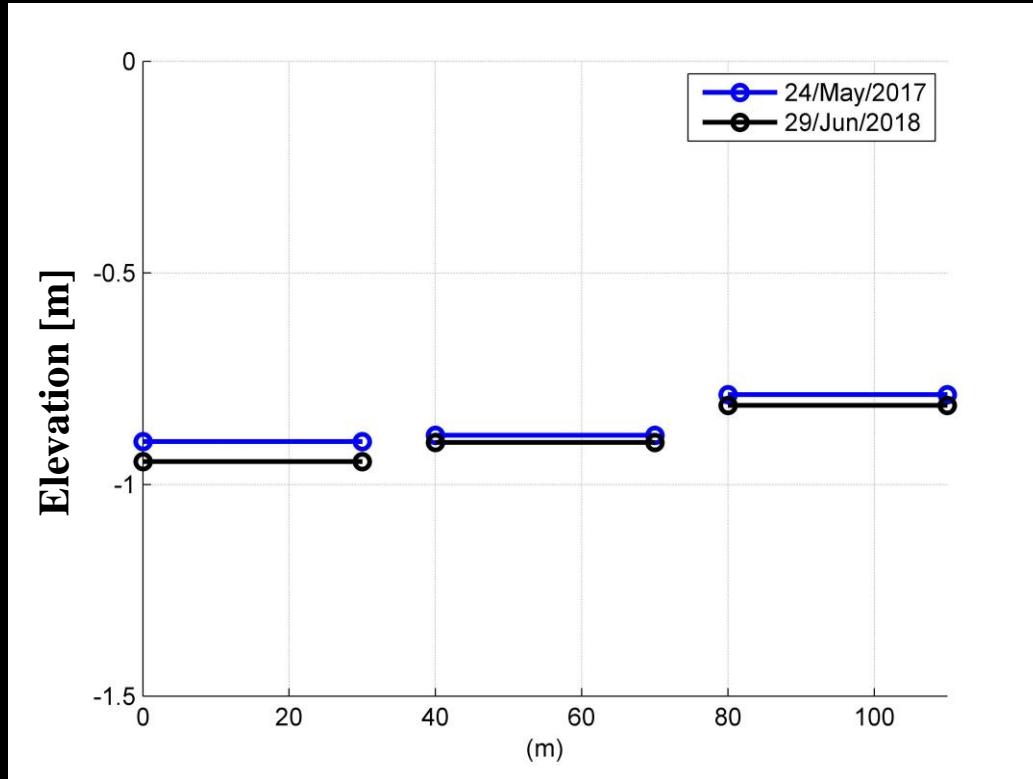
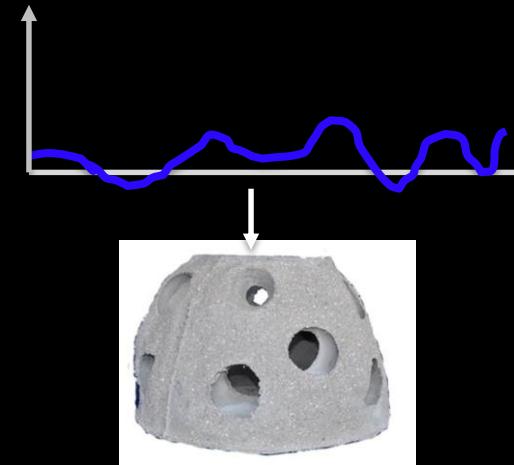
# Stability analysis: El Faro

- Almost uniform elevation along the structure (max differences of 0.1 m)
- 0.1 m freeboard change in one year
