LARGE SCALE SHORELINE PROTECTION WITH MINIMIZED DOWNDRIFT IMPACT, COTONOU, WEST AFRICA

Mohammad Dibajnia, Baird & Associates, mdibajnia@baird.com
Dave Anglin, Baird & Associates, danglin@baird.com
Rob Nairn, Baird & Associates, rnairn@baird.com

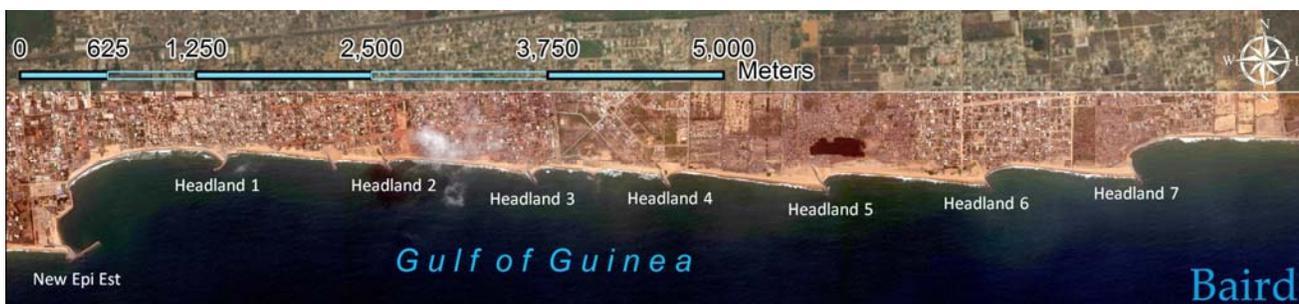
Figure 1 - Overall project conditions in April 2018

The final design to address harbor sedimentation involved a 300 m extension to an existing jetty at the port. The final design to address downdrift erosion involved the reconstruction of an existing jetty (Epi Est) along a new alignment and construction of seven new headland structures spaced approximately 1 km apart along the shoreline downdrift of Epi Est as shown in Figure 1.

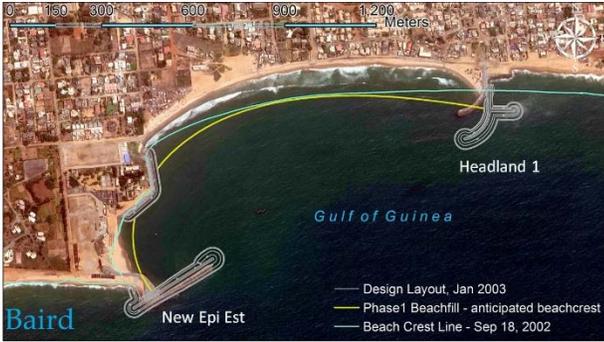
Figure 2 - Conditions of pocket beach between Epi Est and Headland 1 in April 2018

Headland1 has a complex planform with a total length of approximately 200 m as shown in Figure 2. Design and as-built locations do not match due to shoreline erosion prior to the start of construction. Beach nourishment using material dredged from the port was recommended for the pocket beach between the New Epi Est and Headland 1 (shown by the yellow line in Figure 2). However, this was not materialized. The curved shape of this headland was to minimize sediment bypassing and stabilize the pocket beach.

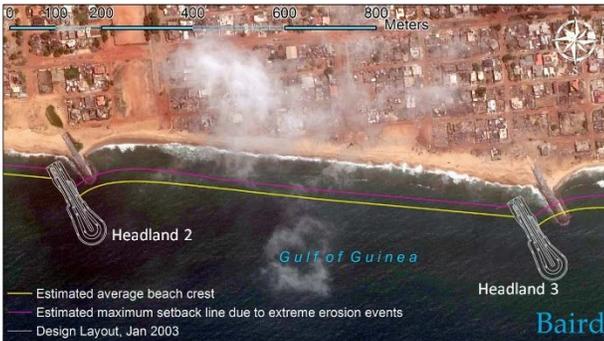
Figure 3 - Design vs. constructed Headlands 2 and 3 locations. The shoreline eroded approximately 100 m between completion of design and start of construction

A review of shoreline response after the construction of the project, including the project impact on the shoreline downdrift of Headland 7 is provided in the following. Note that approximately a decade elapsed between design and construction during which the downdrift shoreline continued to erode back up to about 100 m. See Figure 3 as an example.

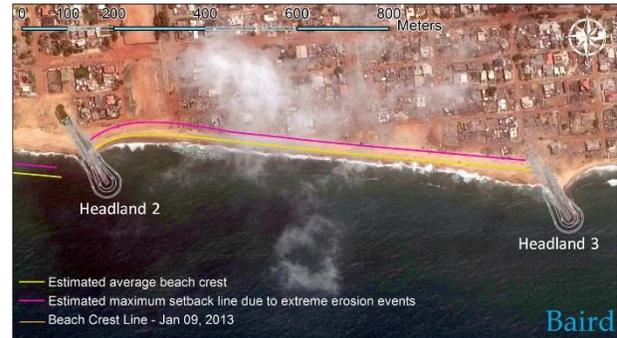
Figure 4 - Predicted average and post-storm beach crest line on the 2018 satellite image (Headlands 2 and 3)

Sample comparisons of shoreline response with design predictions using Hsu and Evans (1989) method at two locations are provided in Figure 4 and Figure 5. Design lines were shifted to match as-built locations. The yellow line in these figures represents the predicted average beach crest/berm line. In both cases the shoreline has responded in reasonable agreement with the predictions. The pink line in these figures represents potential extreme erosion events and was used to define erosion setbacks.

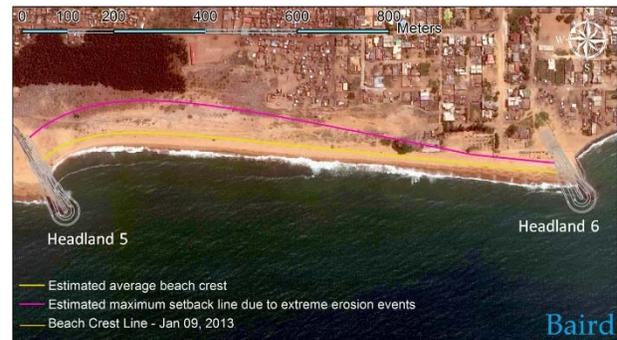
Figure 5 - Predicted average and post-storm beach crest lines on the 2018 satellite image (Headlands 5 and 6)

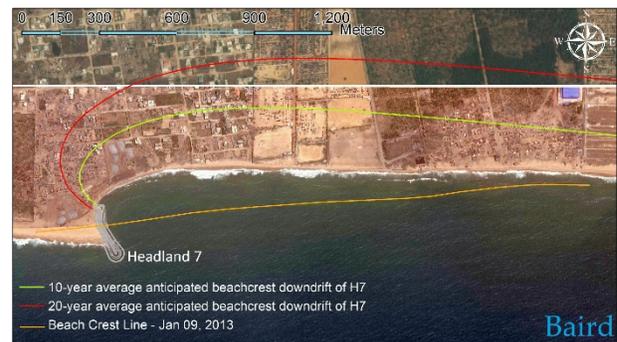
Figure 6 - Shoreline erosion conditions downdrift of Headland 7 in April 2018 vs. 10-year and 20-year predictions.

Figure 6 compares shoreline conditions downdrift of Headland 7 in April 2018, i.e. approximately five years after completion of the project, with 10-year and 20-year predicted erosion lines. The beach crestline around the time of construction (2013) is also shown in this figure. Overall downdrift erosion has progressed in a slightly

slower pace than predicted. While this could be due to variations in annual wave climate, it still indicates that the headland system designed with setback and 30-degree alignment has optimized sand trapping thus minimizing downdrift erosion.
