BLUFF STABILIZATION AND PROTECTION ON THE GREAT LAKES; A CASE STUDY

David T. Farber, OBG, david.farber@obg.com
 Heather Weitzner, OBG, heather.weitzner@obg.com

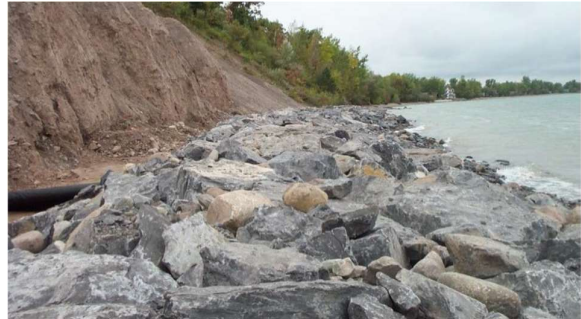
Figure 2 - Armor Stone Installed at the Toe of the Bluff

More than 10,000 tons of armor stone were placed along the base of the bluff, with each stone weighing one to two tons. The crest height was designed to be about 4.5 feet above mean high water level of Lake Ontario. A photo of the installed armor stone is provided in Figure 2.

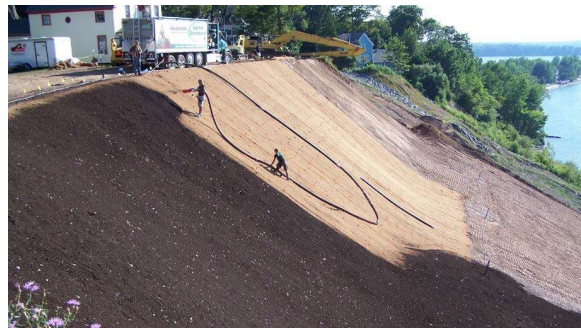
Figure 3 - Installation of the Veneer Cover System

In addition to the revetment, the upper portion of the bluff was regraded and vegetated with a veneer cover system that was designed to resist erosion caused by wind and rain. The veneer cover system consisted of a seeded compost applied over a coconut fiber koir mat. Figure 3 illustrates the compost material being air applied over the koir mat.

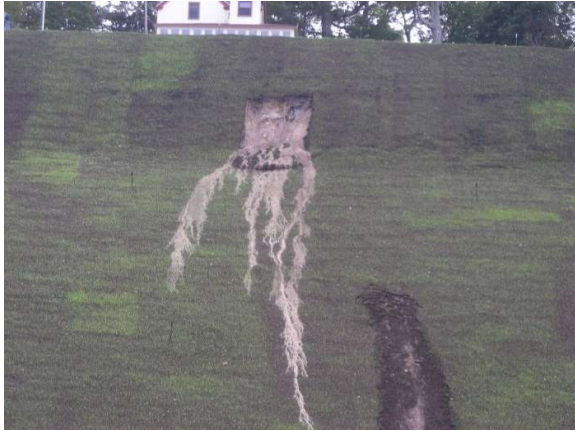
Localized slope failures occurred following the spring thaws in 2010, 2011, 2012, 2013, and 2014. These failures were primarily caused by groundwater seepage from a perched water table in the steep upper slope of the bluff. When saturated with water, the glacial till becomes a wet fluid mud with little or no structural integrity. Groundwater recharge mitigation was implemented to lessen the impacts. The mitigation efforts consisted of installing a French drain system along the top of the slope and diversion of roof drains and surface water flow away from the top of the slope. A photo of the localized failures can be seen on Figure 4.

Figure 4 - Localized sluffing caused by Perched Groundwater

Slope failure remediation was accomplished with additional riprap stone and fresh coverings of seeded compost. See figure 5 for an example of the slope repairs along the groundwater seepage line.

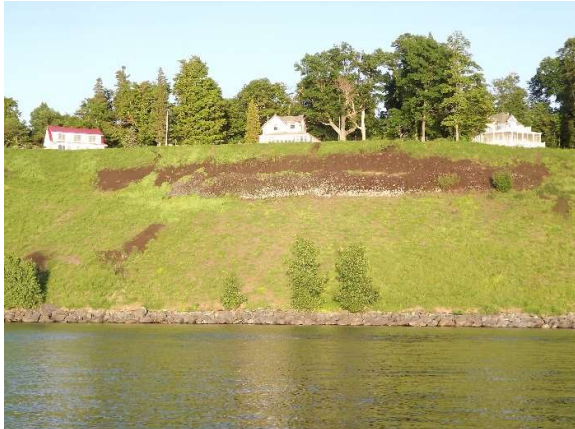
Figure 5 - Slope Repairs along the Groundwater seepage Line.

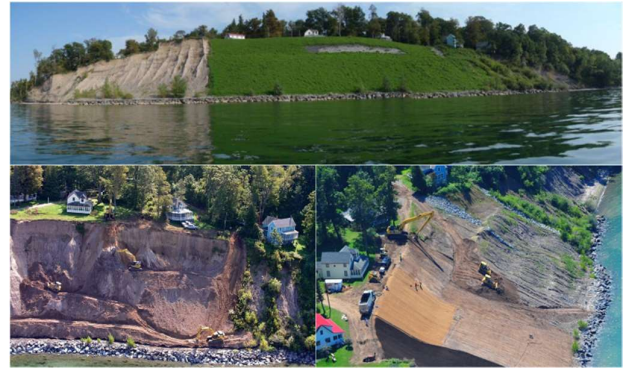
The result of the constructed shoreline remediation system is that it has reduced the bluff recession rate from about 2 to 3 feet per year to less than 0.1 feet per year. The main lessons learned from this project are to control the ground water and/or springs that can destabilize the fine-grained bluff soils and account for extreme long term floods and water levels for wave run up elevations.

Figure 6 - (Counterclockwise from bottom left), Initial excavation, Coir mat installation, Final stabilized shoreline, Lake Ontario, New York
