*ICCE '18 – Baltimore MD USA*

# *Five Key Elements For A Sustainable Beach Nourishment Program*

*Tim Kana PhD PG*

Young Y Kim (ed) **Handbook of Coastal Engineering – 2<sup>nd</sup> Edition**

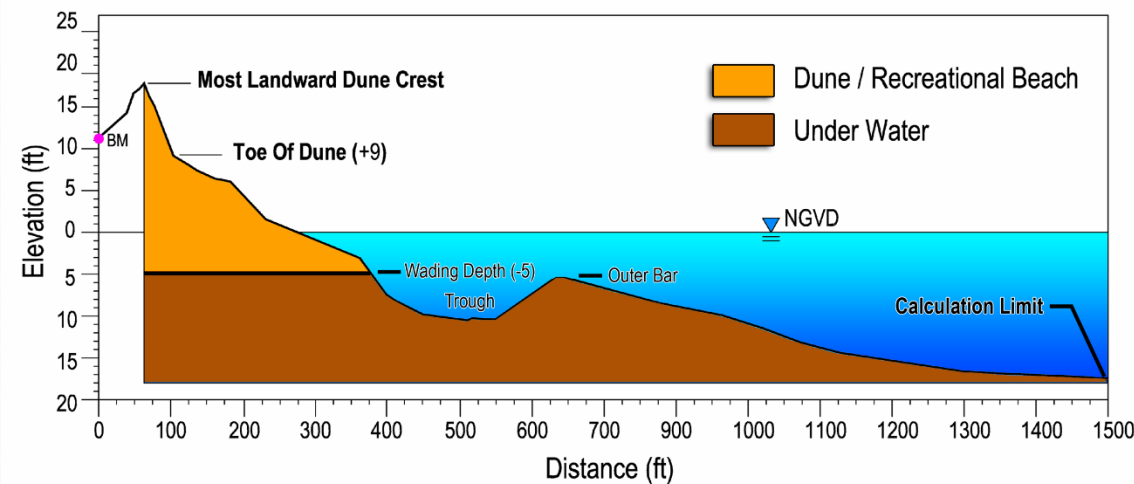
PROFILE VOLUME ANALYSIS - CALCULATION LENSES

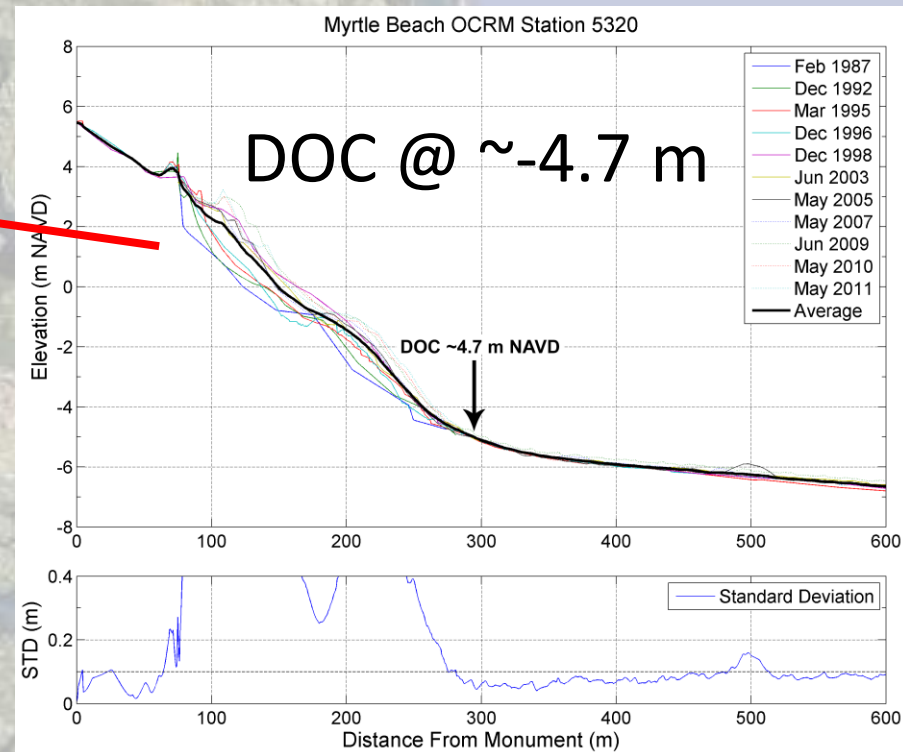
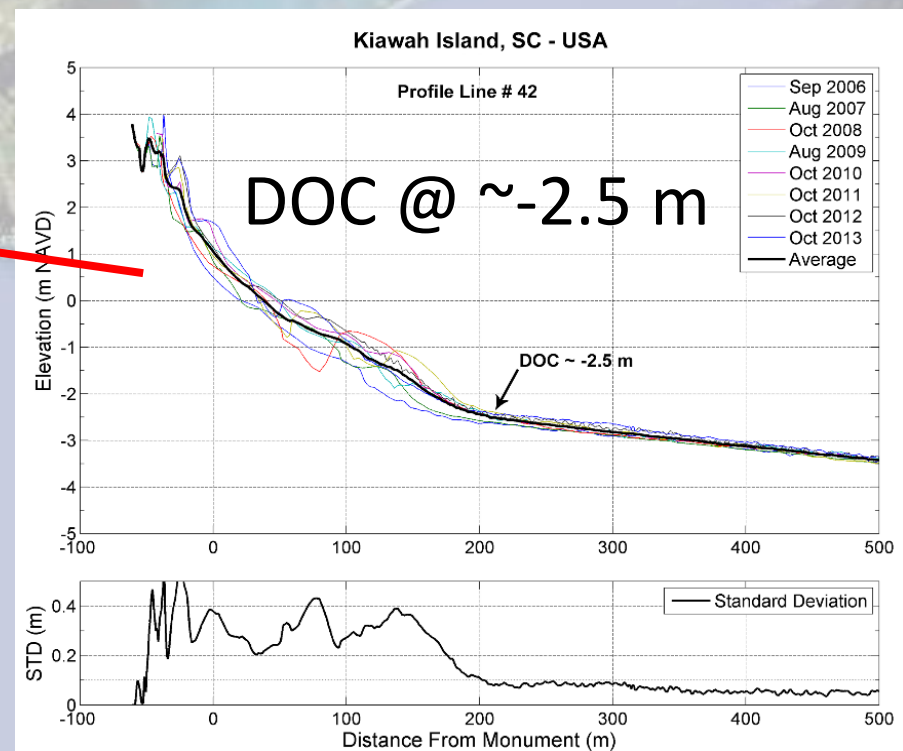
# Determine Littoral Boundaries

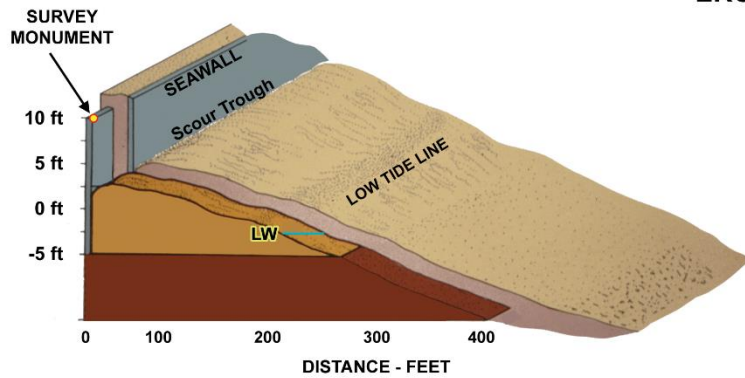
ERODED BEACH

# Beach Condition as Measured by Unit Profile Volumes

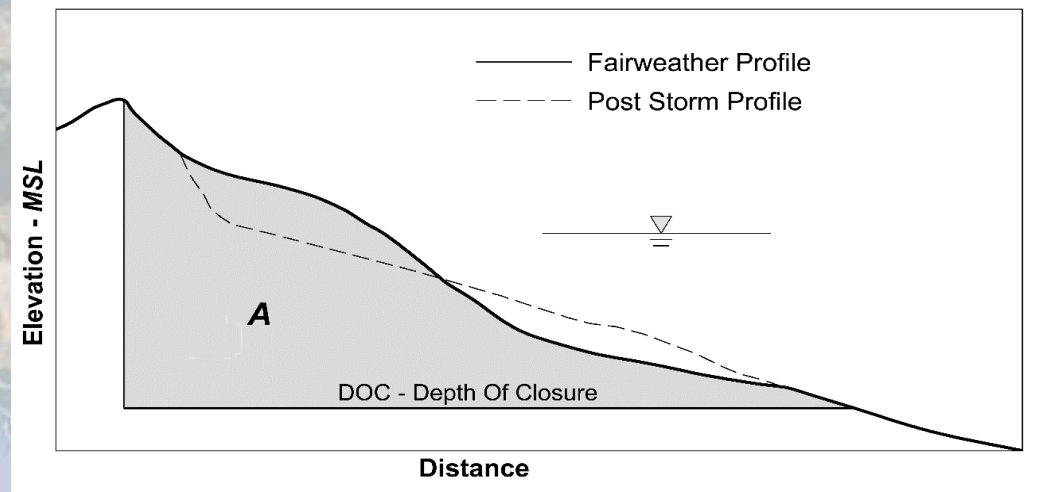
Convert Unit Area,  $A$ , to Unit Volume to DOC,  $V_e$ , for a simple measure of profile condition – irrespective of beach stage

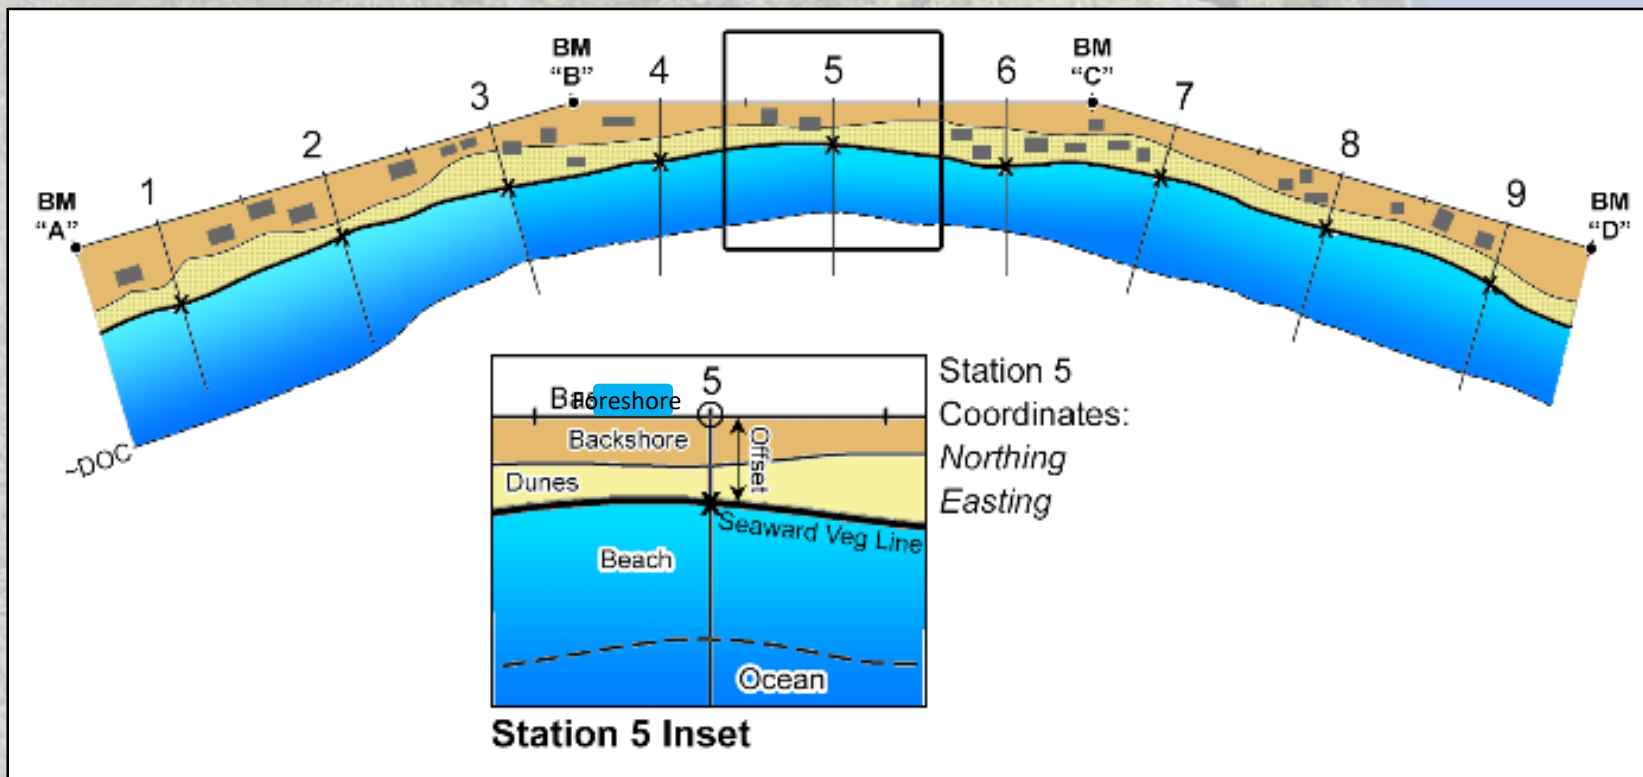
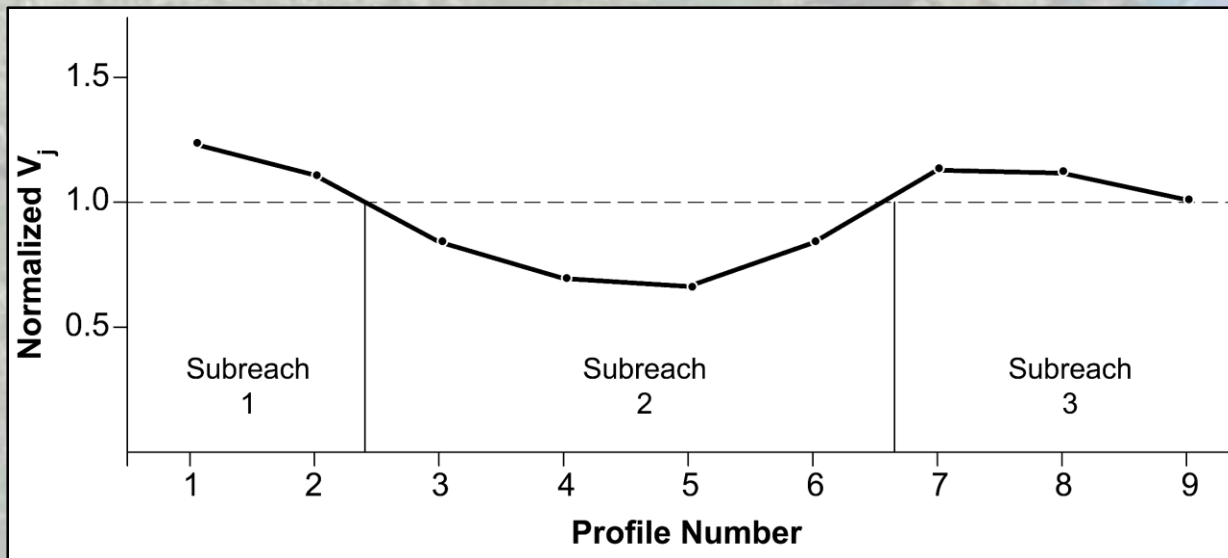
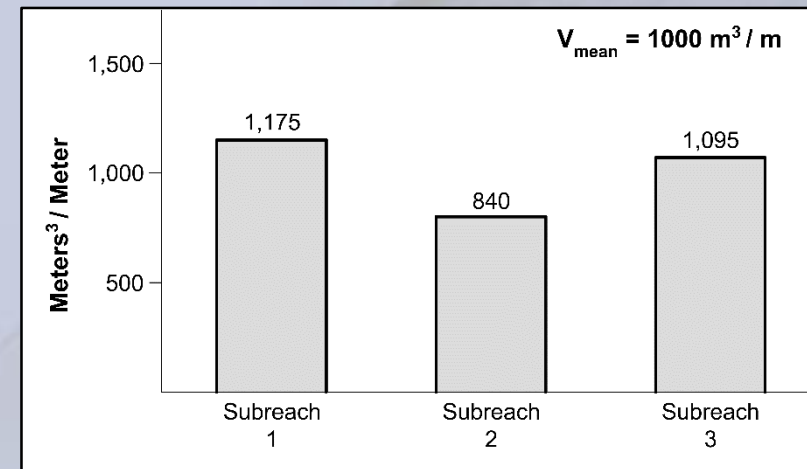
# Determining Site Specific Sand Deficits

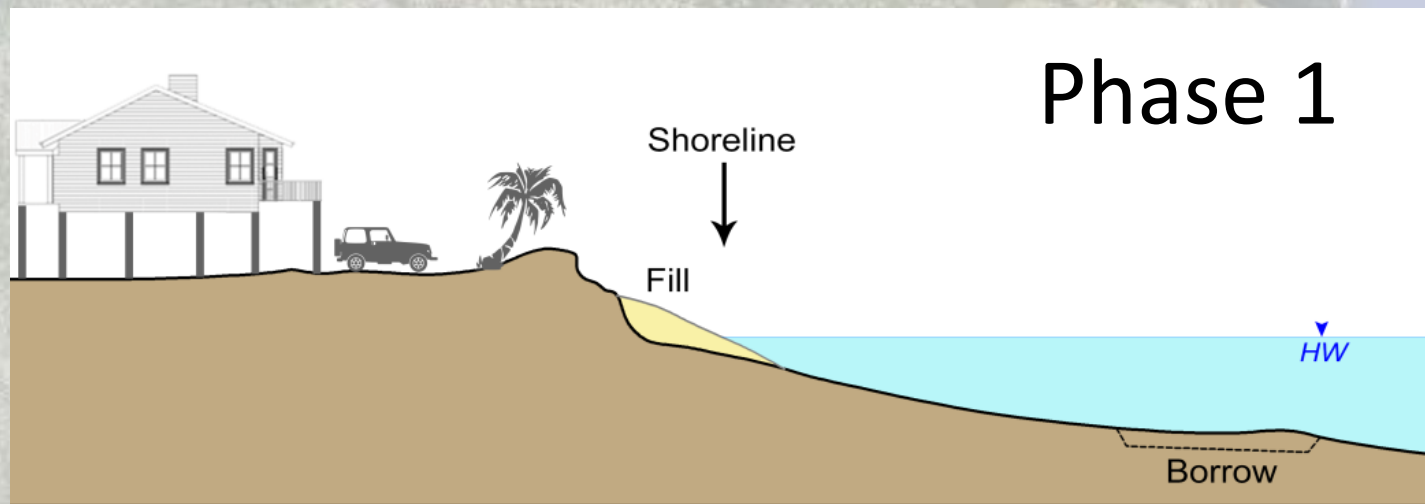
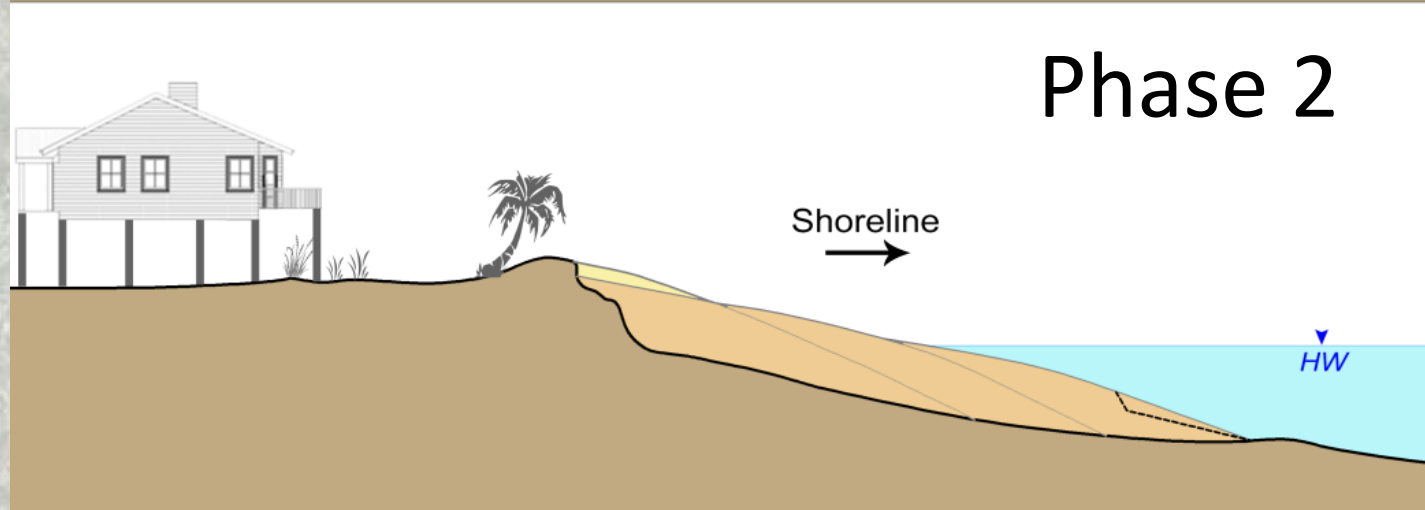
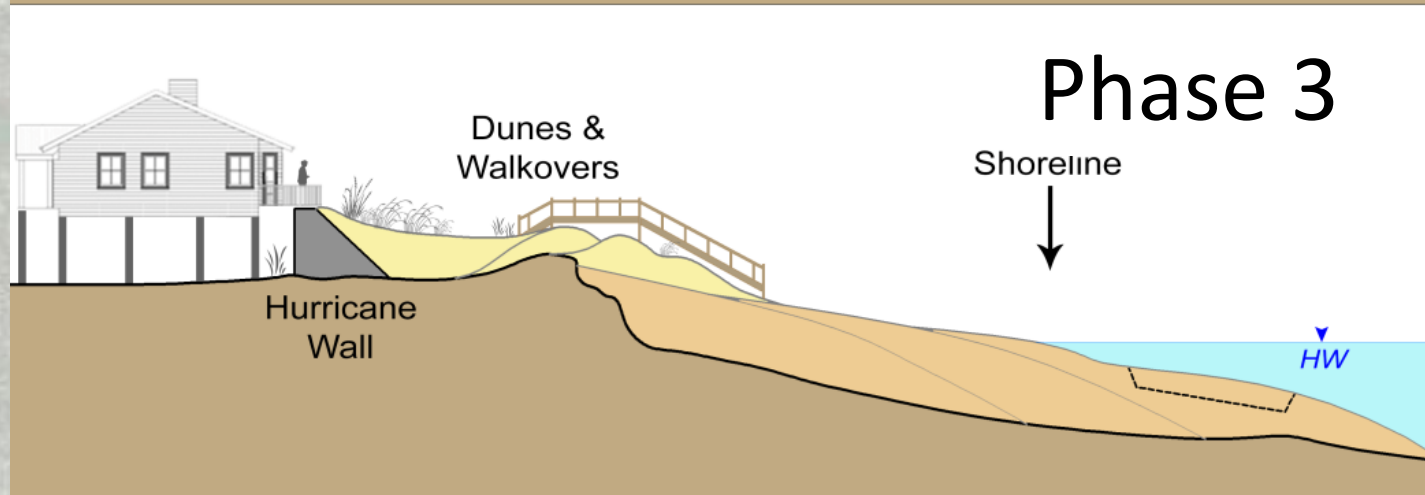
**Define A Target Beach  
Condition**

Performance  
( $f$  Volume)

\$/m

\$\$/m

\$\$\$ /m

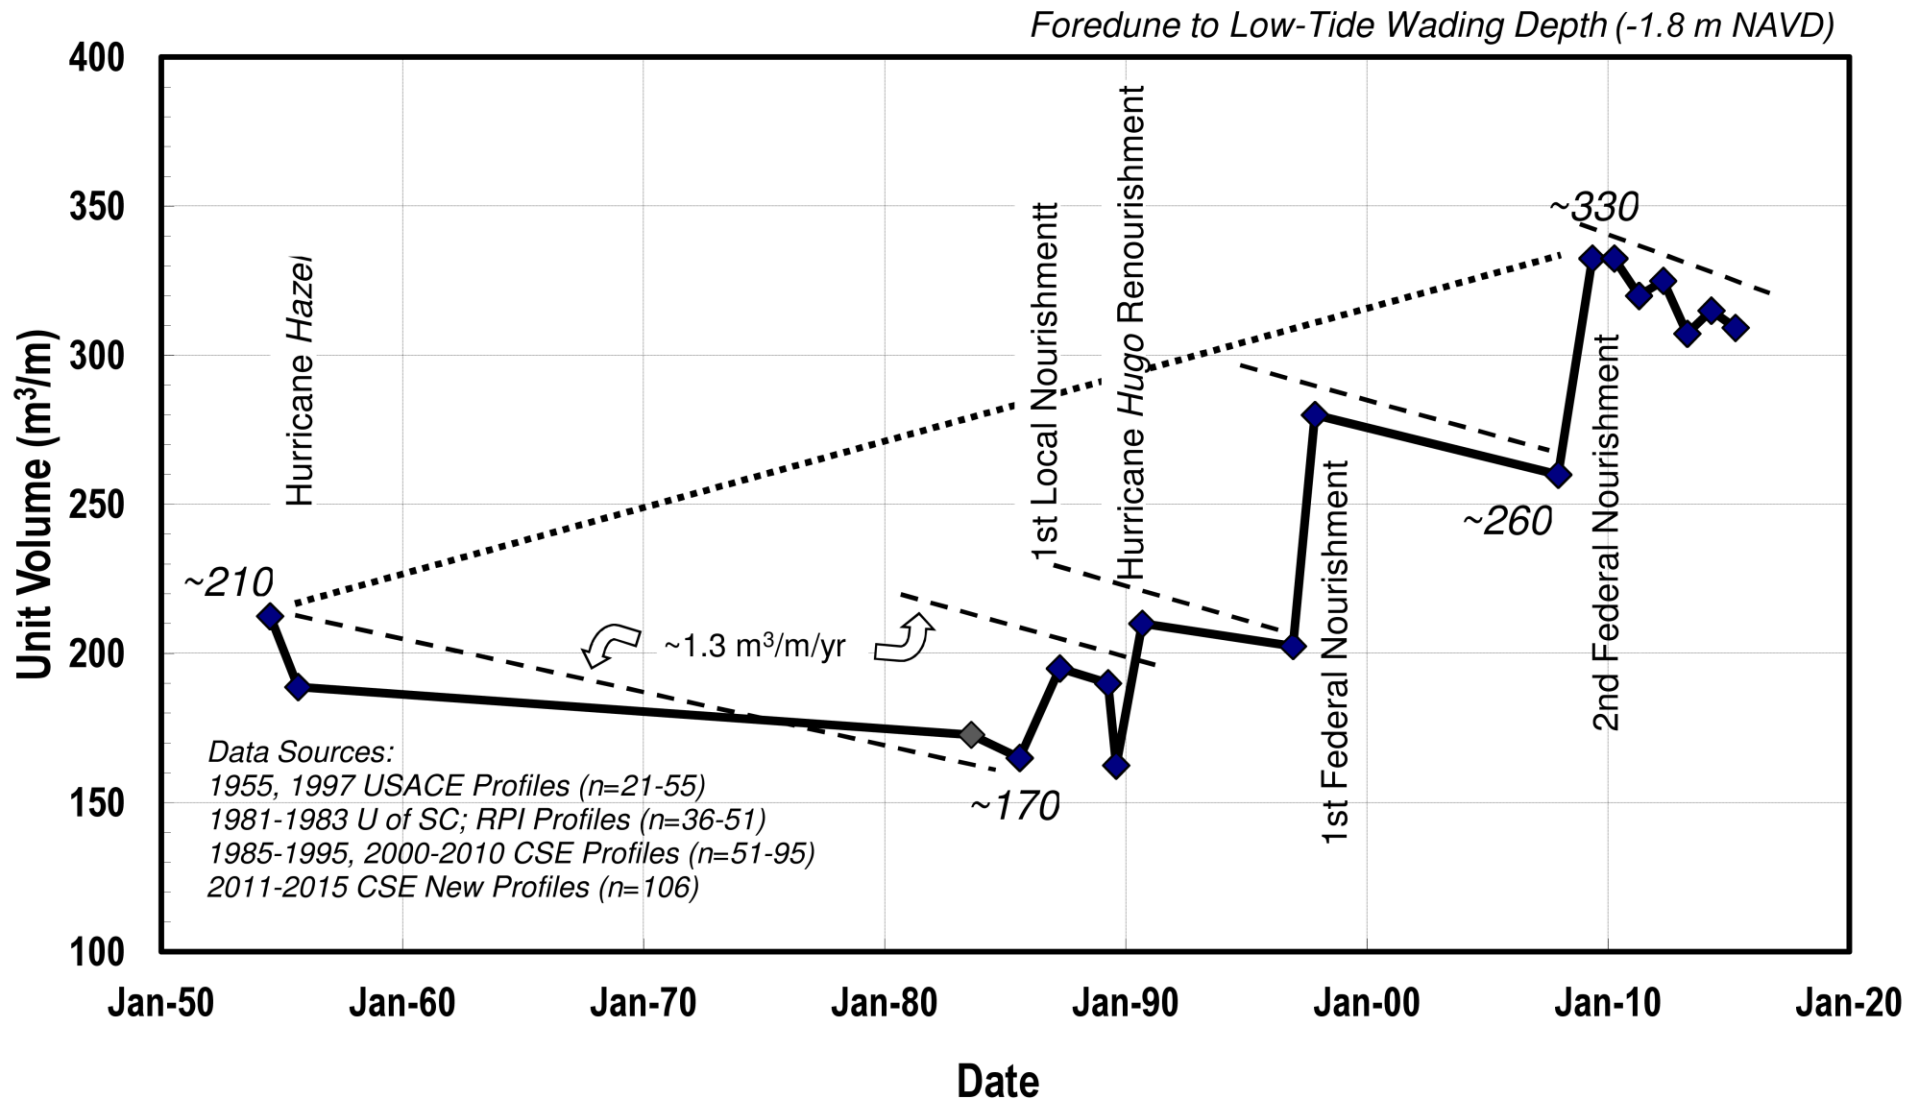
# Sustained Increase in Beach Volume Four Nourishment Events over 30 years

**Average Unit Beach Volume 1954–Present  
Myrtle Beach SC - 14.9 km**

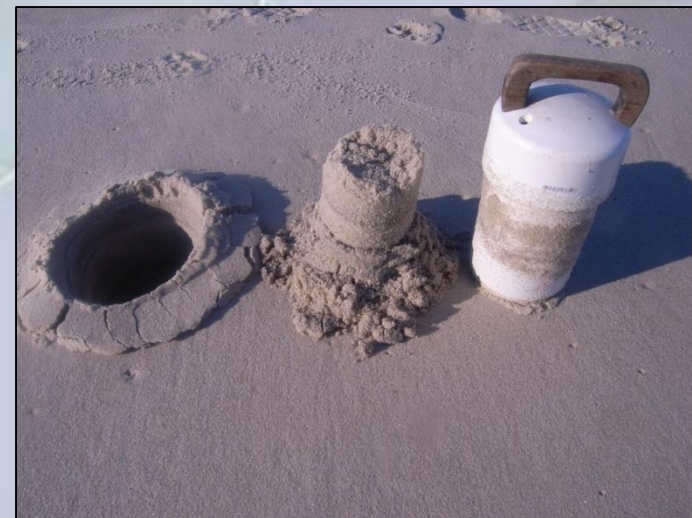
## Native vs Borrow Sediments

### Grain Size Distributions =

- The Proportions of Various Sand Sizes On the "Native" Beach and In the Borrow Areas
- A Perfect Borrow Source Matches The Native Sand
