36TH INTERNATIONAL CONFERENCE ON COASTAL ENGINEERING 2018

Physical Modelling of Propeller Scour on an Armoured Slope

Dr. Sundar Prasad, Neville Berard

Sino Iron Project – Cape Preston, WA

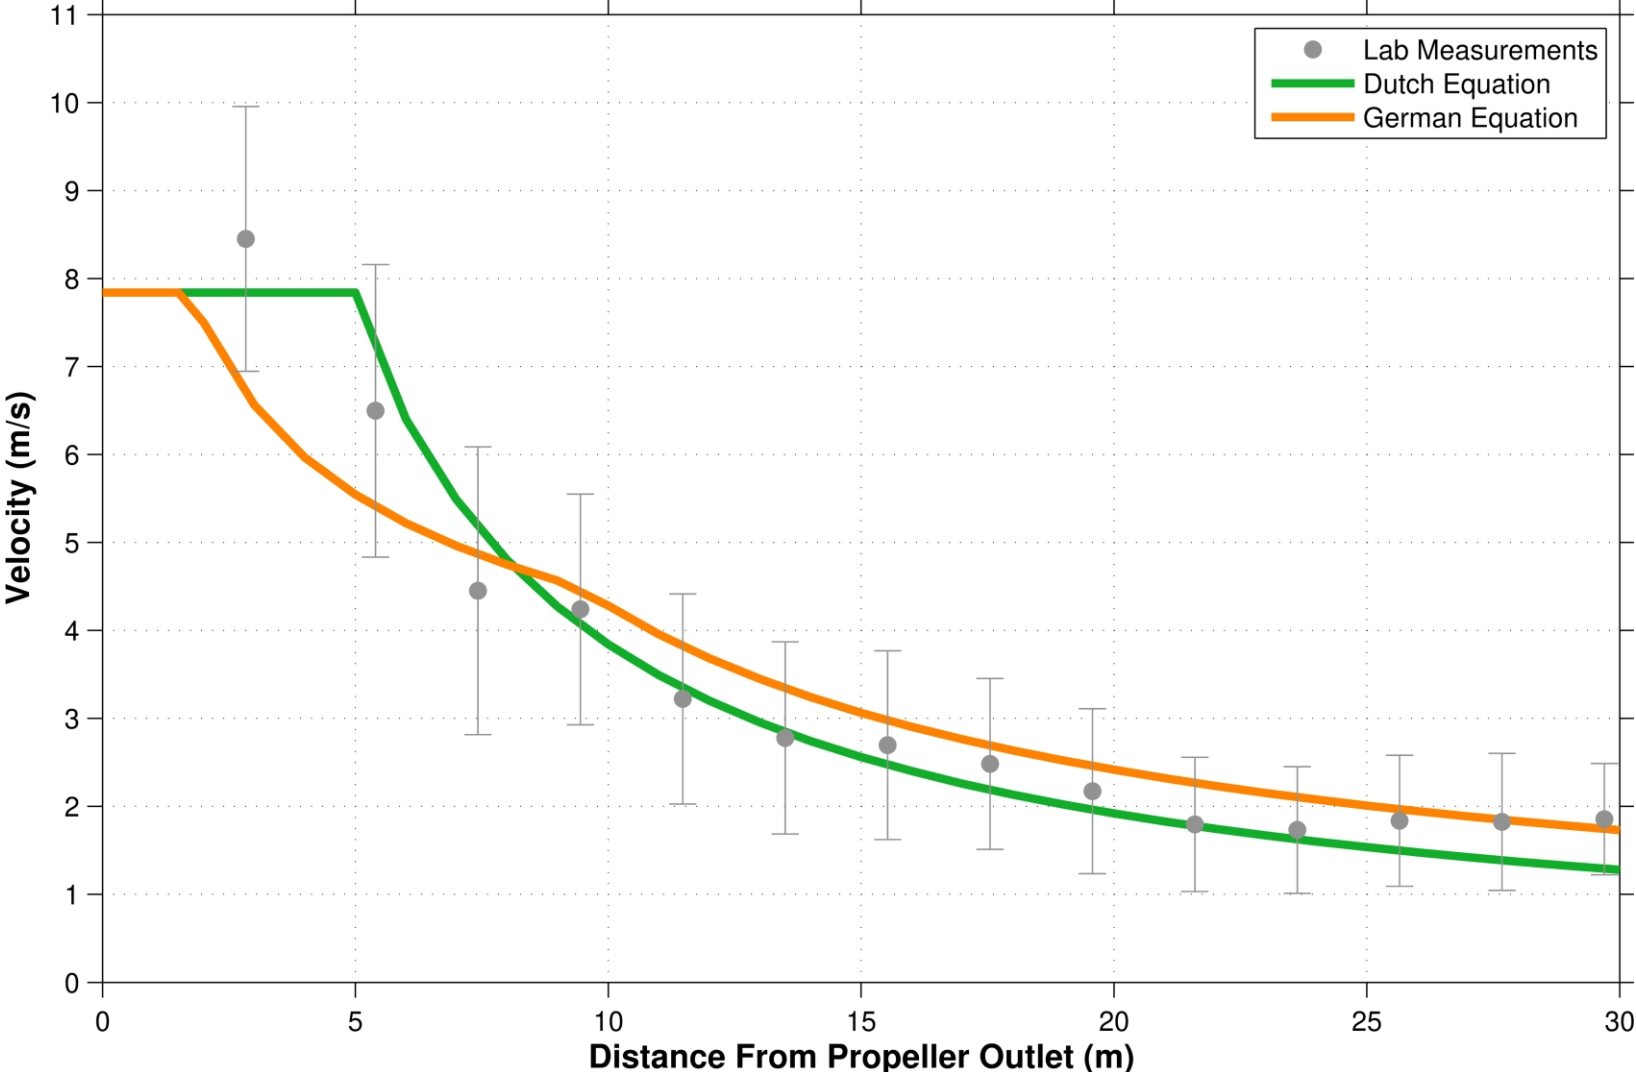
Stern Thruster

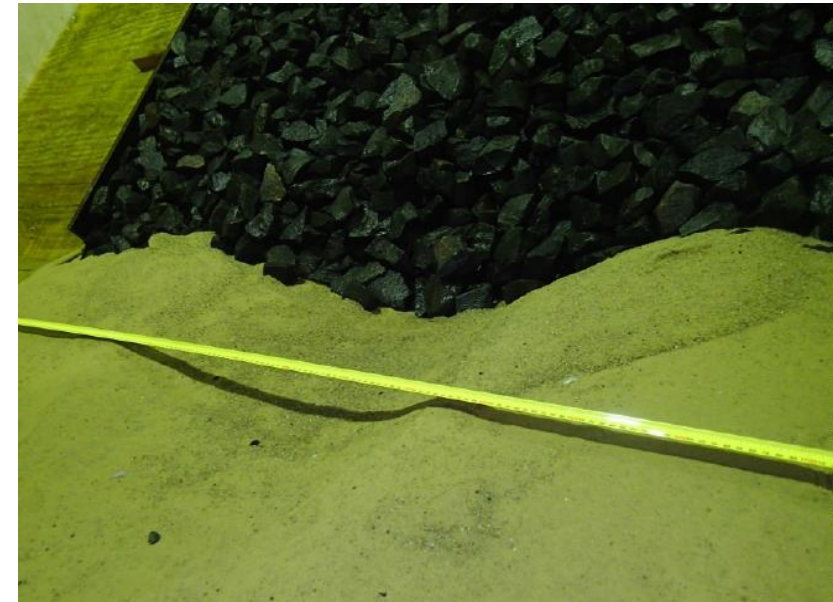
Bed Stability – Mobile Bed Tests

- Main propeller and bow thrusters
- Bed scour and local toe damage observed
- Protection of the seabed at toe of slope likely required

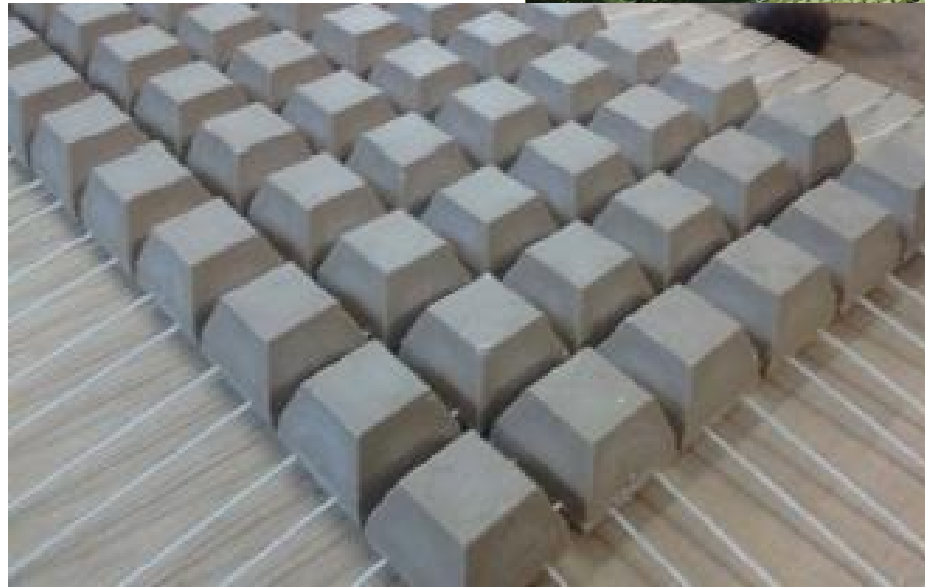
Articulated Concrete Mattresses (ACM)

- Design by Australian manufacturer Subcon
- Subcon used previous model test experience to advise on how to achieve correct density of block material and ensure mats were a good representation of actual product

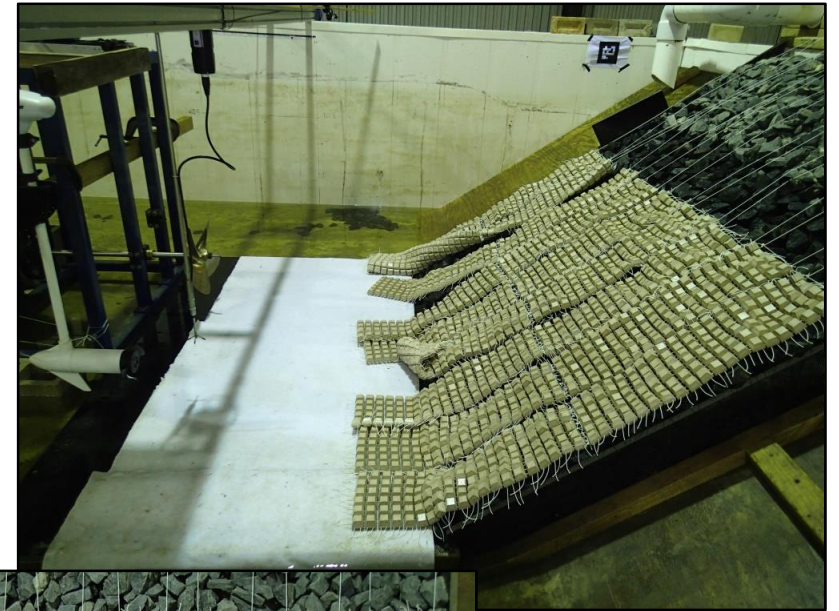
ACM Stability Tests

- Two test series were performed with the ACMs
- In the first series mats were tied to the top of the slope
- Flipping of the lower edge and movement of the long edge of the mats was observed

1. During bow thruster tests, rock movement was witnessed outside of the expected wash footprint (based on 10 deg plume spread)
2. Articulated Concrete Mattresses were observed to perform better in thruster wash when tied together at the toe and top of the slope
3. More lab and field data is required to understand and refine the equations for stable armour weight from PIANC (2015)
 - German and the Dutch/Izbash equations provided reasonable estimates of stable rock sizes for higher wash velocities but underestimated rock sizes at 2.5 m/s
 - Dutch/Pilarczyk method predicted notably higher stable rock weight in comparison to other formulations

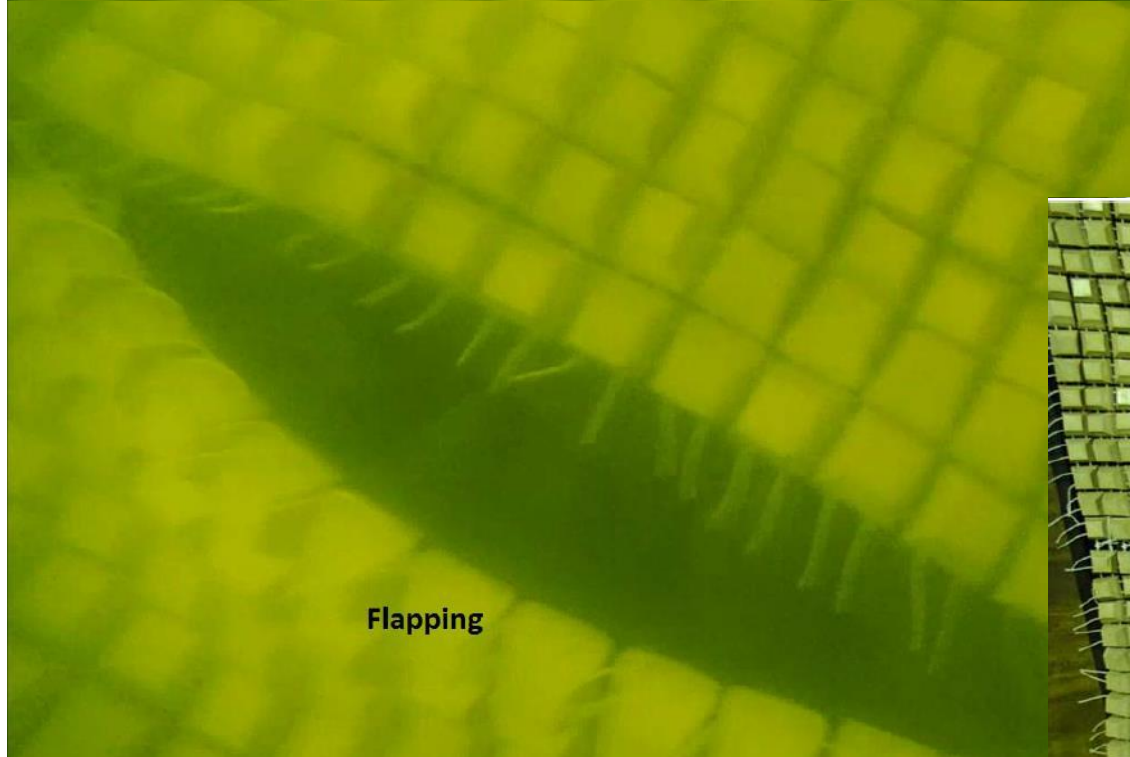
ACM Test Observations

Tying mats together at the toe of the slope for the final test resolved this issue

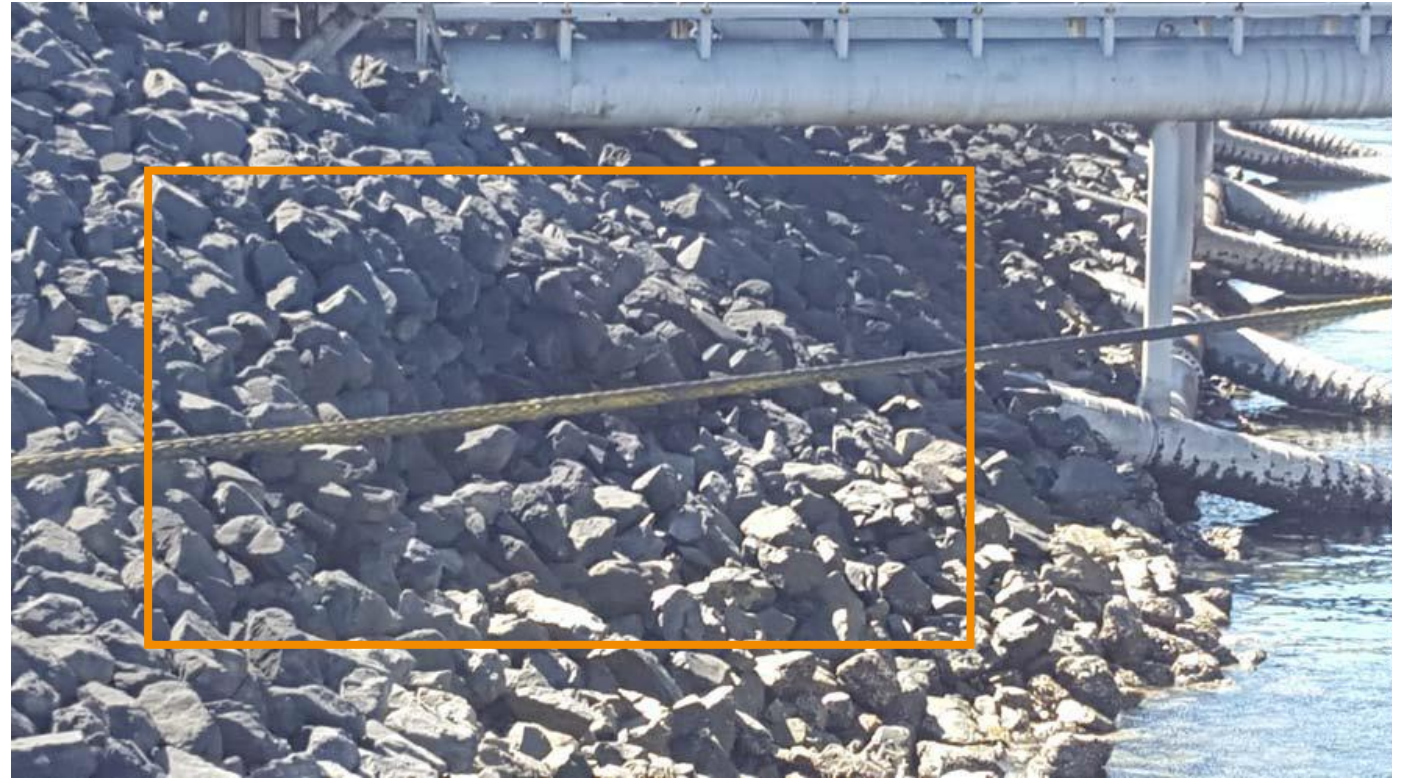
Slope damage after TSV Donnaconna operations

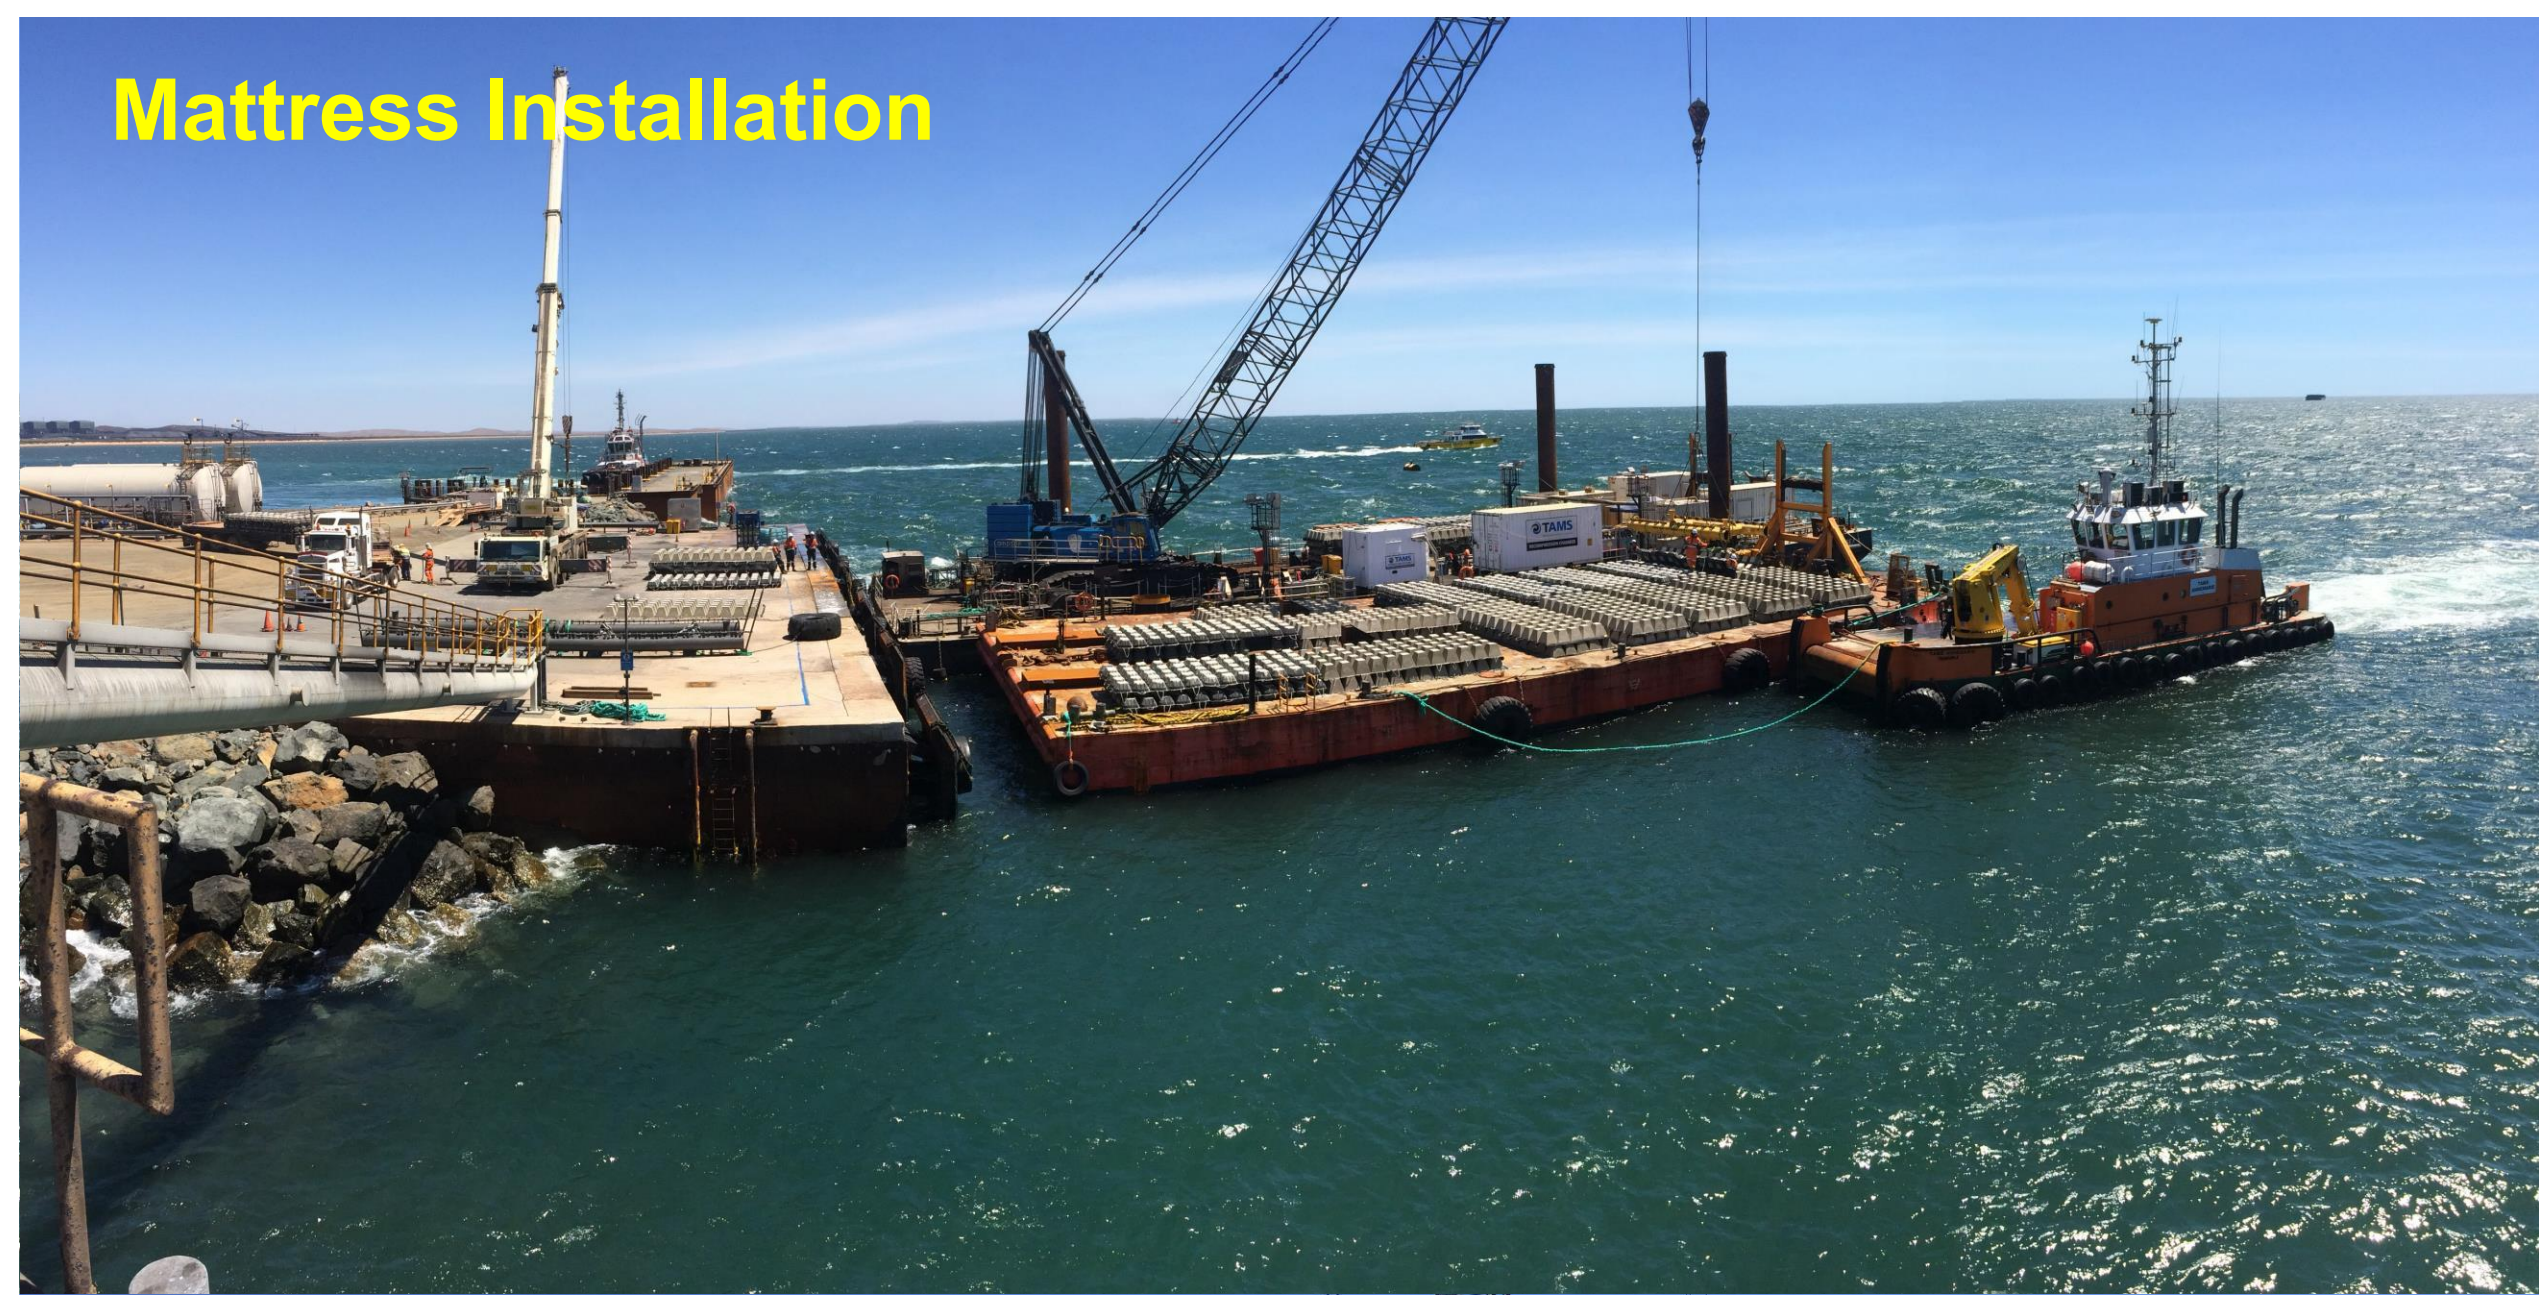
Mattress Installation

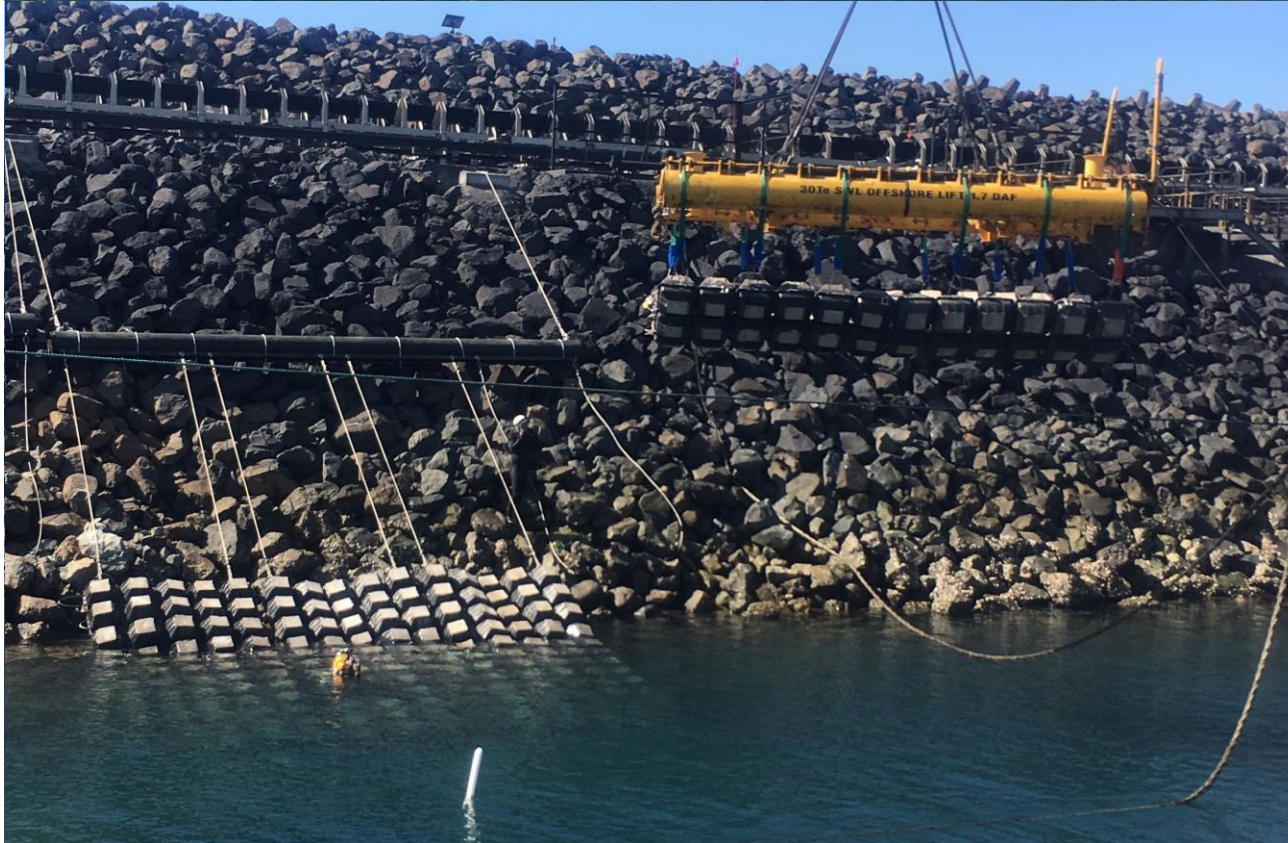
Mattress installation
