36TH INTERNATIONAL CONFERENCE ON COASTAL ENGINEERING 2018

The State of the Art and Science of Coastal Engineering

EVOLUTION OF NOBIRU COAST AT DECADAL TO CENTENNIAL SCALES INCLUDING THE 2011 TSUNAMI IMPACT

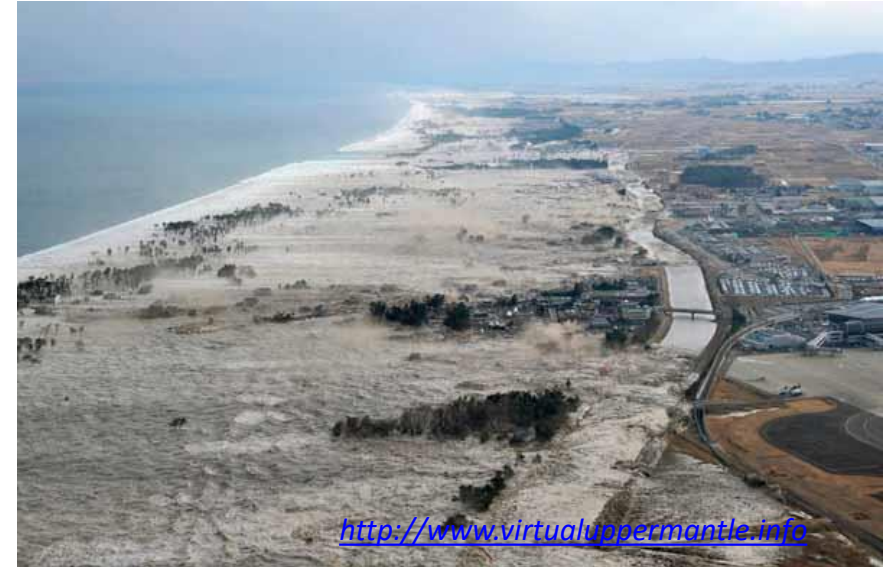
Tsunami in Sendai area

- The earthquake – tsunami happened on March 11th, 2011 in northeast of Japan
 - One of most 5 powerful recorded earthquake on earth
 - Tsunami wave is about 10m offshore and about 40m maximum run-up height on the coast of Japan (about 19.5m in Sendai area)
- Causing extensive and severe damage to infrastructure, and significant changes of coastal and estuarine morphology.

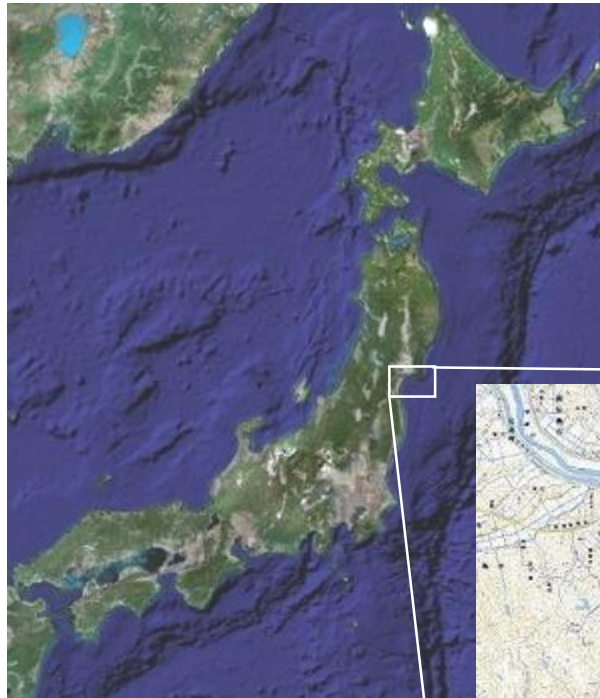
- Located in Miyagi Pref.
- 2.8 km long
- The end of Ishinomaki Coast
- Serious beach erosion by the 2011 Tsunami

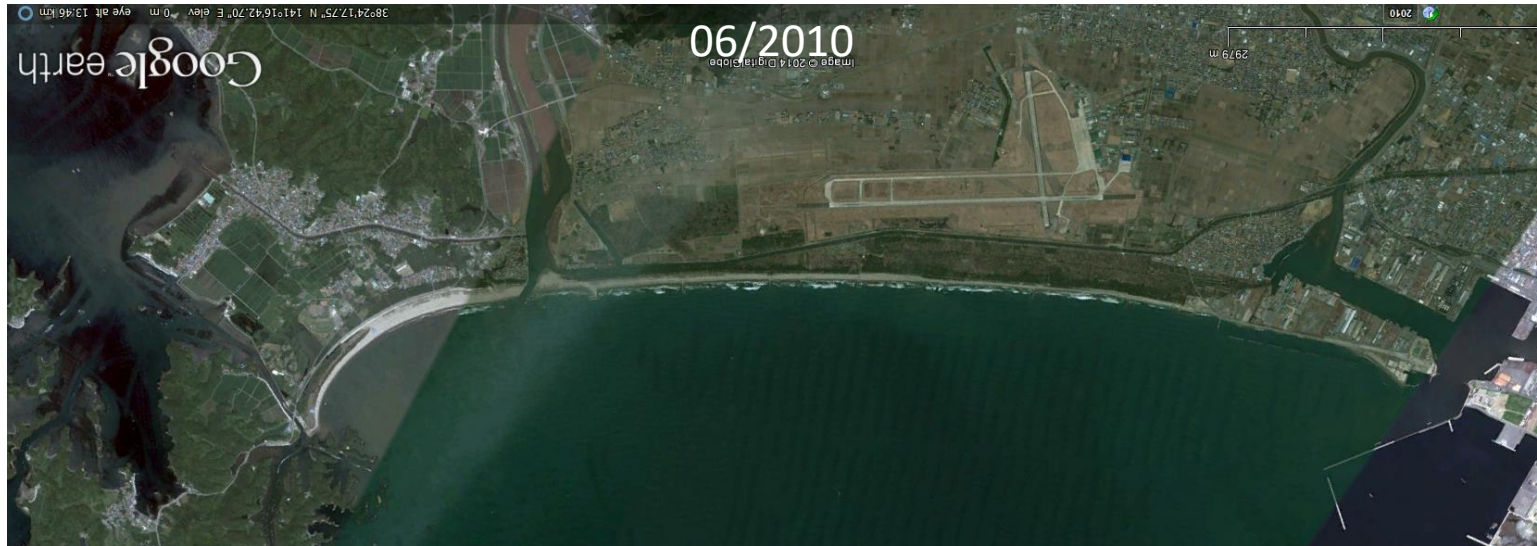
Before tsunami

Coastal and estuarine erosion by the 2011 Tsunami

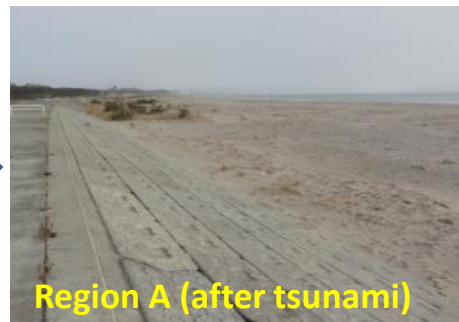
Region A (after tsunami)

The concrete embankment in Region A is still intact by tsunami.

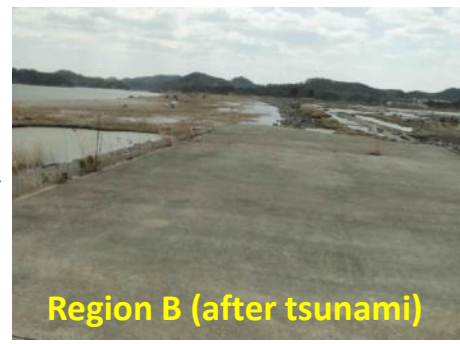
Region B (after tsunami)

Whereas riprap embankment in Region B was completely flushed.

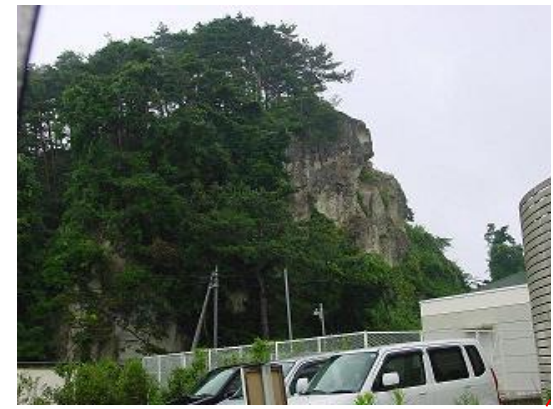
Inoh Map (1801) and latest map (2001) at Nobiru Coast

○ Immovable rocks and rocky hills.

Geometric correction by Affine transformation on the basis of these reference points.

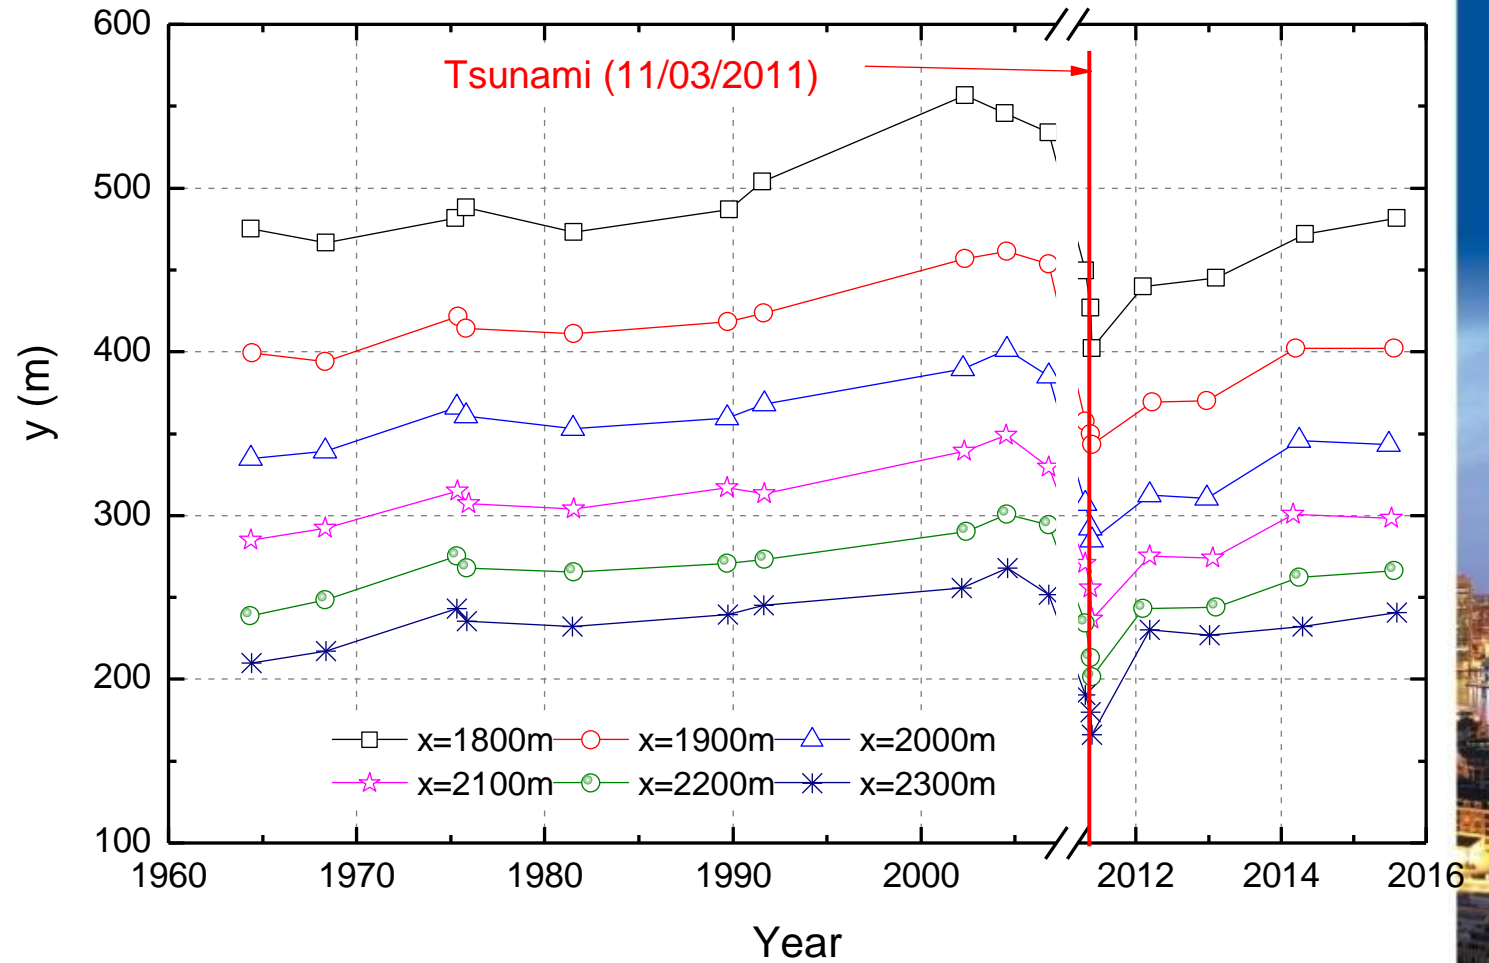
Shoreline change from recent aerial photographs

1. The longshore sediment transport rate on Nobiru Coast from 1964 to 2006 reduced about 60% compared to the one in the previous period.
2. However, that rate does not change much in the period after the tsunami although severe damages could be observed.
3. This result indicates that the effect on the aquaculture in Matsushima Bay due to sediment deposition on the west end of the coast will take place again.

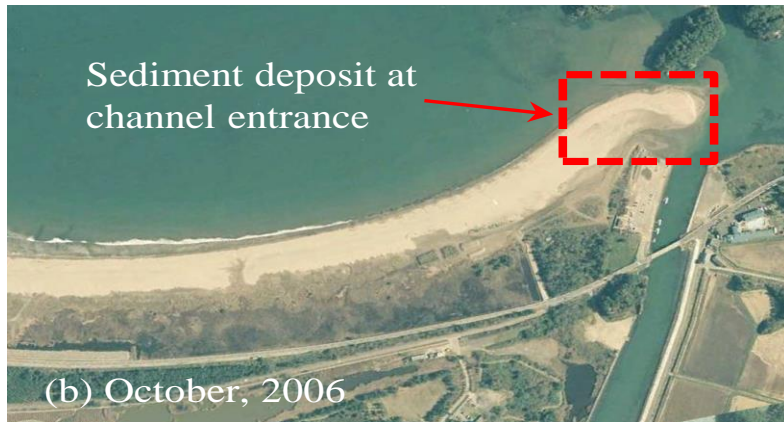
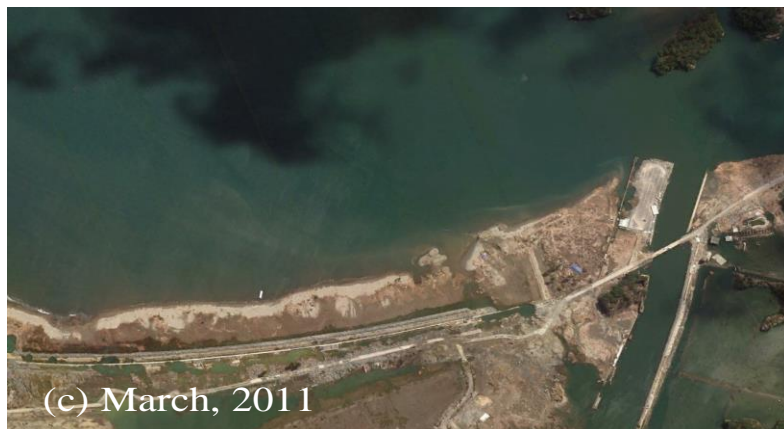
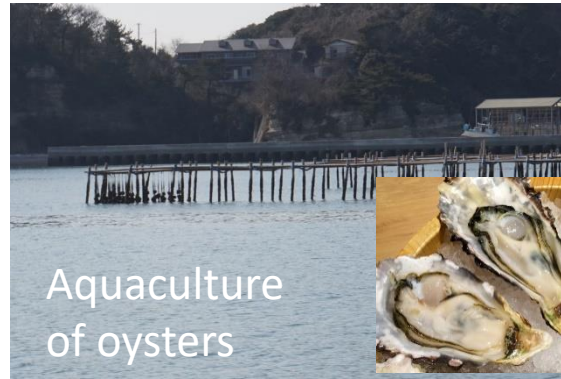
Relationship between sediment deposit and water quality in Matsushima Bay

- Katsugigaura Channel: Artificially excavated in early 1960s for promoting bay water exchange.
- In 2006: the channel has been blockaded.
- In 2011: removal of sediment by the tsunami.
- The blockade problem has been postponed by 30 years due to tsunami-induced erosion.
