# ICCE 2018 - BALTIMORE

## PROTECTION AND IMPROVEMENT OF THE BARRIER BEACH OF FRONTIGNAN (France)

**Marie COUTOS, François HACQUES**  
(ARTELIA EAU & ENVIRONNEMENT)

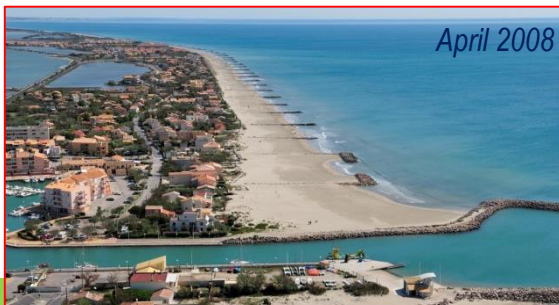
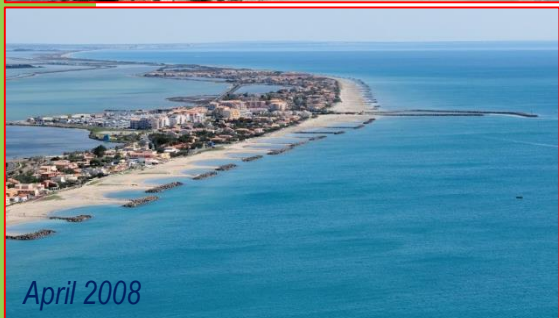
#### 1 Urbanized area

Urbanized area of Frontignan (4.7km) protected with many coastal structures

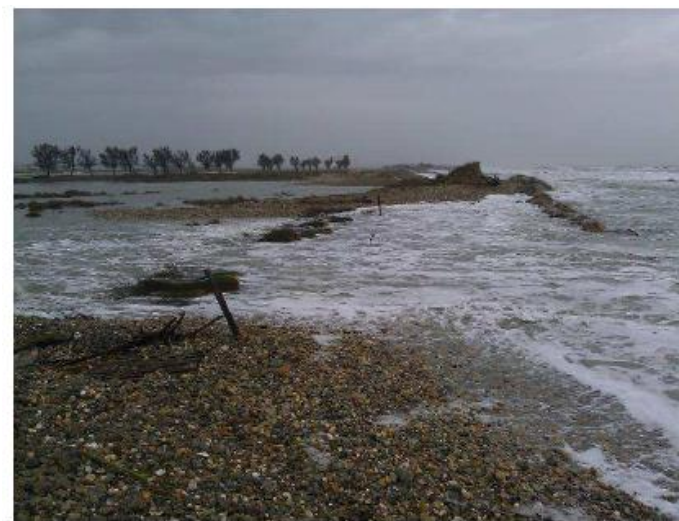
*Waves have reached the dune front. This led to dune erosion, overwash and breaching. The road located behind was destroyed.*

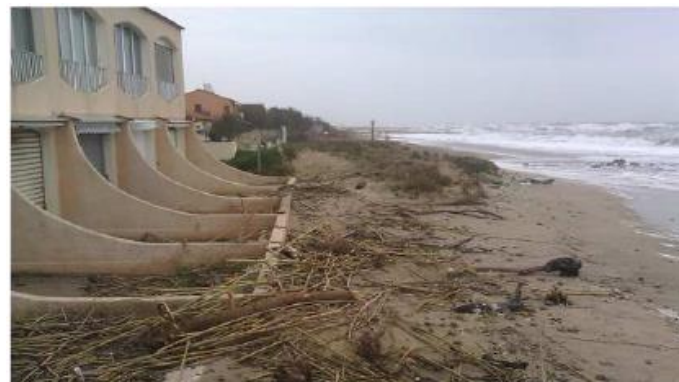
*Waves are very closed to the toe of the houses*

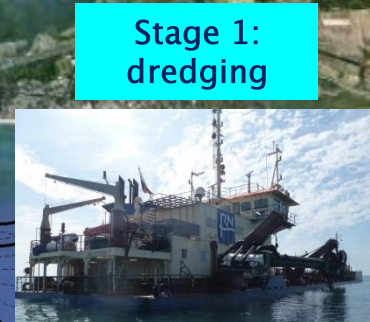
**200 500 m<sup>3</sup>** dredged and transported by the means of a Trailing Suction Hopper Dredgers (TSHD)

**THOR-R**  
 Draft (unloaded) ~ 3,47 m  
 Draft (loaded) ~ 5,50 m  
 capacity ~ 2507 m<sup>3</sup>  
 Speed (unloaded) ~ 21 km/h  
 Speed (loaded) ~ 18 km/h

- 6 h cycle :**
- Load ~ 1h30
  - Transport: ~ 2h
  - Discharge ~ 1h
  - Transport ~ 1h30

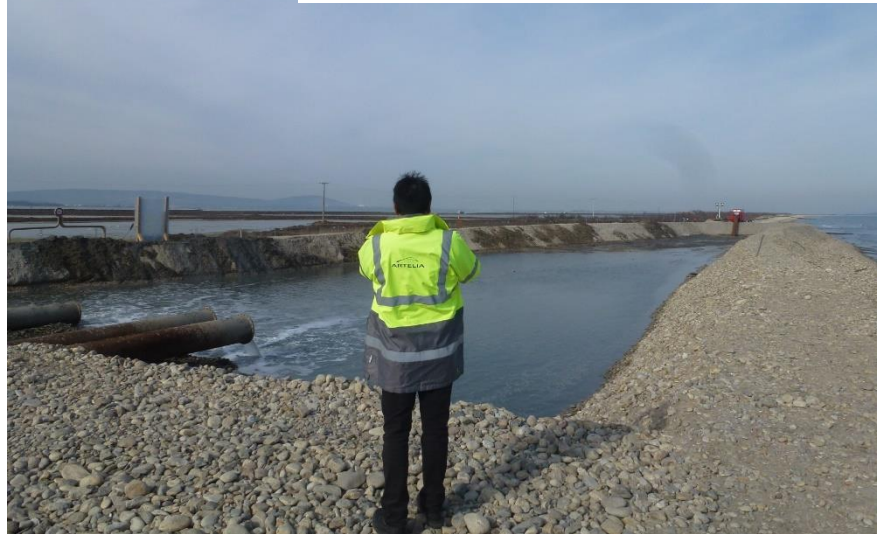
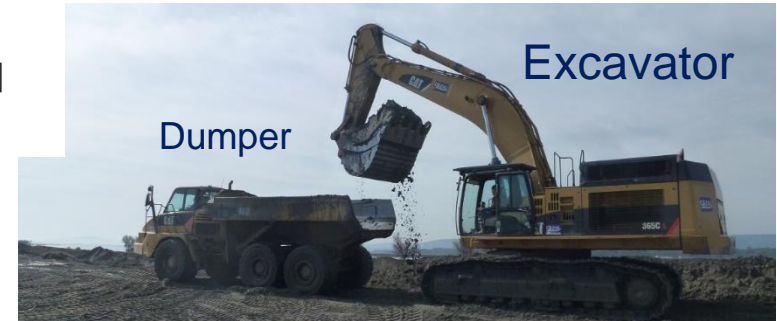
Dumpers were used to transport the sand to the beaches to be nourished located 2 km towards South

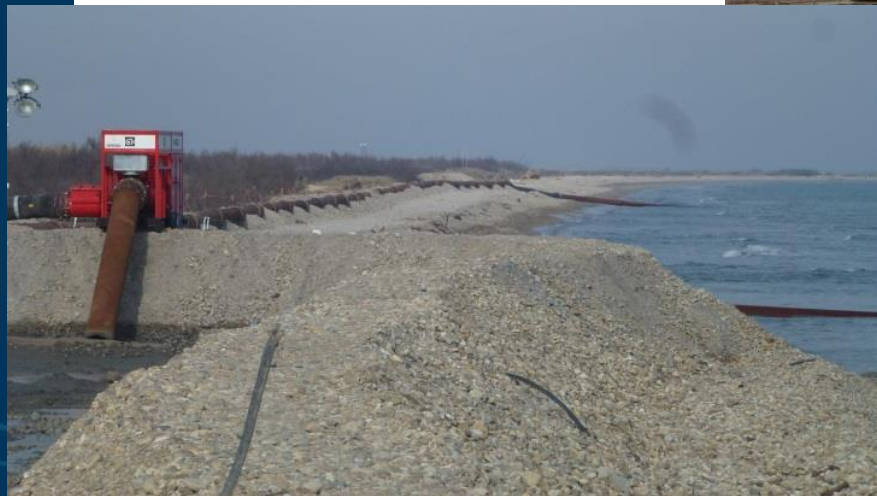
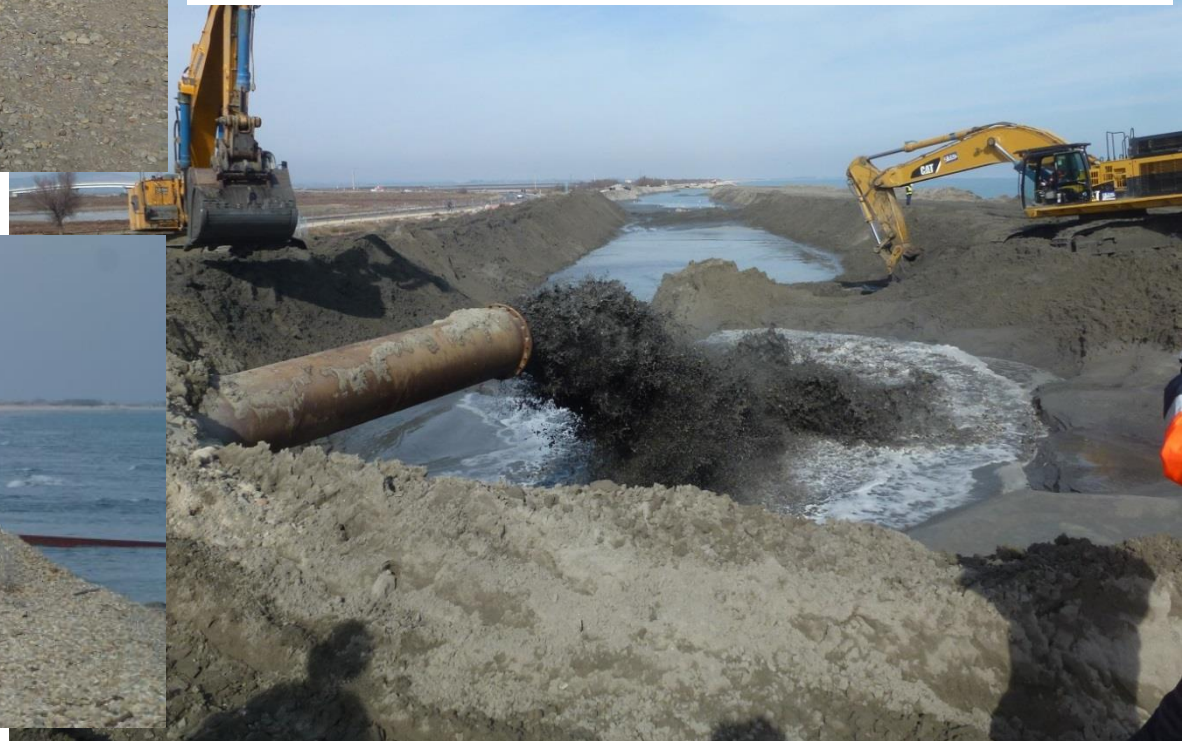
To prevent the increase of the turbidity during dredging discharge operation : dredge spoils were decanted in a temporary sediment settling basin (200 to 300 m length x 5 m depth)

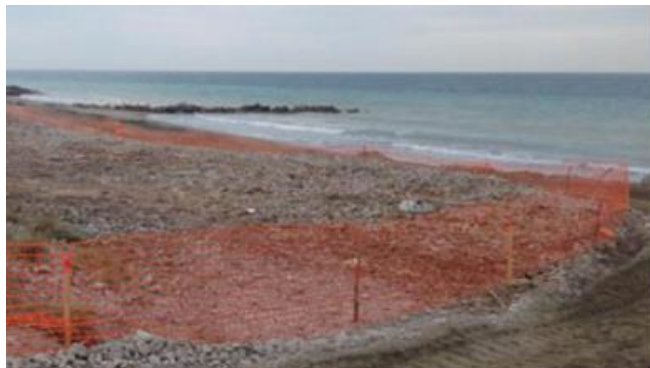
Delimitation of the existing vegetation to preserve it from the works

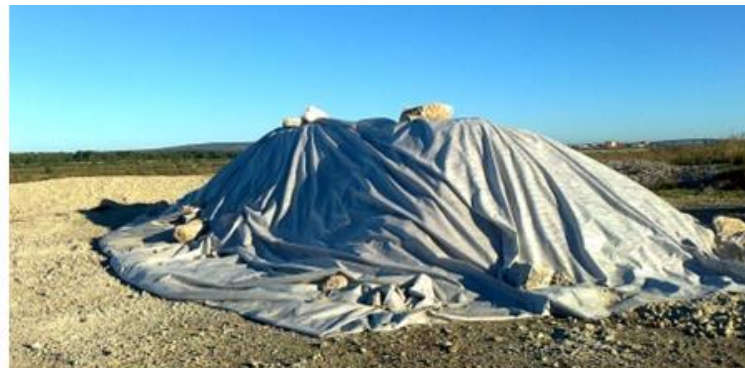
Preservation of the petty surge by nurseryman during the work period

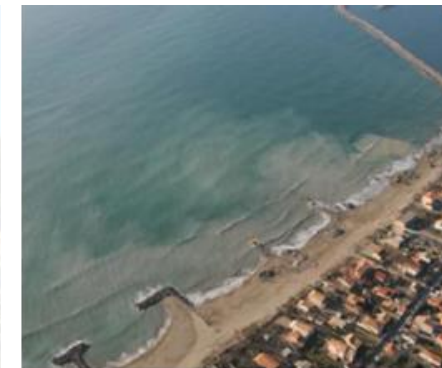
Turbidity assessment during the whole duration of the dredging works

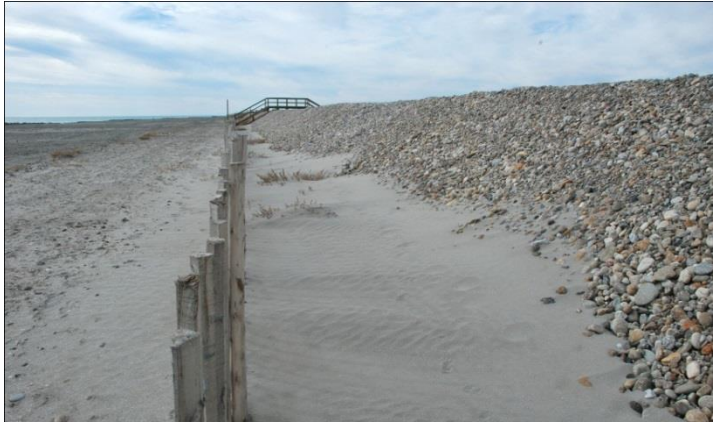
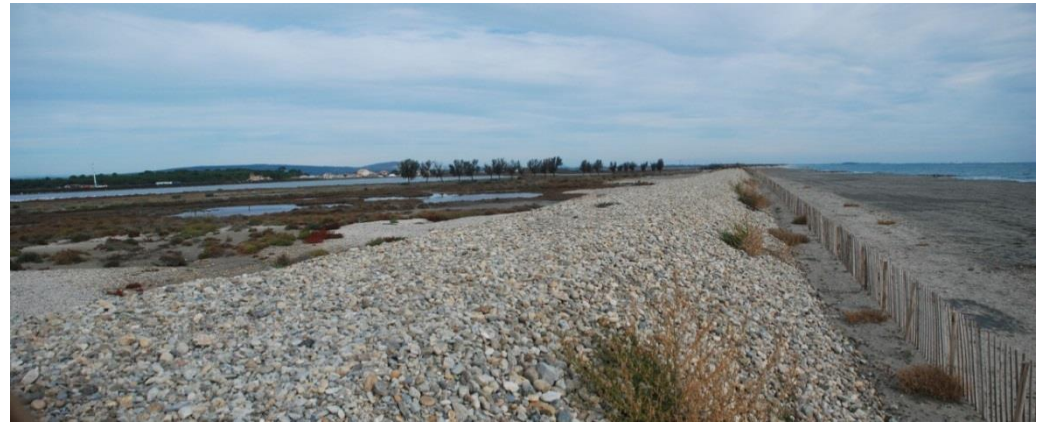
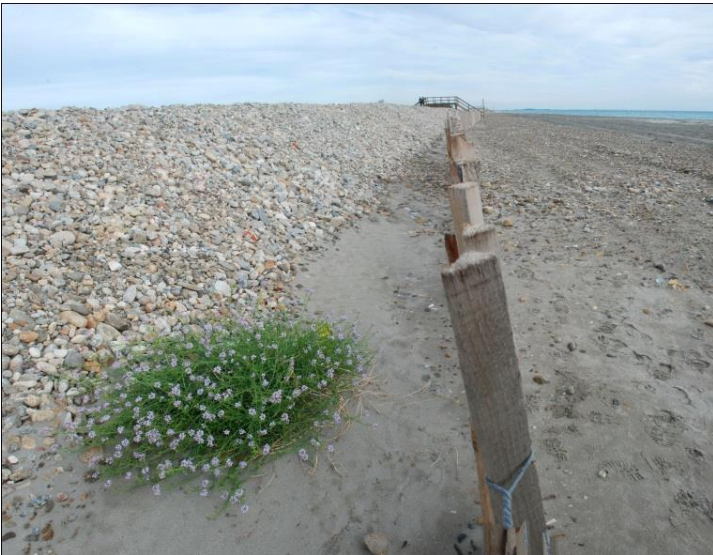
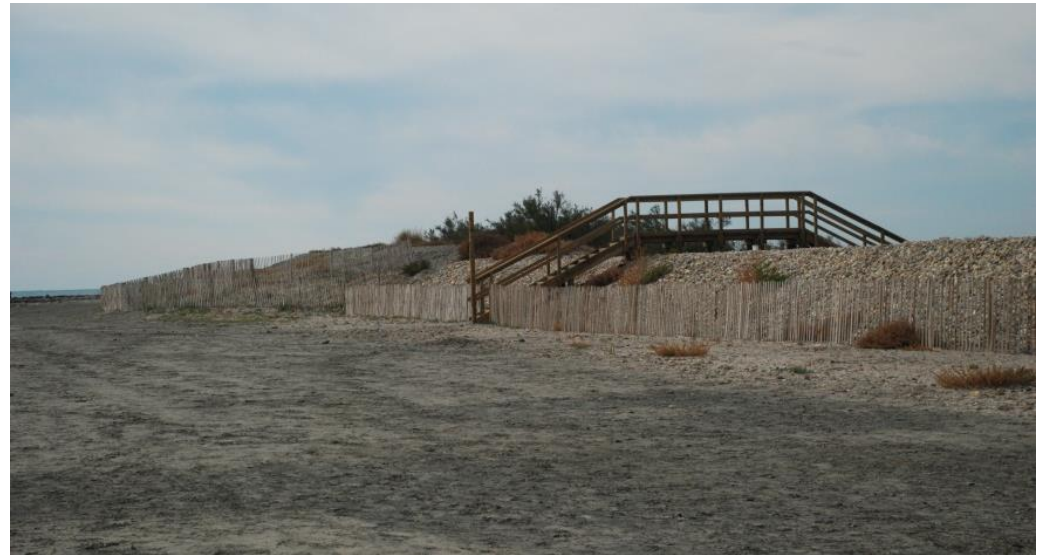
Pictures taken just after the completion of the works
