OVERTOPPING AND STABILITY OF A RUBBLE MOUND BREAKWATER WITH CORELOC ARMOUR UNDER OBLIQUE CYCLONIC WAVES

L. Martinelli¹, P. Ruol¹, C. Favaretto¹, M. Volpato¹

¹ ICEA Department- Università di Padova, Padova, IT, luca.martinelli@unipd.it

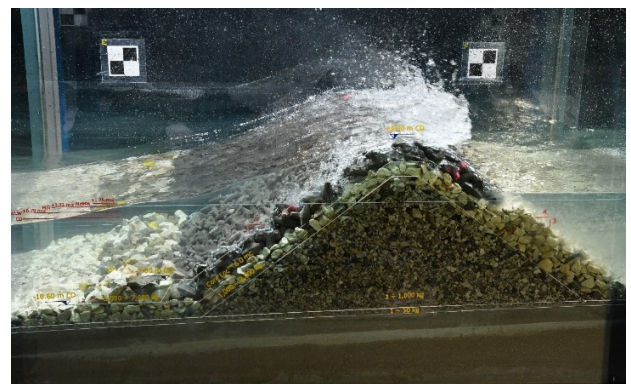
Fig 1. Overtopping event for WS 9

Fig. 1 shows an overtopping event for WS 9, that clearly endangers the CoreLoc stability in the rear side of the crest, whose interlocking is typically very low. Design of these elements is affected by the Cyclonic nature of the wave climate, because of the peculiar crest settlement during the wave event.

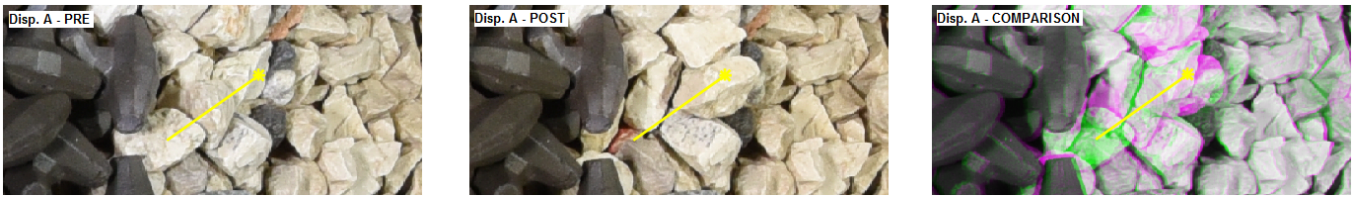
Fig 2. Example of output of the photographic overlay technique to investigate the structure stability

Damage S and N_{od} are evaluated based on a photographic overlay technique. Moreover, a 3D graphical reconstruction was carried out in order to give a quantitative description of the settlement of the structure and possible deformation of the structure cross section. The latter is an essential tool to investigate the model structure settlement and the degree of interlocking during testing.

Figs. 2 and 3 shows the outputs of the methods used to study the structure stability in the wave flume, i.e. photographic overlay technique and the 3D graphical reconstruction.

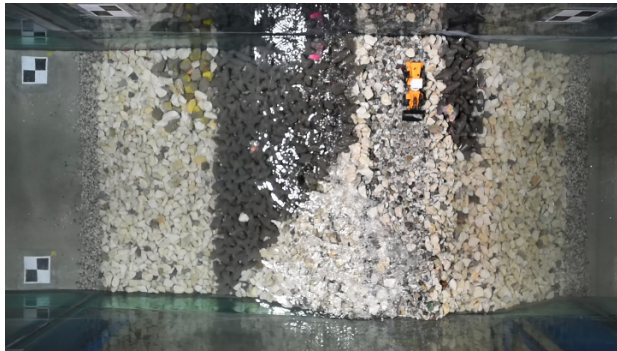
Fig 4. Top view 2D model, tests of structure loaded by a storm during a simulation of the construction phase

Fig. 4 shows a test carried out for an uncompleted structure, i.e. only partially covered by artificial units, that should resist typical wave storm with a return period of a few years.

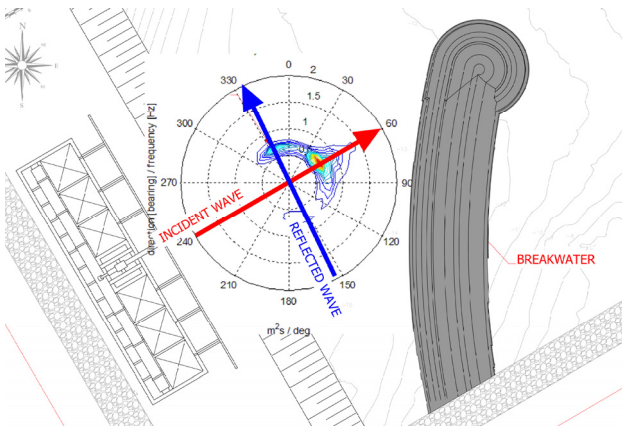
Fig 5. Layout of the 3D model in the wave basin

Fig. 5 shows the layout of the 3D model in the wave basin and an example of directional wave analysis carried out on the basis an array of 7 resistive type wave gauges.

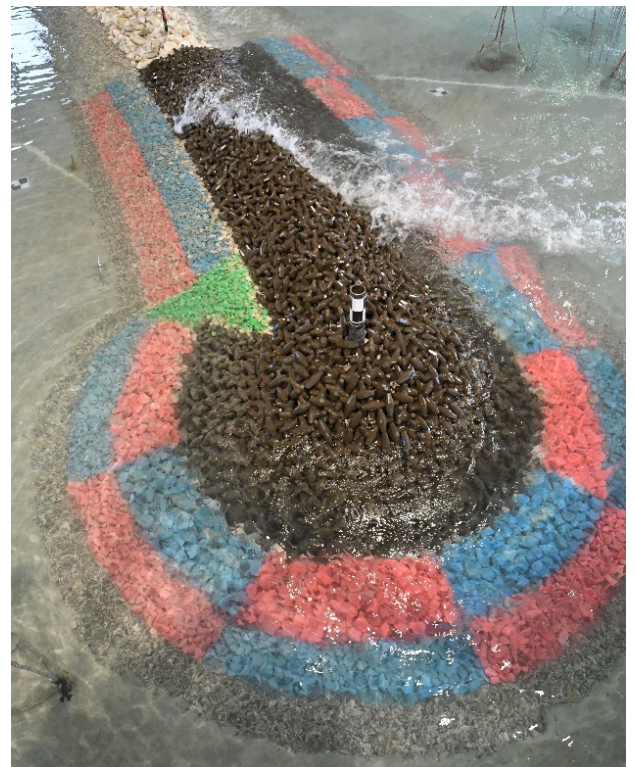
Fig 6. Overtopping event for WS 8

Fig. 6 shows an overtopping event for WS6 for a very oblique incident wave. The wave front propagates along the

breakwater up to the roundhead, applying an horizontal load that endangers the stability of the CoreLocs placed in the front side of the crest. These elements require special attention at design phase for cyclonic wave climates, since the expected low-degree of interlocking may be critical.
