# 36TH INTERNATIONAL CONFERENCE ON COASTAL ENGINEERING 2018

## Design and Performance of a Mixed Sediment Nourishment Project along an Urban Sediment-Starved Shoreline

John Ramsey, P.E., D.CE and Sean Kelley, P.E.

Applied Coastal Research and Engineering, Inc.

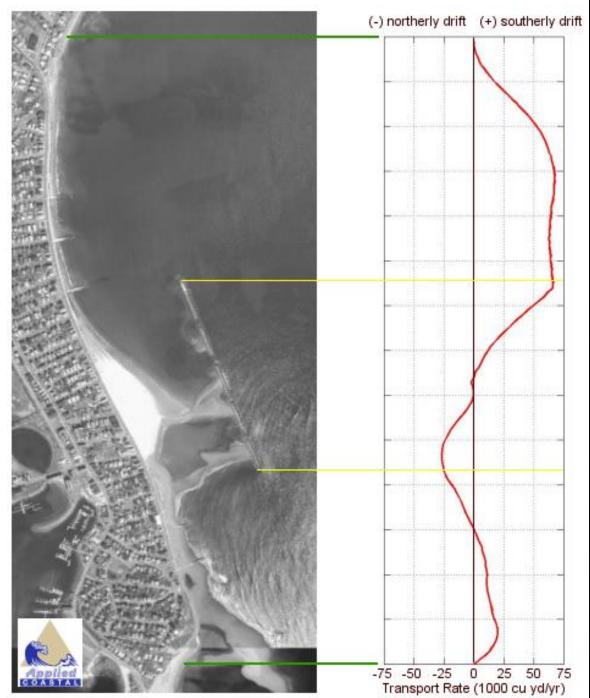
# Longshore Sediment Transport

Transport potential rates were computed from wave modeling Generally, littoral drift is to the south The "Five Sisters" cause the local reversal (diffraction)
Sediment transport is greatest north of the "Five Sisters"

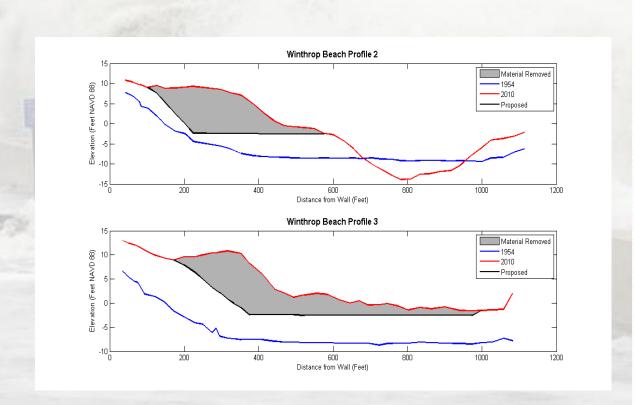
#### **Pilot Project**

**Dredging Tombolo to Provide Southern Nourishment Material**

"Value Engineering" to Reduce Project Costs

Potential Future Borrow Source for Renourishment

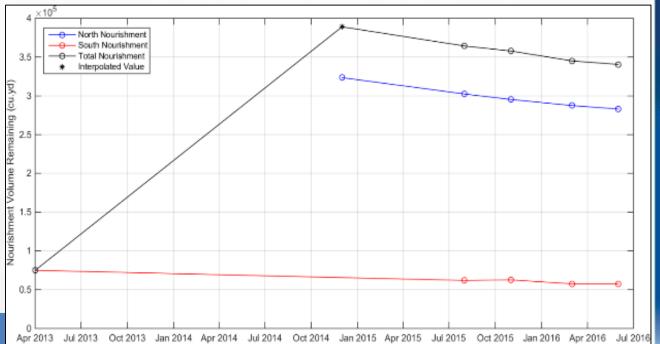
# Beach Nourishment Performance

Survey Date	Nourishment Volume Remaining (%)			
	North Section	South Section	Total	
Apr 2013		100%	100%	
Dec 2014	100%	88%	98%	
Aug 2015	93%	83%	91%	
Nov 2015	91%	84%	90%	
Mar 2016	89%	77%	87%	
Jun 2016	87%	77%	85%

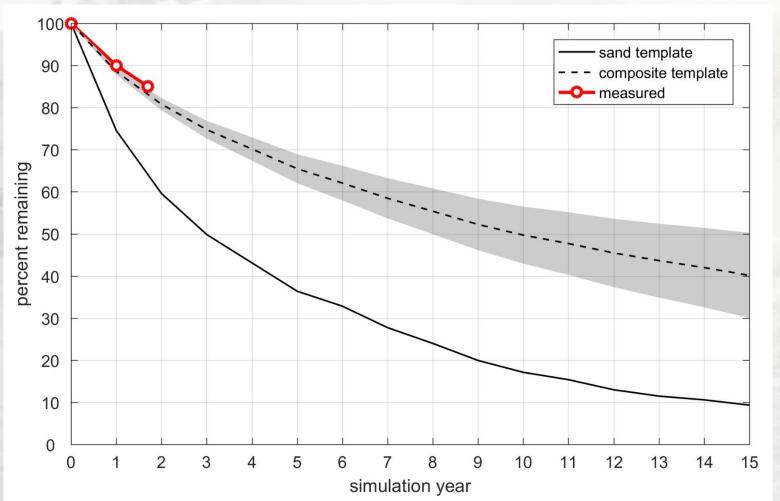
### **Predicting Beach Nourishment Performance**

Comparisons Using Different Sediment Transport Formulations

Sand Only: Kamphuis (1990)

Composite: Kamphuis (1990) for sand

van Wellen, et al. (2000) for gravel/cobble

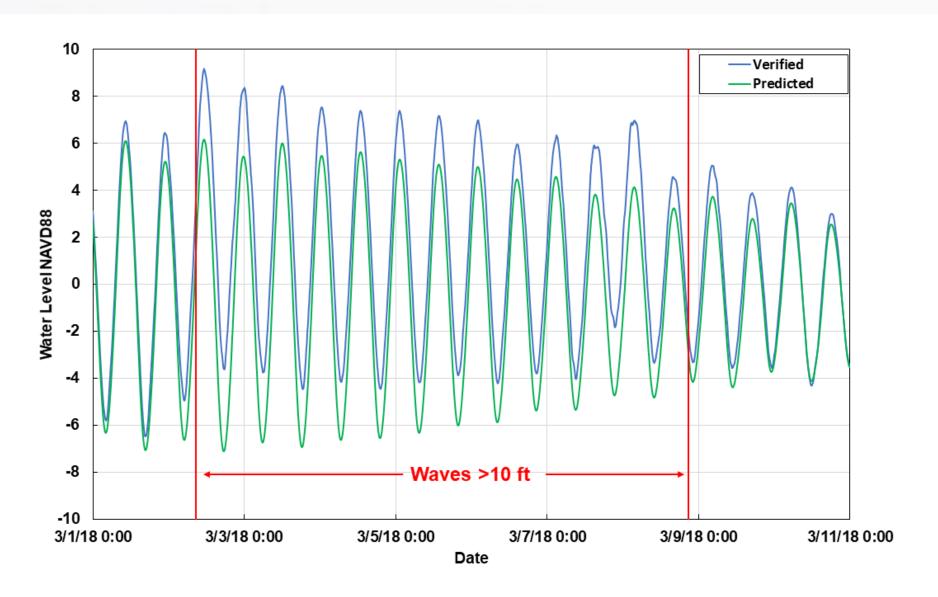
### Major Nor'easter – March 2018

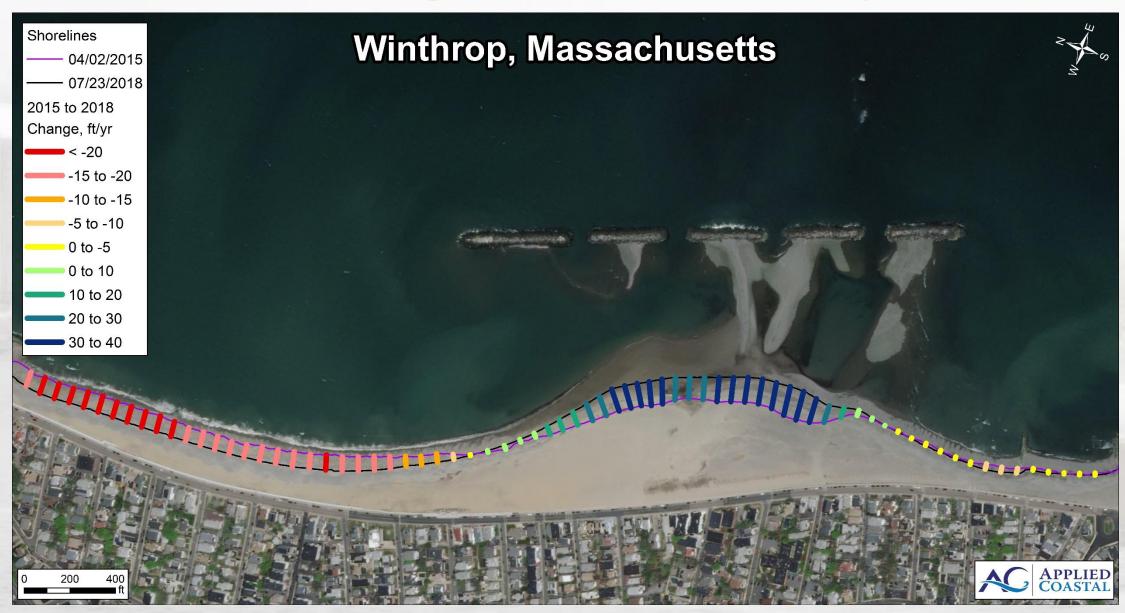
### 2018 High Water Line Survey
