COMPREHENSIVE STUDY AND MONITORING PROGRAM FOR BEACHES AT VIÑA DEL MAR CHILE

Benjamín Carrión, PRDW, bcarrion@prdw.com
Rolando García, PRDW, rgarcia@prdw.com

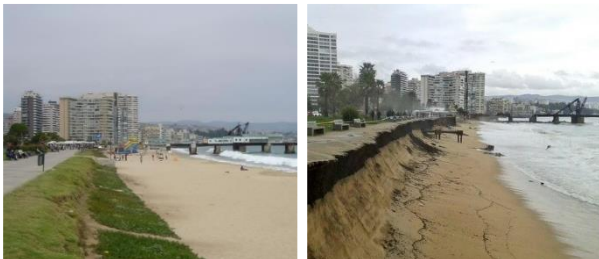
Figure 1 - Playa El Sol, Viña del Mar, before (left) and after (right) storm event of 2015/08/08.

On August 8th 2015, an extreme storm event affected central Chile. Significant wave heights up to 5.0 m at a depth of 20m were estimated in front of Viña del Mar. Beaches suffered massive erosion and relevant damage to coastal infrastructure occur (Figure 1), jeopardizing the touristic industry of the city.

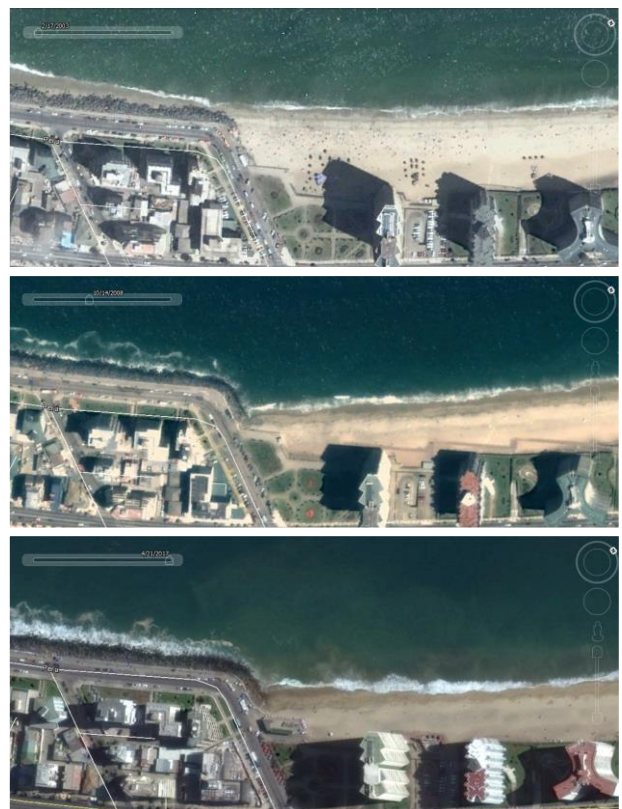
Figure 2 - Aerial photographs of Acapulco Beach on 02/2003, 10/2008 and 04/2017.

Contrary to findings by Martinez et. al. (2017), no significant evidence of local wave climate change was observed among the reviewed period 1979 - 2017, neither on wave parameters such as H_{m0} , T_p , and D_m , nor on the number of extreme storm events per year. The significant recession experienced by certain beaches of this littoral system since 2003, especially those located immediately north of Marga Marga river mouth such as Acapulco Beach (Figure 2), showed no consistent relation with wave climate.

Instead, this recession seems to be closely related with an unusual sediment supply due extreme flood events of Marga Marga river, occurred in 1997, 2000 and 2002, followed by a period with no relevant floods until today. Such diagnosis was confirmed with a hydrological numerical simulation of the the Marga Marga river basin, using measured daily precipitation from 1975 to 2015. Results of this analysis are shown in Figure 3, where the calculated bedload sediment supply from 1995 to 2015 is shown. An excess of sediment supply is verified on year 2003, while on the most recent years, sediment supply seems to be below the average trend.

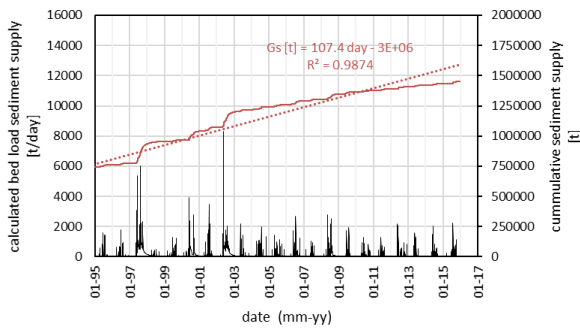
Figure 3 - calculated sediment supply (bed load) by Marga Marga river between 1995 - 2015.
