36TH INTERNATIONAL CONFERENCE ON COASTAL ENGINEERING 2018

COMPREHENSIVE STUDY AND MONITORING PROGRAM FOR BEACHES AT VIÑA DEL MAR CHILE

Benjamín Carrión, Msc, Coastal Modeller

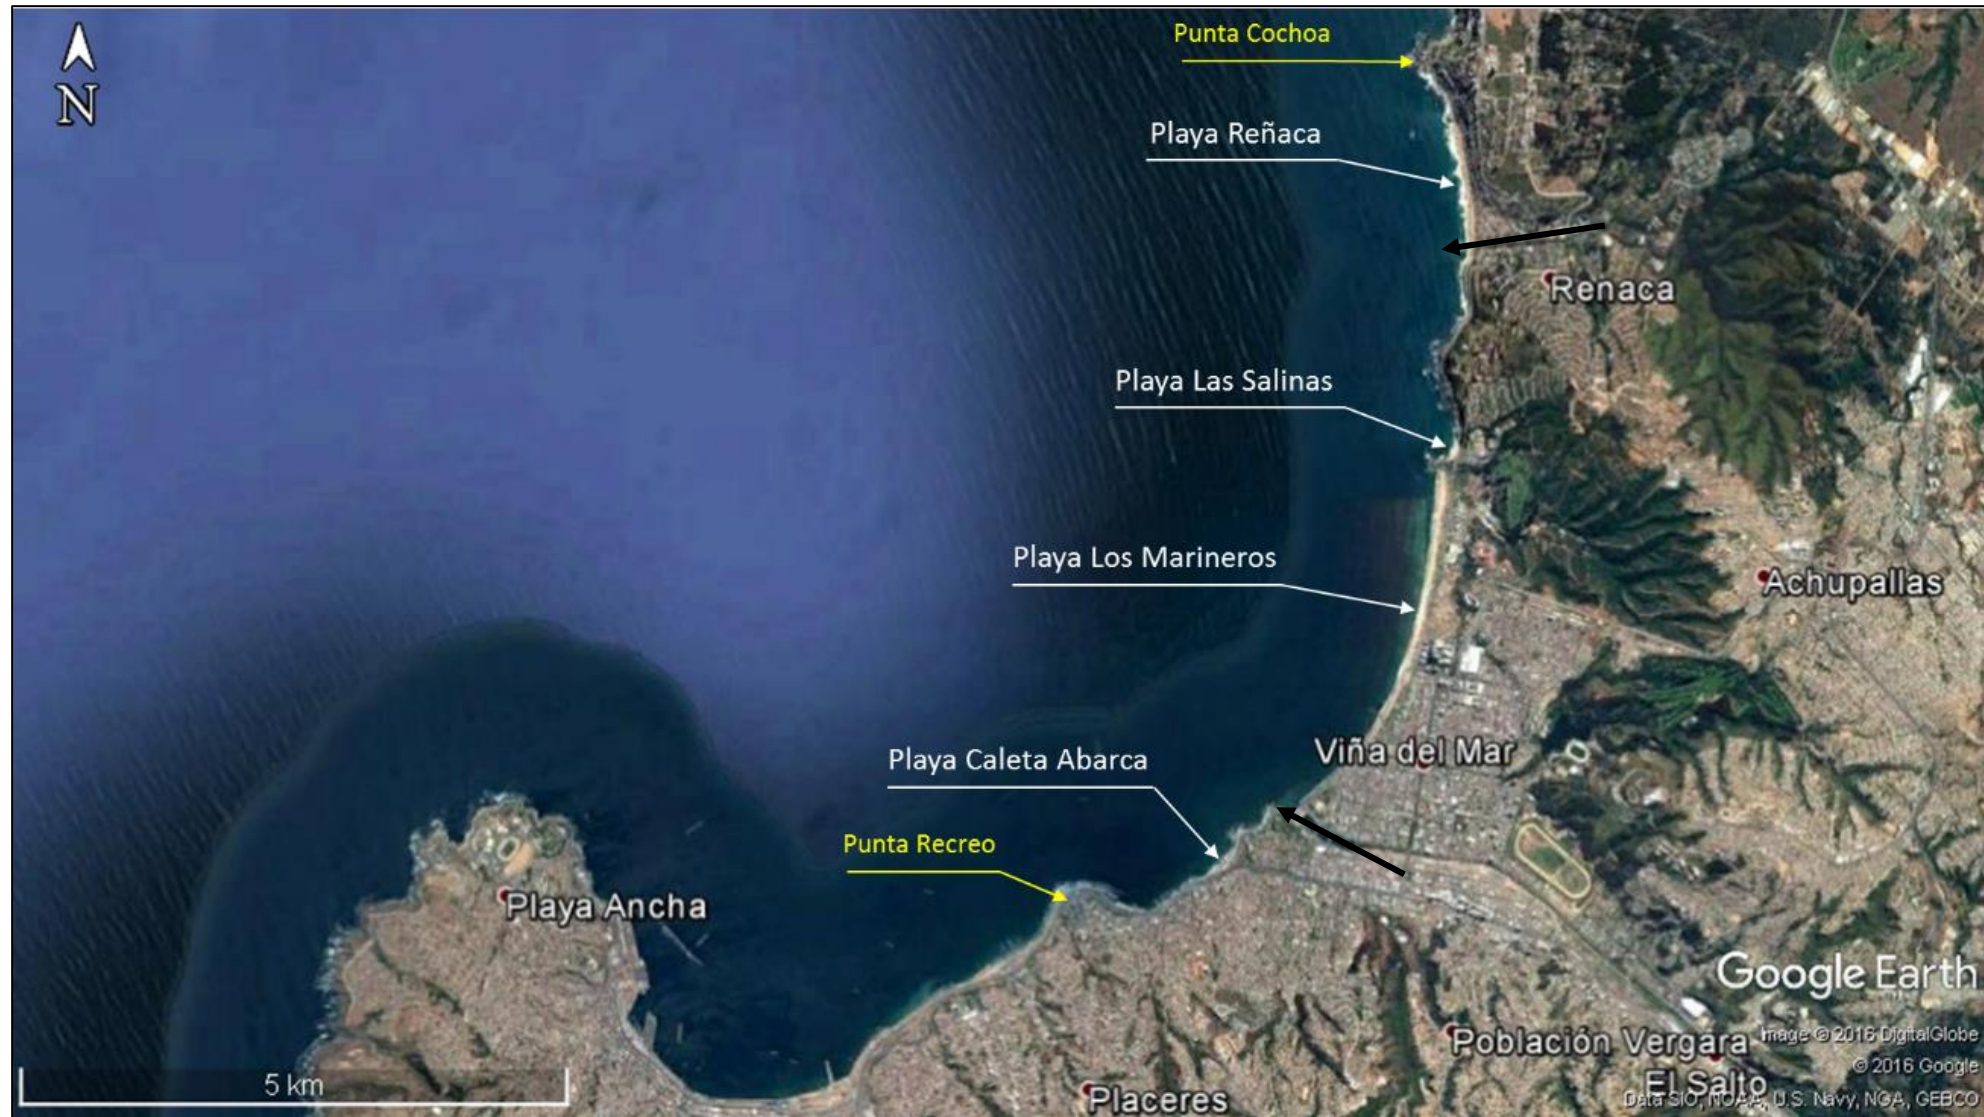
Miramar beach, Viña del Mar
~1930 - ~2010

- Anecdotal fears of erosion
- Unclear current state or causes
 - Sediment deficit?
 - Sediment properties change?
 - Change in wave conditions?
 - Built environment?

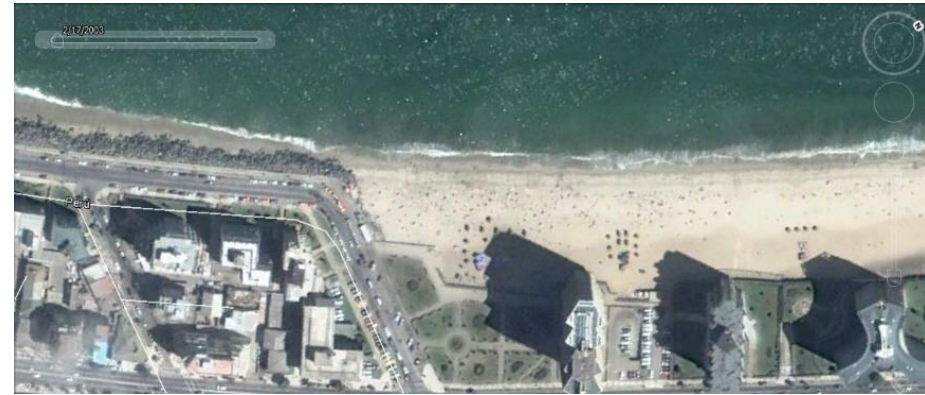
Playa Acapulco: 2003 – 2008 - 2017

- Anecdotal fears of erosion
- Unclear current state or causes
 - Sediment deficit?
 - Sediment properties change?
 - Change in wave conditions?
 - Built environment?
- **Permanent changes?**

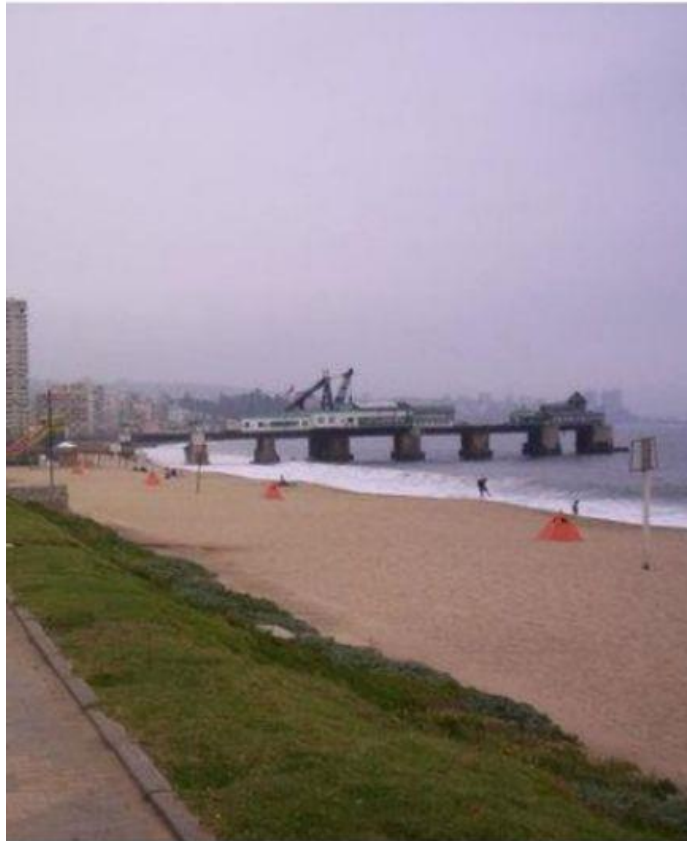
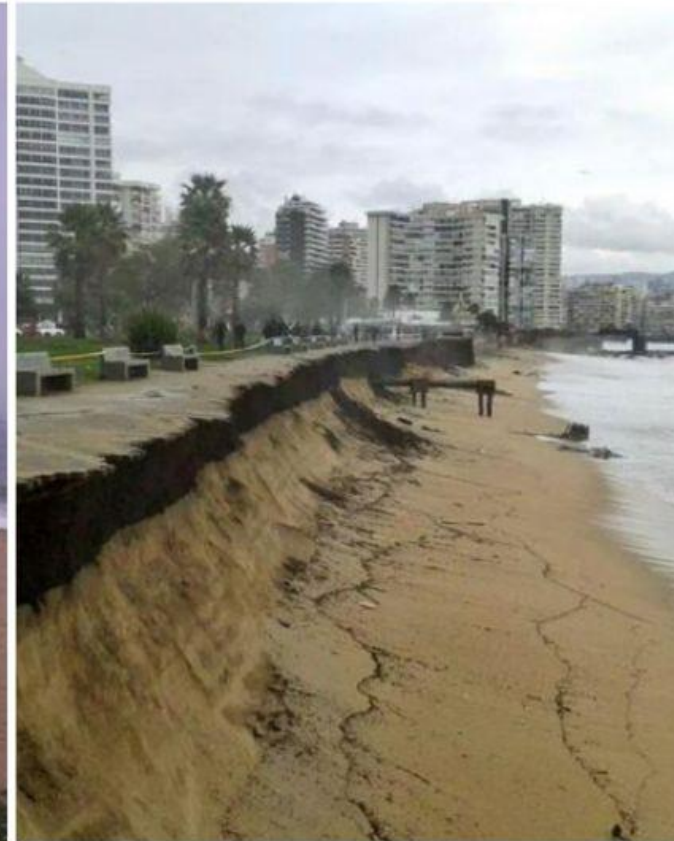
El Sol beach, Viña del Mar
Agosto 2015

- 2015 storm impact
 - Huge erosion
 - Infrastructure loses
- Temporary changes
 - Seasonal wave variability
 - Seasonal beach profiles
 - Permanent change?
 - Recovery times?

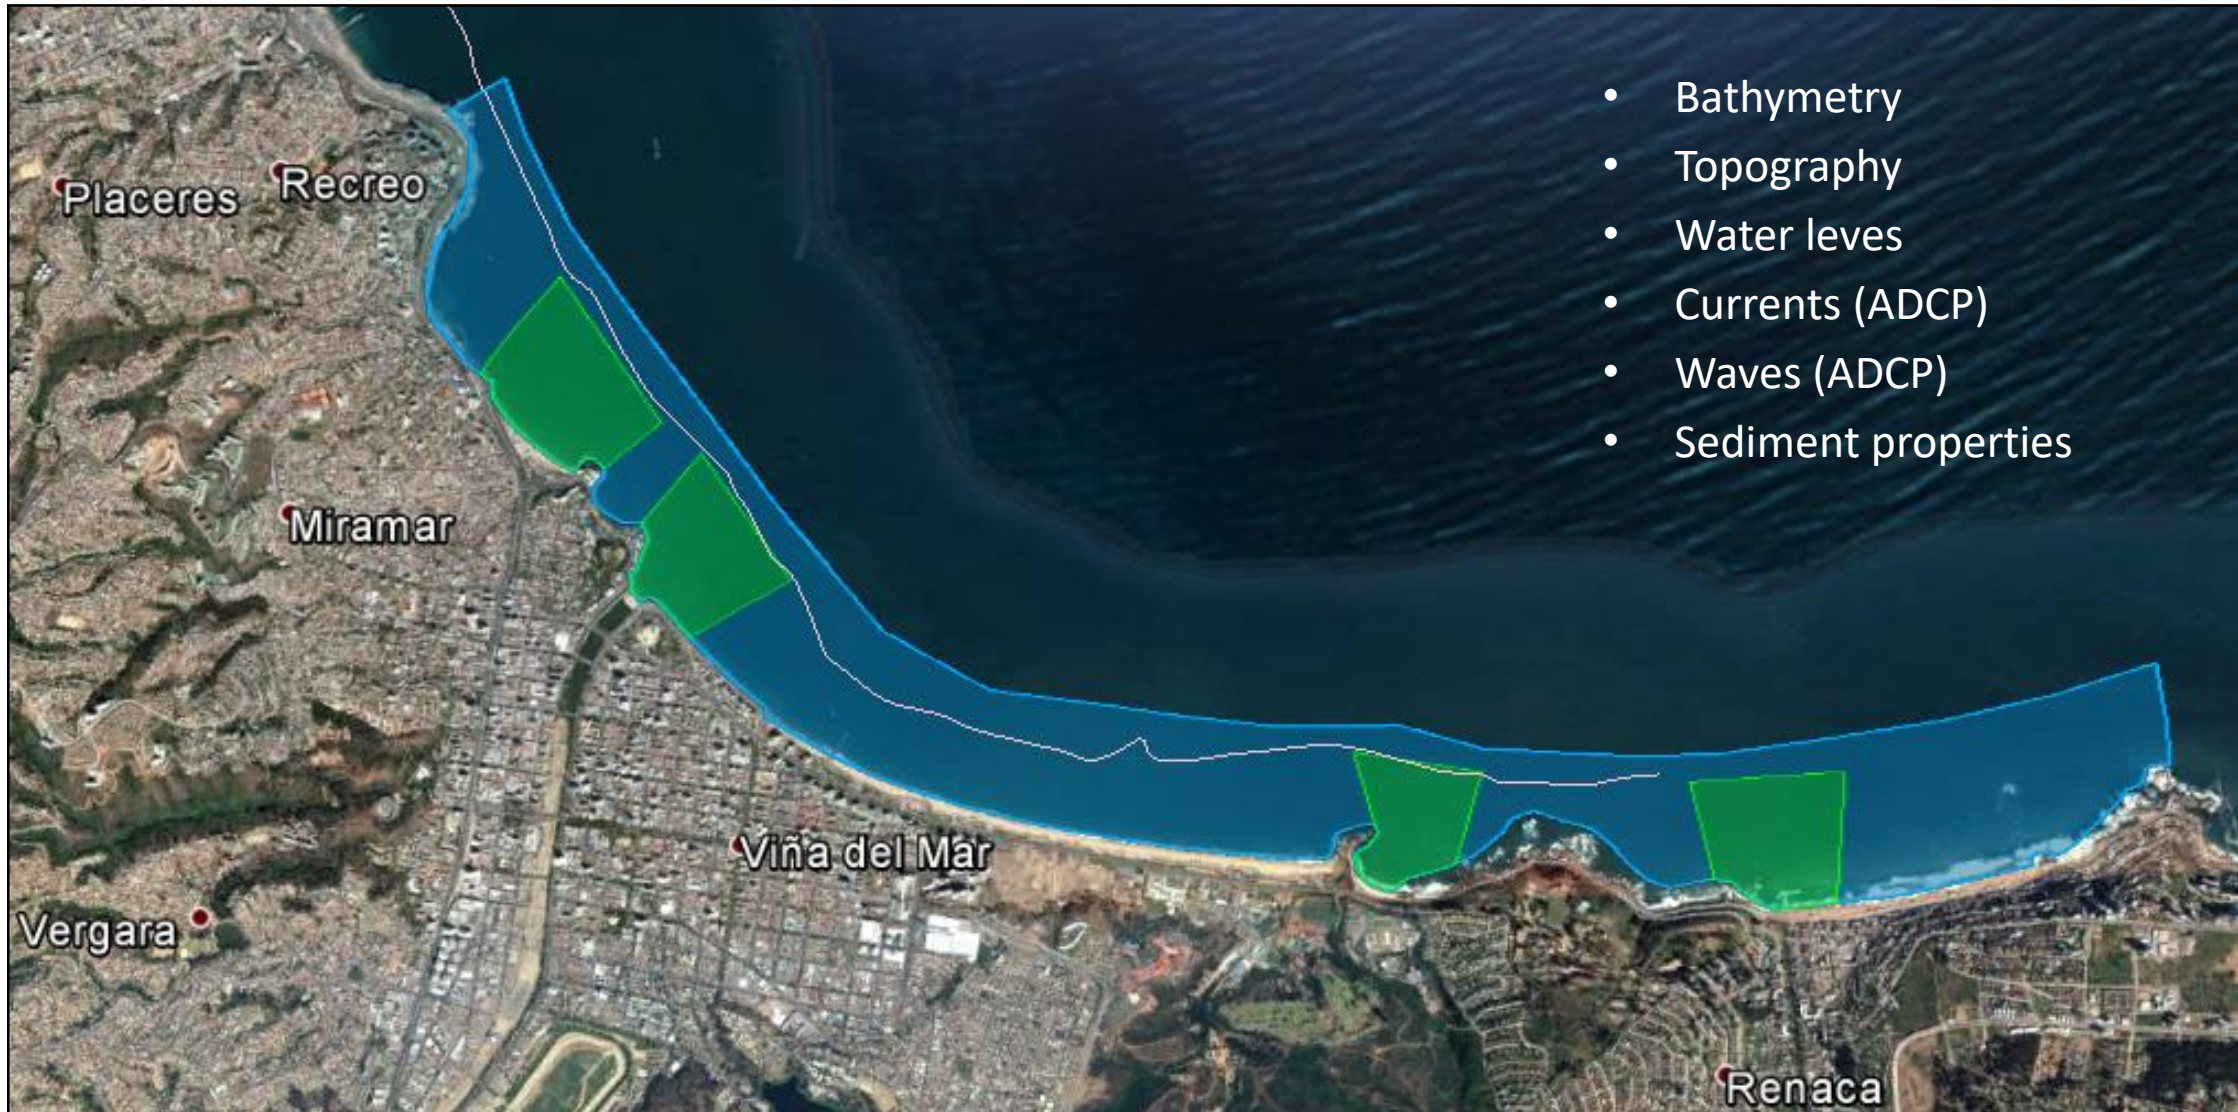
- Bathymetry
- Topography
- Water levels
- Currents (ADCP)
- Waves (ADCP)
- Sediment properties

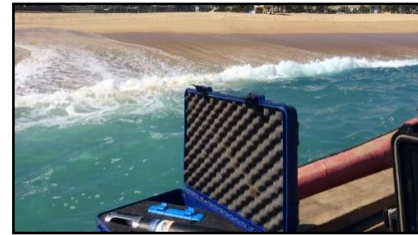
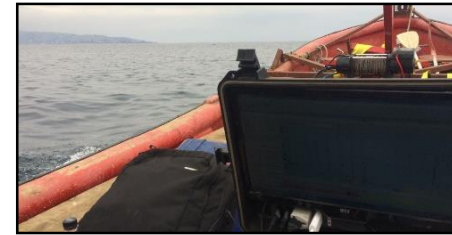
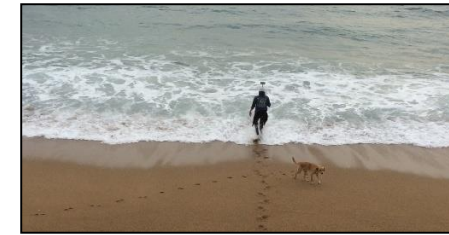
- Beach monitoring

Date	Observation
2017-06-09	Pre storm
2017-06-20	Post storm 1
2017-06-29	Post storm 2
2017-07-31	Recovery month 1
2017-08-29	Recovery month 2
2017-10-03	Recovery month 3
2017-10-31	Recovery month 4

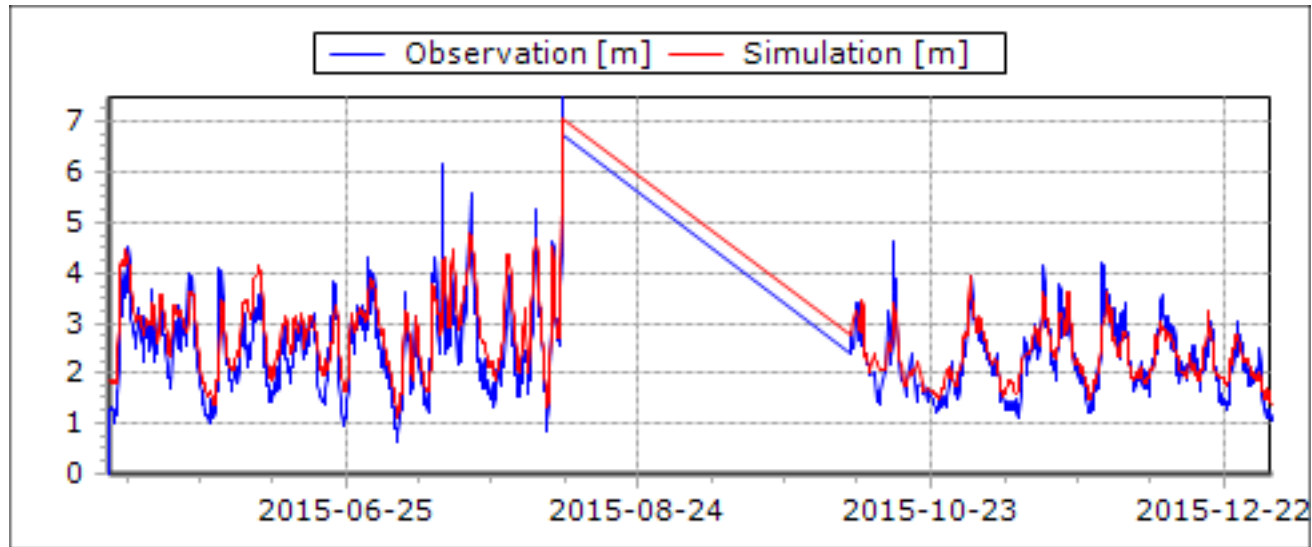
- Fully spectral, every sea state
- NCEP deep water recreated spectra
- Local seas generated by 2D wind field
- Deep water model:
 - Unsteady
 - Calibrated against deep water buoy

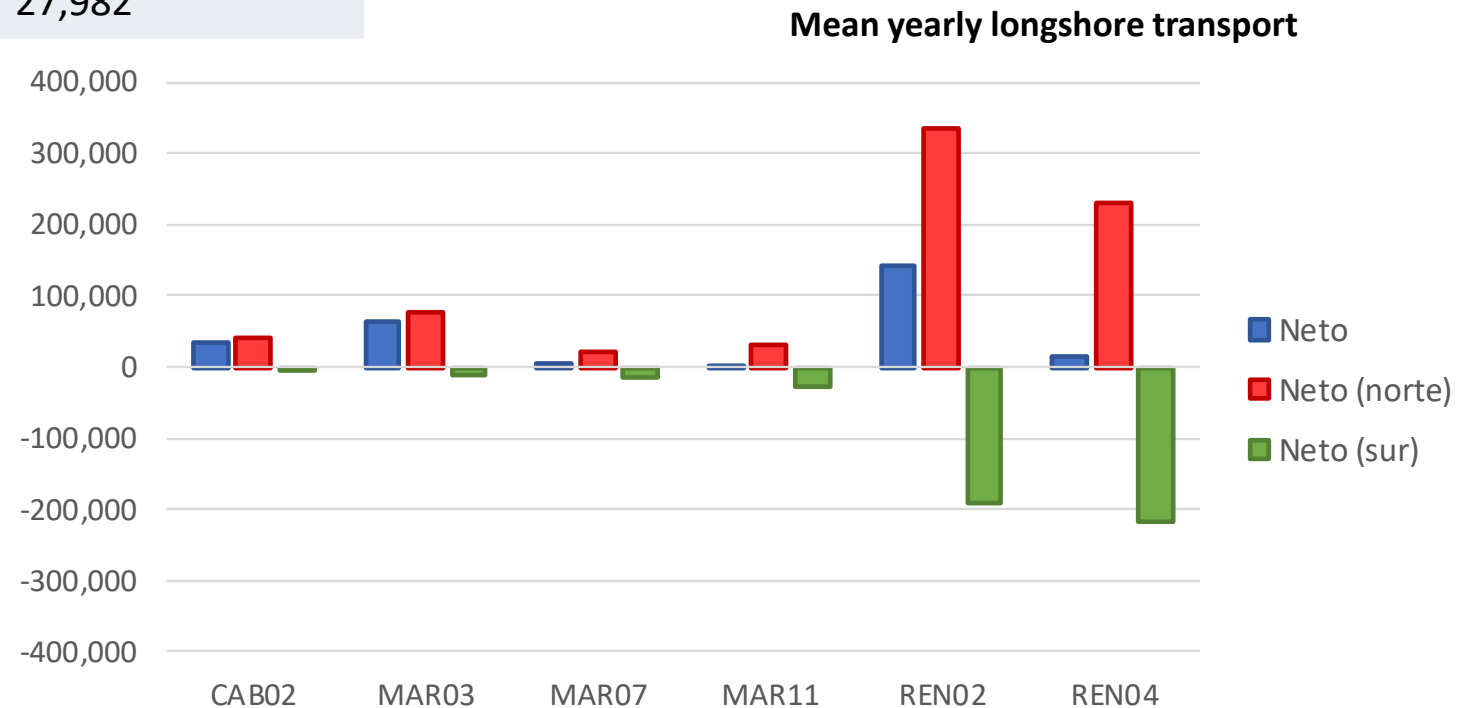
- Net transport close to zero
- Gross transport increases northward

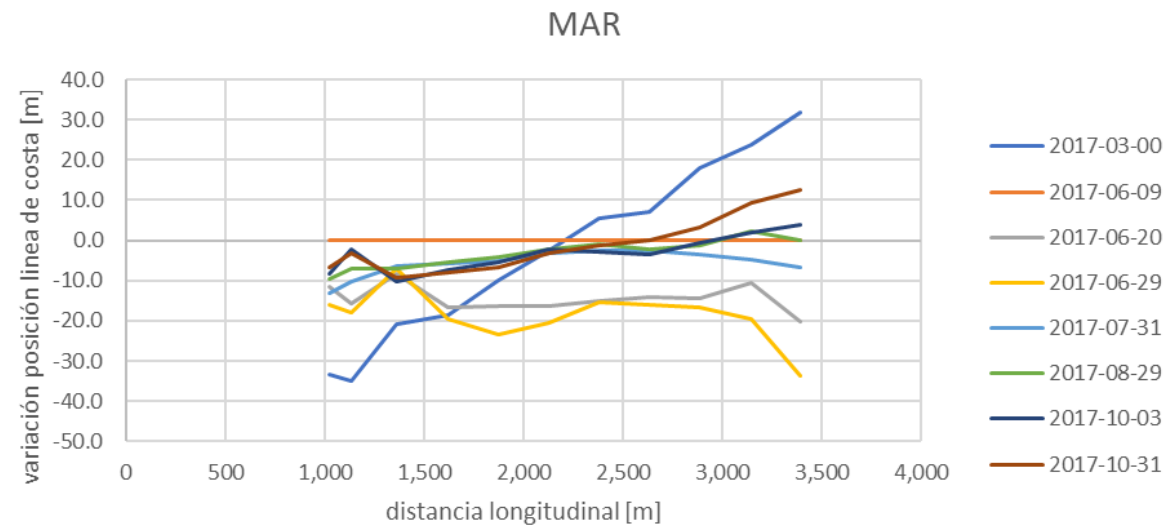
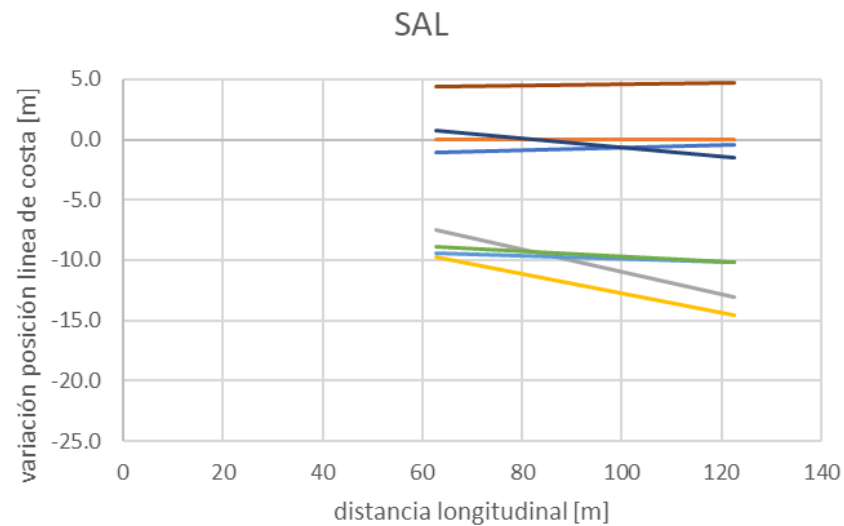
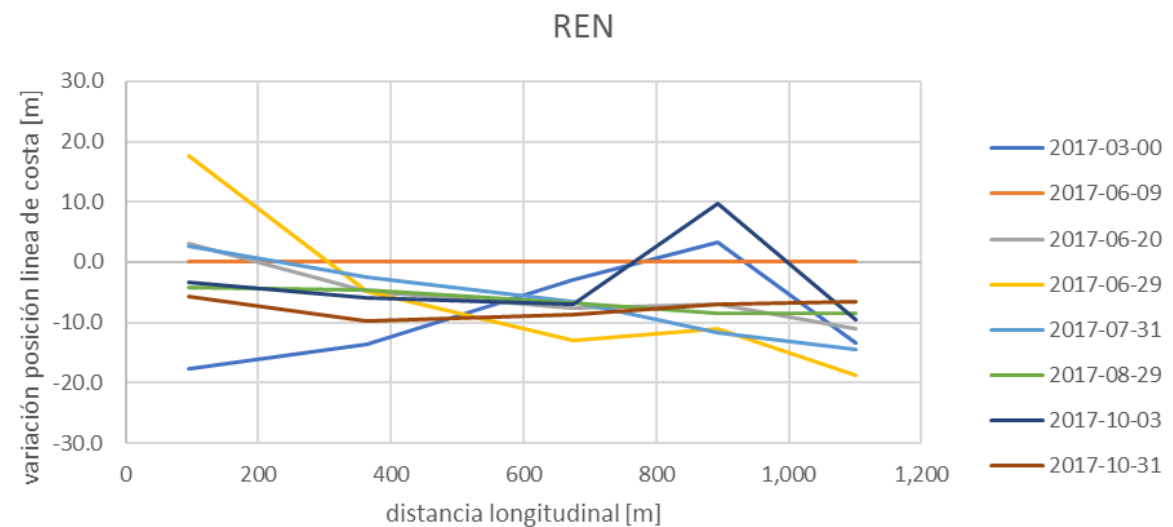
- Beach monitoring – coastline position

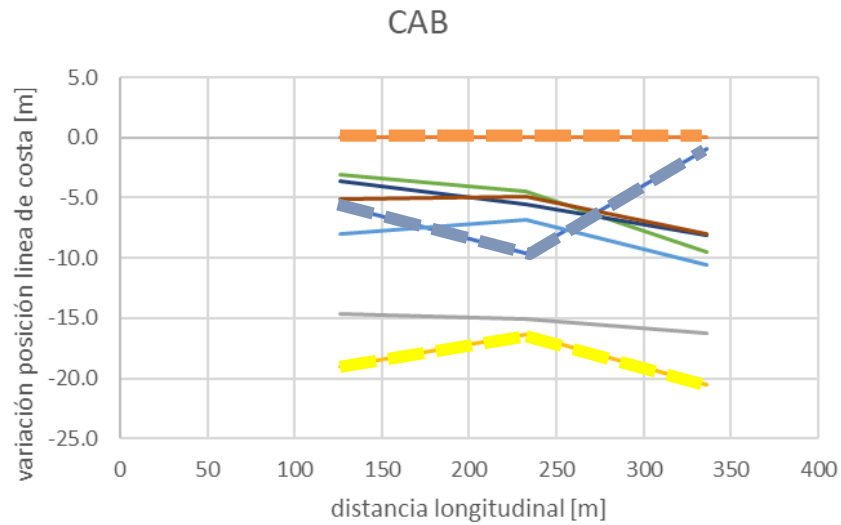
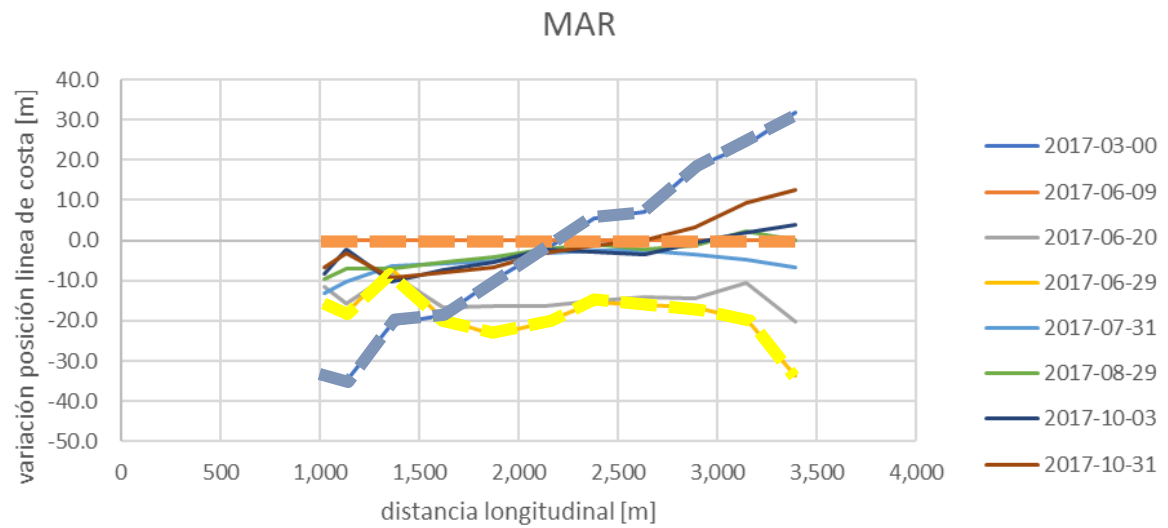
- Two groups of beaches
 - Confined/pockets beaches
- Coastlines reacts to storms
 - Retreat
- Berm volume slowly increases after storms

Longer, tilting beaches

Retreat and tilt

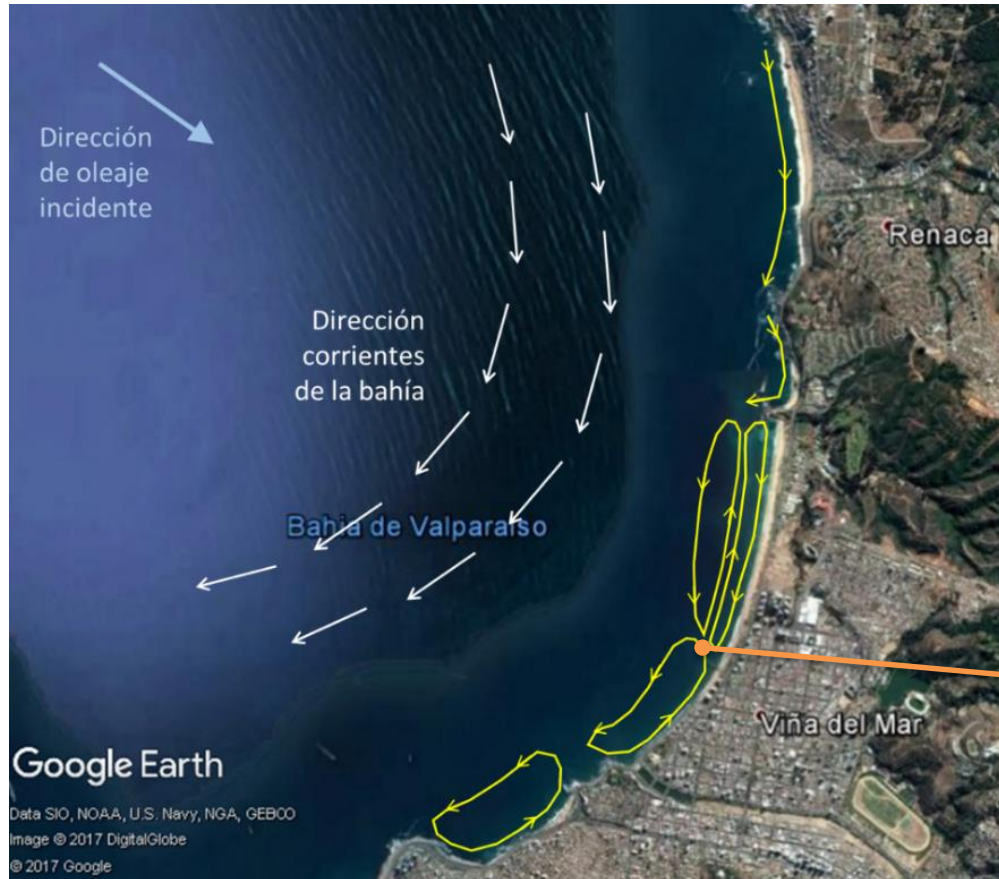
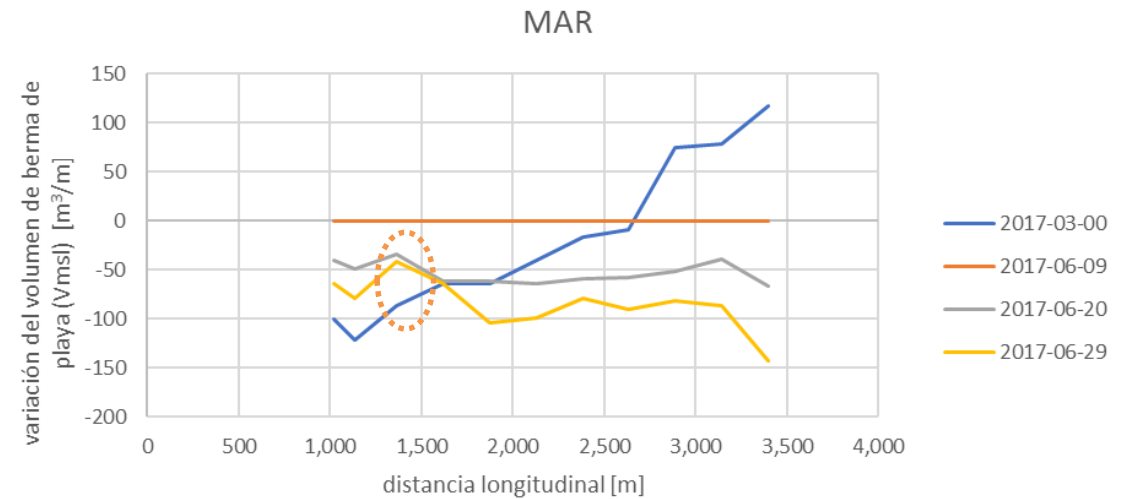
Convergence of currents
→ Expected sediment deposition

Debilitation of circulation might
explain 2015 unusual erosion

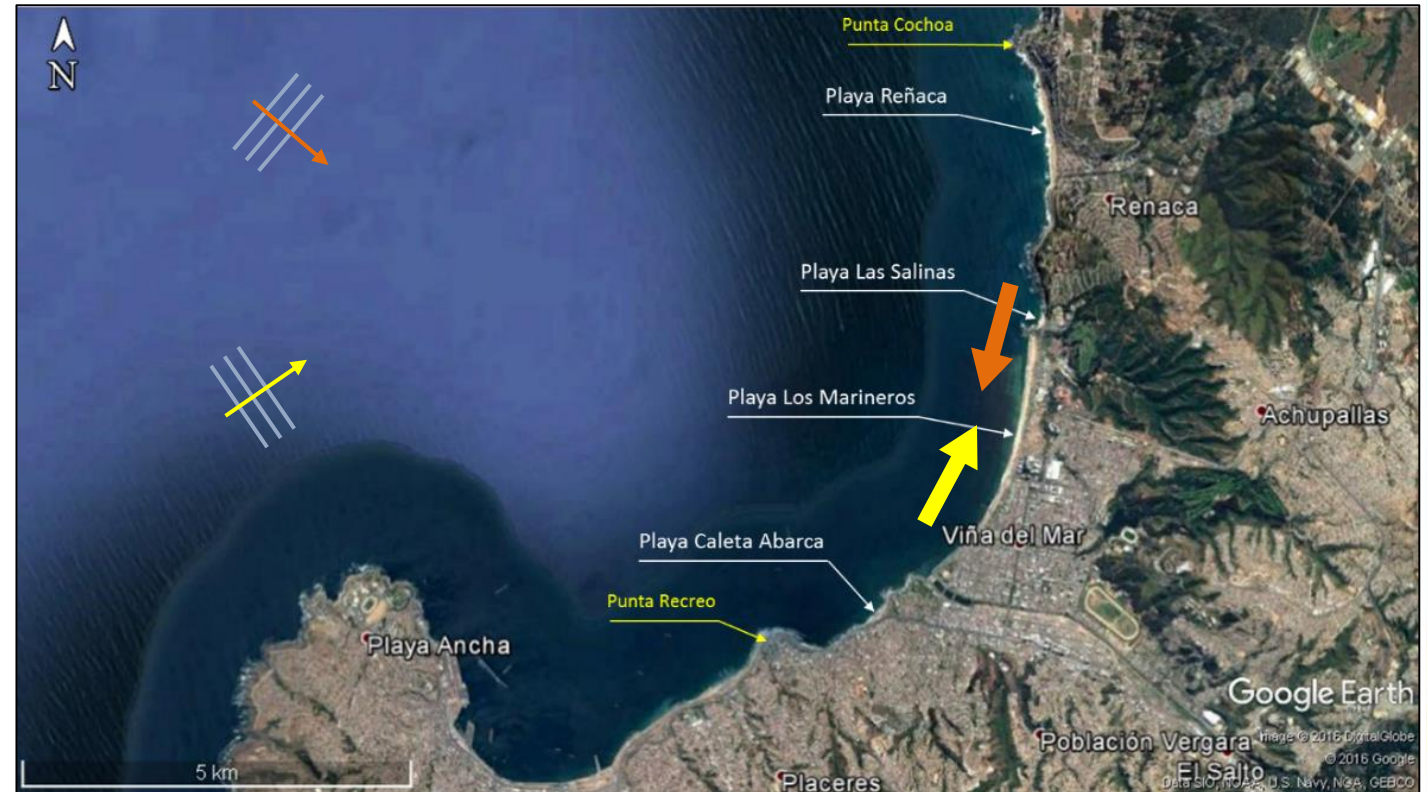
- Northward transport
 - Small rates
 - Rather constant through the year
 - Associated to mean wave conditions
- Southward transport
 - Larger rates
 - Eventual
 - Associated to storm waves
- ~Relatively balanced
- **Beaches are mostly closed systems**
- Debilitation of circulation might explain 2015 unusual erosion
