36TH INTERNATIONAL CONFERENCE ON COASTAL ENGINEERING 2018

Beach Morphological Changes on Sendai Coast by Typhoon Lionrock

1. Introduction ~ Typhoon Lionrock, 2016

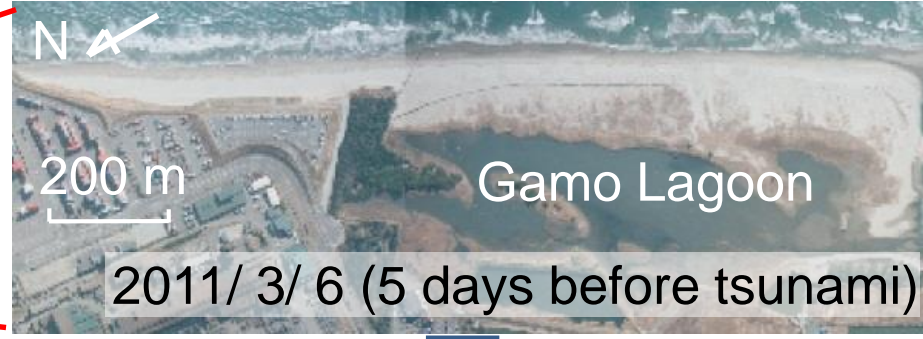
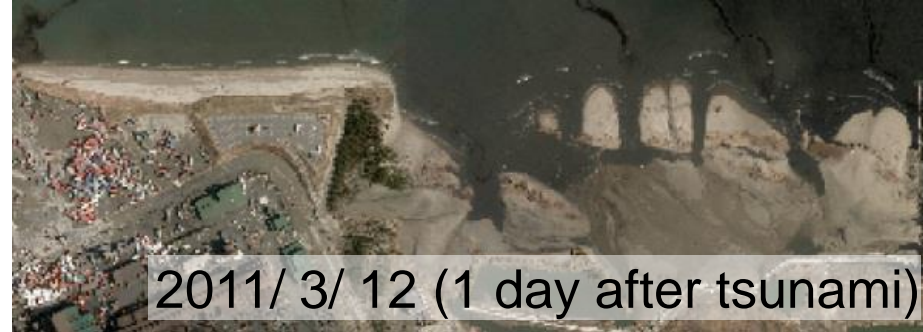
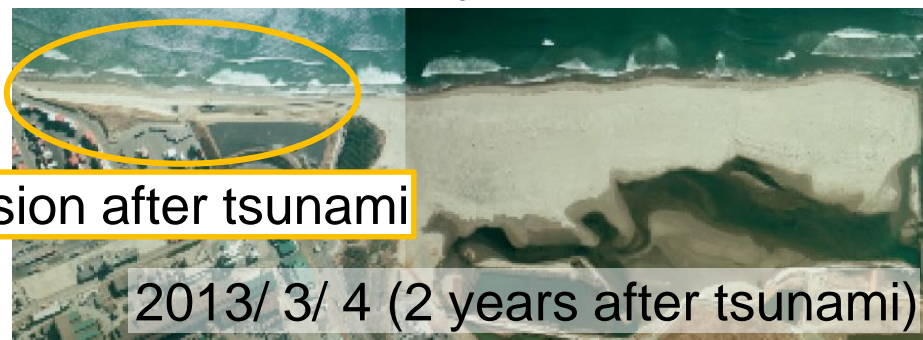
Effect of the 2011 Great East Japan Earthquake Tsunami

Erosion and breaching of sand dune

Remaining effect on the beach process

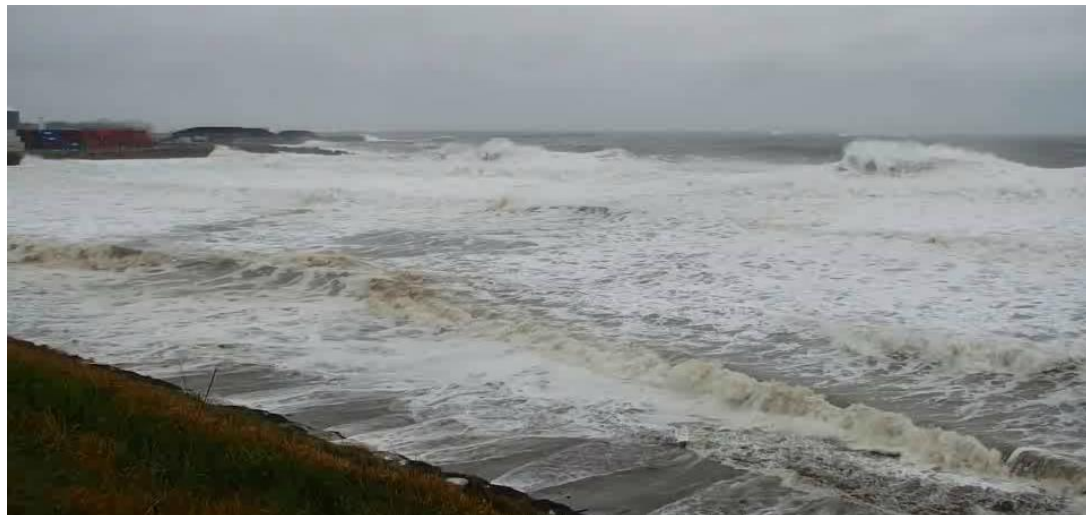
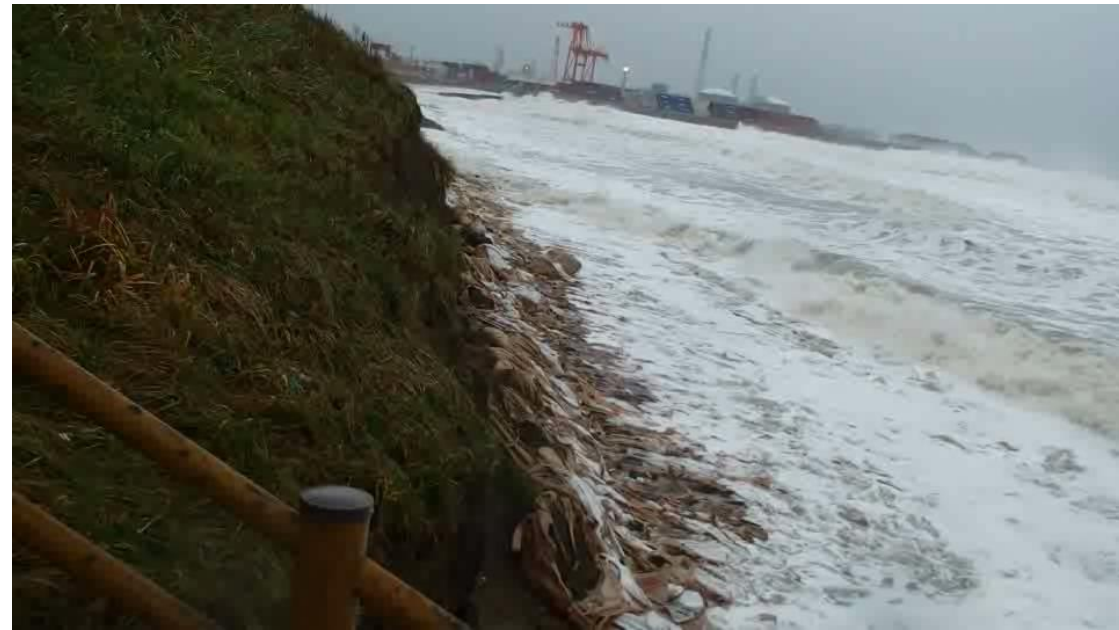
Erosion of embankment toe by the waves

High waves during the typhoon event

- Maximum runup height: about 4 m from MSL
 - ➔ Lower than the original height of the coastal dykes (5m) in this area
- Severe erosion of the embankment toe near Sendai Port
- Wave overtopping of the sand dunes of both Gamo and Idoura Lagoons
 - ➔ Sediment transport over the sand dunes

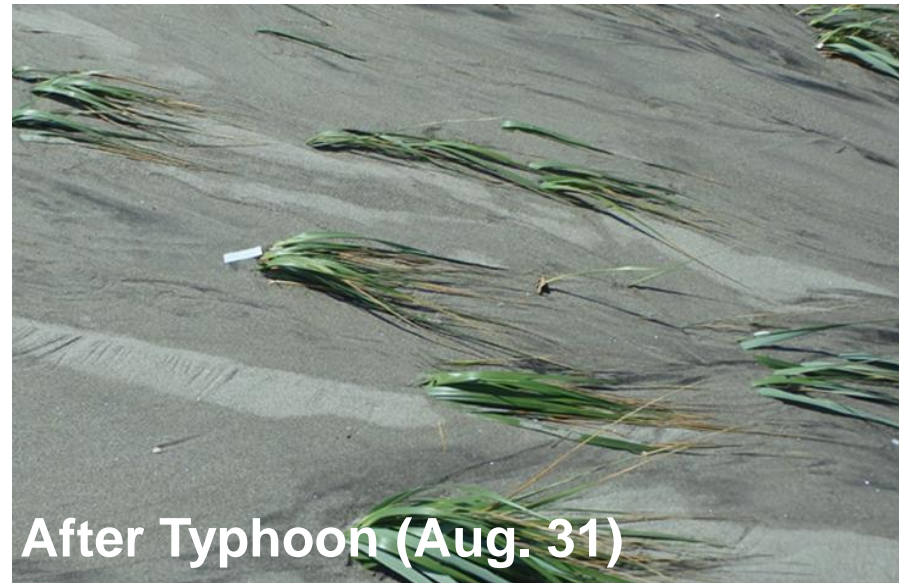
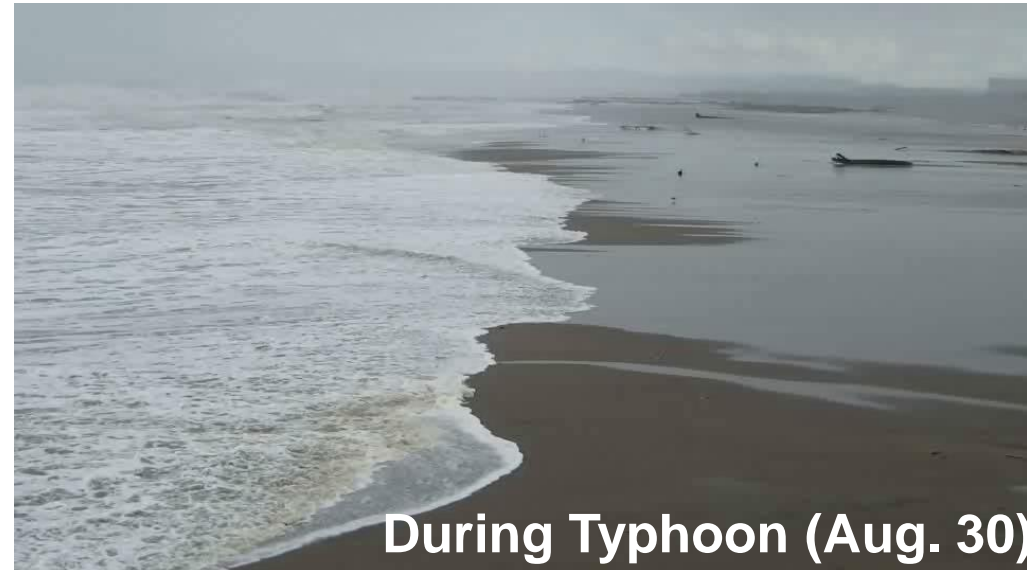
Grasses bended by the wave overtopping

Sediment transport over the sand dune

Wave Overtopping of Sand Dune

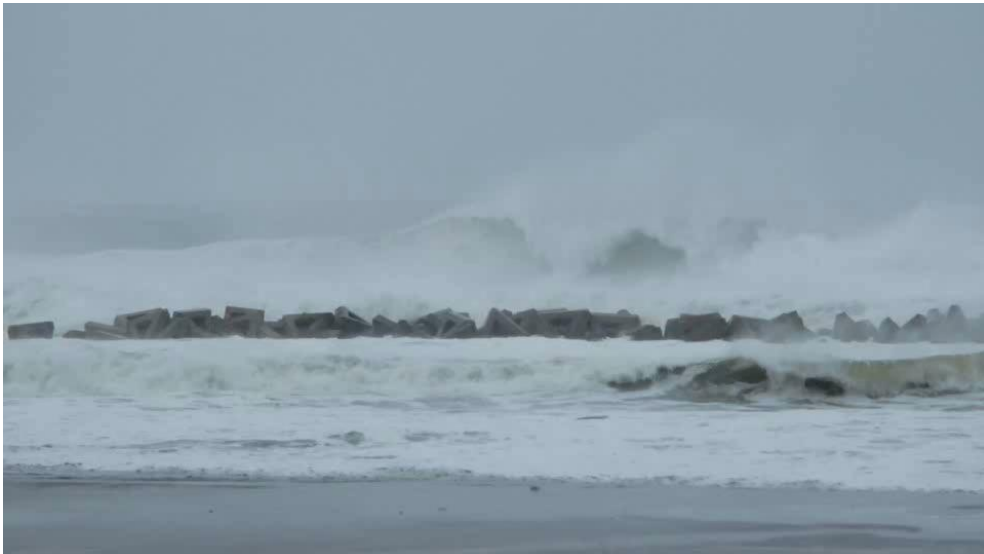
High waves during the typhoon event

Maximum run-up height: approx. 4 m

Lower than the previous height of the coastal dykes (before the 2011 tsunami event: 5.2 m from MSL)

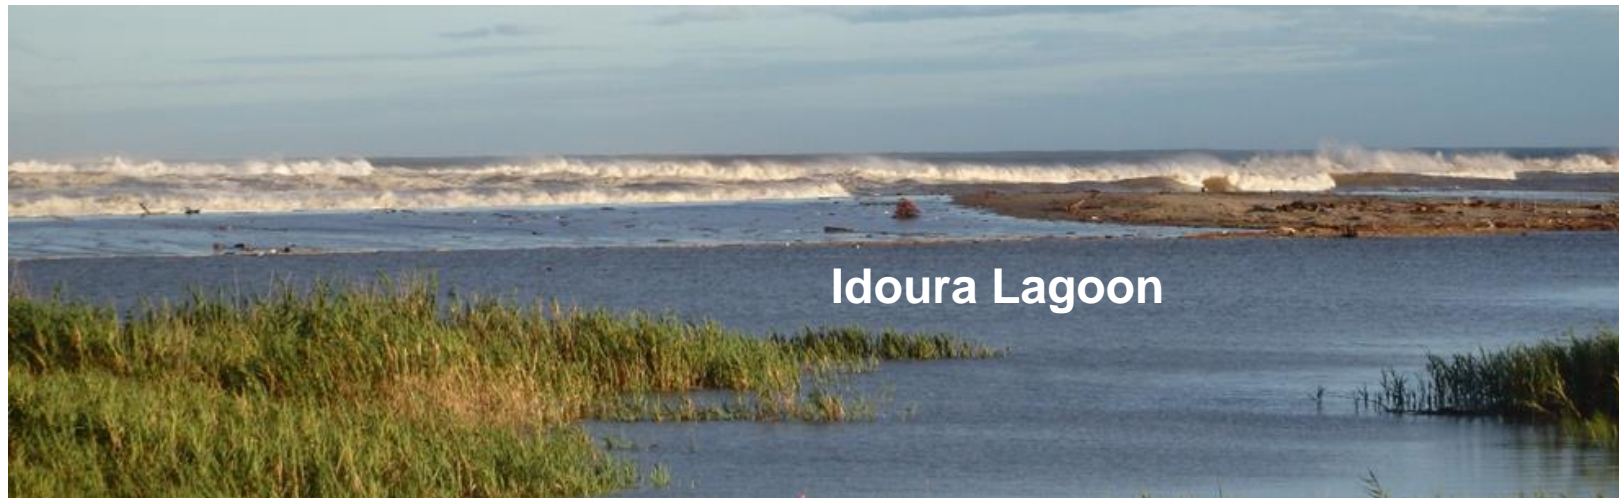
Wave overtopping of sand dune

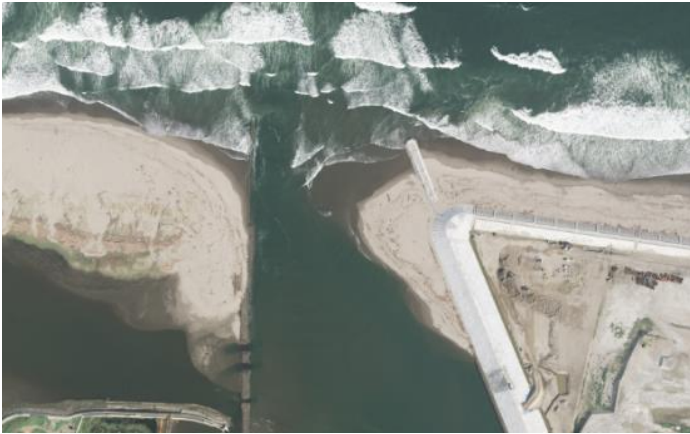
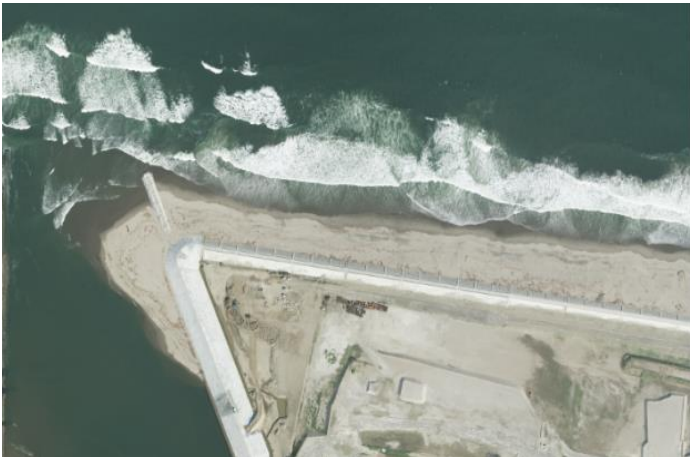
Aerial Photos on Sep. 1, 2016

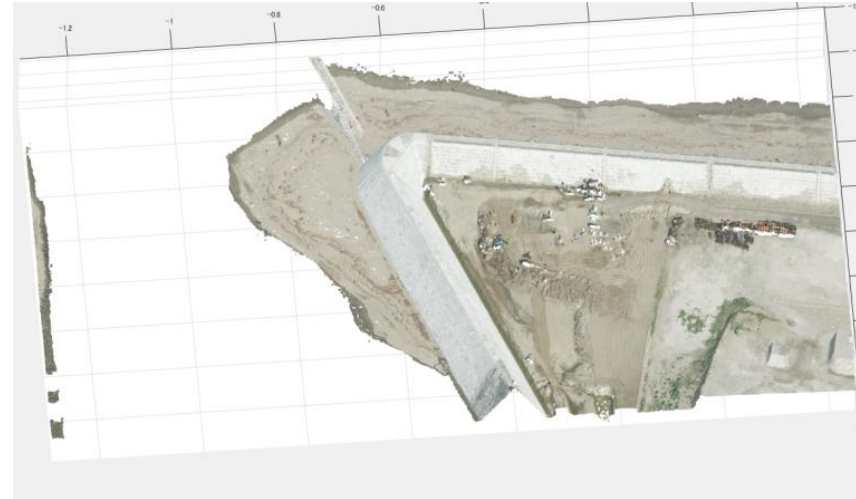
3D Topographical Data

DSM (Digital Surface Model): 1m-mesh

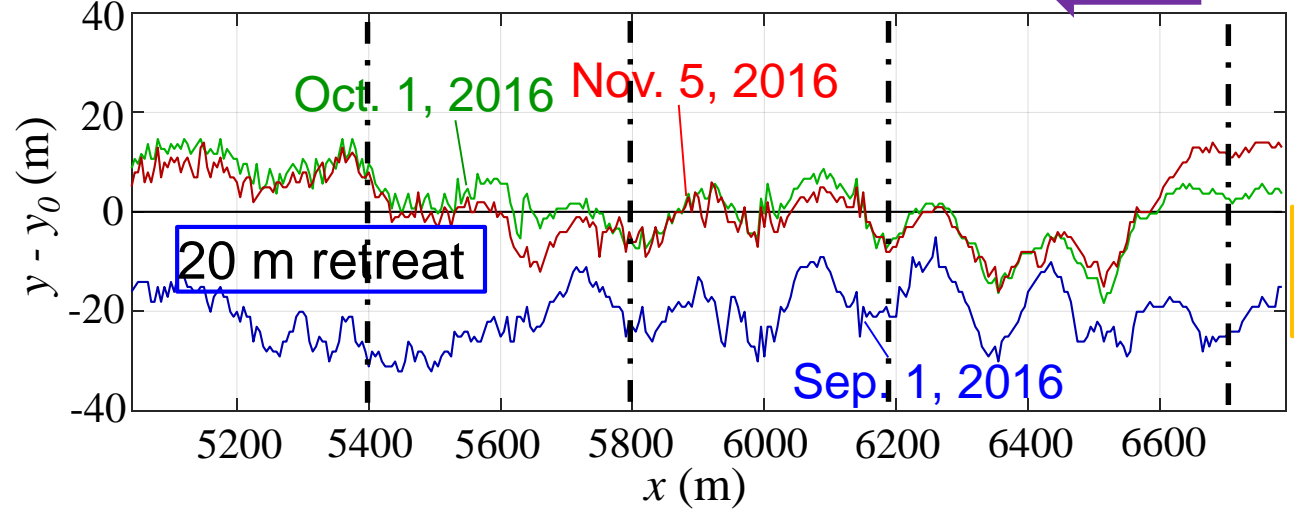
Longshore sediment transport ←

Shoreline Change (y_0 : shoreline position on July 12, 2016)

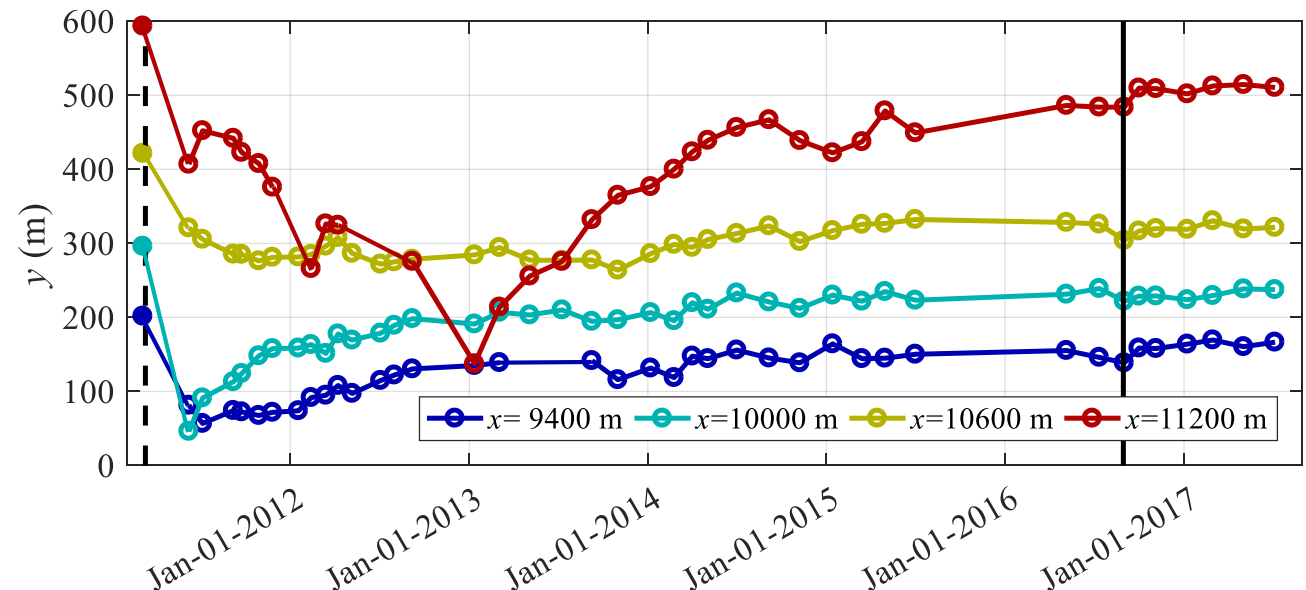
Time series of shoreline positions after the 2011 tsunami

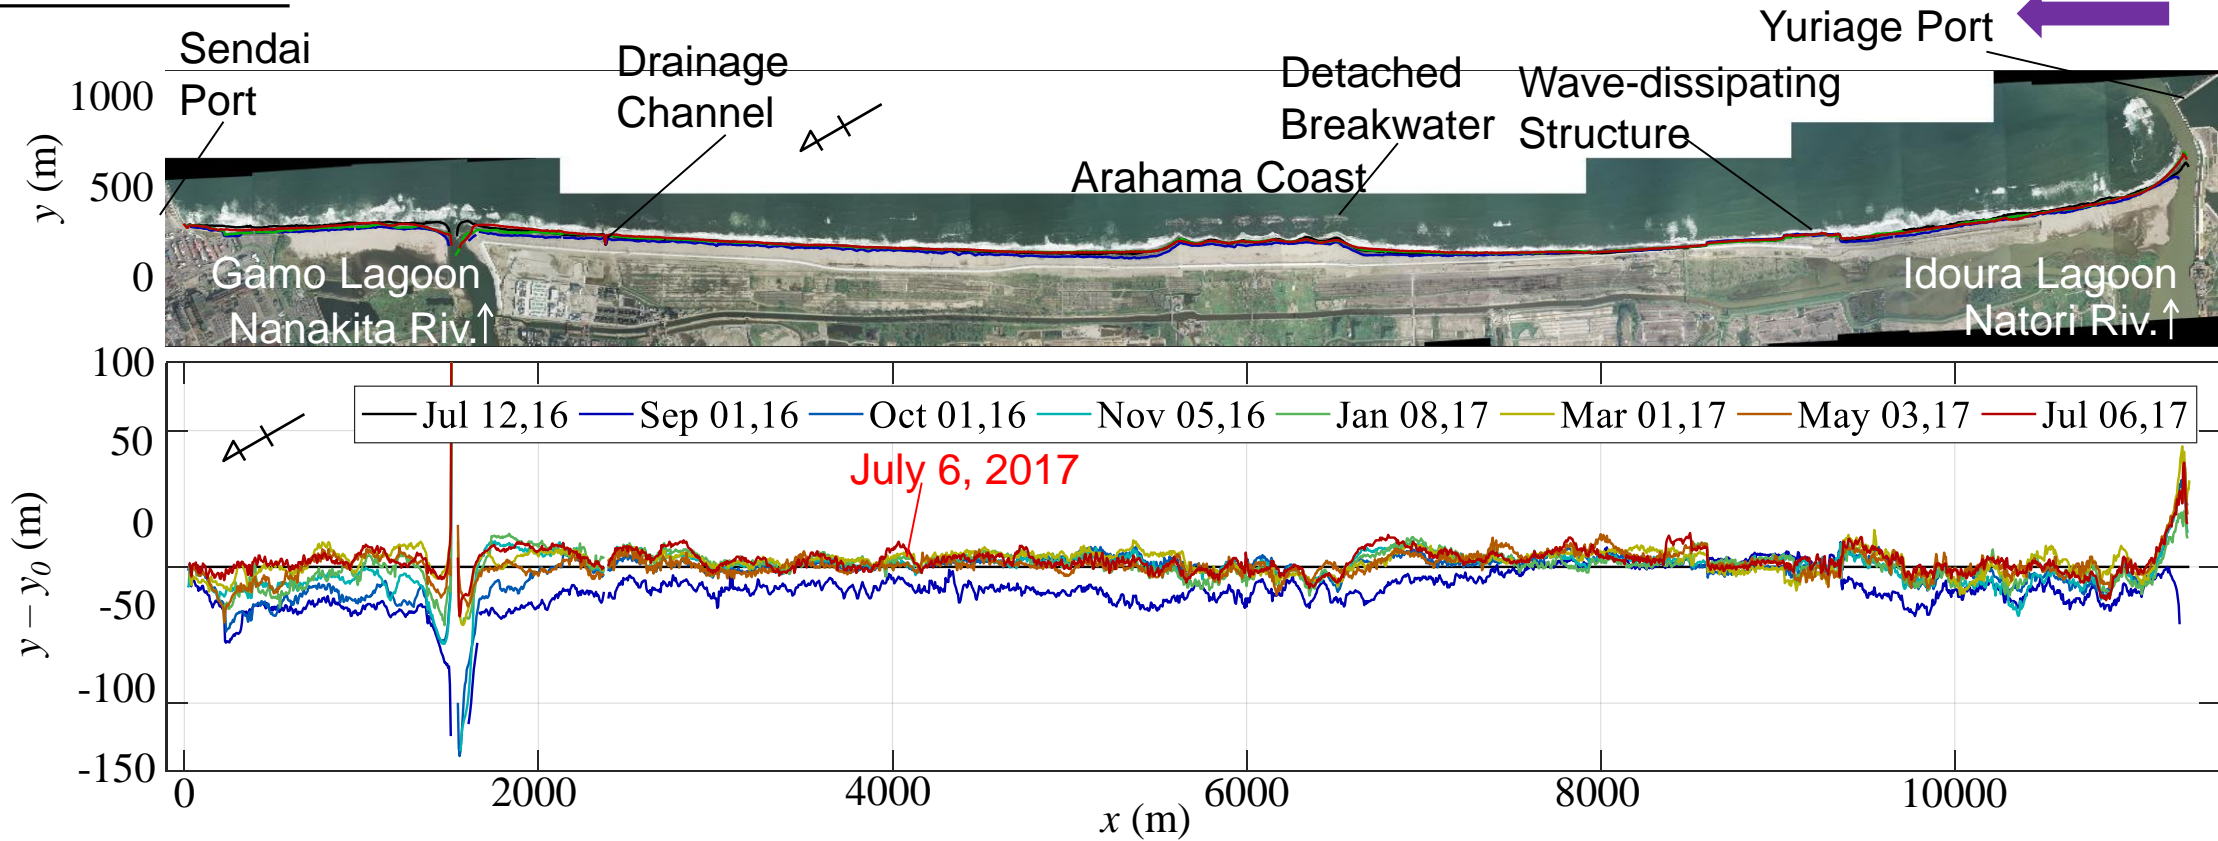
Including the lagoon areas, shoreline positions recovered in one year and no remaining effect has been observed.

- 20 ~ 30 m retreat of shoreline in whole area which is not the most significant after the 2011 tsunami
- More rapid and larger recovery was observed on the updrift sides of river, detached breakwater and structures intruding into coast line due to the effect of the 2011 tsunami
- Deposition of sediment along the seaward toe of the coastal dyke
 - ➔ No significant effect on shoreline changes
- Slower recovery around the lagoon areas which seem to be caused by the loss of the sediment due to the sediment transport by the wave overtopping
- No remaining effect of this event was observed after 1 year from the event
