RAPID DEPLOYMENT AND POST-STORM RECONNAISSANCE OF HURRICANE LAURA

Navid H. Jafari, Louisiana State University, njafari@lsu.edu
Qin Chen, Northeastern University, q.chen@northeastern.edu
Jack Cadigan, Louisiana State University, fcadig1@lsu.edu

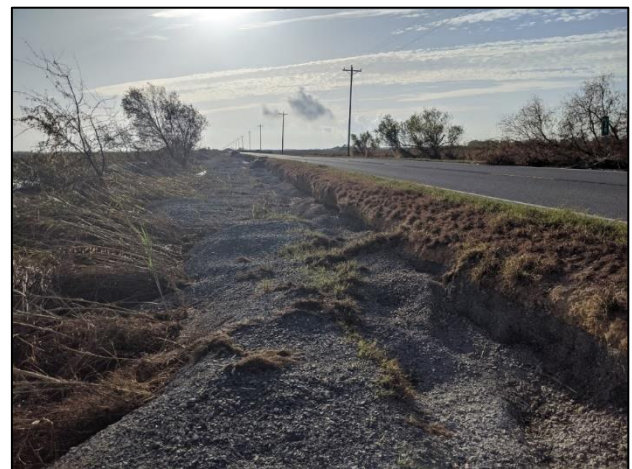
The field observations were focused on overland flow and flood mitigation infrastructure, including earthen embankments, breakwaters, and natural features (wetlands), under the extreme hurricane forcing. For example, the critical failure mode of the earthen embankments that formed Highway 82 was surge and wave overtopping, which led to scour and erosion (Fig. 2A). Measuring overland flow, extent of scour damage, and geotechnical properties of the embankment can lead to better models for predicting overtopping damage.

Fig. 2 Images of (a) Highway 82 showing scouring of coastal embankment, and (b) Shoreline of Rockefeller Refuge after Hurricane Laura.

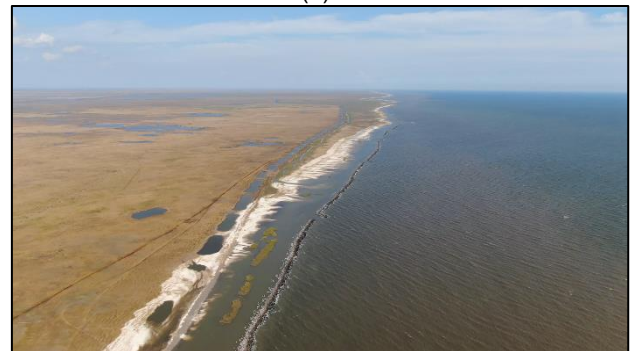
(b)

findings from the elevation transects indicate that the shoreline with breakwaters migrated inland 20 m; without migrated 40m. The elevation for the sand beach decreased from an average pre-storm 1.3 m NAVD88 to 0.8 m NAVD88, i.e., a loss of 0.5 m of elevation due to Hurricane Laura.
