ASSESSING THE EFFECT OF EARTHQUAKE-INDUCED UPLIFT AND ENGINEERING WORKS ON A SURF BREAK OF NATIONAL SIGNIFICANCE

Tom Shand^{1,2}, Simon Weppe³, Peter Quilter¹, Andrew Short⁴, Ben Blumberg⁵ and Richard Reinen-Hamill¹

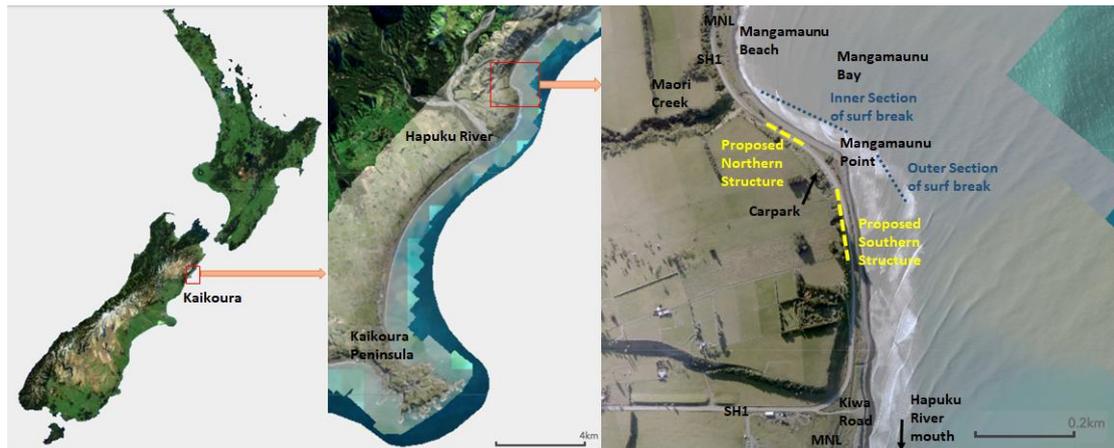
Figure 1. Location and features of Mangamaunu Point, surf break and proposed works

Mangamaunu Point is located on the northern edge of the Hapuku River Delta some 2.5 km north of the Hapuku River mouth and 12.5 km north of Kaikōura township (Figure 1). Mangamaunu is a right hand point break with waves peeling along a cobble and boulder seabed off Mangamaunu Point. The Point comprises an outer section which picks up more southerly swell but is of lesser quality and an inner section which works better on east to northeast swells (Figure 3). This results in waves with long walls and hollow sections peeling for up to 250 m.

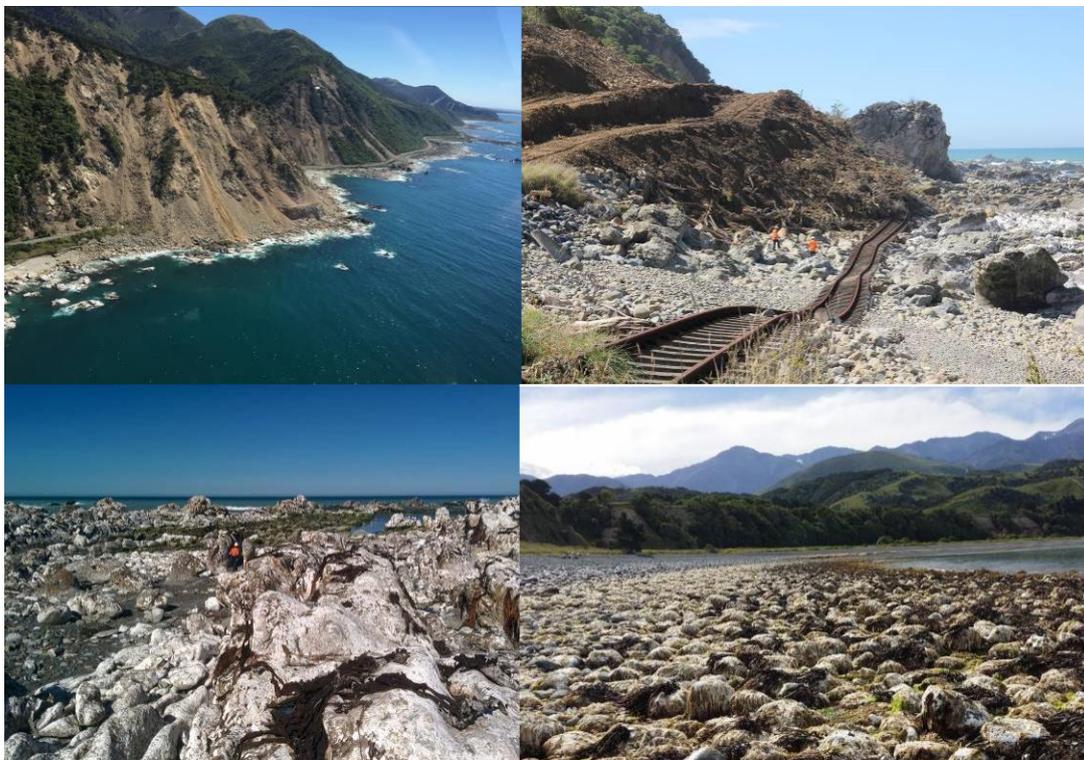
Figure 2. Effects of November 2016 Earthquake: Top Left - Ohau Pt, NCTIR; Top right - Kiwirail Main North Line, Stuff; Lower Left - Uplift at Waipapa Bay, T. Shand); Lower Right - Uplift at Mangamaunu, K. Shaw.

On 14 November 2016, an earthquake comprising a complex sequence of ruptures lasting over 2 minutes and with a combined magnitude of 7.8 occurred approximately 60 km south-west of the Kaikōura Township, on the east coast of the South Island and lower North Island (Figure 1). Rupture reached the ground surface on more than 20 faults with maximum horizontal displacements of up to 12 m and vertical movement of up to 9m (NZCS, 2019). Thousands of landslides were recorded over the region with over 80 landslips occurring along coastal slopes and blocking rail and road corridors (Figure 2).

The surf break was also impacted by the November 2016 earthquake with the seabed and foreshore being raised by around 0.8 m (Figure 2). Based on local surfer feedback, this resulted in changes to the apparent water level and observed wave breaking characteristics.

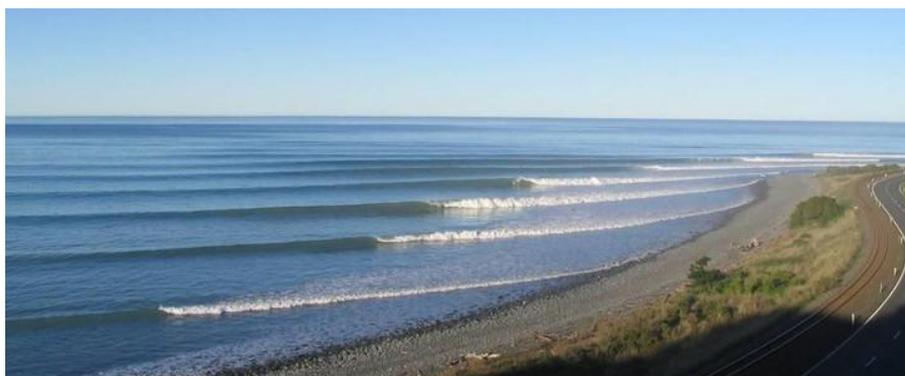
Figure 3. Inside section of Mangamaunu surf break (photo: Brent Proctor)

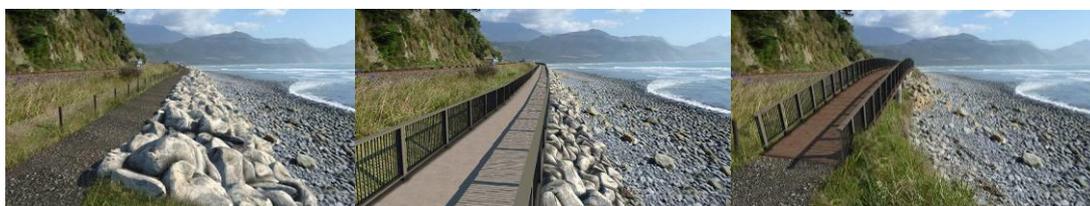
Figure 4. Landscape visualisations of the engineering works proposed to support the shared path (source: NCTIR)

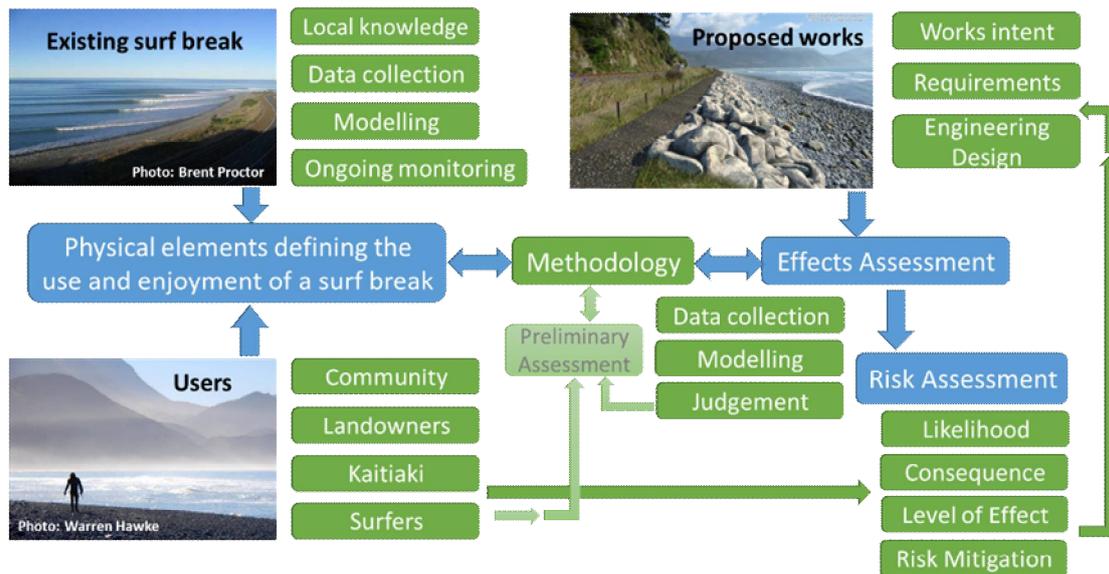
Figure 5. Framework utilised to characterise the surf break, and to assess effects and risk from proposed works (source: Shand et al., 2019)

In order to assess the potential effects of the proposed works on the surf break at Mangamaunu a framework was developed (Figure 5). The framework is described in detail in Shand et al., (2018, 2019) but first characterizes the existing environment and the way in which the surf break is used and enjoyed by the local community (Figure 6). The potential effects of proposed works on that usage could then be evaluated using appropriate methodologies (Table 1) with results used to inform a risk assessment that could be fed into decision-making or design optimisation.

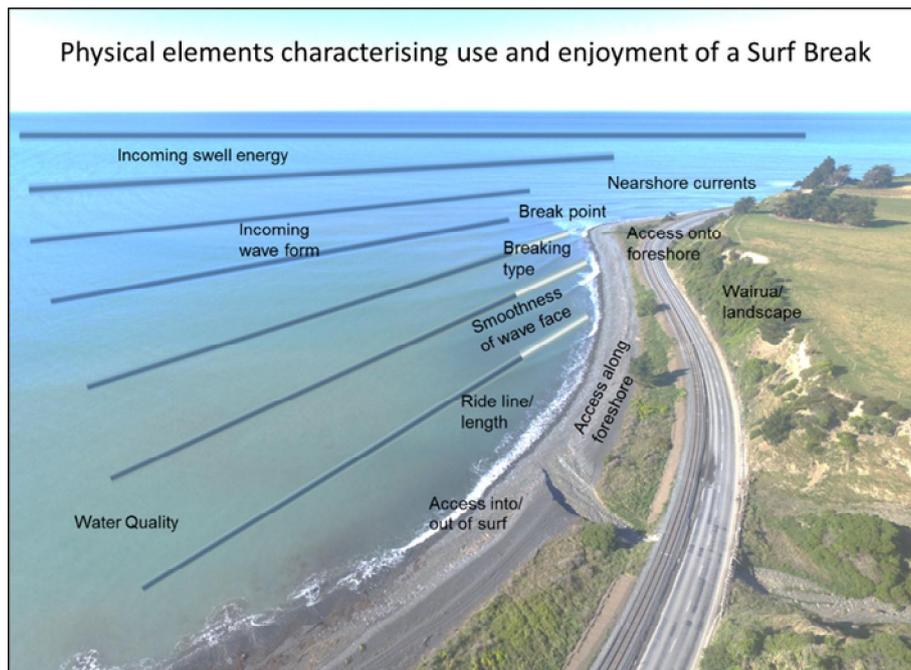
Figure 6. Physical elements affecting the use and enjoyment of a surf break (source: Shand and Reinen-Hamill, 2018)

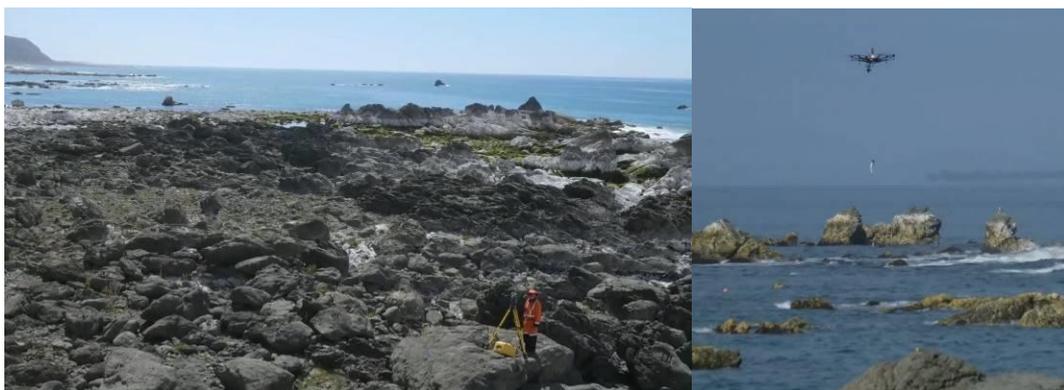
Figure 7. Topography and bathymetry of Mangamaunu Point (m NZVD2016)

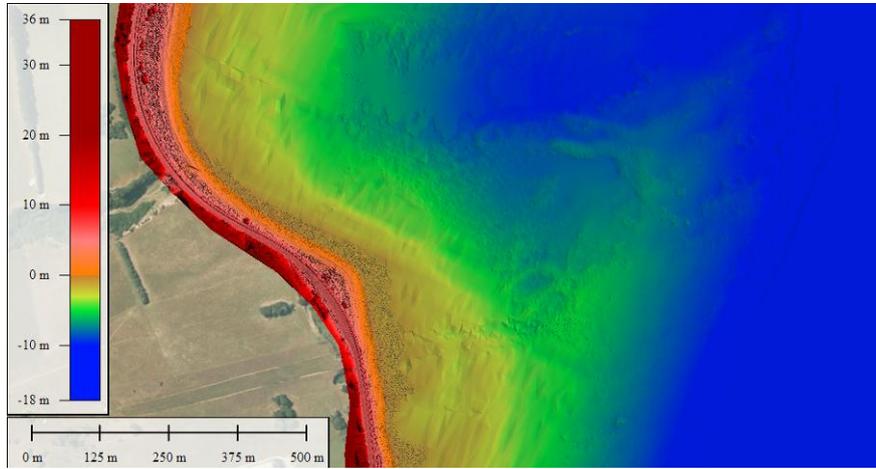
Figure 8. Topography and bathymetry of Mangamaunu Point (m NZVD2016)

Topography has been collected by a combination of LiDAR (Nov 2016, Nov 2017, May 2017, June 2018) and unmanned aerial vehicle (UAV) photogrammetry (January 2018, September 2019). Bathymetry was collected using multi-beam survey offshore (November 2017) and an innovative UAV dipping method (July 2018) in the nearshore. This method, developed during the NCTIR project and described in detail by Perwick (2018), utilizes a Trimble E8 GNSS receiver on a DJI Matrice 600 UAV for accurate positioning with a dipping line and spring mechanism to identify the point at which the seabed is reached a known distance below the UAV (Figure 7). This approach is slower than water-bourne survey but removes or reduces barriers associated with weather, shallow water, other users and obstacles. Combining these various survey, a complete terrain model of the relevant topography and bathymetry has been generated (Figure 8).

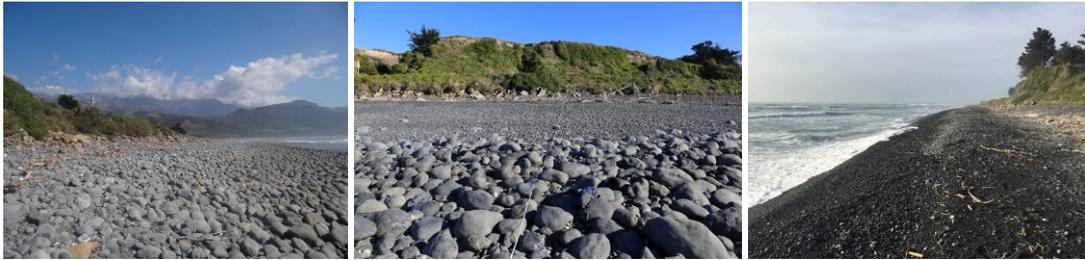
Figure 9. Example of beach sediments in Jan 2018 (top), July 2018 (middle) and Sept. 2018 (lower) south of Mangamaunu Point with a high tide gravel and coarse sand beach evident in the later photographs

boulder and cobble substrate is an ephemeral beach comprised predominantly of gravels with some coarse sand size material. This beach level fluctuates depending on wave and sediment supply (Figure 9).

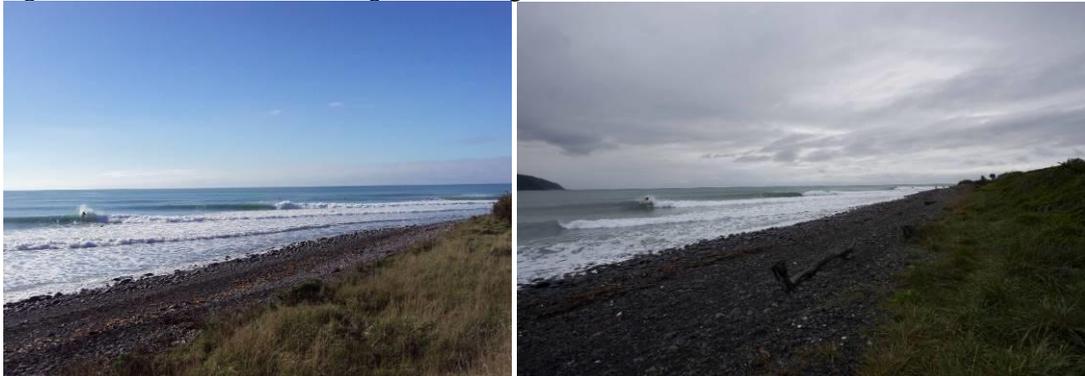
Figure 10. Optimal conditions occurring along the Mangamaunu inside section on 10 May 2010 (left, M. Moriarty) and 22 March 2018 (right, H. Melville)

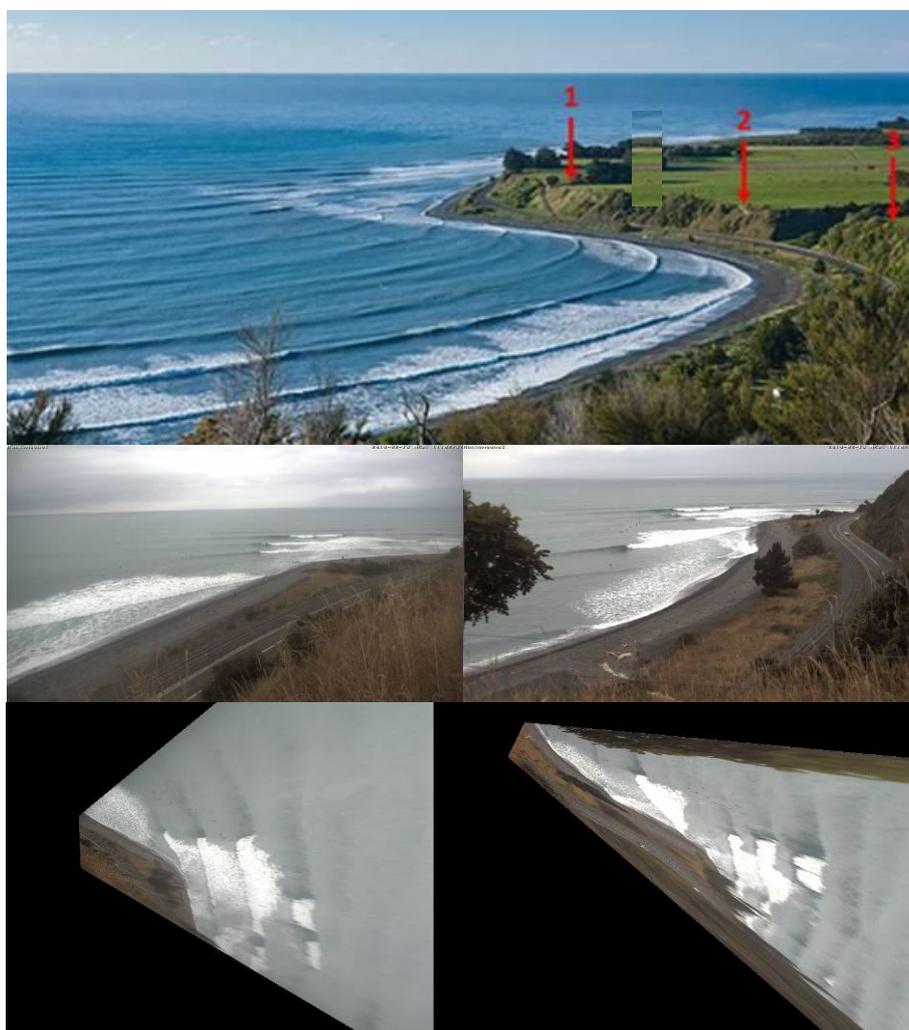
Figure 11. Location, field of view and rectified view of two remote camera systems installed at Mangamaunu

Two solar-powered cameras were installed on the cliff top overlooking the Mangamaunu Surf Break (Figure 11). The southern camera (1) looks over the outer section and the top of the inner section, and the northern camera (3) looks up the point including both the inner and outer sections. The cameras are M26 Mobotix MX-M26A-6D with a L32/B061 (35mm) lens on camera 1 and a L65/B119 (65mm) lens on camera 3. Images are being captured at 1920 x 1080 pixels at 1 frame/second for the first 20 mins of every hour with images transmitted to a control station and stored for processing. These cameras recorded imagery from 13 September 2018 to 12 November 2019.

Ground Control Points were surveyed on land (permanent GCPs), on the foreshore (temporary land GCPs) and in the nearshore (temporary marine GCPs). The land-based GCPs were surveyed using RTK-GPS and the marine GCPs using a Trimble E8 GNSS receiver on a DJI Matrice 600 UAV with a sphere suspended a known distance below. These GCPs are used to relate real world coordinates (Northing, Easting, Elevation) to pixel location (m,n) for each camera. This process allows images to be corrected for perspective distortion and geo-referenced for further analysis. This rectification was carried out using the *g_rect* software package (Bourgault et al., 2020).

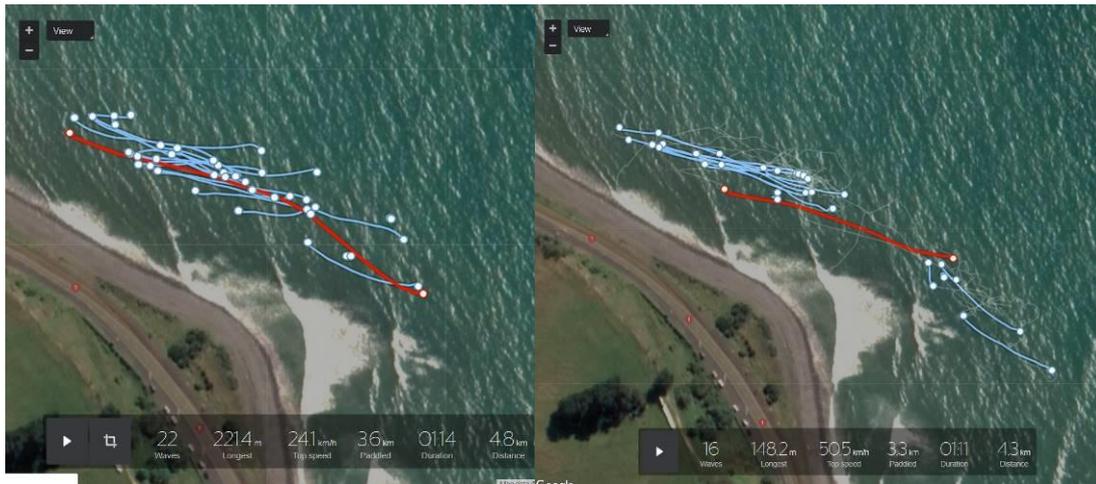
Figure 12. Example of wave ride lines recorded for two session using the GPS surf watch

A GPS watch (Rip Curl Search GPS) has been deployed with local surfers recording information on their rides (Figure 12). Horizontal accuracy is not stated but is expected in the order of 5m. These records are then extracted into a GIS for comparison with camera imagery and wave model break points/ride line during similar conditions to provide further validation.

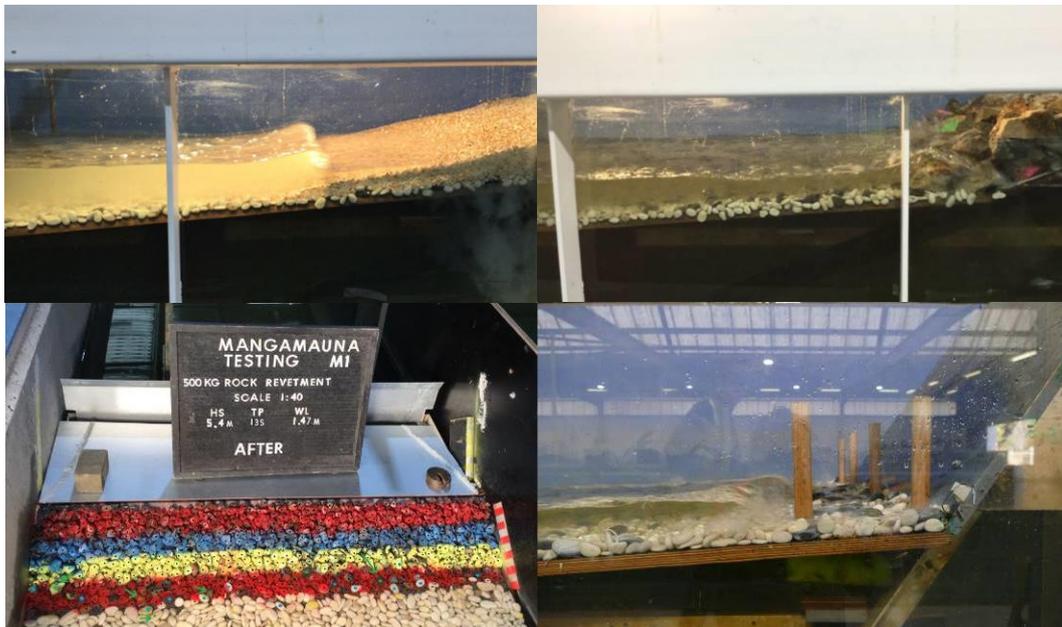
Figure 13. Physical modelling testing of the existing boulder beach (top left), a 2T rock armour revetment (top right) with optimization of the rock revetment (lower left) and testing of a piled structure (lower right)

Physical model testing was undertaken at Manly Hydraulics Laboratory to validate and allow value engineering of the revetment structure, and to test the effect of the structure on wave reflection. Wave reflection was assessed for the existing boulder foreshore without a gravel beach, the foreshore with a gravel beach, 2 T and 500 kg rock armour revetments and a piled structure (Figure 13). Tests were undertaken for the upper limit of surfable conditions ($H_s = 2$ m) with period of 13 s and a range of high tide and high tide + sea level rise conditions as well as 20 and 100 year ARI events. Testing was undertaken on two representative profiles for the southern (M1) and northern (M2) revetments. Reflection is computed using a three probe array in deep water using the methods of Mansard and Funke (1980) to separate incident from reflected wave spectra. A series of three tests were undertaken for the existing foreshore under identical wave and water level conditions. These showed reflection within 0.1% validating the repeatability of tests.

The existing beach exhibited reflection of 17.5% at the southern profile and 12.5% at the northern profile during surfable conditions at MHSW and including +0.3 m sea level rise (SLR) With a gravel beach present, reflection values are slightly (+1 to 1.5%) higher. Results generally indicated that the

revetments do not have substantial effect on reflection with changes to absolute reflection in the order of $\pm 1\%$ under surfable conditions and $\pm 3\%$ under storm conditions. It is acknowledged that these reflections are measured offshore in 10m water depth and higher reflections may occur in shallower water before the reflected waves deshoal.

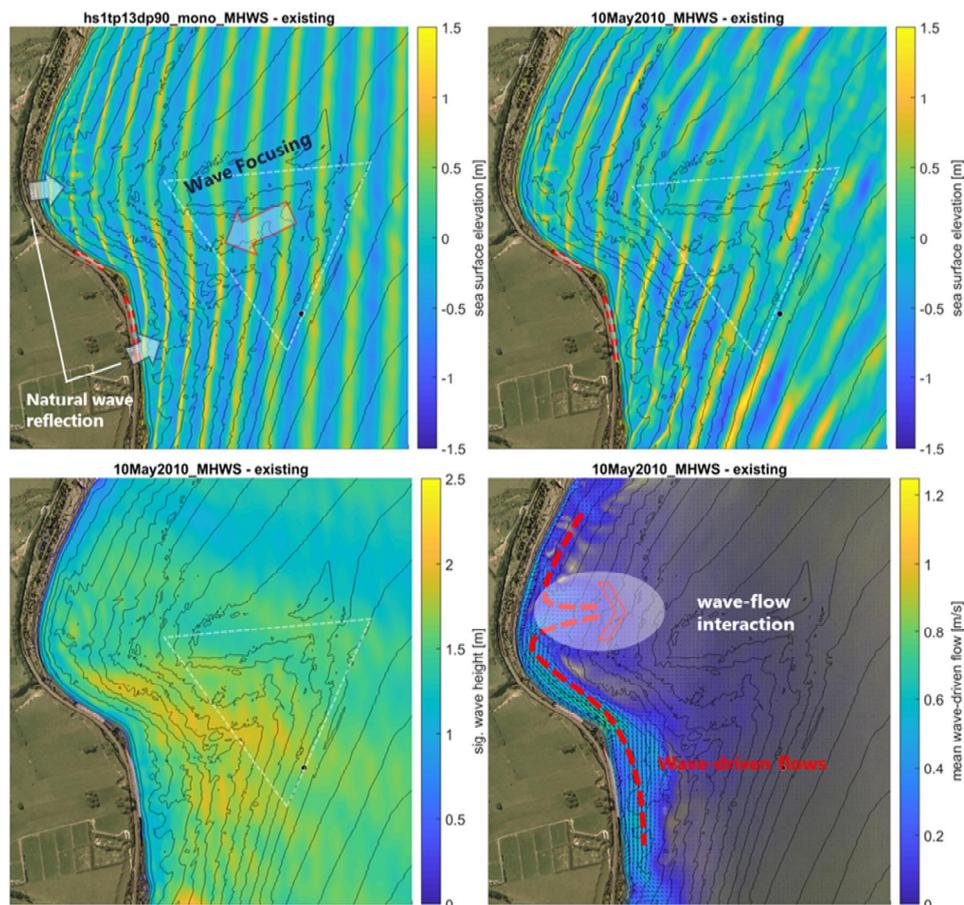
Figure 14. Examples of water level snapshots during optimal monochromatic (top left) and spectral (top right) surfing conditions. Bottom panels show significant wave height (left) and mean flow fields (right) during the 10th of May spectral wave conditions.

The SWASH simulations were applied over a domain of 1400 by 900 grid cells, with a spatial resolution of 2 m (Figure 14). The model was run in depth-averaged mode accounting for wave breaking using the hydrostatic front approximation (Smit et al., 2013). Full detail of the analysis is provided in Shand and Reinen-Hamill (2018) and Weppe et al. (2019).

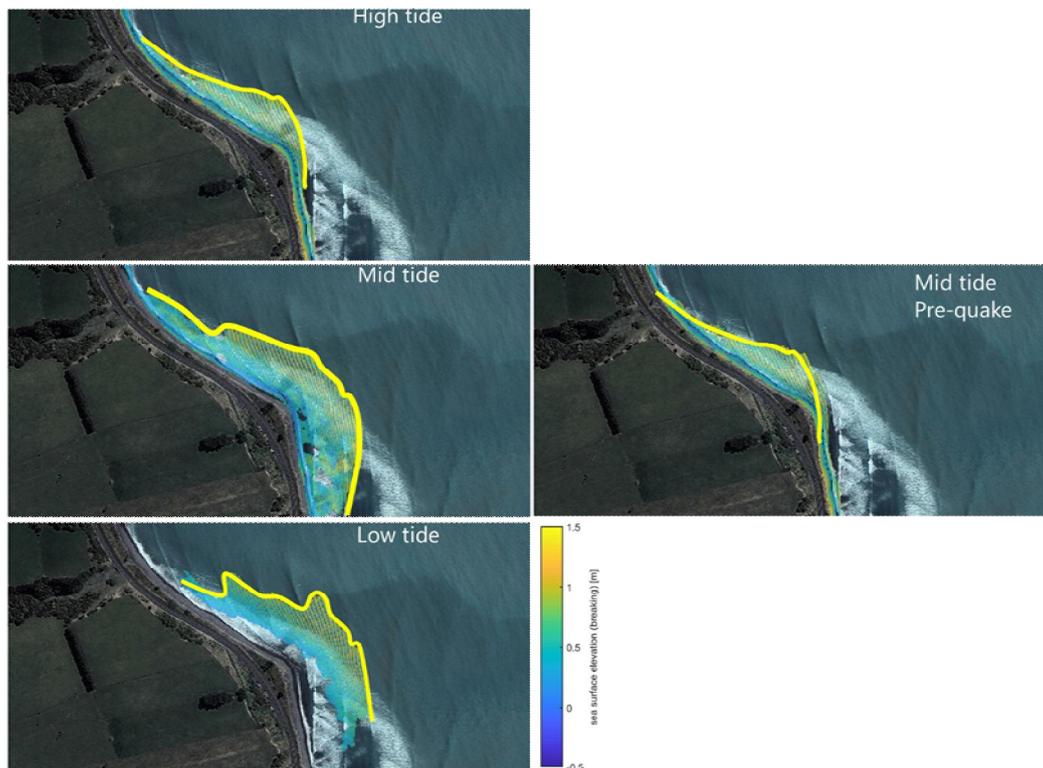
Figure 15. Wave breaking edge for existing (left) and pre-quake (right) conditions. It is evident that high tide now breaks similar to mid-tide before the earthquake

Wave breaking “footprints” can be estimated by overlaying all successive segments of wave crests flagged as “breaking” in the SWASH model over the duration of the simulation (after a spinup period) and these are useful metrics to compare wave breaking patterns for different wave conditions. Wave breaking footprints predicted for the reference monochromatic event at high, mid, and low tides are presented in Figure 15. The effects of the uplift caused by the November 2016 Earthquake were modelled by lowering the bathymetry by 0.8m. Results showed that breaking characteristics at high tide are now similar to those that would have occurred at mid-tide previously. Give the higher quality inner section was reported better during high tide conditions this likely explains the reported decrease in quality. Following this, breaking occurring at mid tide would occur as low tide had previously and breaking occurring at low tide would not have occurred pre-earthquake. There have reportedly been improvements in outer sections of the wave during lower tides.

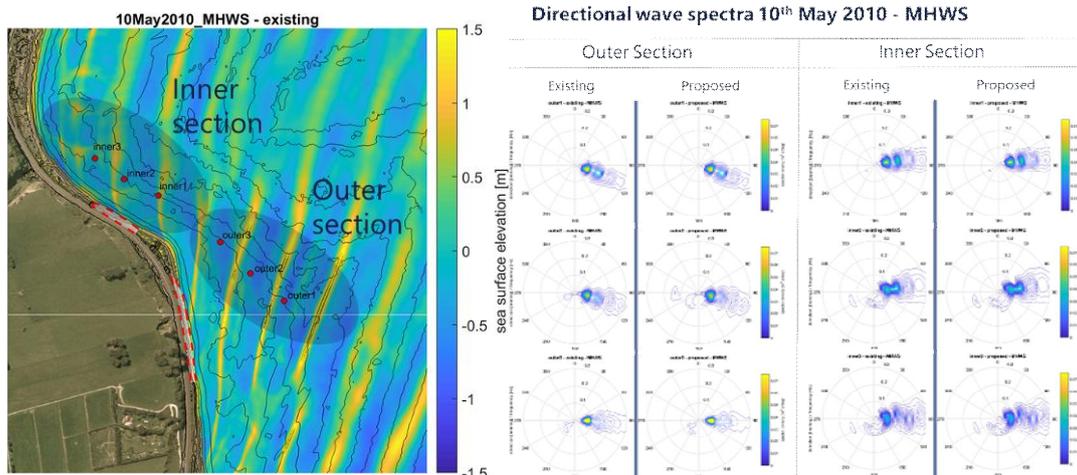
Figure 16. Effect of structures on directional wave spectra at MHWS

The proposed structures’ were added by modifying the bathymetry at the structure locations based on engineering design. Reflectivity was implemented by means of porosity layers which use porous flow model to predicts amount of wave/flow transmitted through and reflected by an obstacle. A porosity value of 0.4 was applied (as recommended for rubble mound van Gent (1995). Examination of the spectra during an optimal condition (Figure 16) show that some reflection occurs during higher water levels under the existing case with the addition of structures slightly increasing reflection in the outer section, by up to 5% but had negligible impact on the inner section. No changes in the breaking wave height or breaking position wave noted any negligible changes in surf zone hydrodynamics during surfable conditions. Further examination of the reflected wave-forms on a wave-by-wave basis (Figure 17) found that the reflections generally occurred off the southern revetment and reflected into the outer section of wave rather than the higher quality inner section.

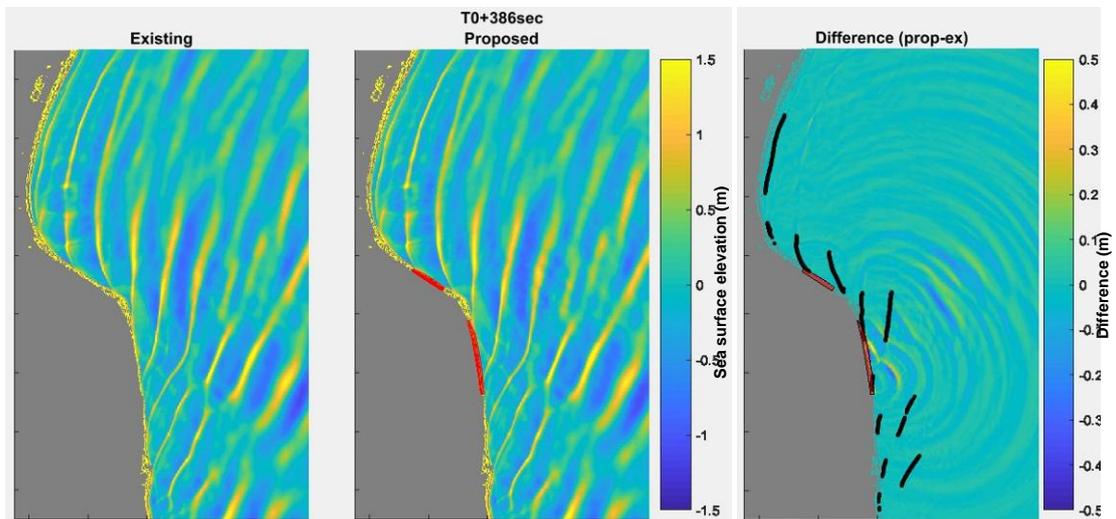
Figure 17. Snap shot of sea surface elevation during the 10th May 2010 event at MHWS water level for existing (left), with the proposed structure (middle) and the difference (right) with breaking waves overlaid in black

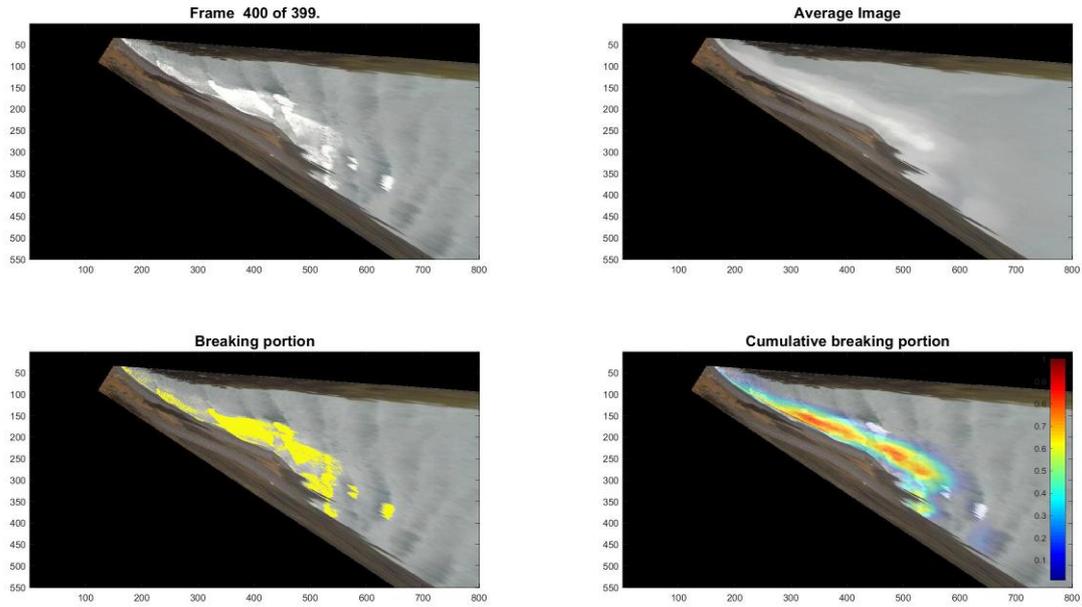
Figure 18. Example of image processing method used to identify the broken wave area in each image (lower left) and the cumulative breaking portion over the observation period (lower right)

After image rectification, images were processed using the matlab toolbox *SurfZoneFun* (Shand, in preparation). A function within this toolbox identifies the individual wave breaking position for each frame and sums the breaking position as a cumulative breaking portion during the observation period (Figure 18). The threshold for defining breaking is a variable and was optimized through sensitivity analysis yet provides more control and definition than more traditional time-averaged techniques applied since Lippman and Holman (1989). A breaking exceedance value can then be extracted from the cumulative breaking portion. Figure 19 shows the 10% exceedance breaking position overlying the time-averaged image.

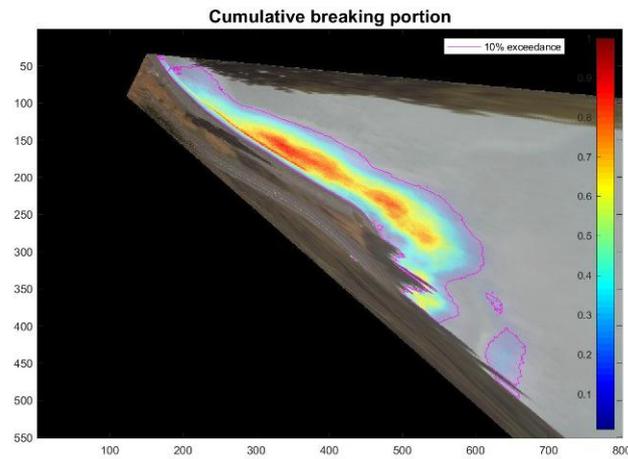
Figure 19. Example of the cumulative breaking portion after the observation period overlaid on the averaged image and with the 10% exceedance contour plotted

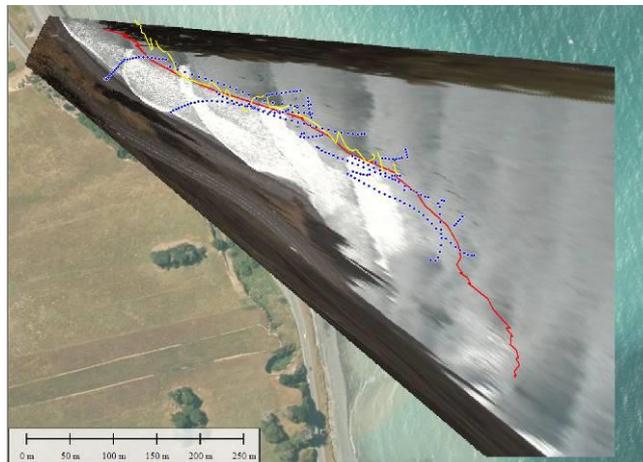
Figure 20. Comparison of the 10% exceedance breaking position from image analysis (red) with the SWASH breaking position for the same wave characteristics and water level (yellow) and GPS ride lines during the same period (blue) for 13 February 2019 at 11am.

Finally, the breaking exceedance position is overlaid with the GPS ‘ride lines’ extracted from the Surf watch for the same time period and the SWASH model outputs for the same conditions (Figure 20). Results show general agreement in these positions indicating that the 10% exceedance position is a reasonable measure the waves that tend to be surfed and that the SWASH model is also reasonably defining the breaking position. It is noted that only a limited number of cases were available with all three measures but over 1 year of image data is available for future processing.
