LESSONS LEARNED FROM RAPID DEPLOYMENT OF WAVE GAGES AND CAMERAS DURING HURRICANE IRMA

Navid H. Jafari, Louisiana State University, njafari@lsu.edu
Qin J. Chen, Northeastern University, q.chen@northeastern.edu
Cody Johnson, Louisiana State University, cjoh296@lsu.edu
Jack Cadigan, Louisiana State University, jcadig1@lsu.edu
Brian Harris, Louisiana State University, bharr96@lsu.edu

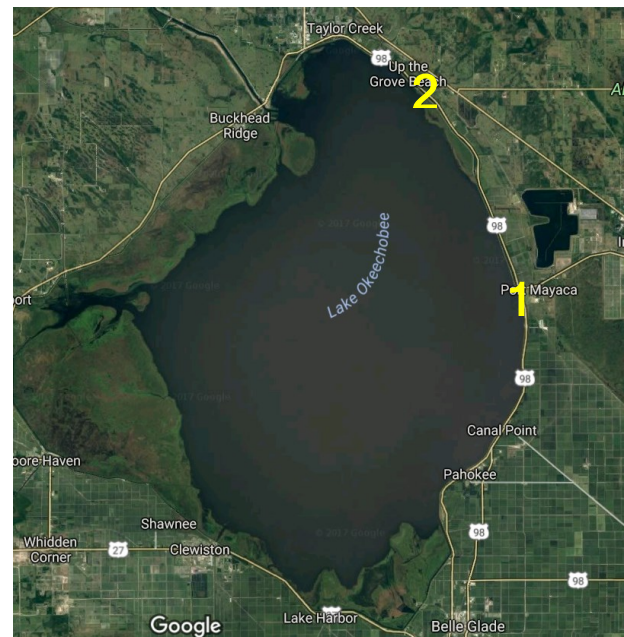
Fig. 1. Locations of wave gage and camera deployments.

In total, four (4) wave gages and two (2) cameras were deployed on the HHD. In particular, two wave gages and the two cameras were deployed at Port Mayaca, on the south end of the flood gate. The initial placement of the gages was planned for several feet in the water, but the close proximity of alligators prevented us from implementing this plan. Therefore, the wave gages were placed along the water line, which was at an elevation of 13.5 ft. The USACE operations team had reduced the water levels in preparation for the hurricane rainfall and storm surge and delayed infilling from bayous. Both cameras were installed on a mailbox at the crest of the levee. They were directed towards the lakeside toe and programmed to capture images at the maximum interval of 10 seconds. The second deployment location was Nubbits Slough. Two wave gages were deployed near the

flood gate. In both locations, hobos were attached to structural objects to obtain the atmospheric pressure.
