# WAVE ATTENUATION AND SEDIMENT TRANSPORT MONITORING OF LIVING SHORELINES IN THE DELAWARE BAY, U.S.

[Katlin Walling](mailto:Katlin.Walling@mottmac.com), Mott MacDonald, [Katlin.Walling@mottmac.com](mailto:Katlin.Walling@mottmac.com)  
[Douglas Gaffney](mailto:Douglas.Gaffney@mottmac.com), Mott MacDonald, [Douglas.Gaffney@mottmac.com](mailto:Douglas.Gaffney@mottmac.com)  
Moses Katkowski, The Nature Conservancy, [MKatkowski@tnc.org](mailto:MKatkowski@tnc.org)

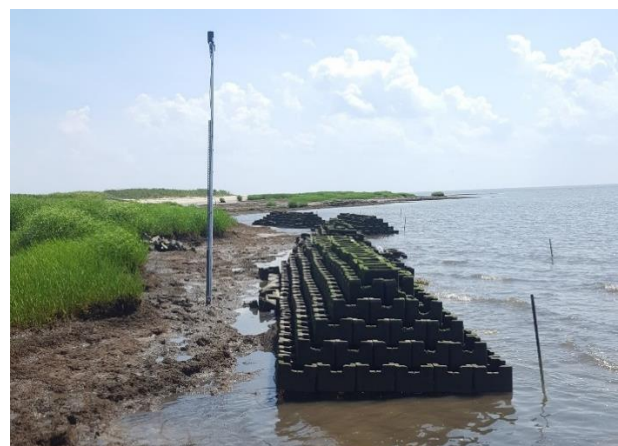
Figure 2 - Living shoreline breakwater structure exposed near low tide at Gandy’s Beach, NJ.

This study required the methodology developed for monitoring and analysis to be engineered to address several key challenges: the equipment needed to accommodate the 5.5-foot tidal range, which leaves the breakwater structures exposed at low tide; the complexity of small scale sediment transport monitoring and analysis would require dense survey data with high resolution to capture minor elevation changes; and the overall approach would need to be practical and cost effective in order to meet project requirements.
