RESULTS OF A 3-YEAR BEACH EROSION CONTROL PROJECT IN HILLSBORO BEACH, FLORIDA, UTILIZING PRESSURE EQUALIZING MODULES (PEM)

Kenneth Christensen¹ and Frank Gable²

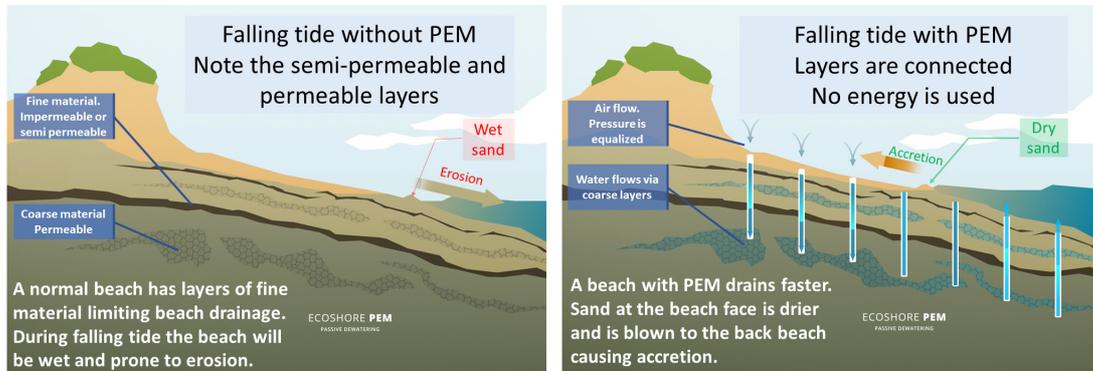
Fig. 1 – Working mechanism of the PEM system

PEM's are hollow permeable tubes inserted vertically into a beach in a grid from the dune to the mean low waterline. The tubes are placed one to three feet under the beach surface making the installation completely invisible. The exact grid design depends on the local conditions. The tubes are not connected, and no energy is used to operate the system. The tubes penetrate and connect the different strata of the beach allowing the water to find the easiest way out by gravity during the falling (outgoing) tide, typically via a coarser layer, resulting in improved drainage as illustrated in Fig. 1.

A vent at the top of the tube connects to the atmosphere allowing pressure to be equalized, hence the name PEM - pressure equalizing modules. As a result, the time period where the beach is saturated and prone to erosion is reduced. With improved drainage (Turner and Leatherman 1997), more sand is deposited in the swash zone and via aeolian transport moved to the back beach and dunes, resulting in reduced erosion and, more often, accretion.

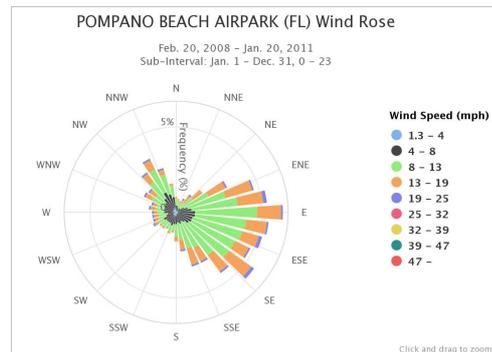
Fig. 4 – Windrose during 3-year project at Pompano Beach a few miles south

The wind rose in Fig. 4 shows that winds are predominantly from the east. No hurricanes affected the project.

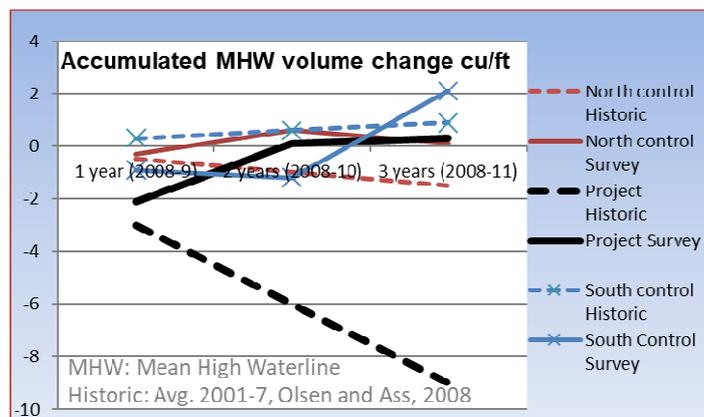
Fig. 5 – Accumulated MHW volume change over 3 years in cubic yards per foot of shoreline. To convert to m³/m: multiply cy/ft with 2.5

From the R-monument line to MHW the 1-mile project area used to lose 16,300 cubic yards per year (Olsen and Assoc. Inc. 2008) equal to -49,000 cy during the project period. Over the 3-year period the 1-mile PEM project area gained 3,748 cy of which 2,118 cy could be attributed to nourishment and must be deducted. The net gain was 1,630 cy (1250 m³). The MHW volume change during the 3-year period in cubic yards per shore foot can be seen in Fig. 5 below.

From Fig. 5, 7, and 8, it can be seen that the PEM project area gained sand instead of historically lose sand over the 3-year project period. The North and South control areas are within the norm. The predominant littoral drift is from North to South and if PEM had caused any negative downdrift effect the South control would be affected. However, the South control performed better than Historic in MHW, DOC, and Shoreline documenting that PEM caused no negative downdrift effect. The result is in line with other PEM projects where the beach downdrift of a PEM area typically accretes.

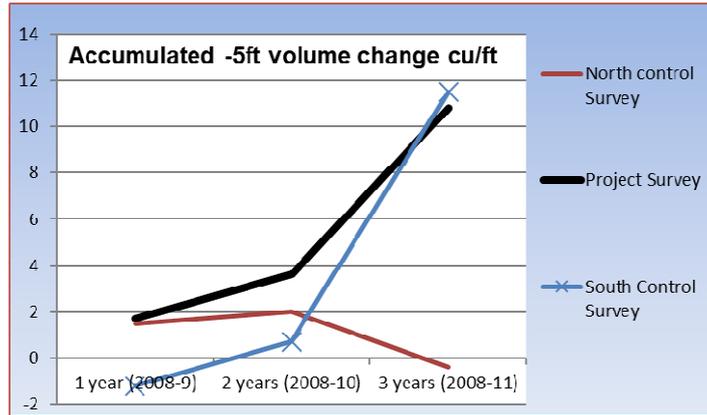
Fig. 6 – Accumulated -5ft NAVD volume change over 3 years in cubic yards per foot of shoreline. To convert to m³/m: multiply cy/ft with 2.5

Over the 3-year period the 1-mile PEM project area gained 10.8 cy per shore ft or 64,700 cy of which 6,300 cy could be attributed to nourishment and must be deducted. The net gain was 58,400 cy (44700 m³). Volume change from R-monument line to -5ft NAVD during the 3-year period in cubic yards per shore foot can be seen in Fig. 6 below.

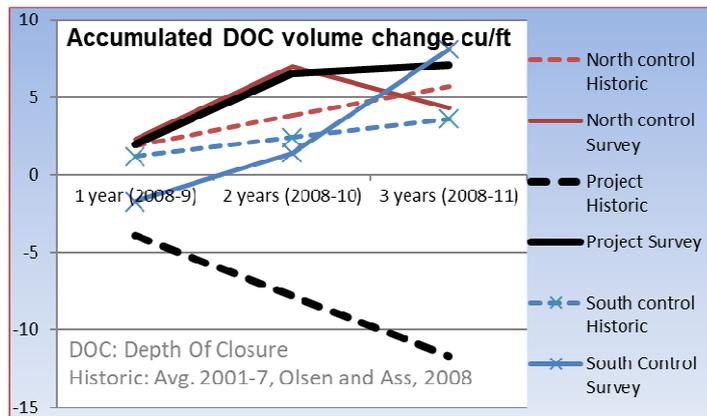
Fig. 7 – Accumulated DOC volume change over 3 years in cubic yards per foot of shoreline. To convert to m³/m: multiply cy/ft with 2.5

From R-monument line to Depth of Closure (-16.57 ft) the 1-mile project area used to lose 21,000 cubic yards per year (Olsen and Assoc. Inc. 2008) equal to -63,000 cy during the project period. Over the 3-year period the 1-mile PEM project area gained 47,000 cy of which 8,500 cy could be attributed to nourishment and must be deducted. The net gain was 38,500 cy (29400 m³). The DOC volume change in cubic yards per shore foot during the 3-year period can be seen in Fig. 7 below.

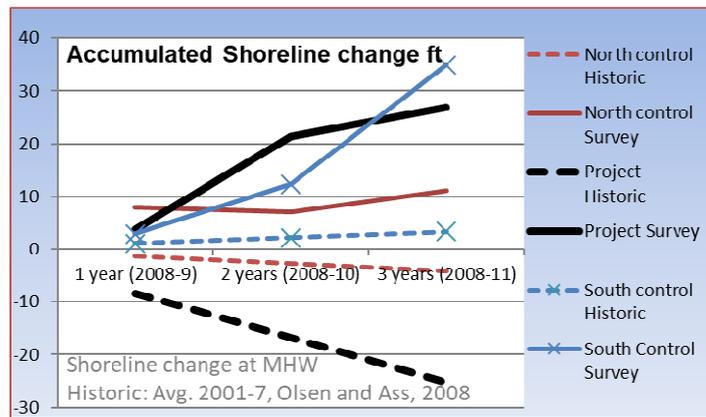
**Fig. 8 – Accumulated shoreline change over 3 years in feet.
To convert to meter: multiply ft with 0.3048**

The shoreline at the 1-mile project area used to retreat 8.4 ft per year (Olsen and Assoc. Inc. 2008) equal to -25.2 ft (-7.7 m) during the project period. Over the 3-year period the 1-mile PEM project area gained 26.9 ft (8.2 m). The nourished sand has NOT been deducted; however, it would only have a marginal effect on the result. The shoreline change during the 3-year period can be seen in Fig. 8 below.

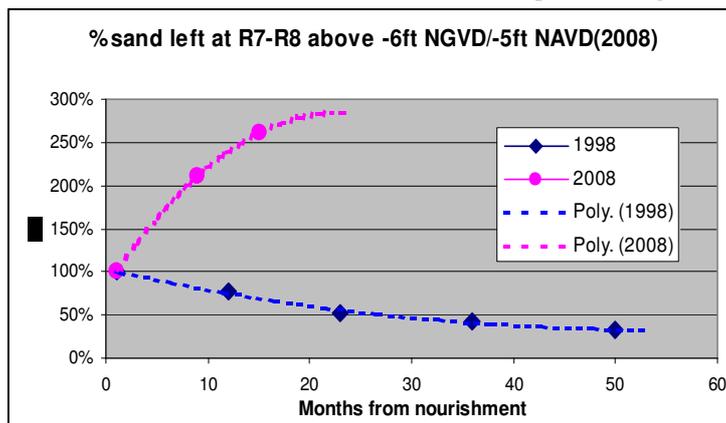
Fig. 9

The graph shows how much sand was left after nourishment. The blue graph represents the 1998 nourishment where sand gradually disappeared. The purple graph (round dots) shows the 2008 truck haul where PEMs were installed before nourishment. The volume of sand was not eroding but increased over time.

The latest major nourishment in Hillsboro Beach took place in 1998. A report³ shows a volume increase from pre- to post-construction between R7 and R8 of 86,000 cubic yards (= starting point and 100%). As it is common with traditional beach nourishment, the sand gradually eroded. In 12 months the volume between R7 and R8 was reduced to 66,000 cy (= 77% remains). After 50 months only 28,000 cy of the nourishment was left (= 33% remains). See blue “1998 line” with squares in Fig. 9.

However, this time PEMs had been installed before new sand was added. PEMs work best when enough sand is available, and work well with nourished sand. After the truck haul the volume increase between R7 and R8 was 7,200 cy (= starting point and 100%). Nine months after the truck haul the volume between R7 and R8 had doubled, and after 15 months the amount of sand had increased to 260% of the original volume between R7 and R8. See Fig 9.

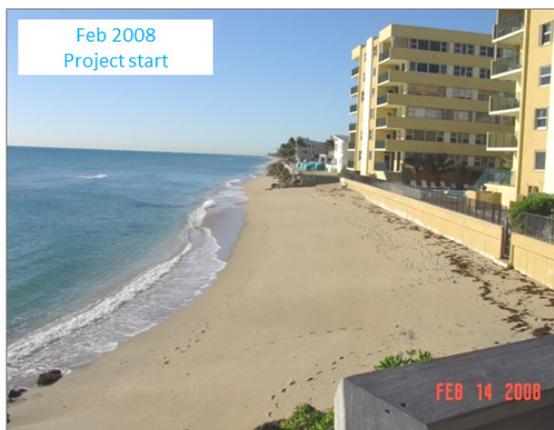
Fig. 10 – Project start at R6.5 looking south

At the end of the 3-year period, the erosion in the PEM project area had stopped and the beach accreted. This was evident to beach visitors as can be seen in figure 10 and 11, both shot at low tide.

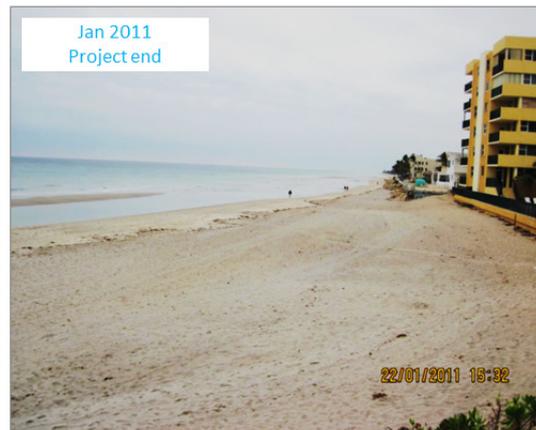
Fig. 11 – Project end at R6.5 looking south
