CAISSON WALL BREAKAGE OF SLOPING TOP BREAKWATER DUE TO COLLISION OF LARGE WAVE DISSIPATING BLOCKS

Kojiro Suzuki, Port and Airport Research Institute (PARI), suzuki_k@pari.go.jp

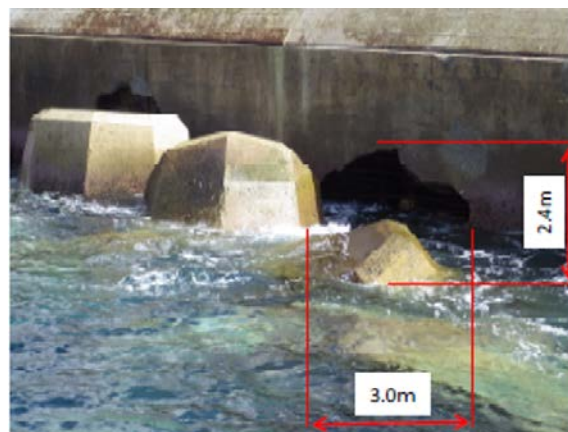
Figure 1 - Caisson Wall Breakage of the U-Breakwater due to Collision of the Wave Dissipating Blocks

A sloping top breakwater covered with wave dissipating blocks (STBWB) has been developed and placed in service under extremely large wave conditions in Japan. The U-breakwater in N-port, designed as an STBWB, and constructed using 50t Dolos (Kd number 20) has been in service since the 1980s. Recently, newly developed 100t wave dissipating blocks (Kd number 10) were used to extend the U-breakwater. The stability of the new U-breakwater blocks was certificated by hydraulic experiment of detailed design. However, breakage of caisson wall, as shown in Figure 1, was caused by the large wave energy of Typhoon 19 in 2014. To clarify the failure mechanics, we conducted a series of hydraulic experiments.

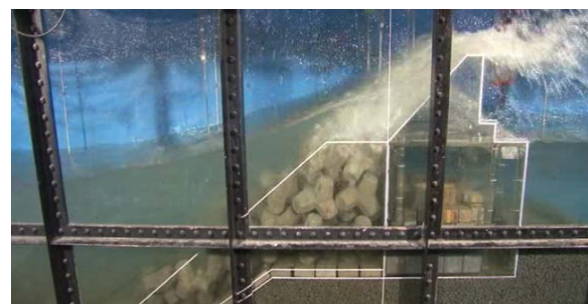
Figure 2 - Hydraulic Experiment of the U-Breakwater

The experiments were performed using a flume with a main-flume length of 105m and a width of 0.8m. The experiment were conducted on a 1/25-scale according to Froude model law. We used irregular waves whose wave height $H_{1/3}$ and wave period $T_{1/3}$ were set as $H_{1/3} = 0.43\text{m}$ (10.8m in prototype scale) and $T_{1/3} = 2.9\text{s}$ (14.5s in prototype scale). In the front wall of caisson model, we installed load cells, wave pressure gauges and acceleration sensors to measure the collision force of wave dissipating blocks.

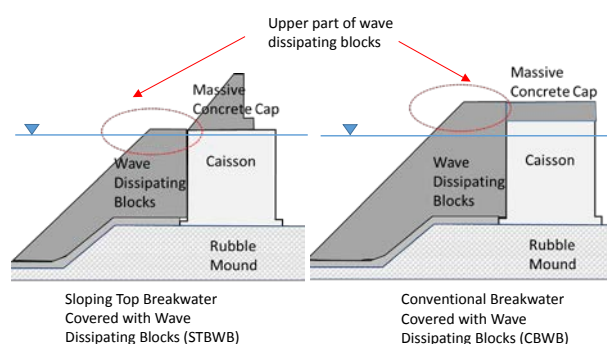
Figure 3 - Comparison between STBWB and CBWB

1) Wave dissipating blocks of the STBWB are unstable compared with the conventional vertical breakwater covered with wave dissipating blocks (CBWB) because most of the STBWB blocks are submerged and are easily affected by buoyancy during wave action, as shown in Figure 3.

2) Upper wave dissipating blocks of the STBWB easily tremble and collide with the top of the caisson front wall. In contrast, the upper wave dissipating blocks of the CBWB collide with the massive concrete cap installed on the caisson.

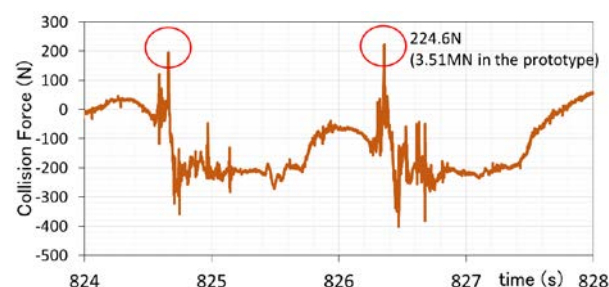
Figure 4 - Time Series of the Collision Force

3) Figure 4 shows the time series of the collision force. The maximum collision force was 224.6N (3.51MN in prototype scale). This was 1.5 times larger than the punching shear load-carrying capacity of the RC caisson wall.
