# STABILITY ANALYSIS OF OLD BREAKWATERS: CASE STUDIES OF FAILURES AND SUCCESSES

Dr. William ALLSOP, Principal, William Allsop Consulting Ltd., UK. [william.allsop51@outlook.com](mailto:william.allsop51@outlook.com)  
 Professor Tom BRUCE, School of Engineering, University of Edinburgh, UK.

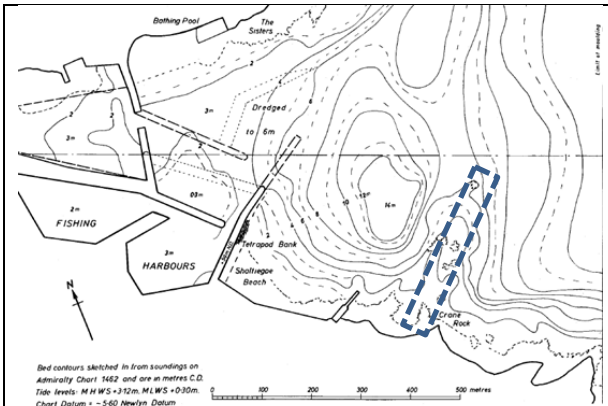
Figure 1 Wick Bay with location of Stephenson's breakwater (after Hydraulics Research Station EX706)

The general bathymetry of Wick Bay (Fig 1) shows the

shoal of Crane Rocks along which the Stevenson breakwater was built. The dashed box indicates the Stevenson breakwater and is used to estimate seabed levels for wave transformation calculations. Paxton (2009) suggests that Stevenson “would have expected waves of ( $H_s=$ ) 7-9m”. In 1975, HRS<sup>(9)</sup> derived 1:1 year  $H_{max}=12m$ , ( $H_s=6.7m$ ) and 1:50 year  $H_{max}=18m$ , ( $H_s=10m$ ). Wave periods used were  $T=14s$  down to  $T=7s$  for frequent conditions. Stability calculations used  $H_s=8m$  and  $10m$ .

To derive incident conditions, waves must be shoaled and/or broken over the last 50-100m. Sections were taken across the line of Stevenson's breakwater normal to the -10mCD contour, chainages of 100m, 180m, and 250m from the shoreline. Bed slopes average 1:10-1:20.
