HOW MUCH LONGER CAN AN OLD SEAWALL LAST? DESIGN, CONSTRUCTION AND MAINTENANCE LESSONS TAUGHT BY NORTH CRONULLA'S PRINCE STREET SEAWALL

Adrian Turnbull, Royal HaskoningDHV, adrian.turnbull@rhdhv.com
 Erin Sellers, Sutherland Shire Council, esellers@ssc.nsw.gov.au
 Patrick Cai, Sutherland Shire Council, pcai@ssc.nsw.gov.au

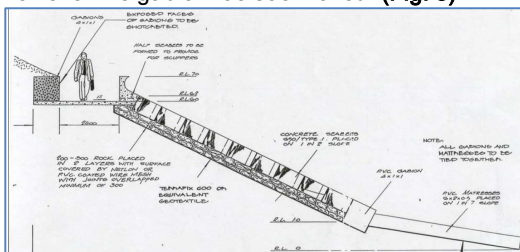
Significant storms in 1967 and 1974 caused extensive erosion and damage, including complete collapse of the Prince Street seawall. In 1985-86 Council decided to invest in a 360m "Seabee" coastal protection structure at Prince Street; a sloping gravity stack wall of hexagonal concrete blocks (internal holes for wave dissipation), (Fig. 2), however the gabion toe soon failed. (Fig. 3).

Figure 2: Cross-section of the original Prince Street Seabee Seawall

Rectification works were undertaken in 2008, comprising the installation of contiguous bored piles with concrete capping beam and permanent ground anchors in place of the gabion toe and reno mattress.
