## Chapter 36

### PRAIA DA VITÓRIA HARBOUR (AZORES) DAMAGES IN THE BREAKWATER DUE TO THE STORM OF 26th - 27th DECEMBER, 1962

José Joaquim Reis de Carvalho  
Head, Estuaries and Rivers Division  
Laboratório Nacional de Engenharia Civil, Lisboa, Portugal

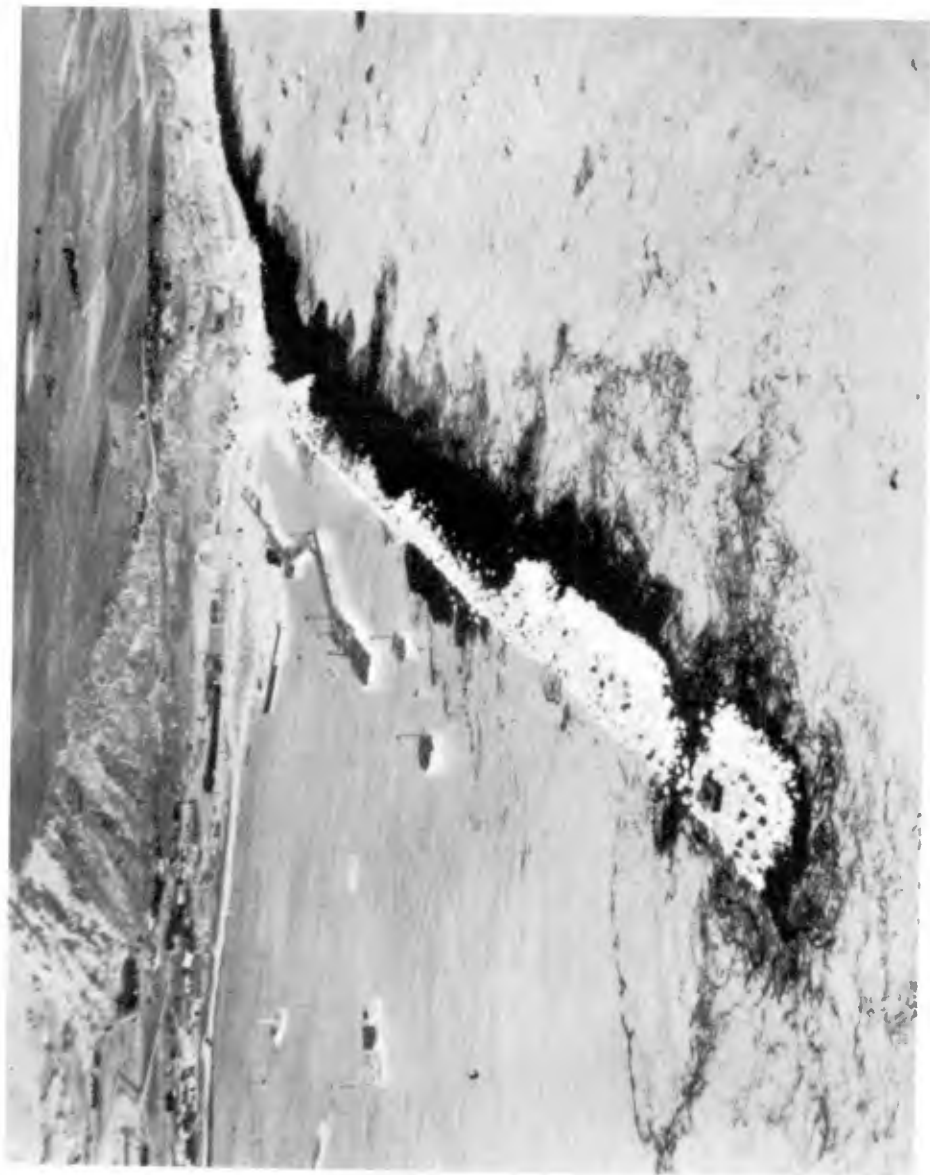
FIG. 3. GENERAL VIEW OF HARBOR

On the night of 26th to 27th, when the storm reached its maximum intensity, the breakwater was particularly hit and damaged. The damages extended to the whole structure and, on the 27th in the morning, a deep breach was visible just near the head, where the storm had ruined the whole profile above elevation (-0.00), attacking even C stones (core).

The damages undergone by the breakwater during the storm can be summed up as follows (fig.3,5,6,7,8):
