## CHAPTER 56

### ROCK MOVEMENT IN LARGE-SCALE TESTS OF RIPRAP STABILITY UNDER WAVE ACTION

Thorndike Saville, Jr.

U.S. Army Coastal Engineering Research Center, Washington, D.C.

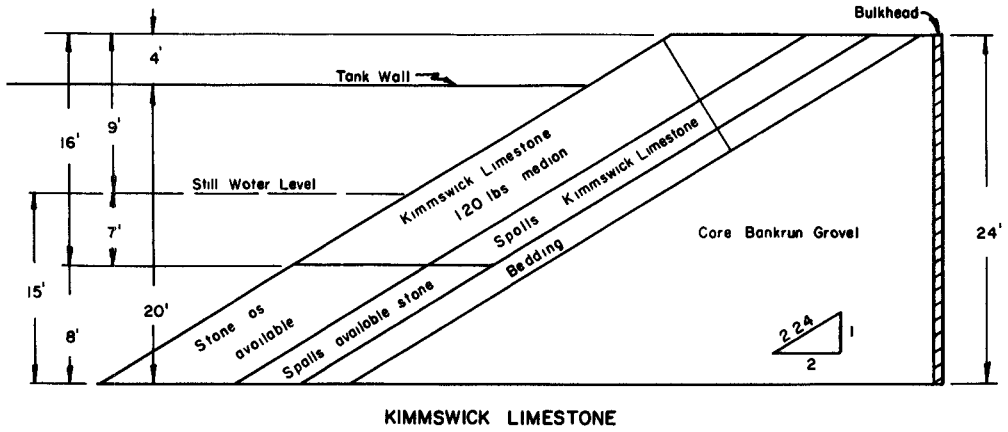
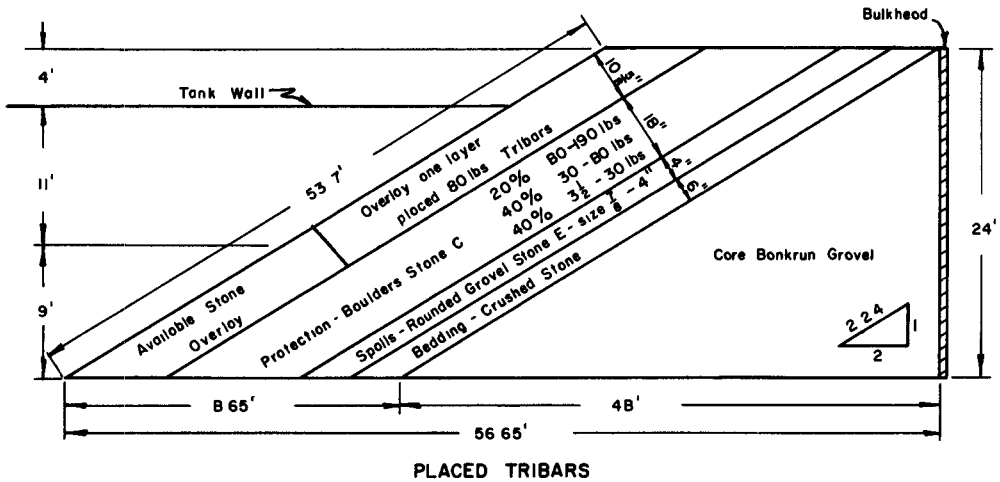
Fig. 1. Test sections for rip rap protection.

Films will be shown for two rubble covers. Sections of these are shown in Figure 1. The first of these, a Kimmswick limestone, is a graded, well-sorted, subangular rock having a median diameter of 120 lbs. Fifty percent of the stone is in the 9 to 12-inch (50-120 lb.) category and the other fifty percent in the 12 to 16-inch (120 to 275 lb.) category. It thus represents a fairly well-sorted graded material. This was placed from an elevation 7 feet below still water level to an elevation 9 feet above still water level. At elevations lower than -7, larger stone was used primarily to support the Kimmswick stone to this elevation. Stone below -7 was not assumed to be critical or susceptible to movement in the tests. The stone was placed over a layer of smaller spalls, which, in turn, was over a bedding layer, with a bank run gravel core below this. The slope of the structure was 1 on 2. This structure was tested as giving generalized information on well-sorted riprap protection for general application. The particular time lapse film shown is for a wave condition of 3.67 seconds, with waves ranging from 2.55 feet to 3.75 feet in height. Considerable motion is observed at the lower wave heights, with major damage being initiated at a height of 3.45 feet, and severe damage occurring at a height of 3.75 feet.
