## CHAPTER 81

### BEACH RESTORED BY ARTIFICIAL RENOURISHMENT

Douglas Edward Newman

Hydraulics Research Station, Wallingford, England

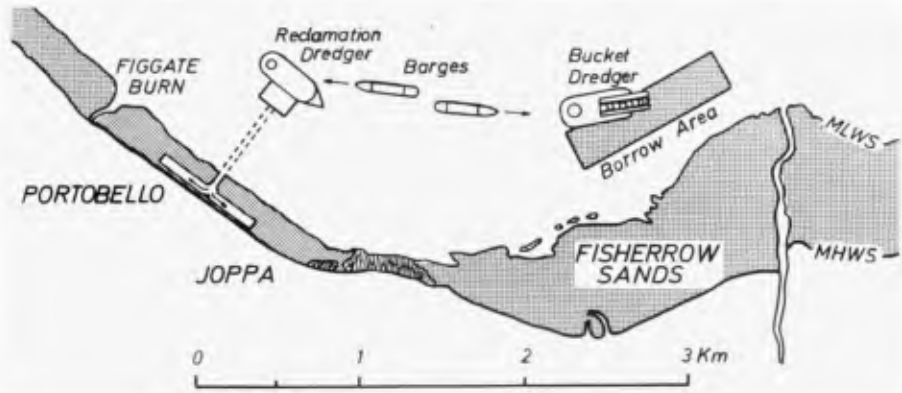
The operation of sand replenishment started in June 1972. A 'bucket dredger' was stationed off Fisherrow at the 'borrow area' (Fig 2).

Fig 2. Renourishment scheme - general layout.

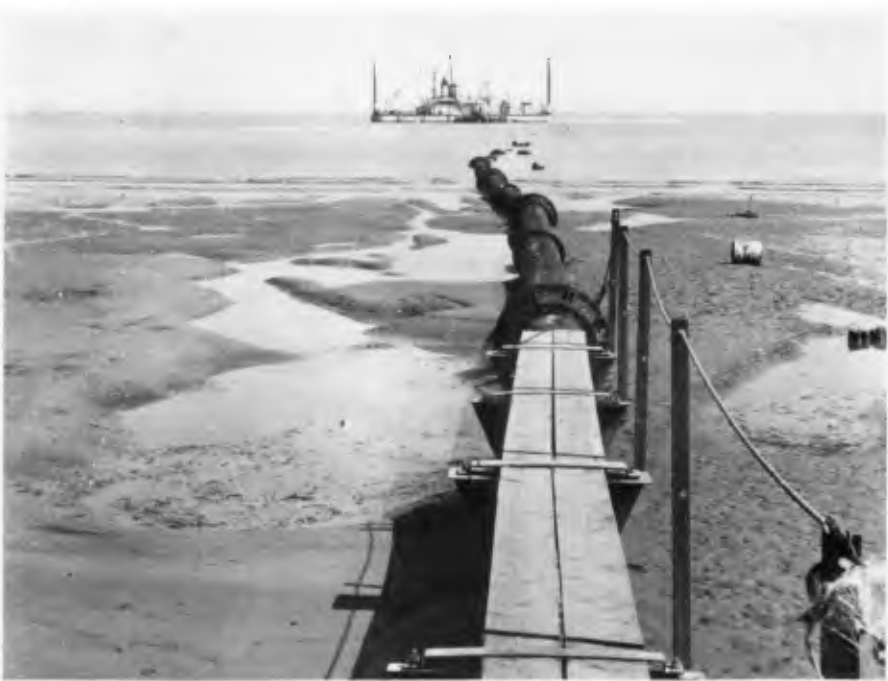
This loaded self propelled barges (each having a capacity of 500 cu.m.) which conveyed the sand at the rate of 1 load per hour to a reclamation dredger positioned some 400 m off Portobello beach (Fig 3).

Fig 3. The reclamation dredger and pipeline.

The barges were unloaded by the suction head of the dredger and the sand transferred directly ashore via a 75 cm dia. submarine pipeline.
