Rosslyn Bay Breakwater, Queensland, Australia

D.N.Foster<sup>(1)</sup>, B.L. McGrath<sup>(2)</sup>, W.Bremner<sup>(3)</sup>

This paper discusses damage to the breakwater from wave and surge action, model studies and repair of the breakwater.

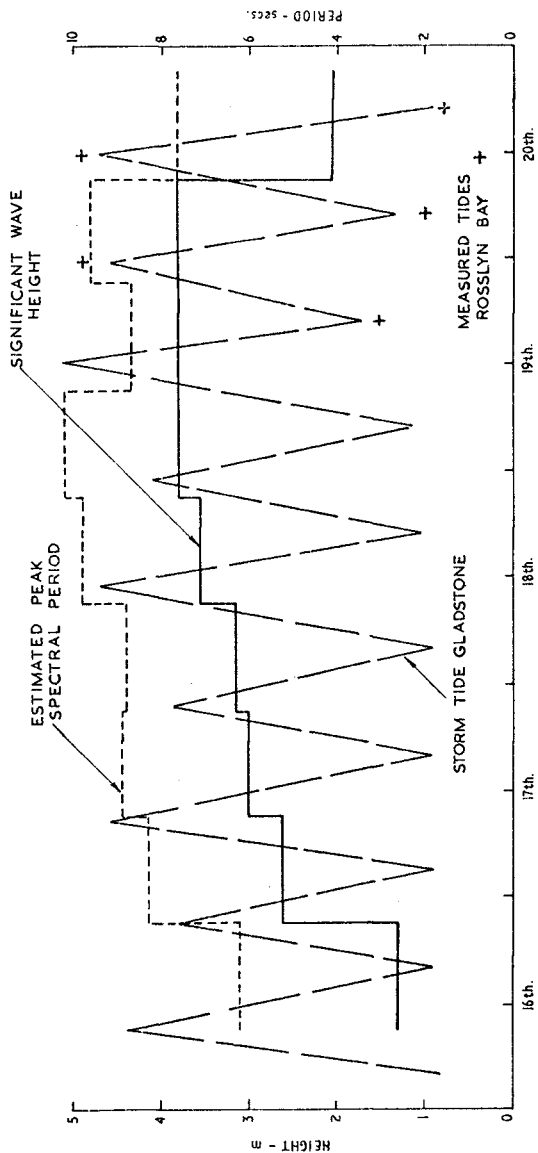
FIGURE 4: WAVE AND STORM TIDE CONDITIONS

Inspection of Figure 4 shows that the breakwater was subjected to wave and surge conditions approaching or exceeding the design conditions from 17th to 20th January. Overtopping of the breakwater occurred at high tide with very heavy overtopping being observed during 19th and 20th. The observed history of damage is given in Table 3.
