CHAPTER 85

Federal Jetty and Sand Dike at the Entrance to Fire Island Inlet, New York

Cyril Galvin*, M. ASCE, Charles, J. Rooney**
and Gilbert K. Nersesian***, M. ASCE

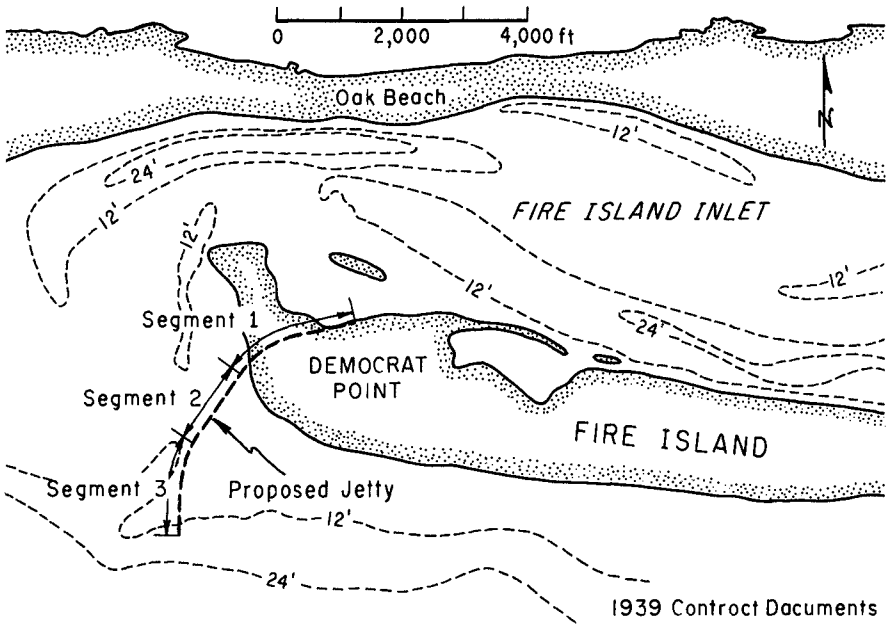
Figure 2. PLAN OF FEDERAL JETTY WITH 1939 SHORELINE AND BATHYMETRY

Design. Figure 2 shows the location of the jetty with respect to the preconstruction shoreline, redrawn from the 1939 contract documents. Total crest length was 4750 feet, and a submerged stone apron extended seaward for an additional 200 feet. The jetty was divided into three segments in plan. Segment 1 covered 2000 feet, crossing land that was exposed at low tide. Segment 2 covered 1350 feet, going from near the then existing shoreline out to a depth of about 8 feet. Segment 3 covered 1600 feet, including the 200 feet of submerged stone apron. Segments 1 and 3 are curved in plan, so that Segment 3 at the ocean is north-south, and Segment 1 at the inlet is almost east-west.

The survey included in the 1939 contract shows that the three-foot thick stone apron would be placed in depths of 12 to 14 feet. However, after placement of the apron, a December 1940 survey (with probings) in the New York District files shows depths from 15 to 20 feet above the stone apron for at least the outer 100 feet of the apron. Probably, the advancing jetty constricted the preconstruction pattern of tidal flow feeding the marginal flood tide channel (Figure 2), causing scour seaward of the tip of the jetty prior to placement of the apron.

When constructed, Segment 1 was on land (Figure 2), and had a weak cross section (Figure 4 and Table 1). Segment 1 now shows damage both by waves and by tidal currents. Waves have damaged and penetrated behind the jetty for at least 1200 feet, eroding significantly into the dunes east of the jetty (Figure 9). This damage occurs in a relatively sheltered position within the inlet, but the recurved spits, pointing at or terminating at Segment 1, may provide a wave channel which can concentrate ocean waves on the jetty. (During storms, the recurved spits may be submerged, and refraction would concentrate wave energy above the spit, delivering the waves to the jetty.) Recurved spits on the inlet side of the jetty have been a common feature through time. These spits appear across the top of photos in Figures 5, 6, 7, and 8, with shapes and relative positions identical to those observed in recent years. A recurved spit intersecting the damaged length of Segment 1 was especially well developed after the severe northeast storm of 29 March 1984 (Galvin, 1984). Figure 9, based on a June 1984 photo, shows a remnant of this March 1984 spit. However, such a spit was not well developed after Hurricane Gloria (Terchunian, 1986).

At the ocean shore east of the jetty, there has been a large accretion of sand since the jetty was constructed. This is made evident by comparing the 1939 shoreline and bathymetry on Figure 2 with the recent shoreline (June 1984) on Figure 9. The present accreted condition was reached rapidly, probably by 1950, according to Saville (1960).

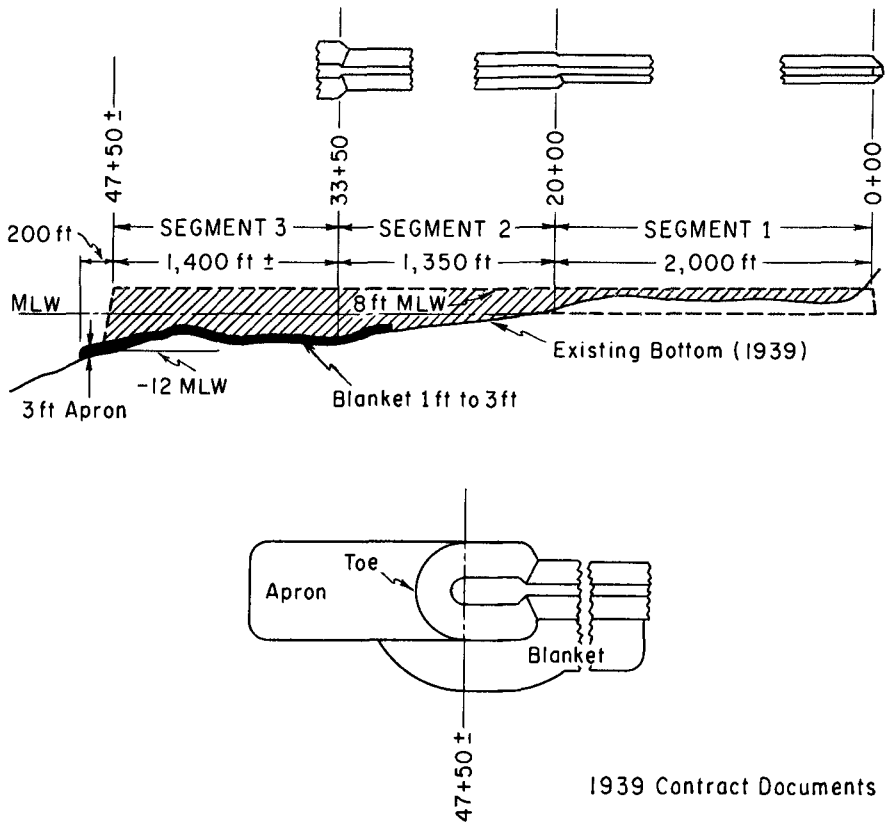
Figure 3. LONGITUDINAL SECTION ALONG JETTY CENTERLINE, WITH PLAN VIEWS OF SEGMENT TRANSITIONS AND SEAWARD END.

The design of the jetty is shown in longitudinal section in Figure 3 and in cross section in Figure 4. Noteworthy features of the longitudinal section (Figure 3) include the relatively low crest elevation (8 feet above MLW), and the stone blanket and apron at the seaward end. A stone blanket from 1 to 3 feet thick underlies the entire Segment 3 and extends landward to the 1939 -6 foot MLW contour, about 350 feet into Segment 2. Along the outermost 500 feet of the jetty, this blanket extended 50 feet east of the toe of the jetty side slope. For 200 feet along the centerline (extended) of the jetty, there was a stone apron 3 feet thick and approximately 90 feet wide.
