# DESTRUCTION MECHANISM OF COASTAL LEVEES ON THE SENDAI BAY COAST HIT BY THE 2011 TSUNAMI

Akira Mano<sup>1</sup>, Hitoshi Tanaka<sup>2</sup> and Keiko Udo<sup>3</sup>

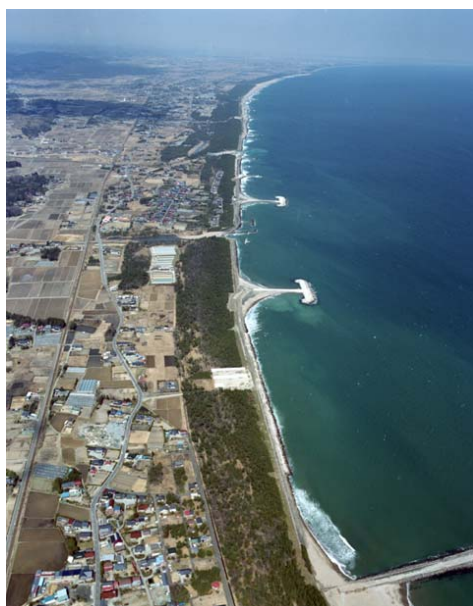
**Photo 1. Yamamoto Coast before the tsunami taken by MLIT on March 2010**

Figure 3 shows a map of the Sendai Bay Area with some names referenced. Here the Yamamoto Coast in the south was most significantly damaged. The photos before and after the tsunami are shown in Photos 1 and 2 respectively. This coast is suffering from severe erosion and T shaped jetties were constructed as the countermeasure. Wave dissipation blocks were placed in front of the levees. The tsunamis breached the levees in many places and a coastal channel was formed behind the levees by the tsunami erosion.

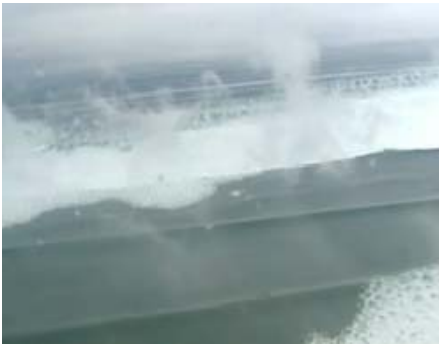
Photo 3 shows countless solitons which are a series of solitary waves and appear for long distance propagation in shallow water regions. Photo 4 shows breaking of solitons as they approached near the coast and a series of surges were hitting the coast.

**Photo 3. Countless solitons off the Natori Rivermouth, at 16:13 JST captured from “Michinokugo” video**

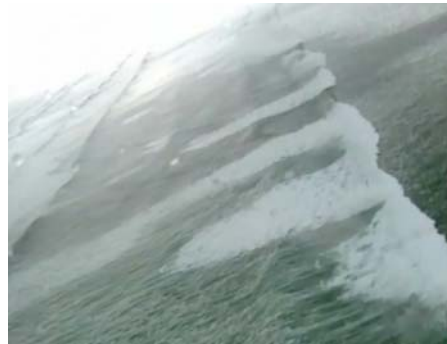
**Photo 4. Breaking solitons off the Natori Rivermouth, at 16:14 JST captured from “Michinokugo” video**
