# FAILURE MECHANISM OF KAMAISHI BREAKWATERS DUE TO THE GREAT EAST JAPAN EARTHQUAKE TSUNAMI

*Keywords: Kamaishi breakwater; tsunami overflow; stability of breakwaters*

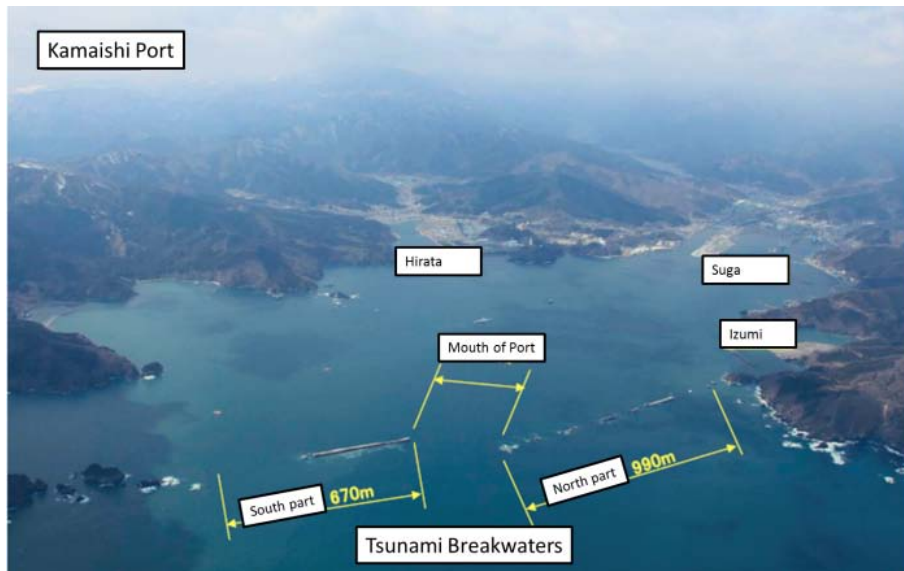
Photo 1. The Kamaishi Bay mouth breakwaters (taken by Tohoku Regional Bureau)

The Kamaishi Bay mouth breakwaters include the North Breakwater (length 990m), South Breakwater (length 670m), and the Bay mouth section (length 330m) as shown in Photo 1. The maximum depth at the breakwaters is 63m.

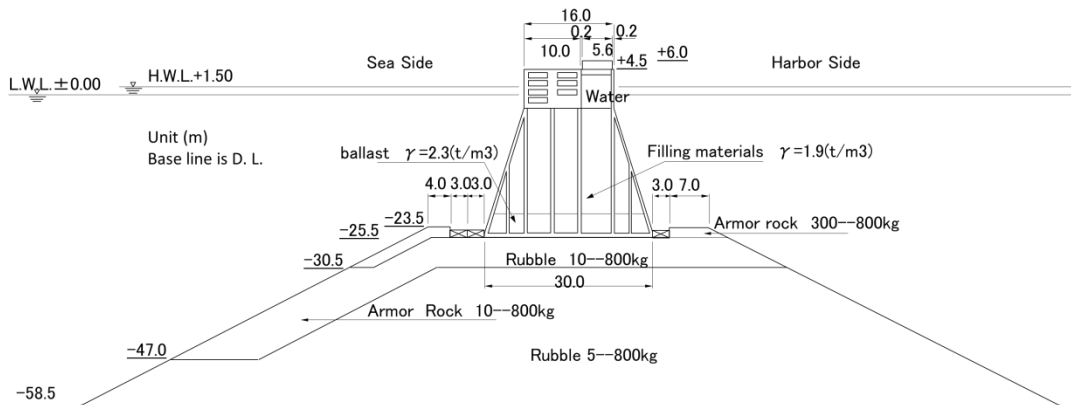
Figure 1. Cross Section of Kamaishi Breakwater at Deep Area of North Side

At the North Breakwater, the deep section consists almost entirely of trapezoidal caissons shown in Fig. 1., and its foundation mound ranges from -60m to -27m, and above it, caissons weighing about 36,000 tons are installed. In shallow parts, the caissons are rectangular with height ranging from 10m to 15m. At the South Breakwater, 3 caissons are, as in the North Breakwater, trapezoidal caissons, and the rest are approximately 32,000 ton rectangular caissons. Their crest height is D.L. +6.0m (T.P. +5.14m), and their foundation mound extends from depth of -55 to depth of -22m. At the mouth section, a submerged breakwater has been built, the depth at the mouth is D.L. -19.0m, and armor blocks are inserted around it.

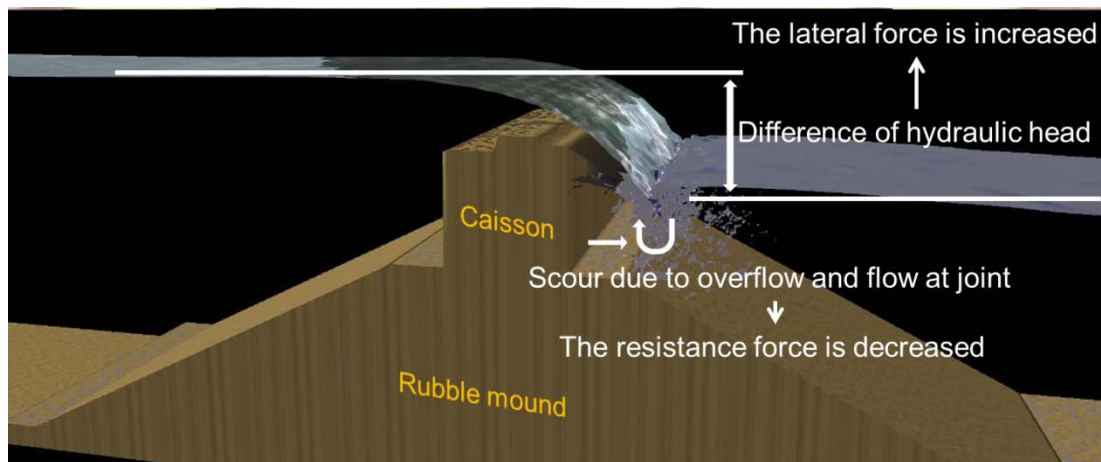
Figure 6. Major failure causal factors under tsunami overflow

The failure causes considered are as follows.

- [1] Dynamic water pressure as wave force
- [2] Water level difference between the outside and inside of the harbor
- [3] Scouring of the foundation mound caused by overflowing and joint flow velocity
- [4] Decline of bearing capacity caused by increase of pore water pressure

Assuming that during overflow, [1] is small, hydraulic model tests were done to study [2] and [3] in particular (see Fig. 6).

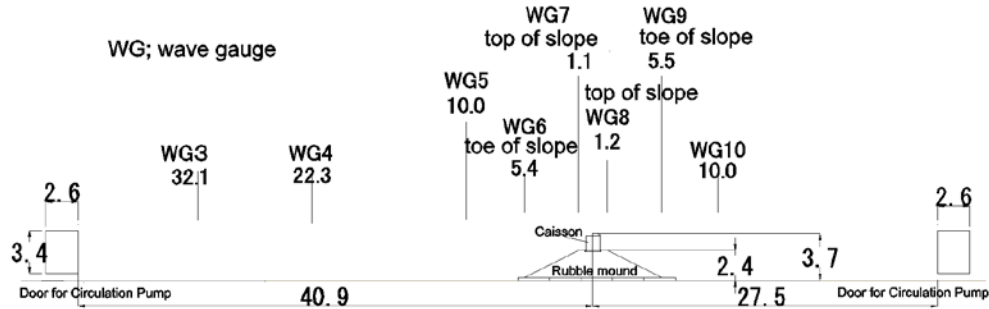
Figure 7. Experimental cross section (rectangular case, unit m)

Fig. 7. is a full section diagram of the experiment. The model scale was 1/20 for the deep part at Kamaishi. A wave meter was attached as shown in the figure. The model was installed inside an approximately 70m section in the circulation device. The foundation mound was installed so that the heights of the crests of the caissons were aligned at 3.7m. The numbers in the diagram show distances from the reference line. The shapes of the caissons were trapezoidal used in the deep part and rectangular (Fig. 8.). The height of the trapezoidal caisson was 1.65m and that of the rectangular caisson was 1.4m. Wave meters (PG) were attached to the front, back, and top surfaces, while pore water pressure meters (UG) were attached to the bottom surface. The caissons were both 1.5m wide. The channel width was 3.5m, so the 1.5m wide caissons were installed in the center, and 0.9m wide dummy caissons were installed at both ends. The trapezoidal and rectangular 1.5m wide caissons

weighed 4.5m tons and 4.0 tons respectively. The trapezoidal and rectangular dummy caissons weighed 3.0 tons and 2.6 tons respectively. The weight per 1m of the dummy caissons was increased 10%. The joints were 2.5cm wide.

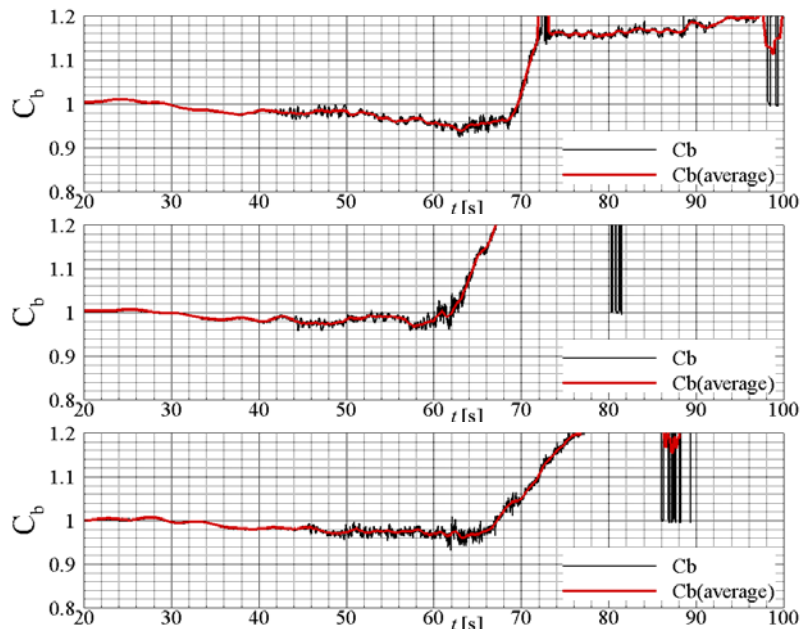
Figure 9. Time histories of the average rate of reduction (Top case 1, middle case 2, bottom case 3, red line is represented as the line, which is smoothed with moving average method)

And this experiment also confirmed that the front surface wave pressure is almost unchanged from the hydrostatic pressure, failing to reach a few percentage points. On the other hand, the water level at WG10 was used to study the back surface wave pressure as a percentage of the hydrostatic pressure. If the pressures at each point on the back surface are integrated by a typical surface area and the average rate of reduction is represented by  $C_b$ , the third time series in each case are as shown in Fig. 9.

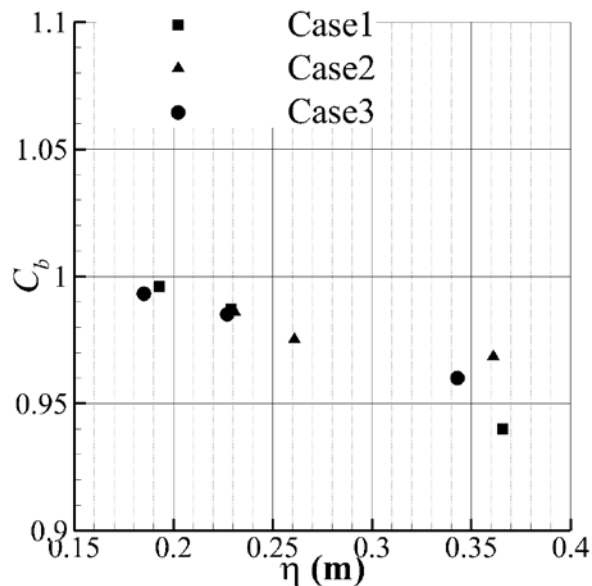
Figure 10. Relationship between the average rate of reduction and overflow height

Fig. 10. plots the smallest value obtained after moving averaging at 0.5s of the rates of reduction for all experiments in all cases. The axis of abscissas represents the height of the water surface above the caisson crowns. As it clearly shows, the overflow quantity increases at the same time as it falls to a maximum of about 6% of the hydrostatic pressure on the rear surface.

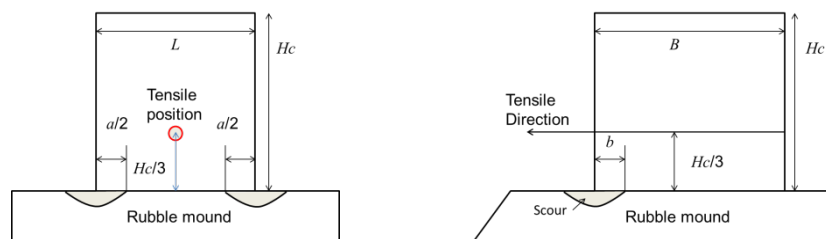
Figure 11. Image of Joint flow scour (left) and overflow scour (right)

Tensile testing was done in the atmosphere in order to confirm the friction coefficient. A foundation mound was built in the atmosphere and at a location about 1/3 below the height of the caisson, it was pulled with a winch. It was done to both the rectangular and the trapezoidal caissons, and in order to see its relationship with scouring, it was compared with a case where joint scouring and overflow scouring were excavated in advance. Each case is shown in Table 3. The percentages in the table are, in the case of joint scouring, percentages of the caisson width equal to the width of the joint, and the percentages of the width combining both ends (see left side of Fig. 11.) The percentages of the overflow scouring width are ratios to the caisson length (direction pulled), and excavation is done across the entire bottom (see right side of Fig. 11.). Photo 7. shows an example of the initial state when it was done forming scouring.

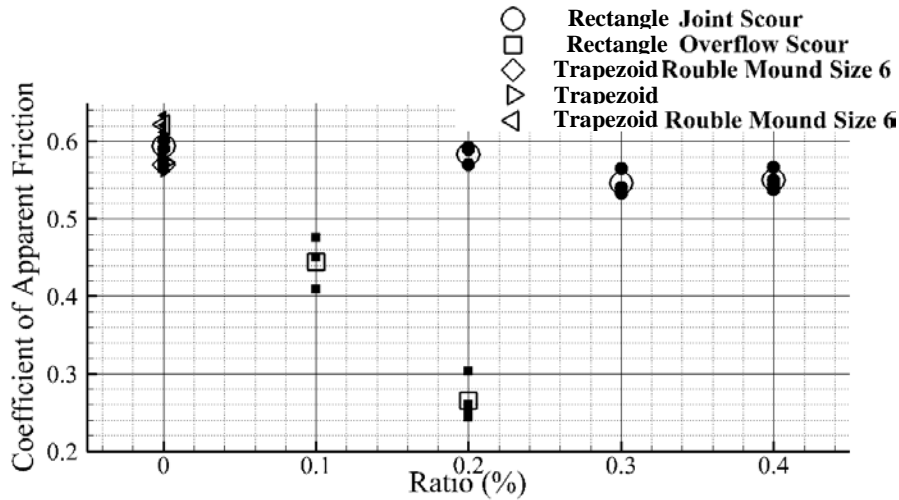
Figure 12. Relation between coefficient of apparent friction and scour ratio

Figure 12 shows the results of performing each three times. It was organized as the friction coefficient when, after being stable for a few centimeters, it started to move. It is assumed that because it moved very slowly, it is not a coefficient of dynamic friction. The friction coefficient itself is presumed to not depend on the installation surface area, but if the scouring width was increased, the friction coefficient changed, so it was organized as the apparent friction coefficient. The mechanism should probably be studied in detail in the future. The results are the average shown in white. It was done from 3 to 4 times, and the block spots represent each time, while the white spots represent the

averages. Examining this shows that the apparent friction coefficient is also impacted by the joint scouring width, but that it is impacted even more by the overflow scouring width, which declines about 25%, even at 10%.

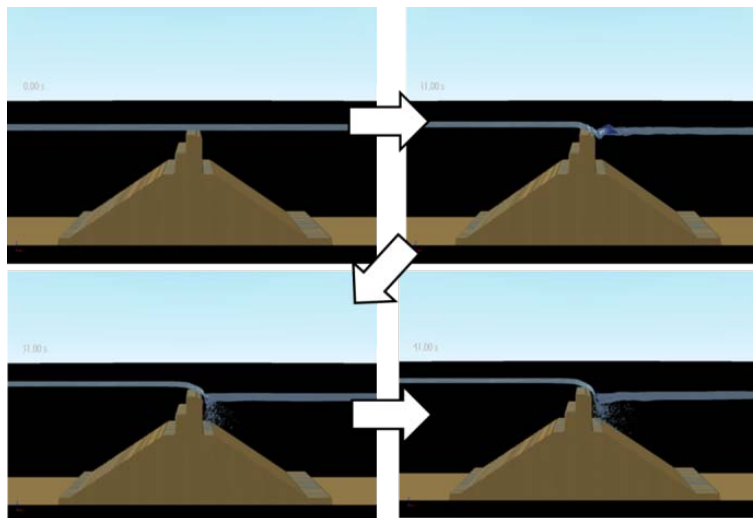
Figure 13. State of calculation

Fig. 13. shows one example using a rectangular caisson, where the water level gradually changed from the initial water level (discharge/inflow 0.1m/s). This shows that it is possible calculate the same situation as that in Photo 1.

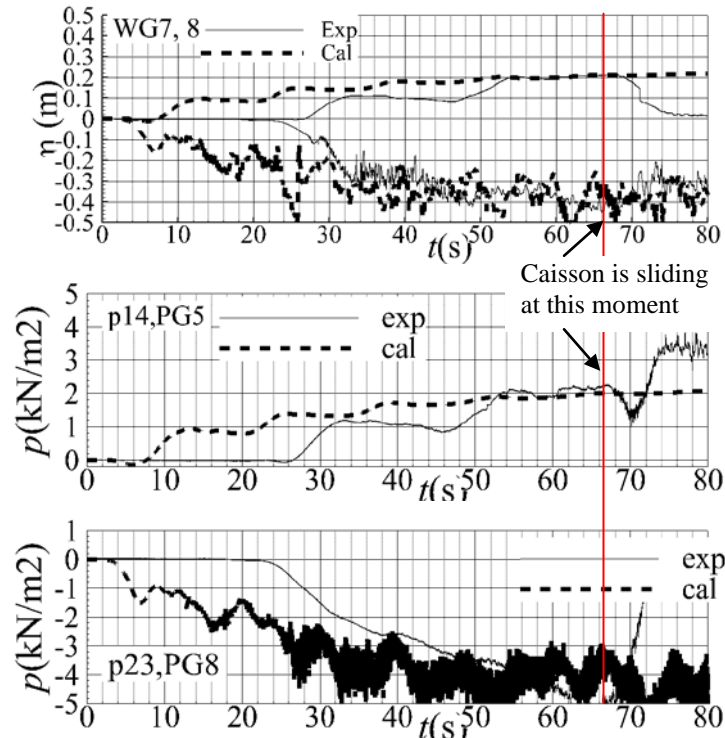
Figure 14. Time history comparison with the experimental results at WG7, WG8, PG5 and PG8

Fig. 14. shows the rectangular model at 0.1m/s case. Because the caisson slid in the experiment near 65s, the computation was greatly displaced, but it shows that in this area, the water level and wave pressure of the calculation and experiment conformed. Turning to the trapezoid, it conformed with the 0.125m/s case.

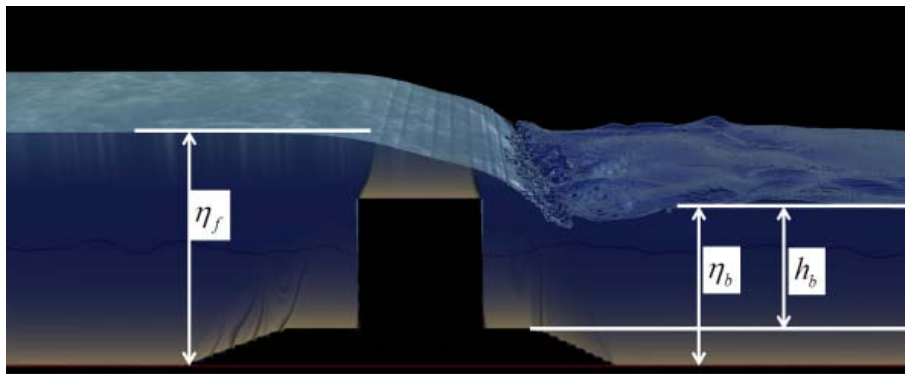
Figure 15. Definition of water level

In Fig. 15, the water level of the front surface of the caisson is  $\eta_f$ , the water level at the back surface is  $\eta_b$ , the distance from the foundation mound to the back surface water level is  $h_b$ , and the ratio of the water level difference and at the front surface and back surface  $(\eta_f - \eta_b)$  and  $h_b$  is considered to be the water level difference/back surface water level ratio.

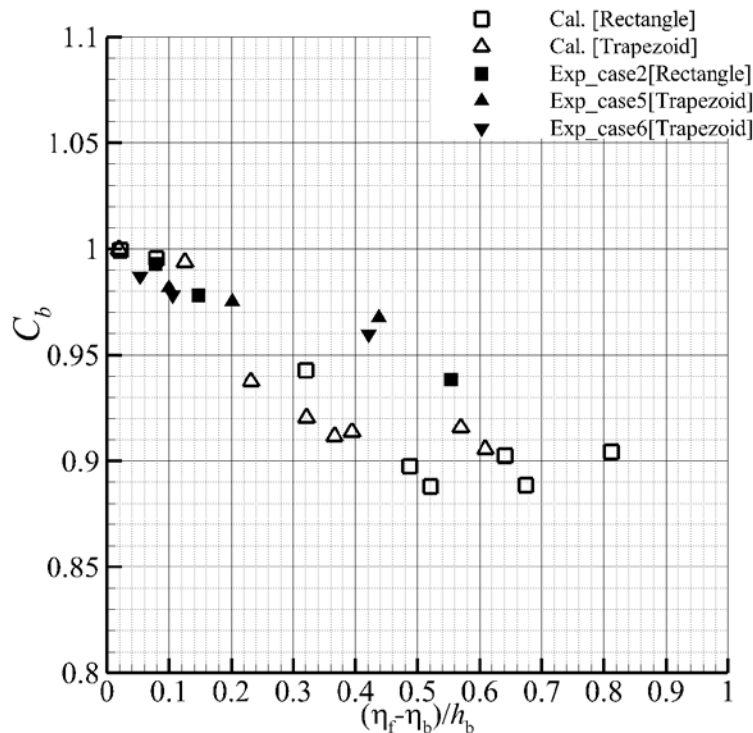
Figure 16. Relation between the rate of reduction and water level difference

Fig. 16. plots the relationship between the water level difference/back surface water level ratio and reduction rate ( $C_b$ ) at the time when the reduction rate was lowest, based on time history data of the reduction rate and water level difference/back surface water level ratio in each case. Black shows the experimental results and white shows the calculation results.

Although overall they conform, if the water level difference/back surface water level ratio increases, the numerical calculation obtains  $C_b$  smaller than that obtained by the experiments. This means that because the disturbance of the pressure fluctuation behind the caisson is larger in the calculation results, it is presumed that the overflow water mass splashed down nearer the back surface than in the experiment, and that its impact is one cause.
