Battling the Bering Sea:

St. George Island's Berm
Breakwater

Philip Blackmar, P.E.
Ronny McPherson, P.E.

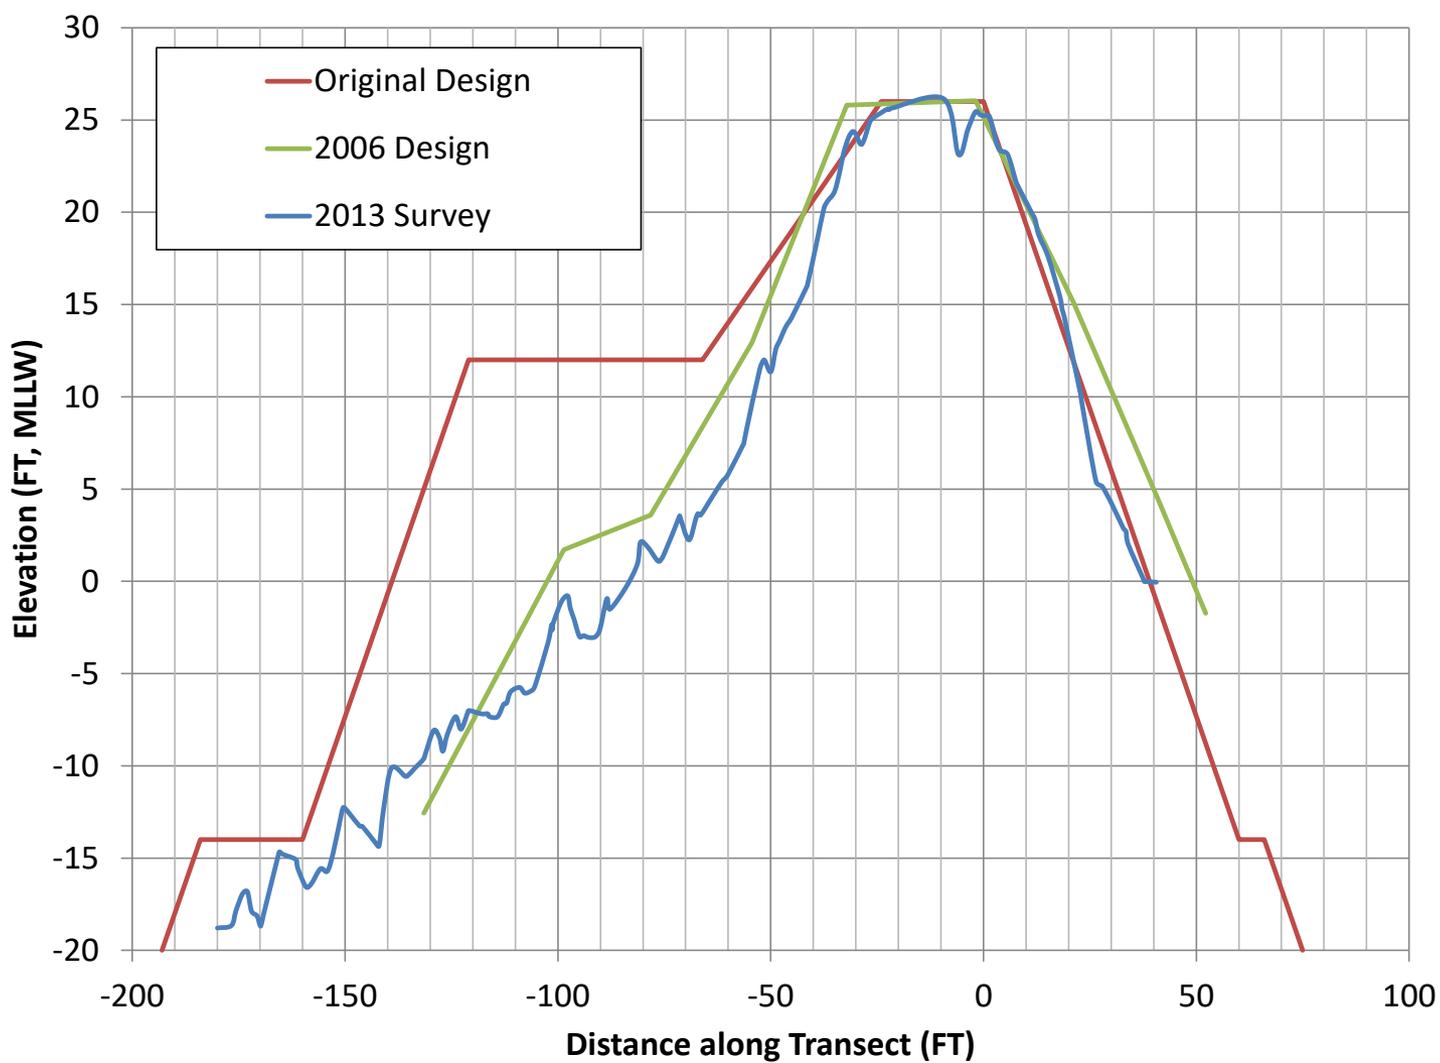
Breakwater Cross-section Performance

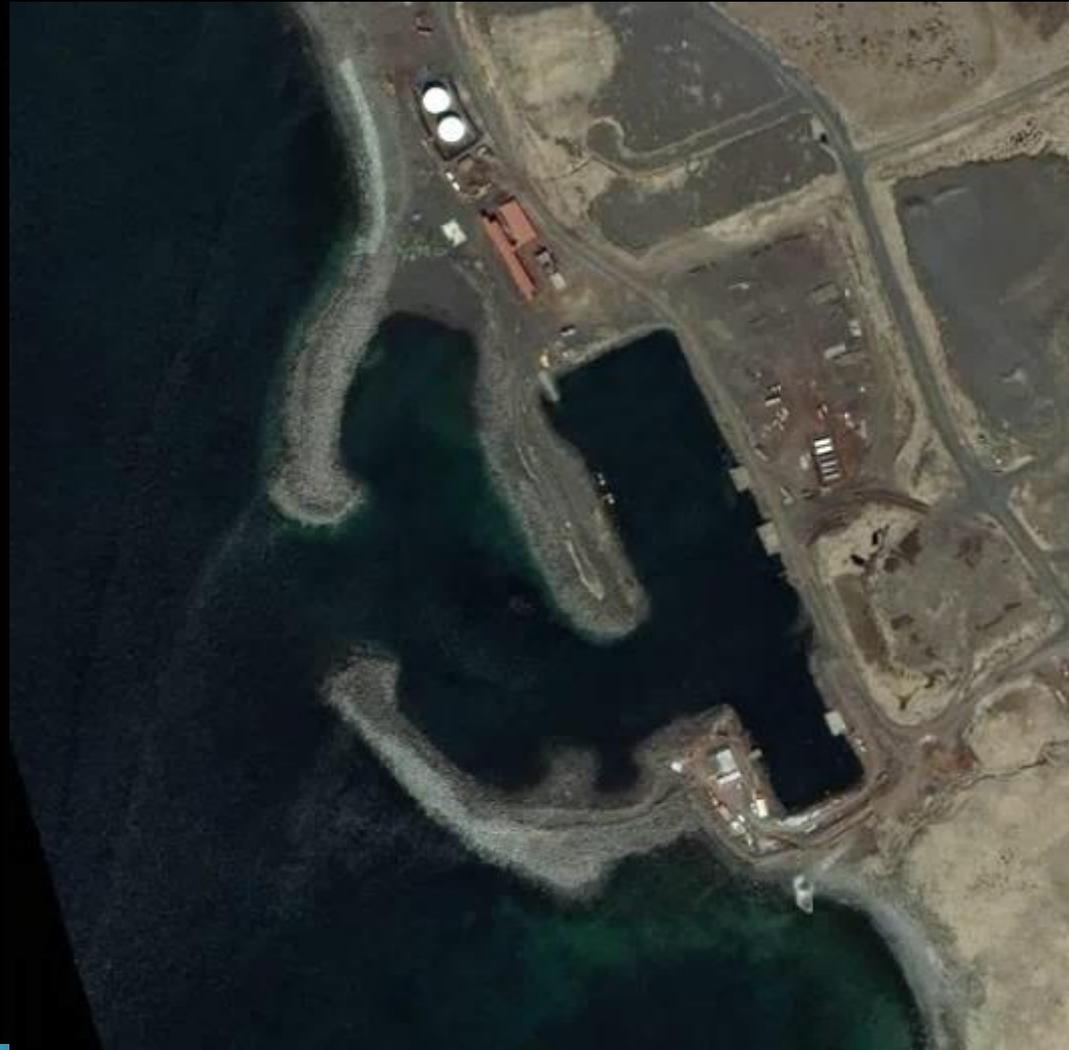
Berm Performance Discussion

- Loss of berm material apparent in available survey data
 - Original design was considered dynamically stable
 - Armor stone used in original project was basalt rock with low durability
 - Potential lateral transport of berm stone

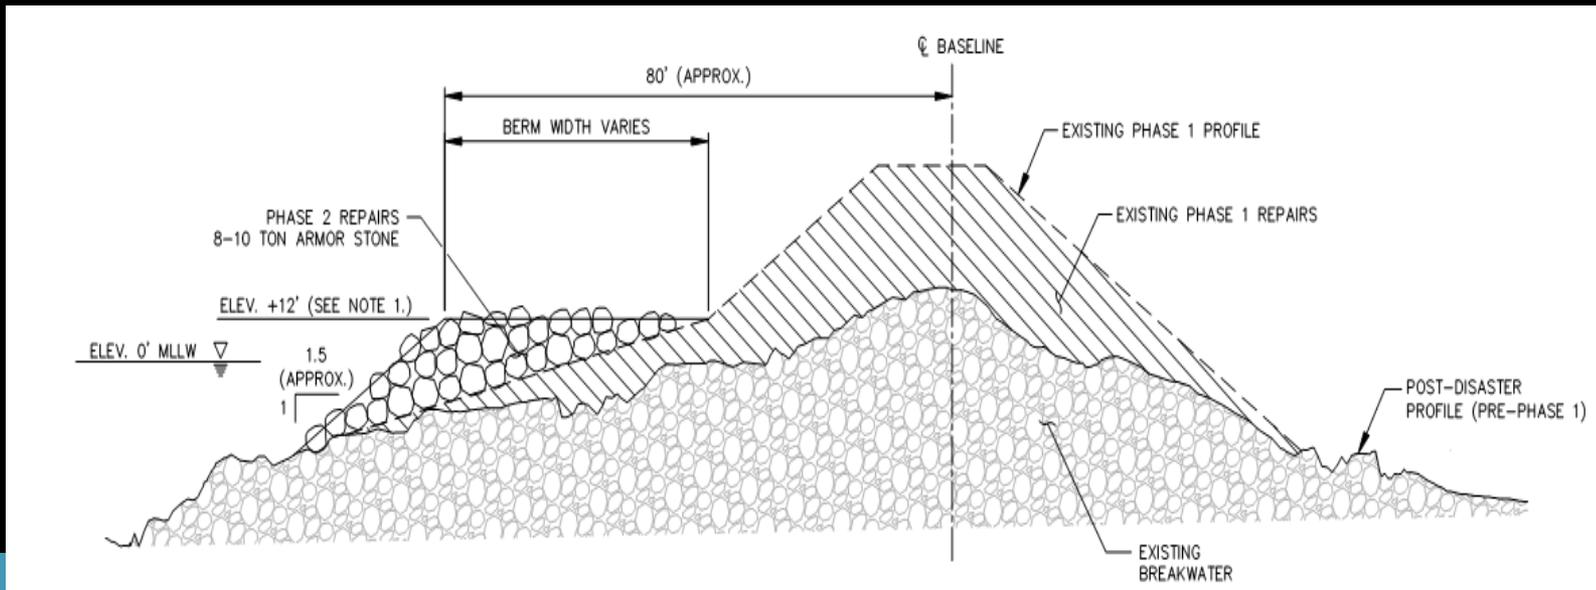
Phase 2 Repair Design

- Phase 2 designed by Alaska DOT&PF and HDR
- Survey data collected in 2016 showed significantly more losses than originally anticipated
- Berm breakwater and composite slope breakwaters were considered
 - Berm breakwater was utilized
 - Previous success at St. George
 - Easier construction
- Higher quality and larger stone was transported for construction
