# COMPARISONS OF STORM SURGE DISASTERS IN ASIA ----CASES OF CYCLONES SIDR IN 2007 AND NARGIS IN 2008----

Field surveys were performed in the southwest of Bangladesh after cyclone Sidr in 2007 and in Yangon River Basin after Cyclone Nargis in Myanmar in 2008 in order to learn lessons out of severe disasters due to storm surges. Spatial distributions of inundation heights were measured around the most damaged areas. Both Bangladesh and Myanmar were severely damaged, but the preparedness against storm surge and the experiences were different. The resultant total losses in these two countries were significantly different. In Bangladesh, many people witnessed that storm surges inundated with bore-like waves. Counter measured against storm surges should account for the physical mechanisms for the development of such bore-like waves and possible damages due to such waves. Embankment showed significant roles to minimize the damage. Development of riverbanks especially around the river mouth is one of most essential counter-measures to be carried out in Bangladesh. Shelter functioned well to save significant number of lives in Bangladesh. But in Myanmar, there were few experiences on storm

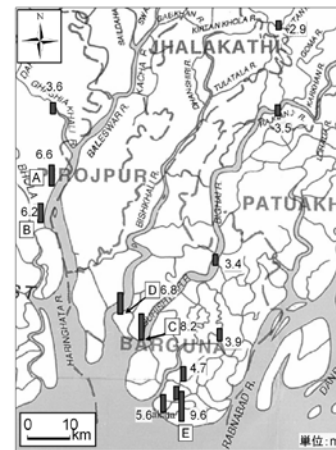
The basic method of survey was to detect flood height and to measure distances by using laser distance meters and to measure locations by using GPS. Fig. 1 shows the survey route and distribution of measured storm surge heights in meters.

Figure 1. Survey route and measured storm surge height. (Shibayama et al., 2009a)

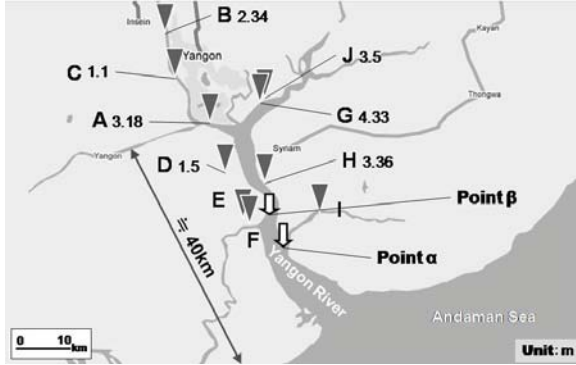
(1) Yangon Port (location A in Fig. 11: N16deg. 46min. 5.2sec., E96deg. 9min.43.5sec)

Figure 12 shows one example of flooded height in Yangon area. The storm surge height was around 1.2 m above the bank. The water flooded over port area and many boats are damaged to sink. The high water continued for around four days.

(2) Left Bank of Bago River (location G: N16deg. 46min. 58.84sec, E96deg. 14min. 01.61sec)

Fig. 11: Survey route and measured storm surge height. (Shibayama et al., 2009b)
