**COMPARISONS OF STORM SURGE DISASTERS IN ASIA
----CASES OF CYCLONES SIDR IN 2007 AND NARGIS IN 2008----**

Tomoya Shibayama¹

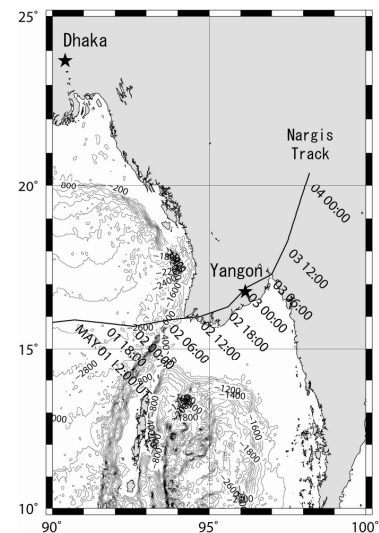
Figure 10: Track of Cyclone Nargis (Data from UNISIS and U. of Alaska). (Shibayama et al., 2009b)

The cyclone 'Nargis' hit the southern part of Myanmar on May 2nd and 3rd 2008. Figure 10 shows the track of Nargis and the contour map of southern part of Myanmar coast. This strong cyclone caused more than 130 thousands of loss of lives, enormous number of casualties as well as fatal damages to houses and paddy fields. Particularly both the downstream areas of the Irrawaddy and Yangon River basins were seriously damaged. In the present field survey, the activities were limited to the area near Yangon city due to strong governmental restrictions. As results of field survey through interviews to residents and measurements by using the laser type distant meter, it was found that the tide due to the storm surge was probably up to 2m and more and came up to around 50 kilometers upstream of the river mouth of Yangon River. In the followings, some of the survey results are summarized and described. In figure 11, the survey results are summarized.

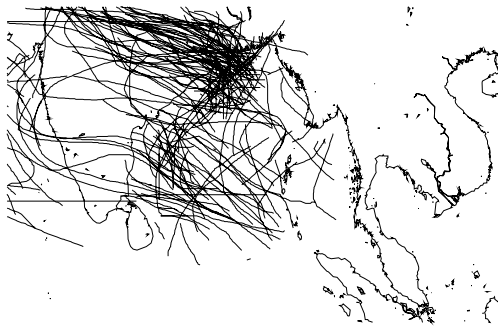
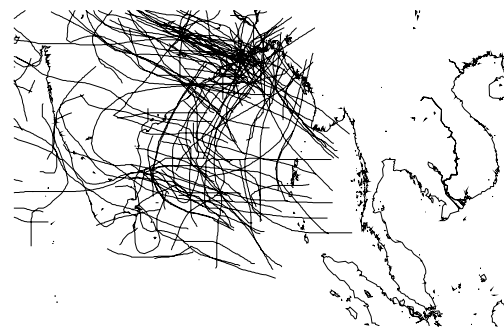
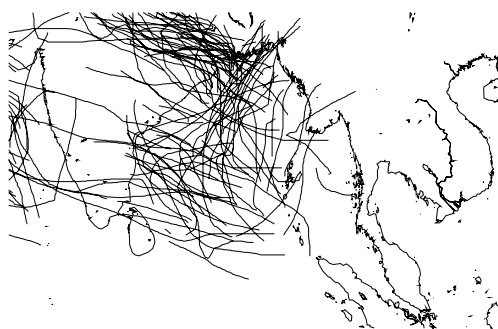
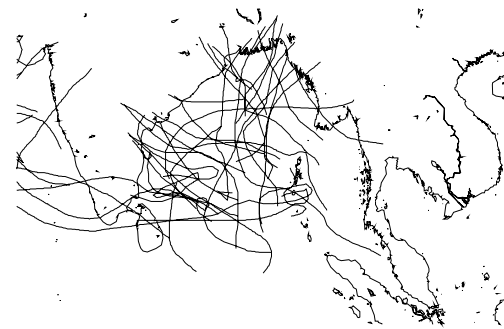
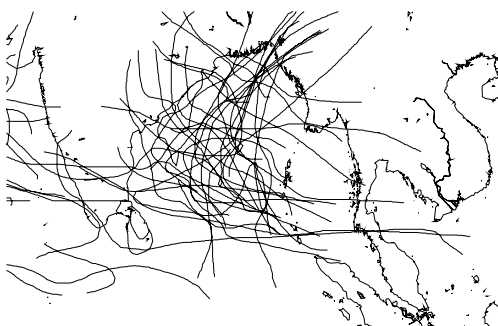
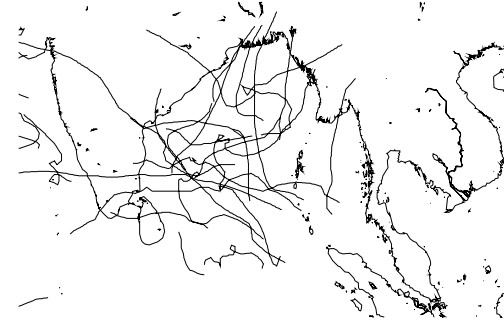
Figure 15: Historical paths of cyclones in the vicinity of Myanmar. (data from JTWC and Chu and Sampson, 2002) (Shibayama et al., 2009b)

Apart from the investigation, the tracks for the present and past cyclones (1945-2007) (see references UNISIS, University of Alaska, JTWC and Chu et. al) have been analyzed based on a string of best track data as shown in Fig. 15. The results reveal that quite a small number of cyclone (roughly 2 times on average every 10years) have hit the southern coast of Myanmar compared to the number of cyclones that hit the coast of Bangladesh, and that the route that Nargis traced is rather unique. Since the residents have few experiences of storm surge, they didn't get any image of the possible disasters when the storm surge came.
