## JETTIES AT BODEGA HARBOR

To create and maintain a navigable entrance for small craft between the Pacific Ocean and the natural lagoon now referred to as Bodega Harbor, the construction of two rubble-mound jetties and the associated dredging of interior channels were authorized by the United States Congress in the late 1930s. The jetties were built by the United States Army Corps of Engineers in the early 1940s. Elements of the planning, design, construction, monitoring, and maintenance of the jetties are discussed herein.

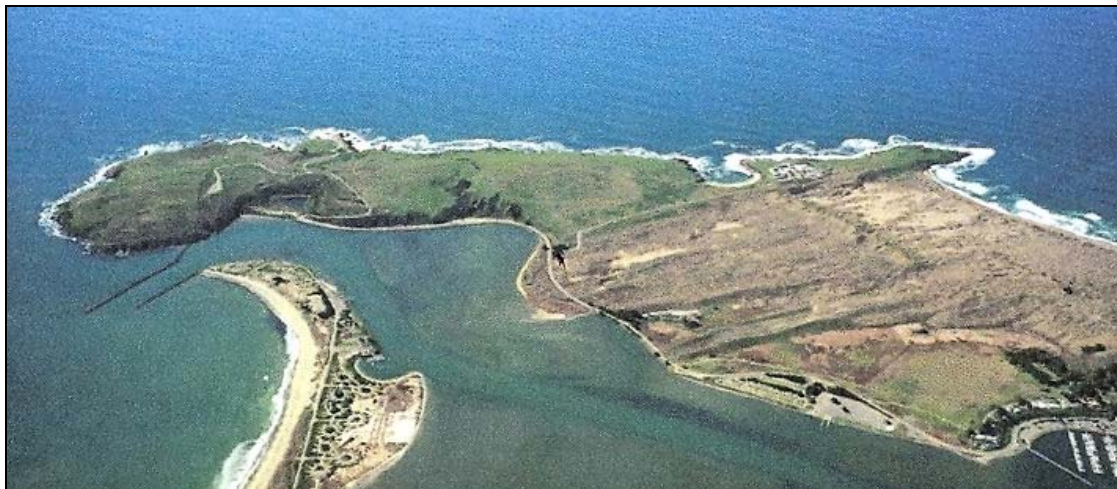
**Figure 1. Aerial View of Jetties and Dredged Entrance Channel at Bodega Harbor**

The project undertaken in the early 1940s by the United States government to improve the situation included two entrance channel jetties, a bulkhead to help retain the natural sandspit, and dredging of interior channels and turning basins. Figure 1 is an aerial view of the jetties, the sandspit, a portion of the dredged channels, and the seaward (western) end of the peninsula known as Bodega Head.

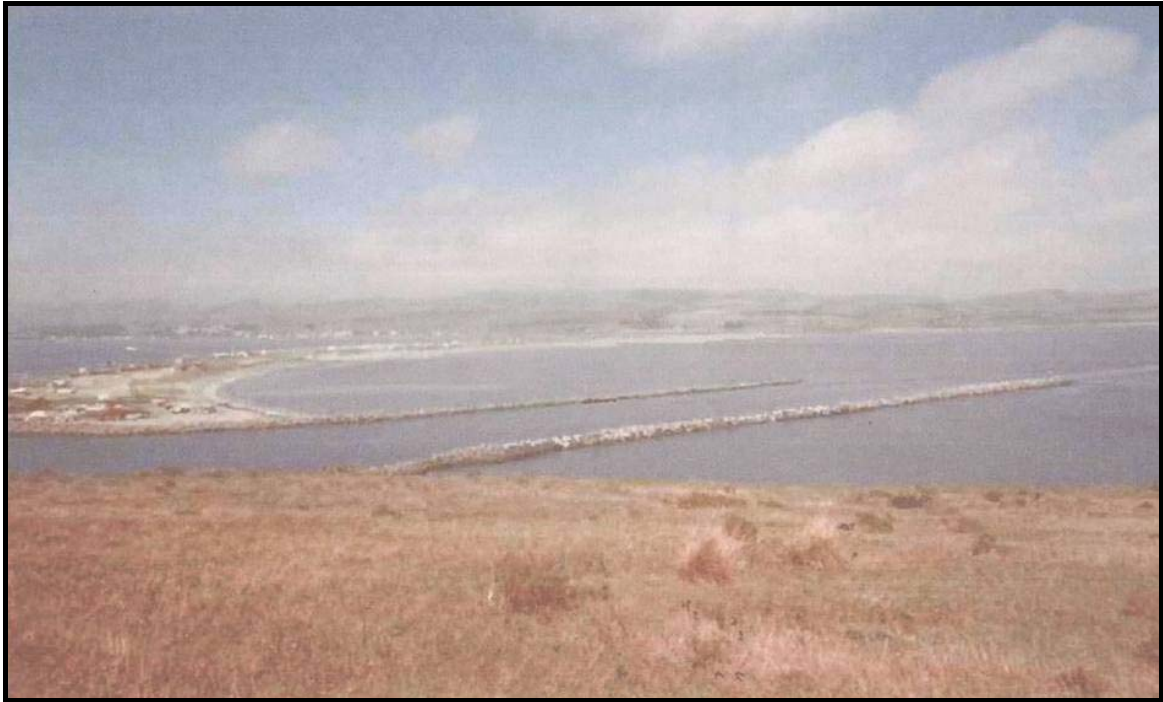
Figure 7. Bodega Harbor Jetties and Doran Beach Looking to the Northeast (1975)  
(Photograph by Lawrence B. Karp)

By the early 1960s, settlement and/or loss of armor stone had occurred along the seaward portion of the south jetty (Corp of Engineers, 1963). This area was rebuilt in 1961 where the crest of the seaward end of the south jetty was widened and the slopes flattened to 1V:2H. The amount of stone used to improve the south jetty was about 17,200 tons, slightly more than 10 percent of the tonnage used in the original construction. Improvements to the north jetty were not needed. The jetties were reviewed and observed in detail by Karp in 1975 (see Figure 7).

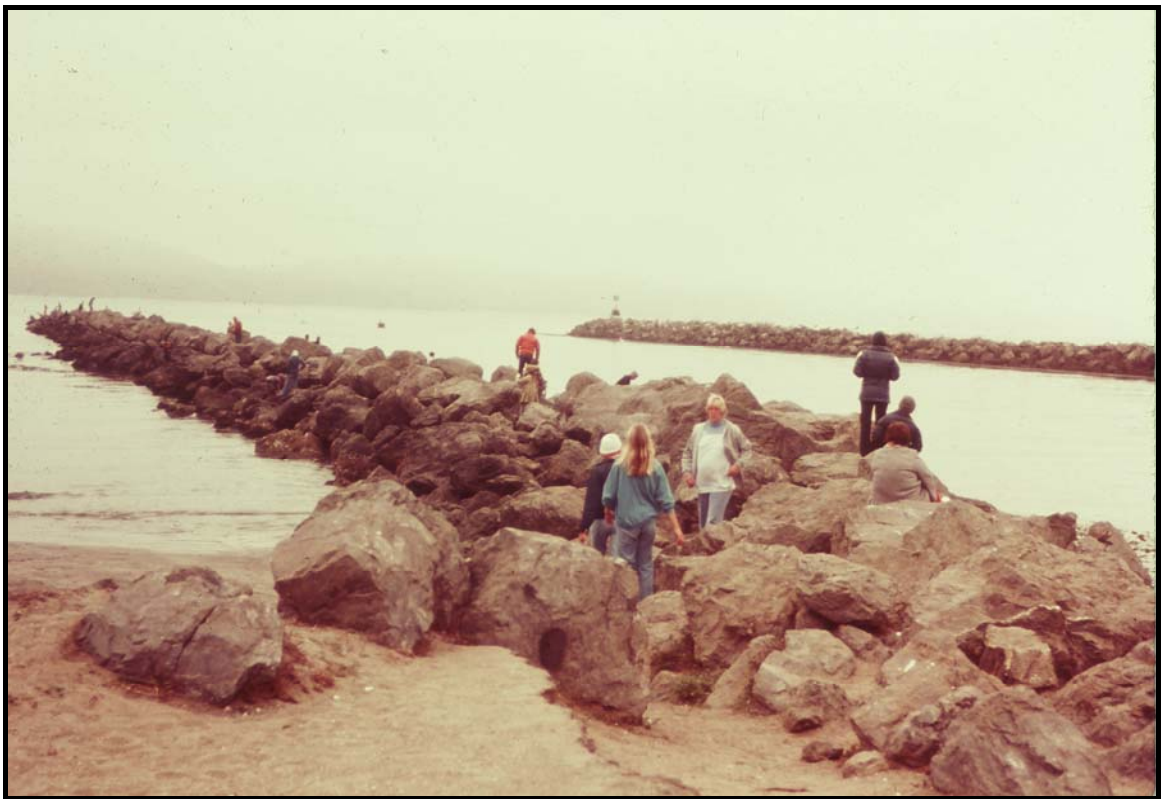
Figure 8. Bodega Harbor Jetties in June 2010  
(Photograph by Orville T. Magoon)

Given the well-documented maintenance problems and failures (Magoon, Sloan, and Foote, 1974; Whalin, 1994) that have plagued many coastal structures, it appears that the Bodega Harbor jetties have generally performed well over the decades. And, as relatively little shoaling has occurred in the improved entrance channel, the planning, design, construction, monitoring, and maintenance of both jetties is considered satisfactory and they are serving the purpose for which they were designed. This opinion was confirmed by visual observations made by the senior author in June 2010 (Figure 8).
