### SUBMARINE SIPHONS FOR ATHENS SEWERAGE SYSTEM

Description of the data collection for and the design, manufacture and construction of these submarine siphons are presented in this paper.

In 1983, the Greek Government undertook a \$100 million program dealing with the collection, transportation, treatment, and disposal of sewage of the greater Athens area serving a population of over three million people. The program involves the collection of sewage from the mainland and its transportation to the small island of Psyttalia through two 1300 meter long submarine siphon pipelines with an inside diameter of 2.8 meters. A treatment plant on Psyttalia will process the sewage prior to its ultimate disposal through a 1600 meter long diffuser outfall into the 60 meter deep water of the Gulf of Saronikos.

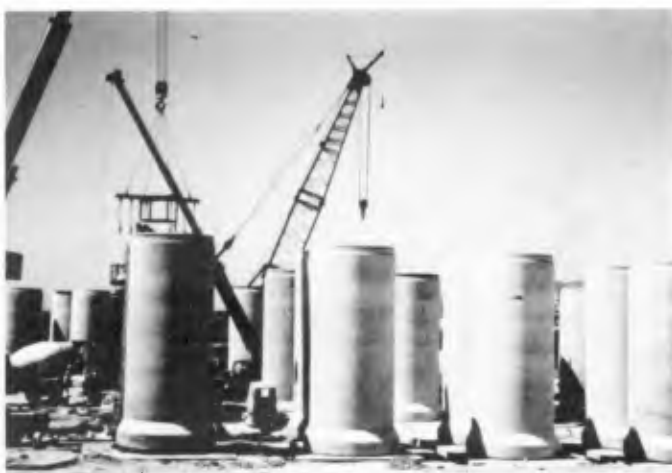
**Figure 8**

**PIPE PLANT**

The pipe was cast-in-place vertically with the raised bell down. Three sets of forms were fabricated locally with some of the problems which should be expected. The tolerances on the bell and spigot

The double reinforcing cages were fabricated at the jobsite using PIPE's imported machine, which they had used on San Francisco's Southwest Ocean Outfall Project.

The concrete was batched on the job into ready mix trucks and then craned into place. As the local aggregates are not high strength, the Contractor elected to use generous proportions of cement, resulting in exceedingly high compressive strengths. The Greek Ministry of Public Works maintained a complete and competent inspection force at the jobsite.

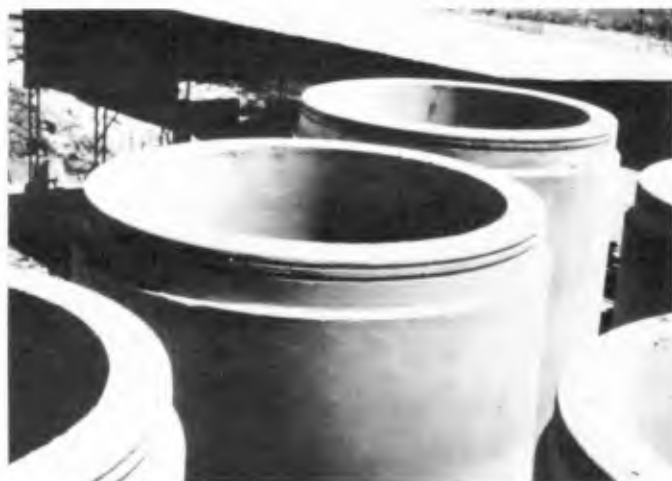
**Figure 9**

**PIPE SPIGOT DETAILS**

The spigot is the "tenderest" part of the pipe, and any spalling or cracking of the front edge usually results in a test failure at installation, which is a costly expense to the Contractor. Unfortunately, due to the nature of the spigot being cast up, this concrete has the least consolidation, most segregation, air entrapment and laitence formation requiring extraordinary care in concrete placement, vibration and finishing. Unfortunately, this lesson is not appreciated until major problems are encountered with the laying, at which time a considerable amount of defective pipe has already been cast.

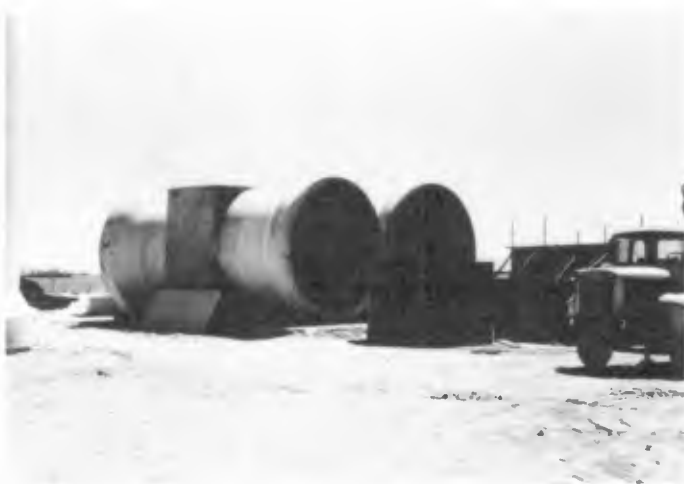
Figure 10

**DOUBLE BELL SECTION**

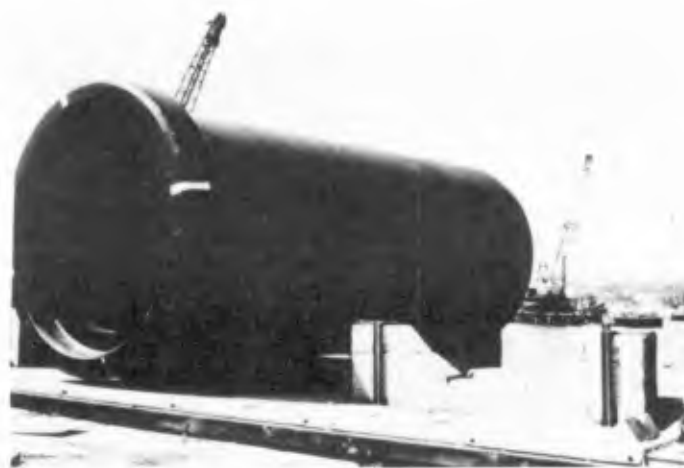
Figure 11

**COAL-TAR EPOXY FINISH ON PIPE**

The epoxy painting of the interior and exterior was an unusual requirement and made for a very high-quality finish, which should more than pay for itself in increased longevity and flow characteristics. A side benefit was that the light sandblast prior to application of the paint revealed many air-entrapped pockets under the grout surface, particularly on the interior of the pipe, including high porosity conditions at the rebar chairs. These areas were epoxy patched before painting.

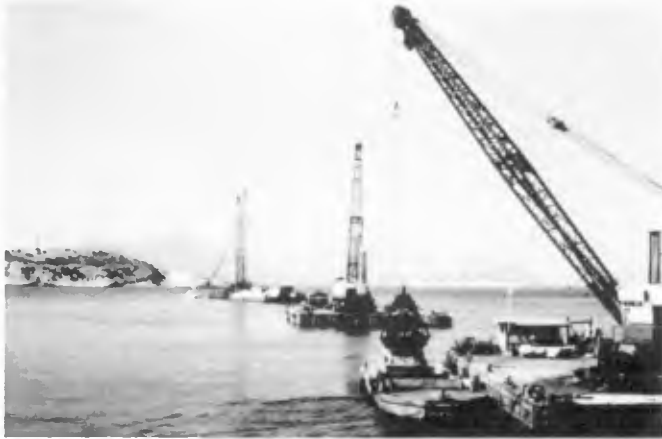
Figure 12

PIPE TRENCH EXCAVATION

The trench was dredged in its entirety using three 2400 Lima barge-mounted cranes clamming into small dump scows (i.e., 250 m<sup>3</sup>) and disposing of the material a short distance away.

The 7-meter deep trench in the seabed was founded generally in hard clayey sand, posing considerable problems for the Contractor. One-half of the material lies below a 40-meter depth and almost three-quarters below 30 meters.

Upon experiencing the hardness of the seabed material, the Contractor elected to help offset the adversities by excavating the trench to the minimum width (12 meter) with the side slopes standing competently at near vertical. This, of course, minimized the quantity of material to be excavated and the quantity of manufactured rock backfill to be produced and placed. The minimum width combined with the vertical side slopes did cause some difficulty in trying to maintain adequate clearances for the pipe laying, as one can imagine the difficulties in trying to clam a 12 meter-wide groove 40 plus meters below you in the blind!

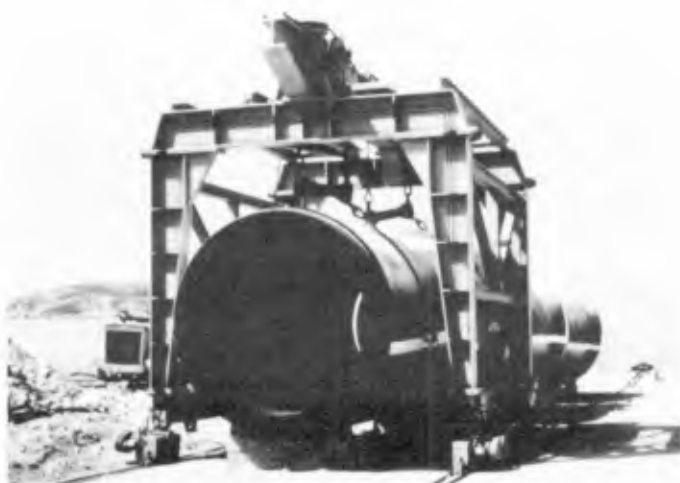
Figure 13

**PIPE CARRIER**

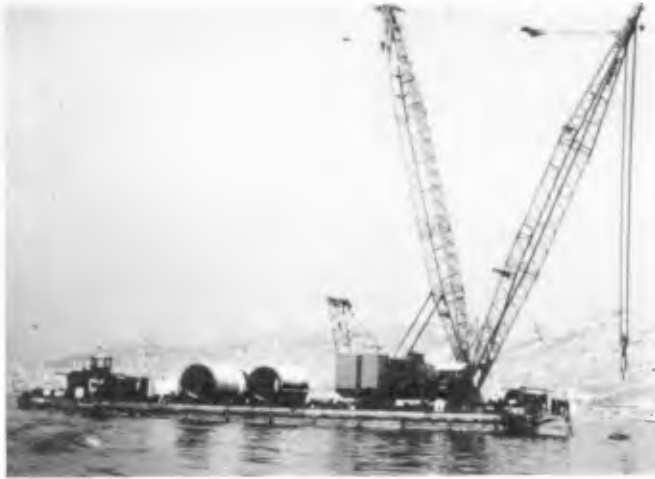
Figure 15

**PIPE LAYING BARGE**

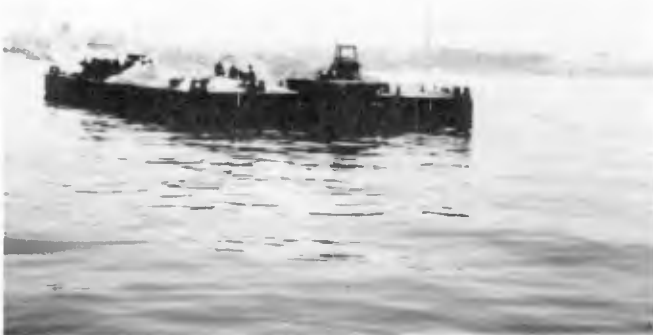
Figure 16

**BACKFILL BARGE**

The armor rock was very laboriously placed using the 2400 Lima clamshell rigs -- up to four rigs operating at a time, which in the end ran the rock quarry dry.

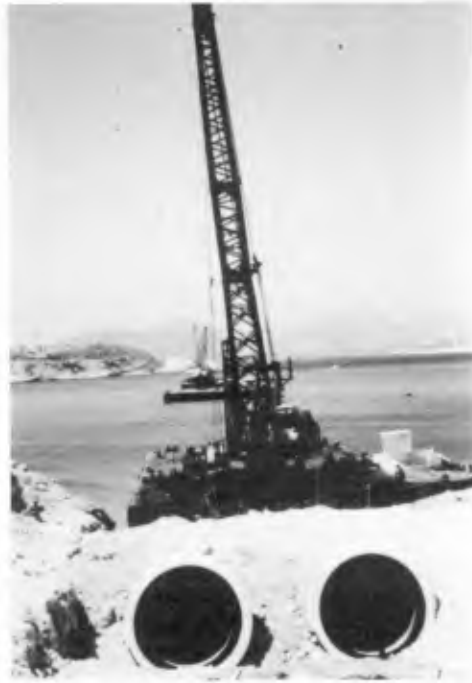
Figure 17

ON-SHORE TERMINUS  
OF SIPHON PIPES
