Comparison of Sill and Revetment in Reducing Shore Erosion and Wave Overtopping

Z. Tugce Yuksel and Nobuhisa Kobayashi

Center for Applied Coastal Research, University of Delaware, USA

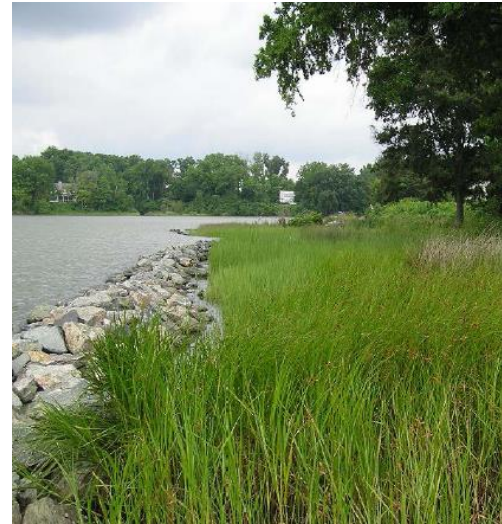
Typical Sill
Living shoreline
engineering guidelines
New Jersey Department
of Environmental
Protection, 2016

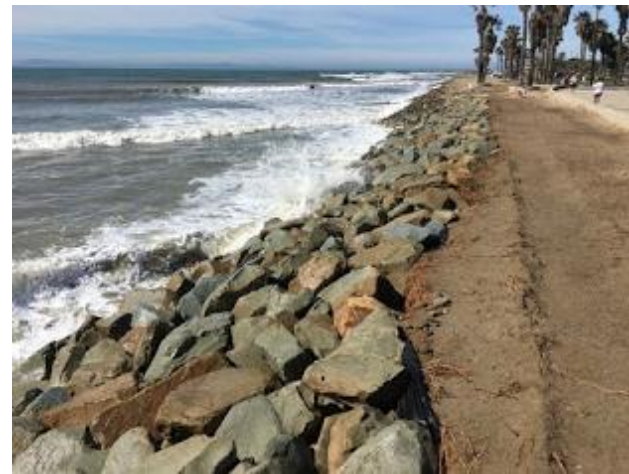
Revetment
Ventura rock revetment,
Ventura river ecosystem, 2017

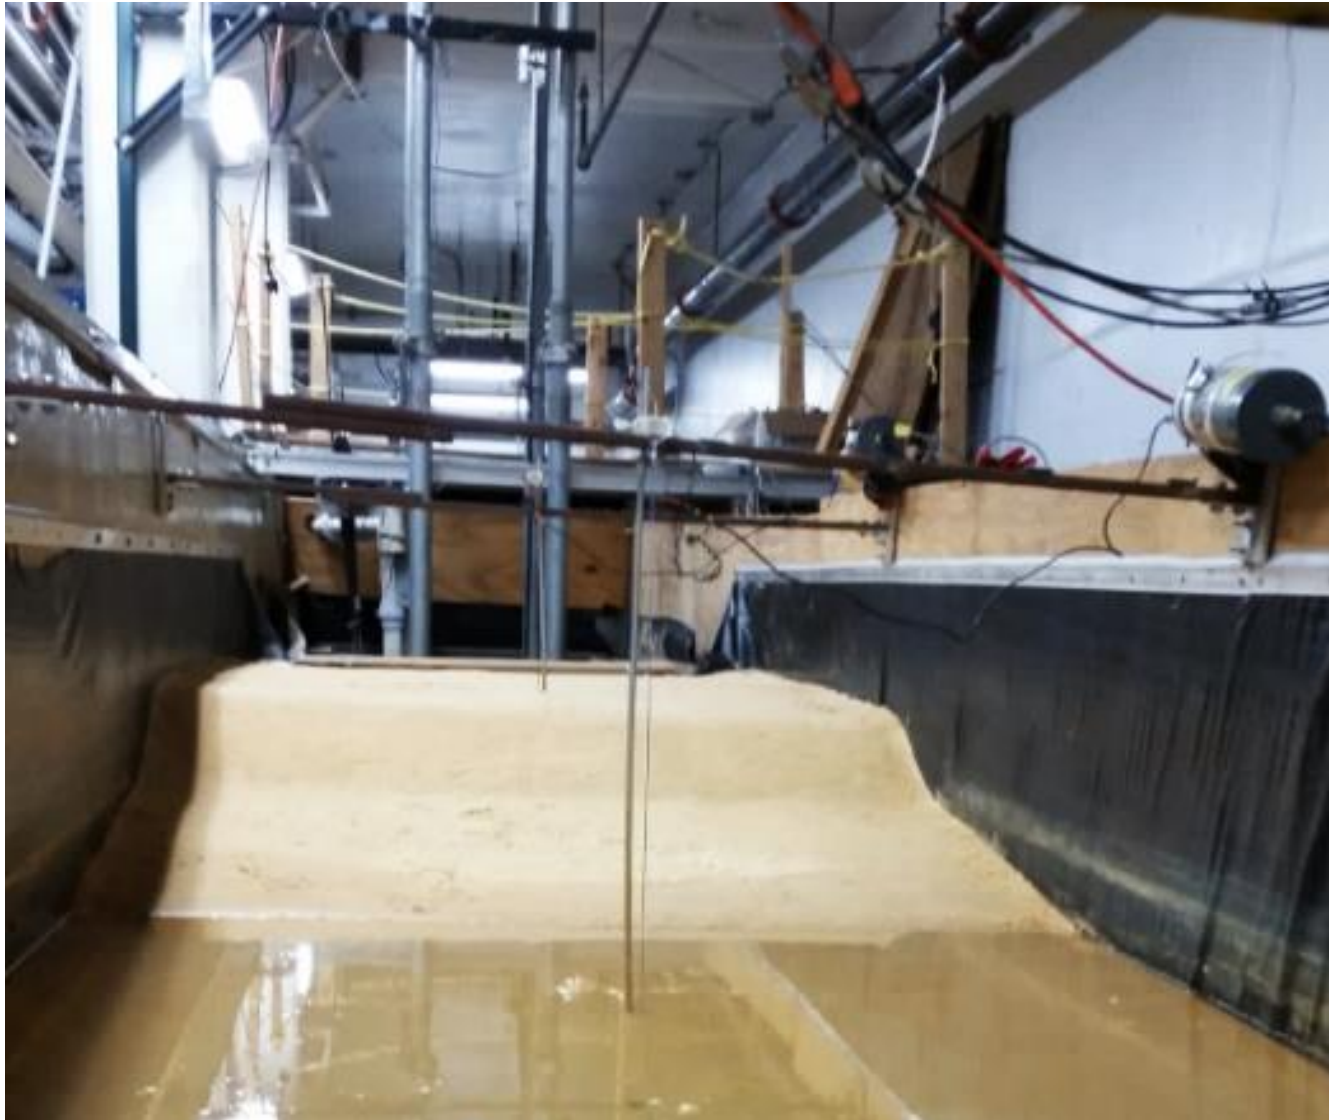
Berm in no protection test N

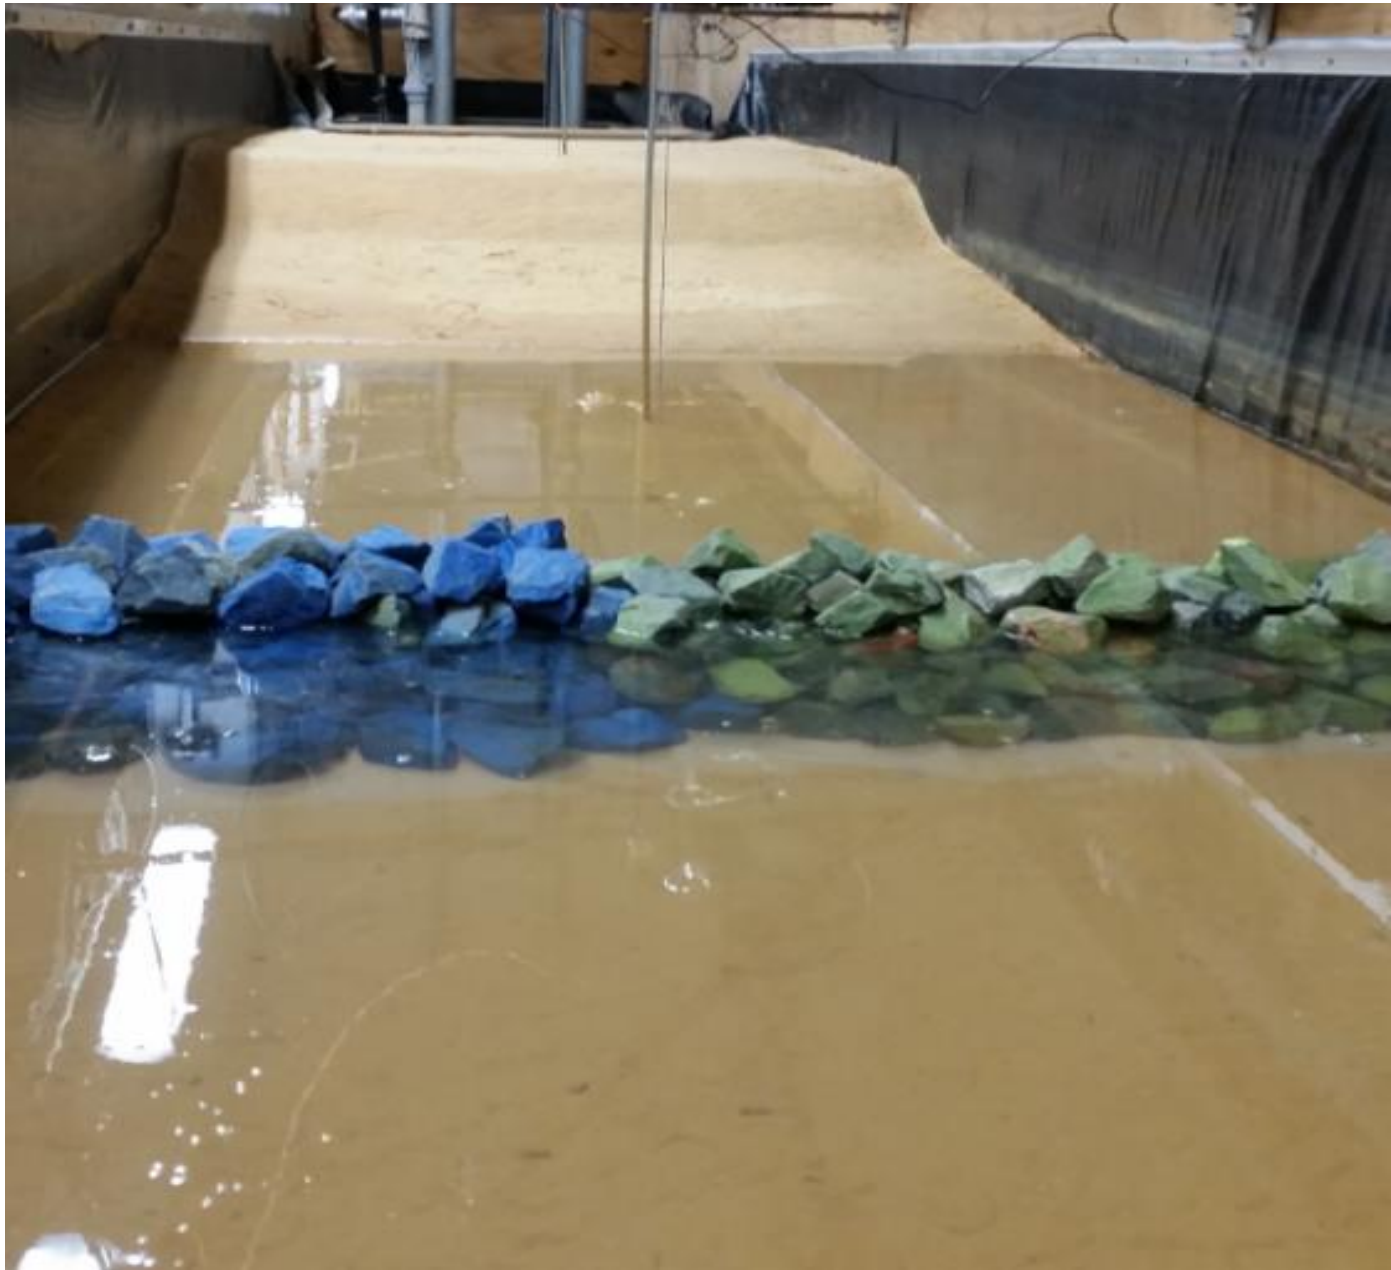
Berm protected by sill in test **S**

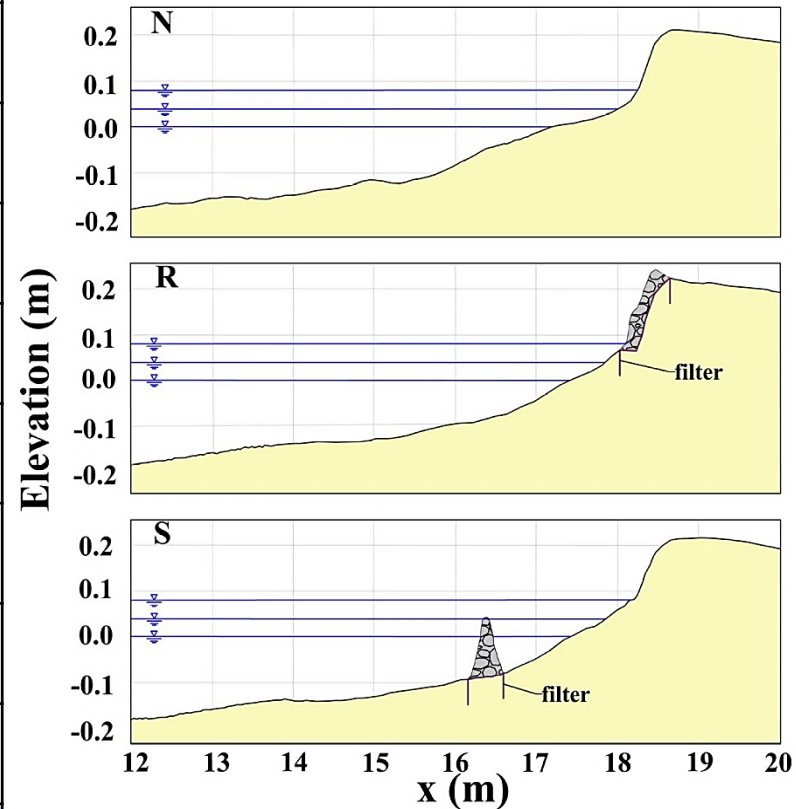
Sequence of 3 tests with still water level increase of 4 cm after 10 runs (400-s duration for each run)

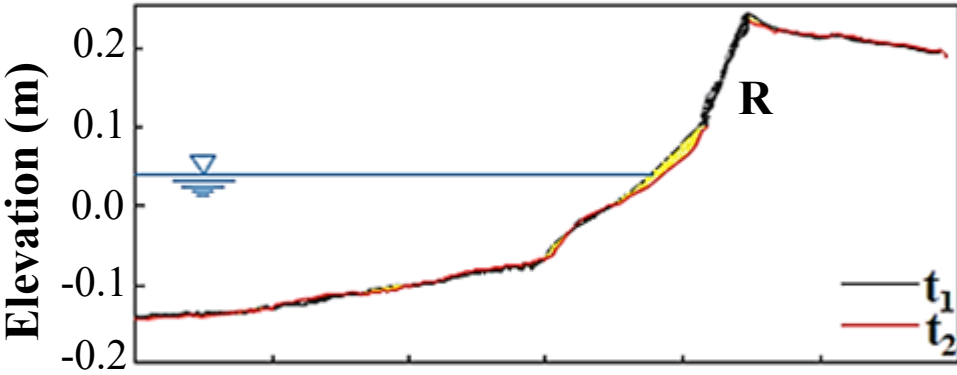
Stone surface settlement.
Minor erosion at toe and crest of revetment.

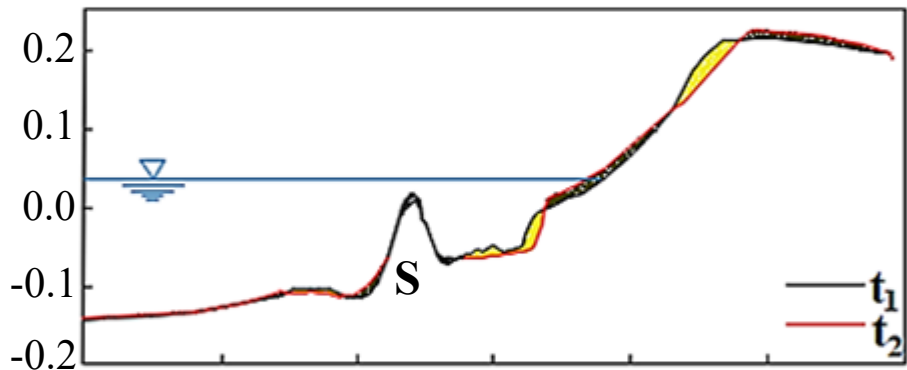
Reduced onshore sand transport and sand accretion on berm crest.

Stabilized sill crest.

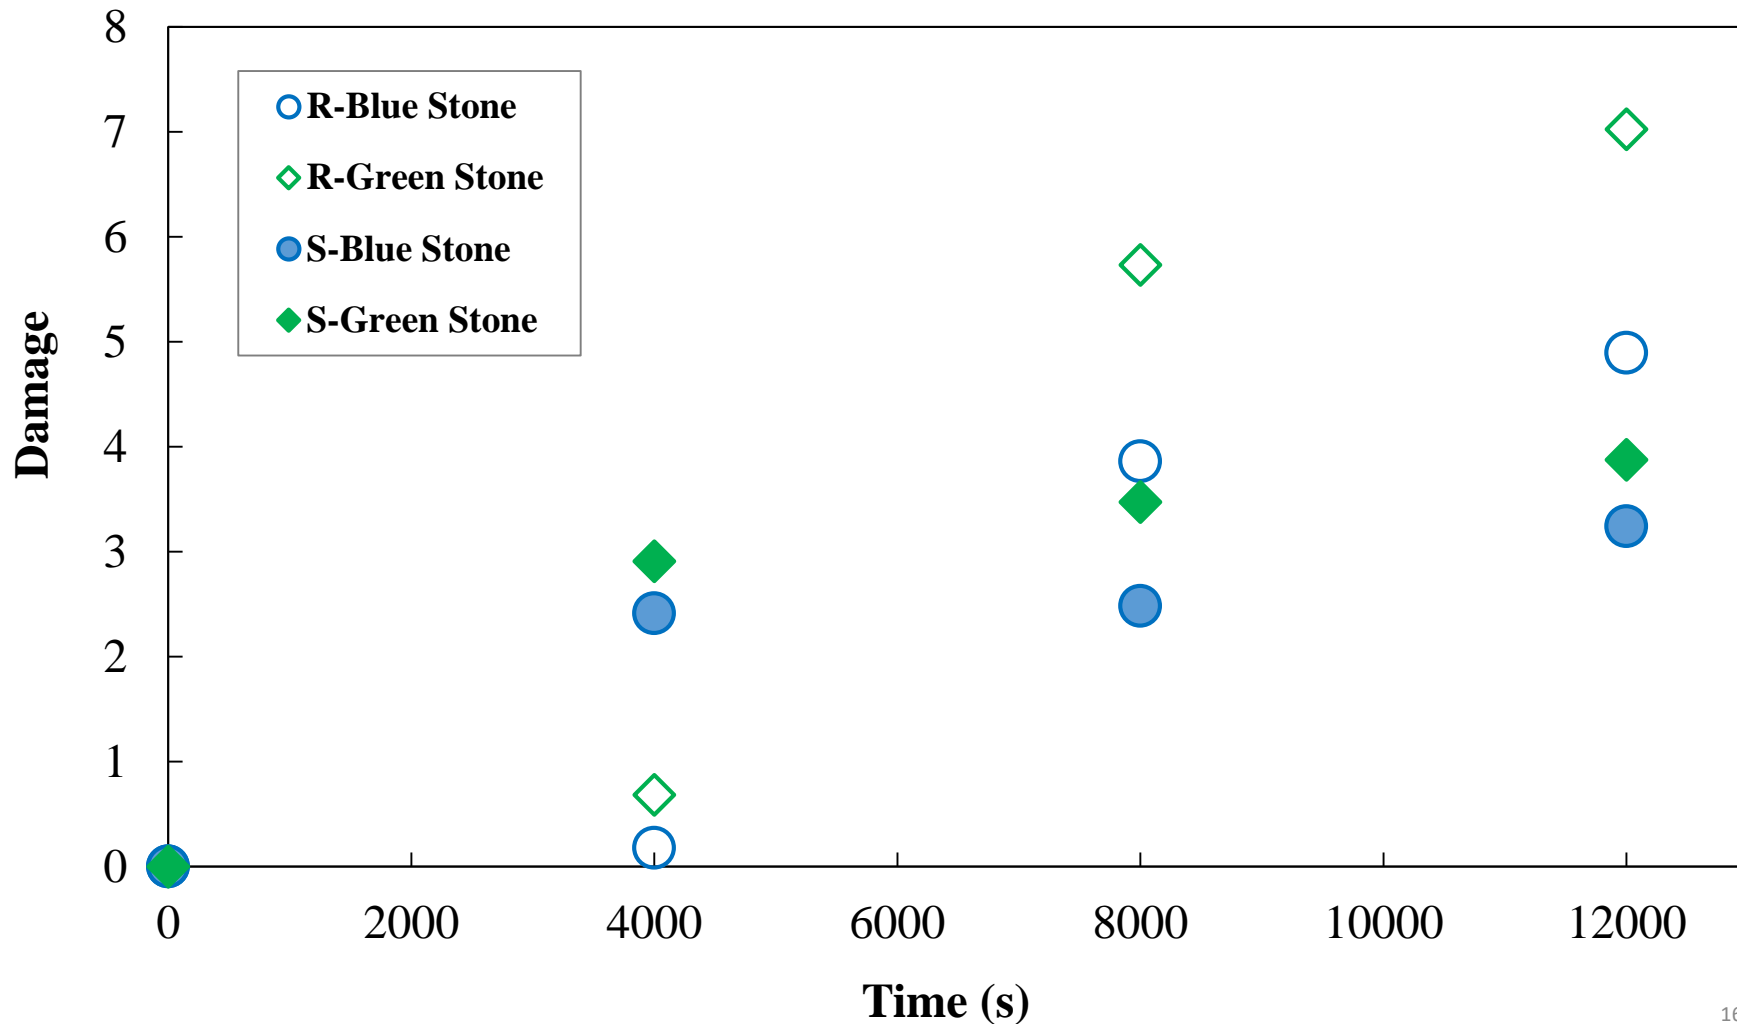
Damage = (eroded area in stone zone) / (nominal diameter)²

Damage progression of blue and green stones in tests **R** and **S**.

More damage for slightly smaller **green** stones.

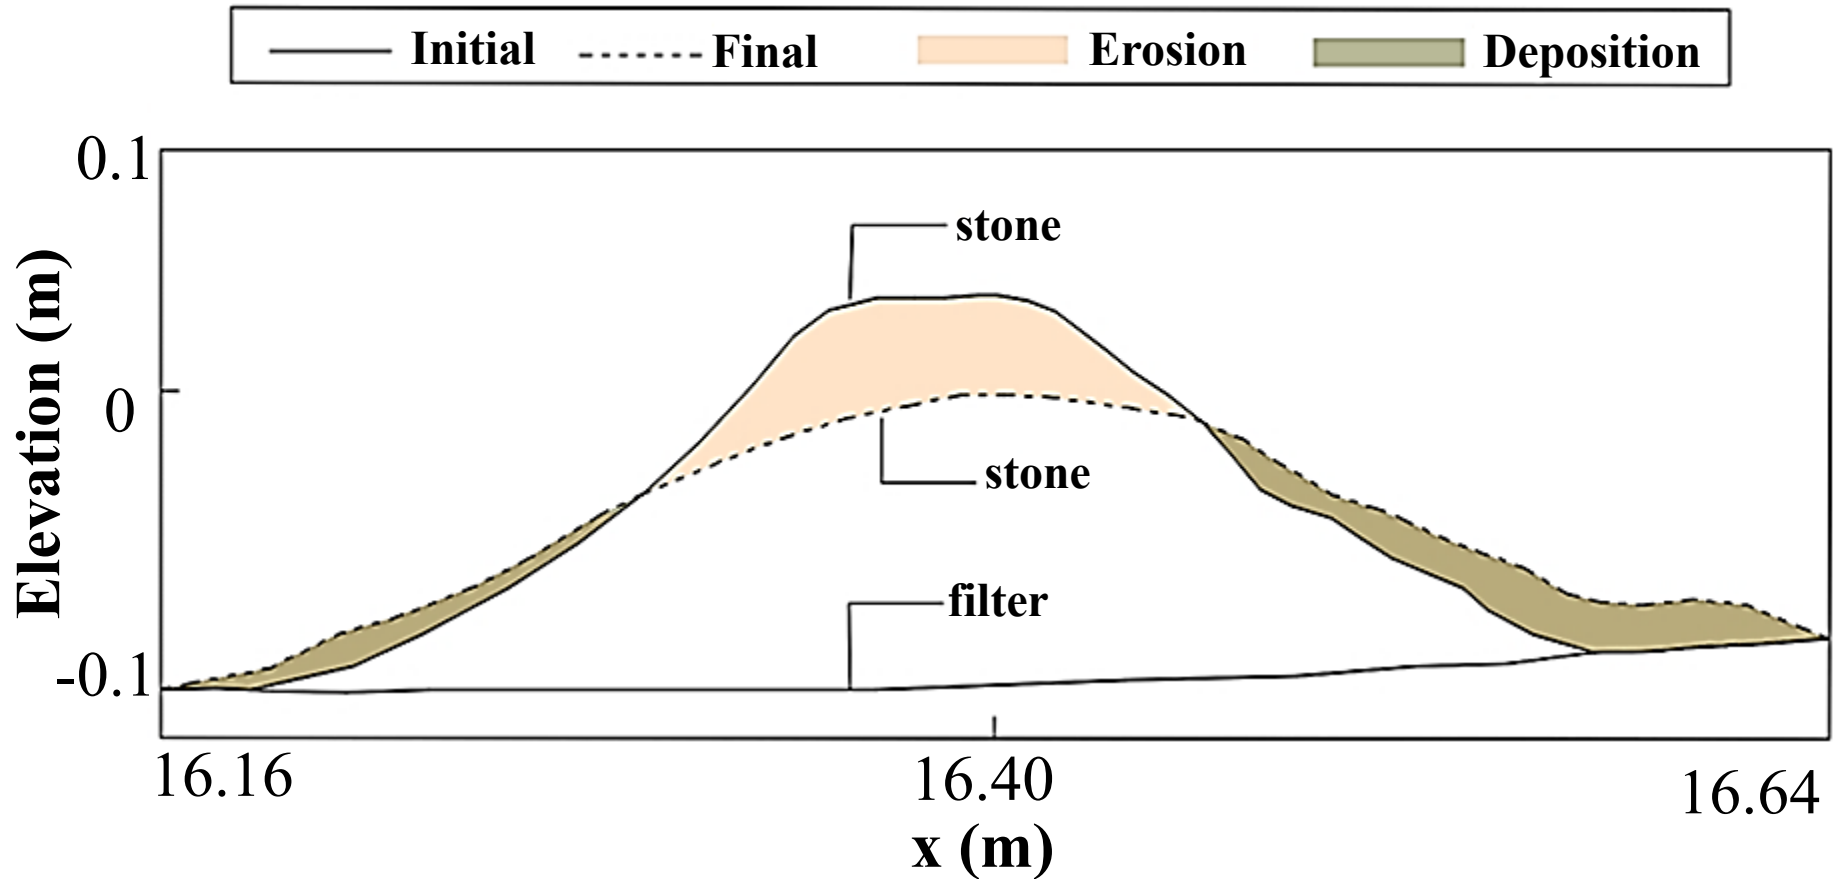
Measured stone surface and filter elevations before and after test **S**

Sill damage was caused by landward and seaward displacement of piled stones on its crest.
